The Great Eastern Japan Earthquake and Tsunami

Field observations on the coast of Tohoku six months later

NOVEMBER 2011

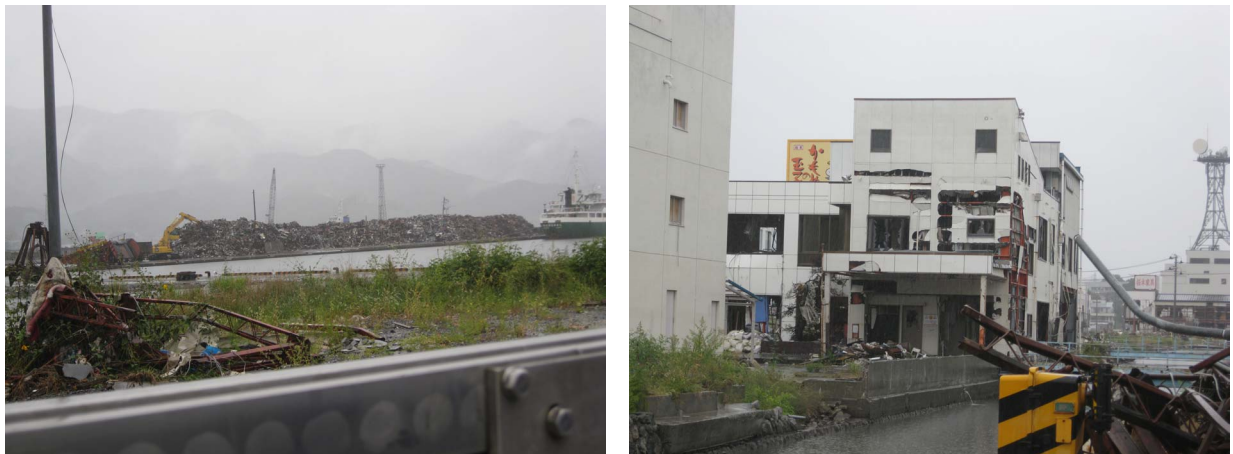
Figure 7: Left: Accumulations of debris in Ofunato port; Right: Damage of steel frame building. The height of the damage is indicative of the inundation height.

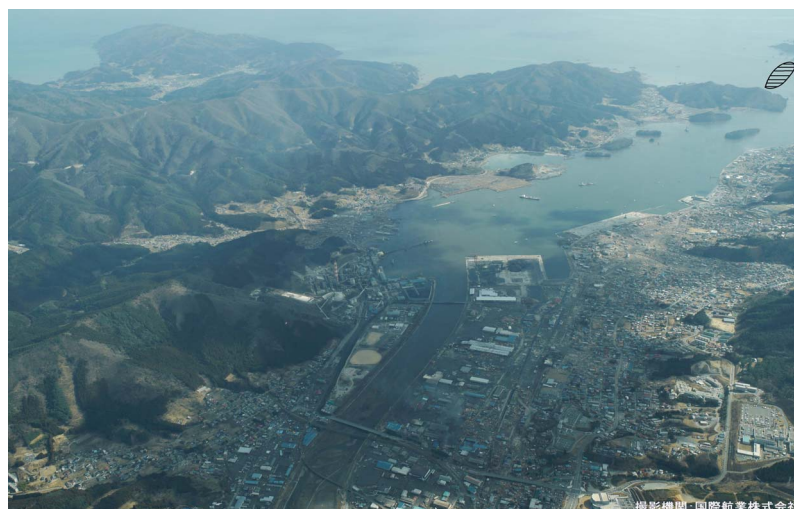
The bay of Ofunato used to be protected by an offshore tsunami breakwater, which after the tsunami of March 11, was completely disappeared. This breakwater was designed to withstand the attack of the Chilean tsunami that caused severe damage in the area in 1960, but still much smaller than the one of March 2011. It is still not clear what was the mechanism that caused this catastrophic structural failure.

Figure 8: Ofunato bay on March 12, 2011. The position of the completely destroyed tsunami breakwater is designated on the upper right corner (Kokusai Kogyo Group; www.kk-grp.jp)

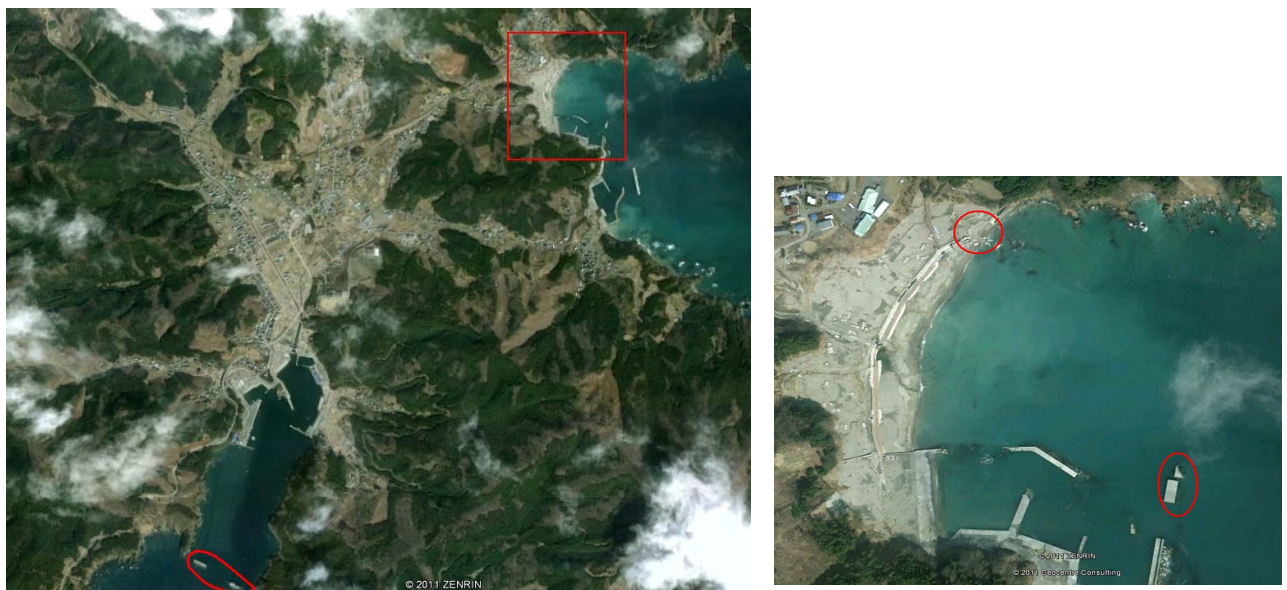
Ryori is a town 8km to the east of Ofunato in a smaller bay, protected by a caisson breakwater. On the east of the town there is another small bay with a sandy beach and a harbor. There is a tsunami wall on that beach that was overtopped, and seriously damaged, with a big breakage on its north end.

Figure 9: Left: Ryori bay after the tsunami. The severely damaged caisson breakwater and the sandy beach with the tsunami wall are designated; Right: Zoom in the tsunami wall bay. The large breakage on its north end, and the severe damage of the caisson breakwater are noted (Google Earth images, 2011)

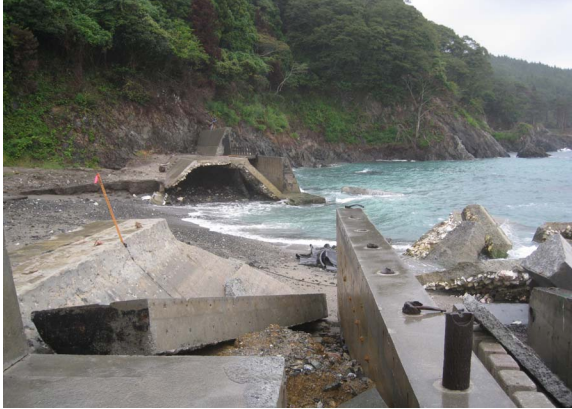
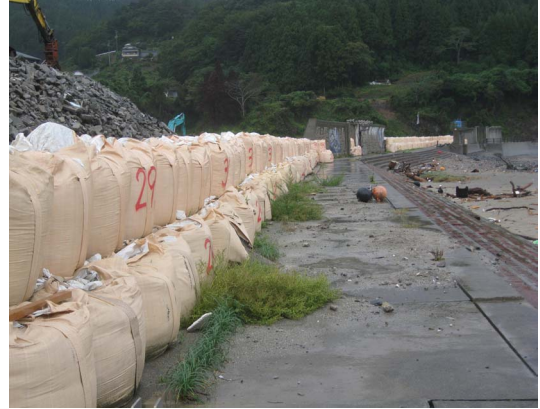
The tsunami gates that were originally attached on the wall were displaced. It is notable that the gates were displaced towards the seaside, which shows that the cause of their failure was the run-down of the tsunami. At this area the maximum reported run-up height was more than 24m, in a distance of about 500m from the waterfront. As the land slope is quite steep in that area, a forceful run-down must have been induced. On the backside of the wall there were large accumulations of debris and stones, which can also be evidence of a forceful run-down. There were works taking place for the temporary strengthening of the structure with placement of sandbags. The caisson breakwater of the small harbor was seriously damaged as well.

Figure 10: Left: Large breakage of tsunami wall in Ryori; Right: Temporary protection measures against storm surges.

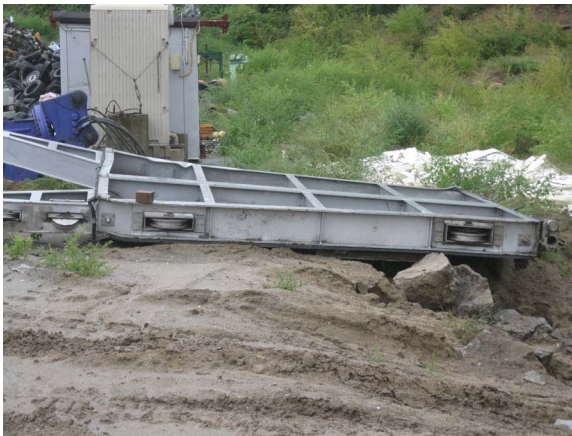
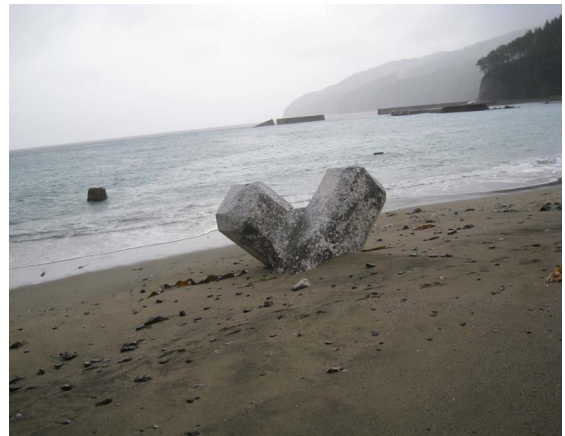
Figure 11: Left: Detached tsunami gate; Right: Severely damaged caisson breakwater. The armour unit was part of its outer side protection.

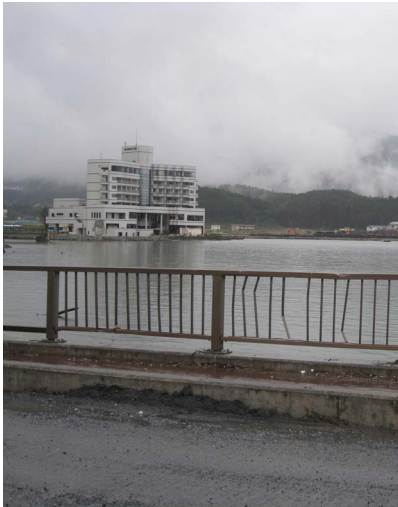
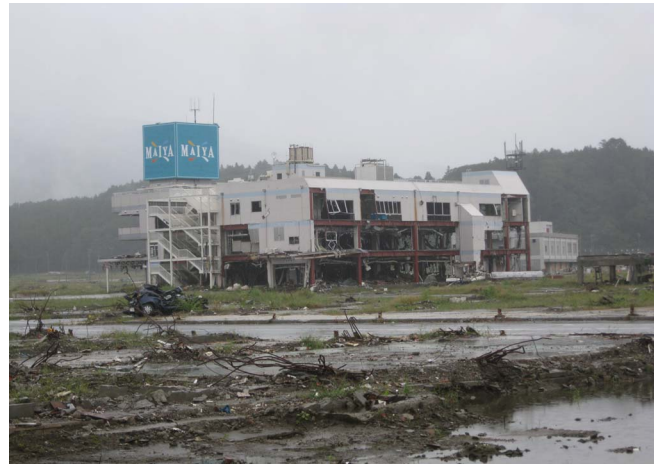
Figure 15: Left: Concrete building that survived. It might have also been evacuation building. Right: Damage on steel frame building.

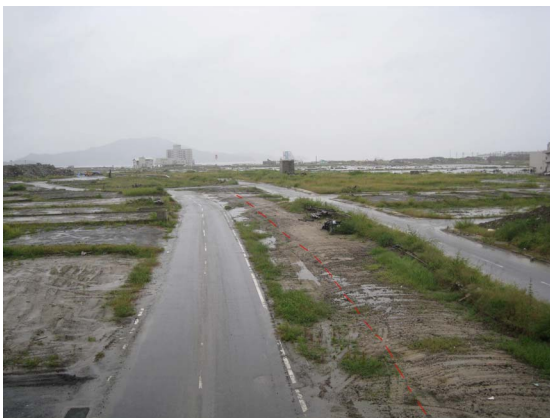
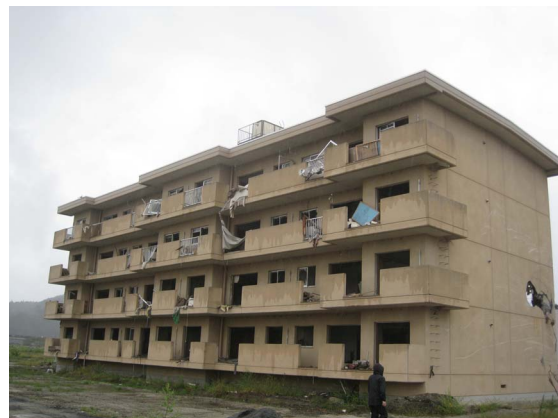
Figure 16: Left: Empty space that used to be a railway reaching a station. Both rails and station were devastated. Right: concrete building that was overtopped.

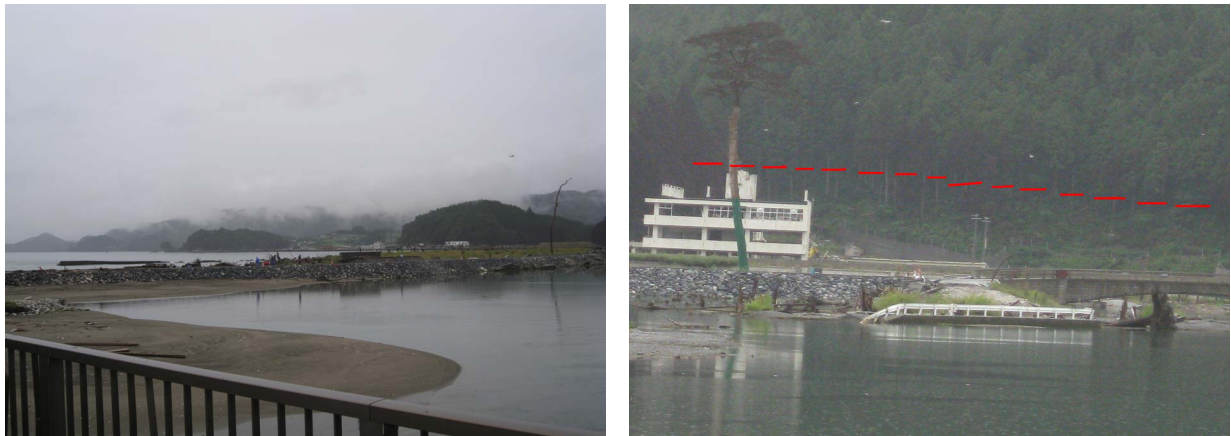
On the waterfront, there used to be a coastal forest of more than 70,000 pine trees, which was devastated. There is only one tree left standing in that area. The removal of trees can be used as an indicator of the tsunami drag forces. All over that place there was evidence of subsidence, which exceeded 1m near the waterfront. As the waterfront was so seriously damaged, the risk of further coastal erosion due to a storm or a typhoon is increased. Hence some urgent measures have been taken to prevent further erosion of the shoreline, with use of sandbags or rock armoring. The inundation depth near the shoreline reached the 15m. On the west side of the city there is a river reaching the coast, along which the tsunami run up several kilometers. Some of the river viaducts survived the tsunami, while others were seriously damaged with their slabs removed.

Figure 17: Left: Area of the former coastal forest of Rikuzentakata. On the right the only tree left can be seen. Right: The lone standing tree a few months earlier. On the background the corrosion of the first lines of woods is indicative of the inundation line, demarcated by the red line.

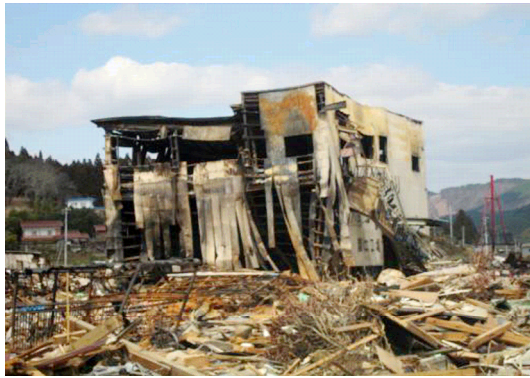
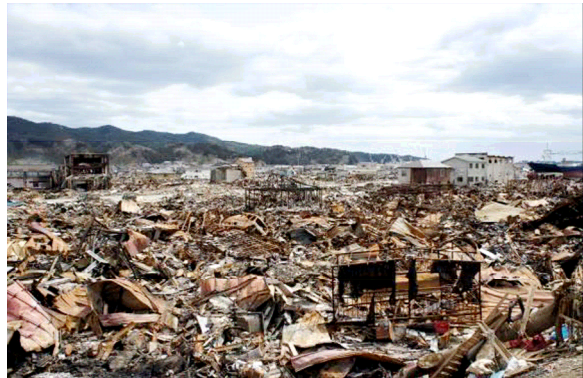
Figure 19: Damages in Kesennuma photographed one month after the tsunami (DPRI, 2011)

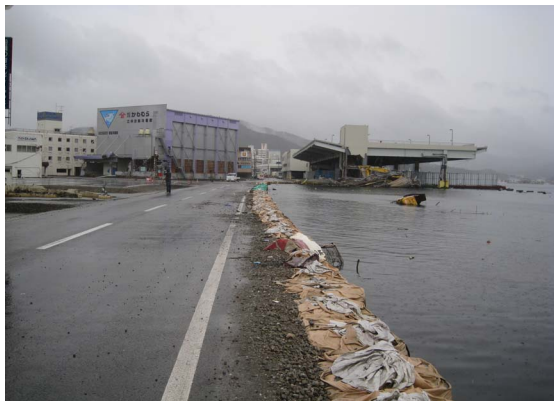
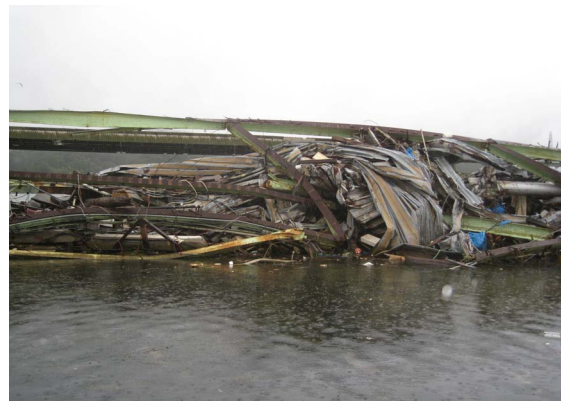
Figure 21: Left: Temporary land protection, Right: Destroyed warehouse on former quay wall

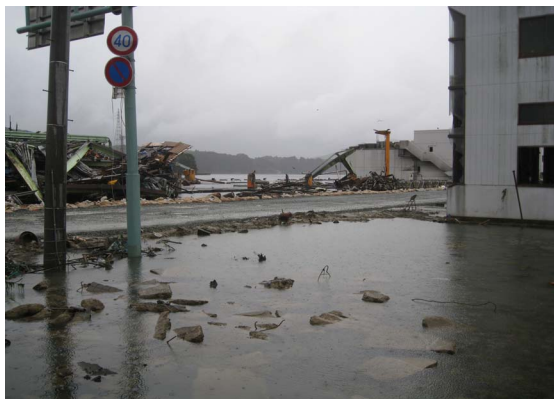
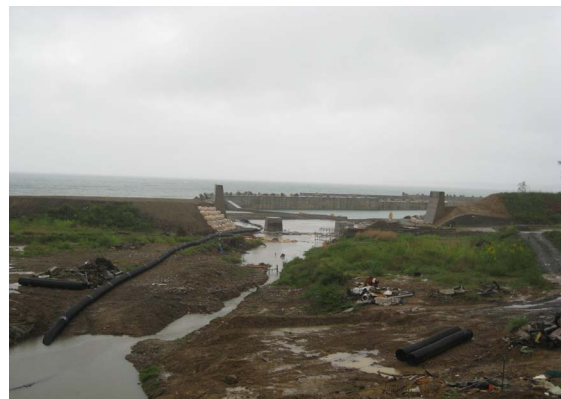
Figure 22: Left: Subsided land, Right: Retaining works at severely subsided land near Kesennuma

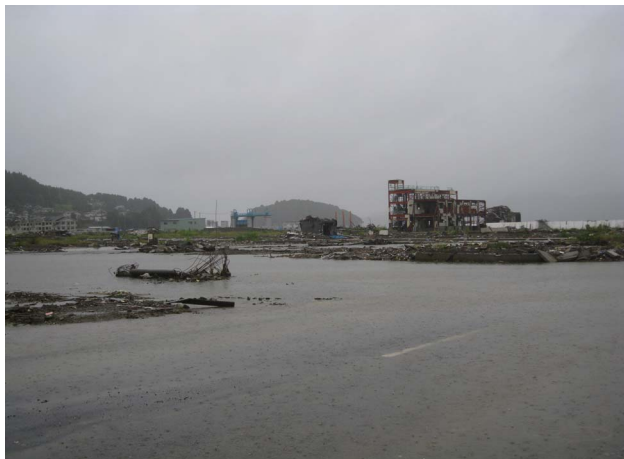
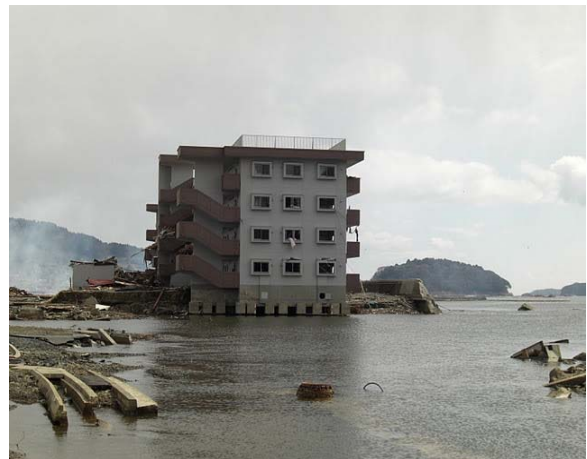
Figure 26: Left: Subsided land near the shoreline; Right: Evacuation building on the waterfront that was just overtopped, people sheltered on the top of it survived (The 2011 Tohoku Earthquake Tsunami Joint Survey Group; www.coastal.jp/tsunami2011)

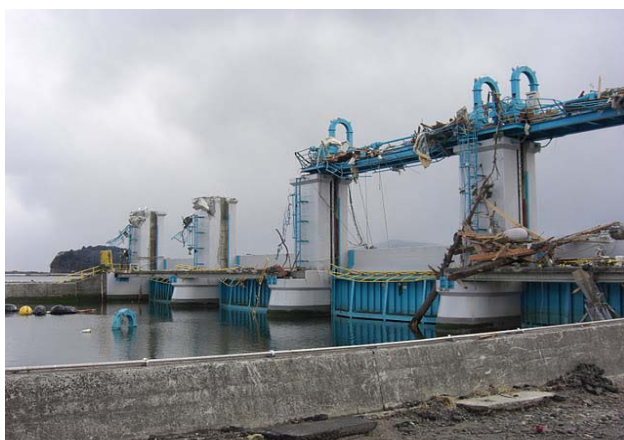
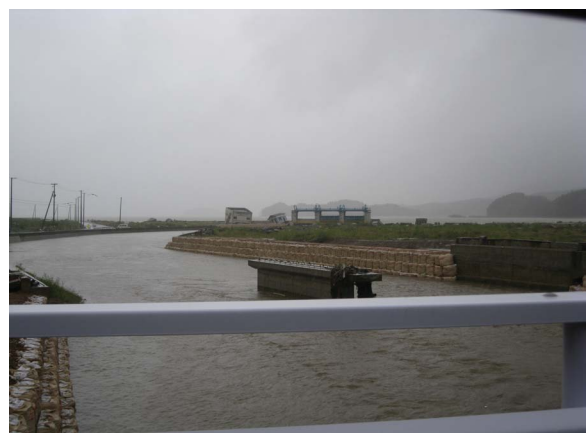
Figure 27: Left: Severely damaged storm-surge gates (The 2011 Tohoku Earthquake Tsunami Joint Survey Group; www.coastal.jp/tsunami2011) Right: Temporary retaining measures on the riverbanks and lone standing bridge abutments. The slab was washed away.

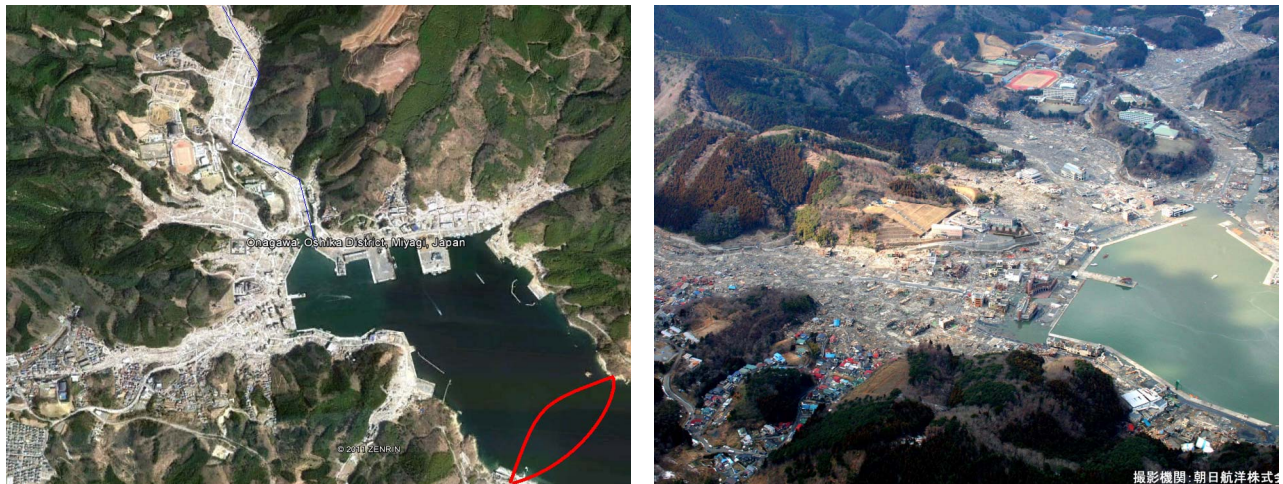
Onagawa is located further to the south of Miyagi prefecture, yet still in the ria coast, almost south end of it. This town had a lot of attention from the media due to extensive damages. The bay of Onagawa was protected only against storm waves by a caisson breakwater, and not against tsunami. This breakwater was completely destroyed.

Figure 28: Onagawa after the tsunami(Google Earth image, 2011). Left: satellite picture where the position of the totally destroyed breakwater is indicated (Kokusai Kogyo Group; www.kk-grp.jp)

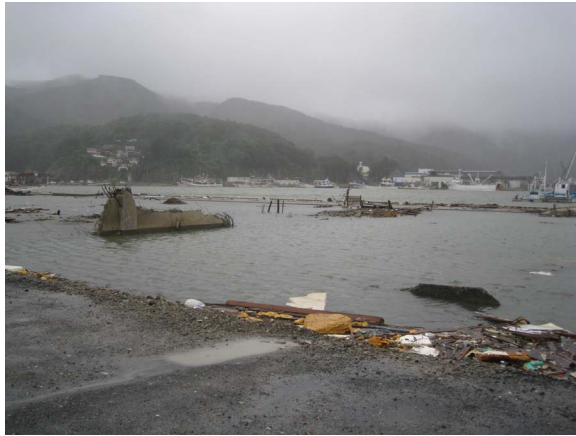
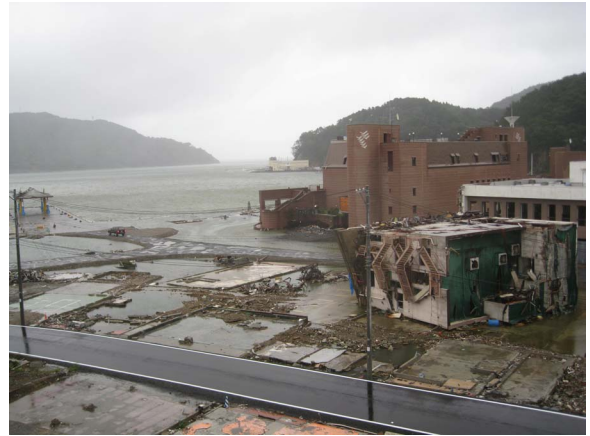
In the low-lying part of the city all wooden buildings were devastated, while it was interesting to see that many concrete buildings were overturned. It is believed that the cause of this special type of failure was the fact that those buildings had pile foundations that due to the earthquake were detached from the bottom of the building, and as a consequence the uplifting tsunami forces overturned the entire building. Liquefaction might have also played a role to this failure. Furthermore, some significant subsidence at the waterfront was evident, like in most areas in the rias. The inundation height near the shore was around 15m.

Figure 30: Devastated waterfront of Onagawa. Note the overturned building on the right picture.

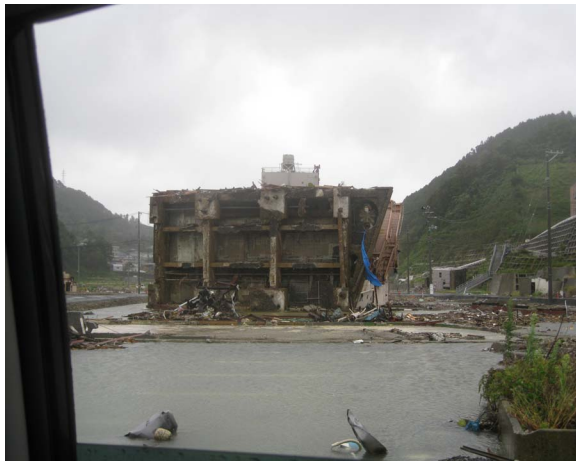
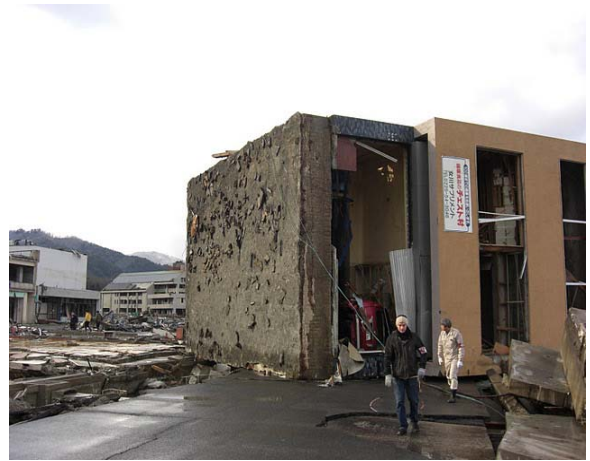
Figure 31: Overturned buildings (Left: The 2011 Tohoku Earthquake Tsunami Joint Survey Group; www.coastal.jp/tsunami2011)

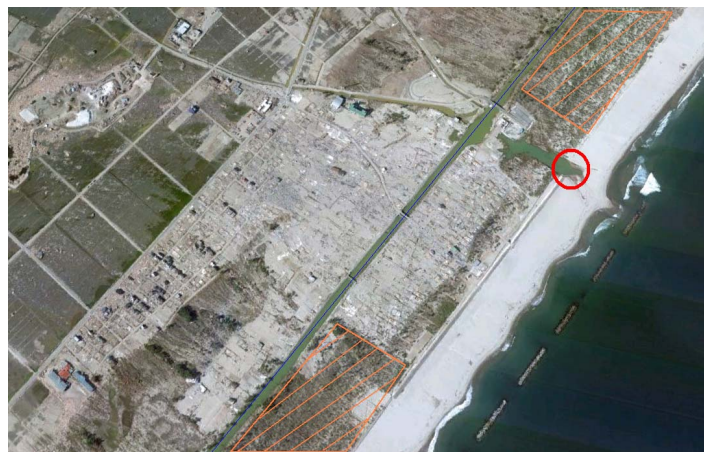
Figure 32: Arahama after the tsunami. The breakage on the sea levee is remarked with red, and the devastated forest zone is remarked with orange (Google earth image, 2011)

The levee was overtopped by the tsunami of March 11 and propagated to the flat land, inundating many square kilometers of rice paddies, and devastating a coastal pine tree forest and the settlement. A big breakage of the levee can be found on the northeast of the settlement. The inundation depths in Arahama were relatively lower than the ones recorded in the coastal cities in the rias. The watermarks and damage on concrete buildings that survived the tsunami were up to the second floor. It is notable that some concrete buildings behind the dike that were founded on sandy subsoil did remain in place, yet with significant scouring on their toe, which exceeded 2.5m. Scouring due to overtopping tsunami waves is considered to be the main cause of failure of the sea levees in that area.

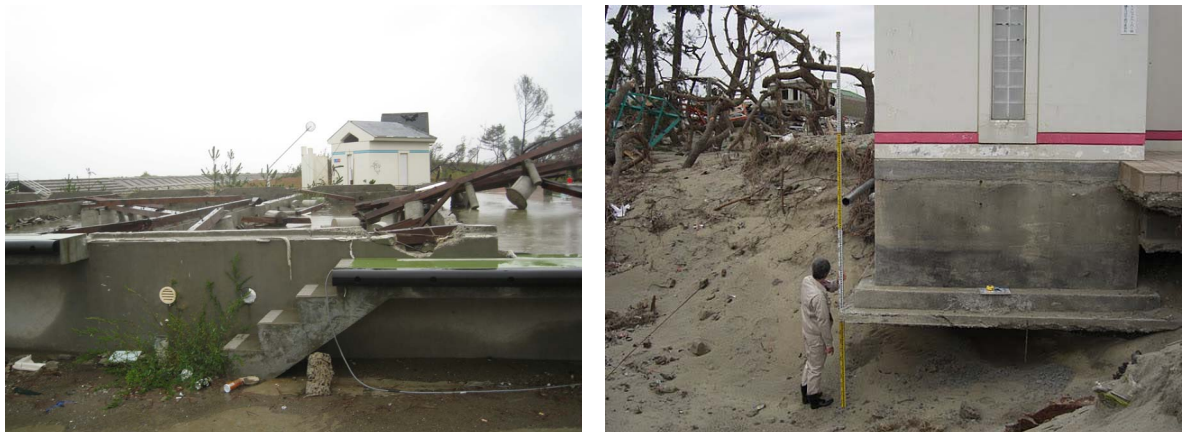
*Figure 34: Left: Devastated buildings behind the dike, Right: Scouring on the toe of concrete building
(The 2011 Tohoku Earthquake Tsunami Joint Survey Group; www.coastal.jp/tsunami2011)*

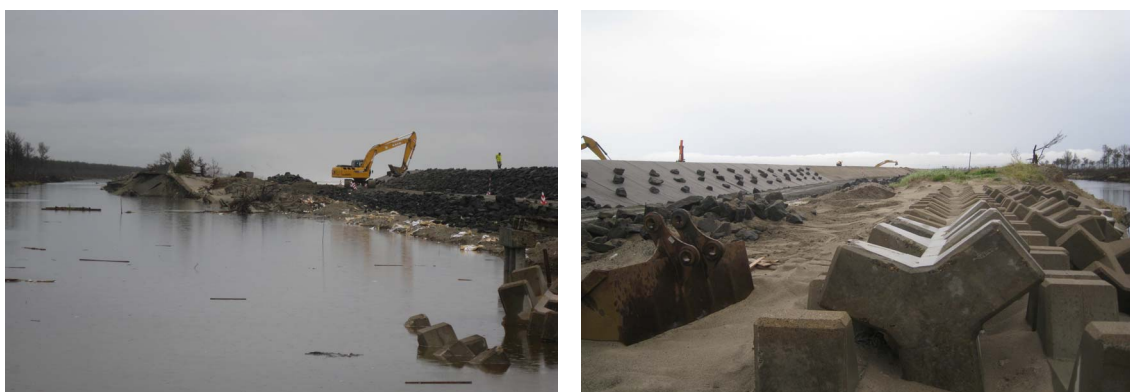
A few more parts of the coastal levees of Sendai plain were visited at the frontage of Watari, which is a town of 35,000 citizens. A lot of sections of the dike were destructed in that area, mainly due to significant erosion in the inner slope and toe. The core of this structure consisted of sand and gravel and was protected by non-reinforced concrete on the seaside slope, and armor units at places. According to local researchers, this part of the levee had no geotextile protection between the core and the encasing concrete layer, which might be the reason of their failure, as similar sections in the same area with a geotextile survived.

Figure 40: Left: Breakage of coastal levee, where the original cross section is displaced several meters inland and its core is exposed due to the lack of a geotextile; Right: Armor units of the original cross-section.

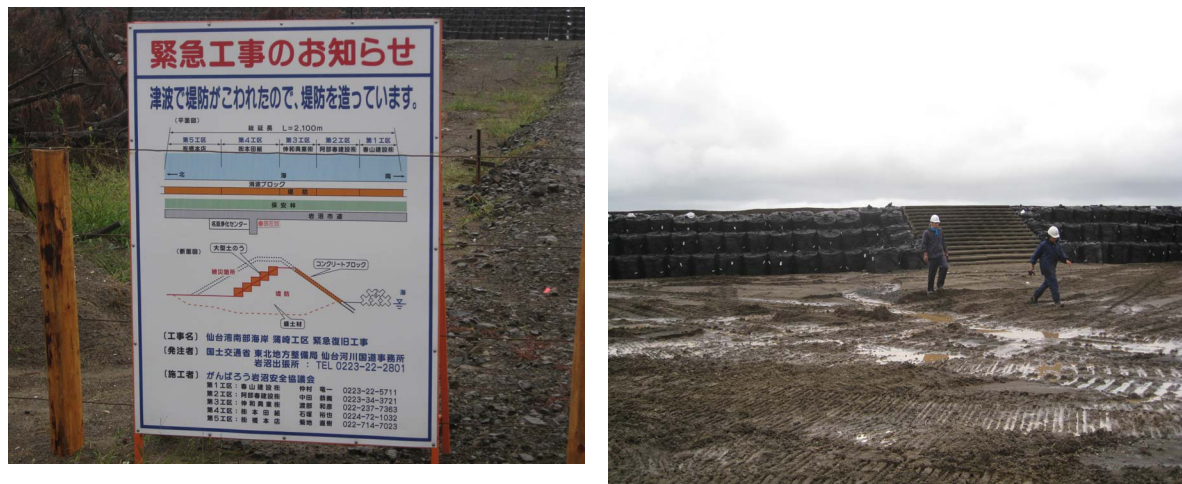
Figure 41: Left: Plan for temporary retaining works, indicated with orange. The original cross section is indicated with grey; Right: Sandbags placed urgently the day of the visit (September 22, 2011), as the cross section was further destroyed by typhoon Roke.

As the levee is meant to protect the inner land against high storm surges, which are quite common in the area, many temporary reconstruction works were taking place six months after the tsunami, with a lifetime of 5 to 6 years. The day of the visit was right after typhoon Roke hit the same coast on the 21st of September, inducing high storm surges that overloaded the already damaged levee and caused some important additional damage on the structure, while a part of the already devastated land was again flooded. This shows the necessity of temporary interventions in order to keep the inner land dry. Nevertheless it is unknown if those interventions are based on the results of an economic optimization.

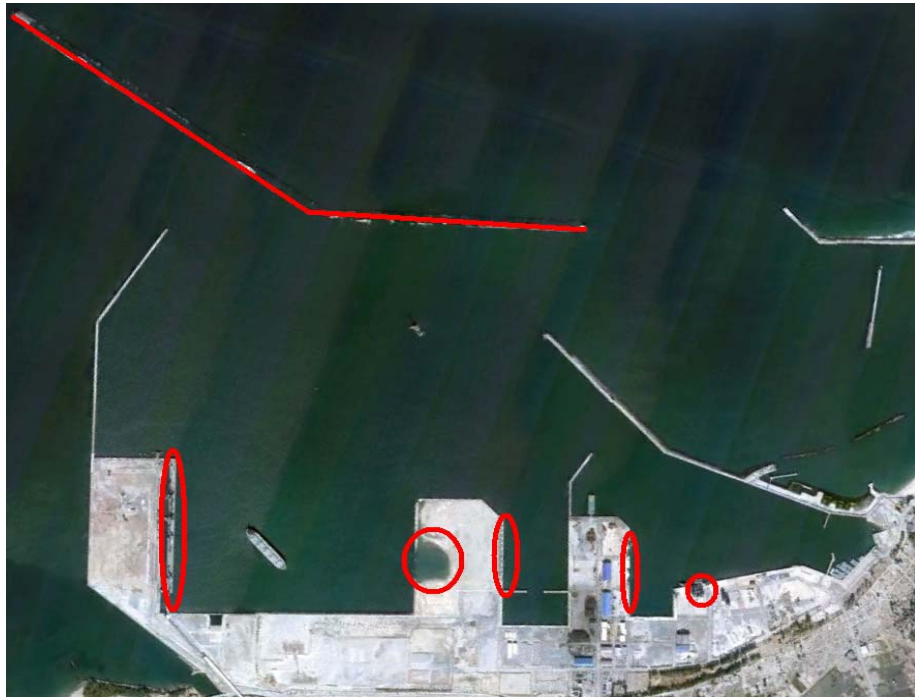
The port of Soma is an important commercial port on the coast of Fukushima, 32km to the south of Sendai airport. As it is located on the straight coastline and not sheltered by natural barriers, it is protected against storm waves by a 2.6km long offshore caisson breakwater. The water depth on the outer side of the breakwater is 25m. The port infrastructure was severely damaged by the tsunami of March 11.

Figure 43: Port of Soma after the tsunami. The most severely damaged parts are indicated (Google Earth image, 2011)

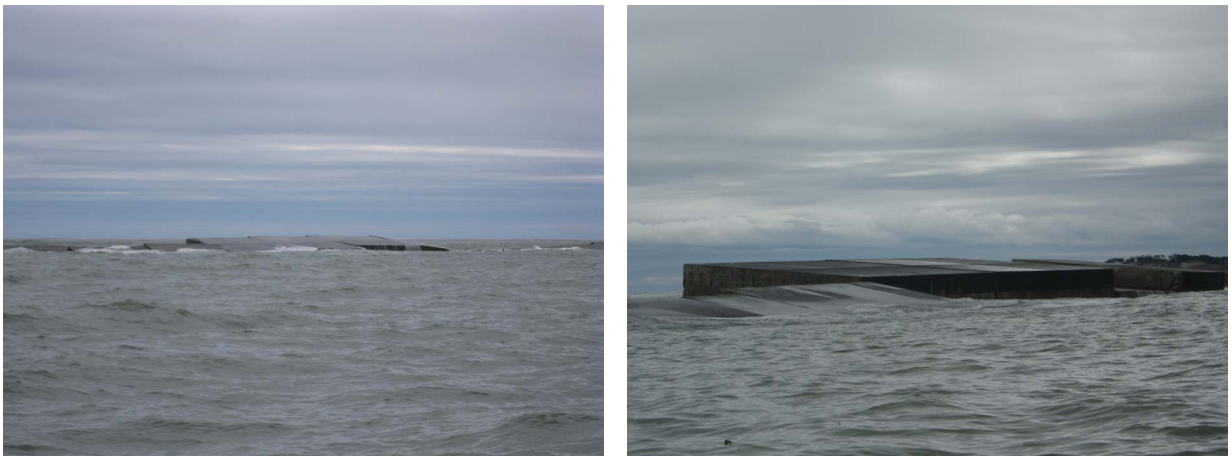
Only 3 out of the 546 caissons of the breakwater remained in place, the ones at the toe of the structure that were well protected by armor units. The rest were displaced, and some totally inundated.

Figure 44: Damage of the caisson breakwater

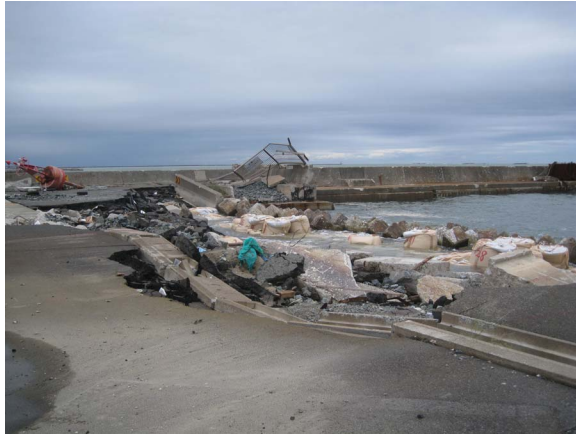
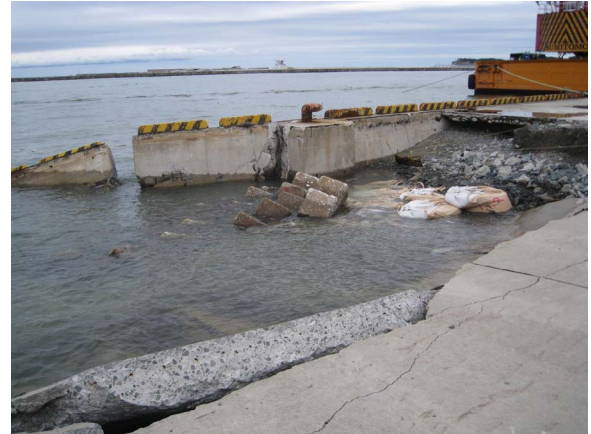
Some significant subsidence of the quay walls that exceeded 1m in places was evident, and severe scouring at their foundation took place. It was notable that some concrete elements of the quay wall, with approximate dimensions 6x10x3 cubic meters were overturned and left standing with their foundation upwards, which shows the enormous uplifting forces caused by the tsunami and intensified by the scouring. Furthermore some severe damage of warehouses and cranes could be observed. Inundation heights of up to 10m were recorded in the port of Soma.

Figure 45: Damage of quay wall and fallen apart post-tsunami retaining measures

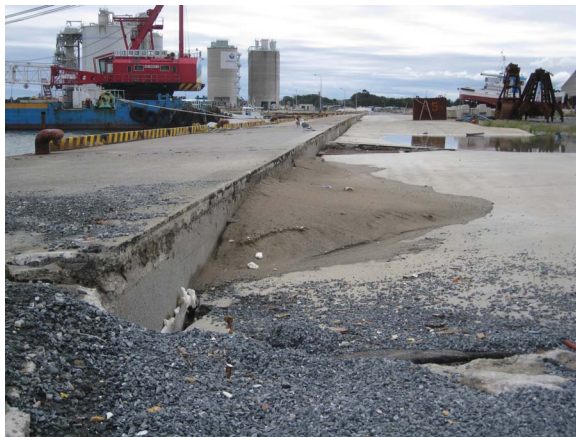
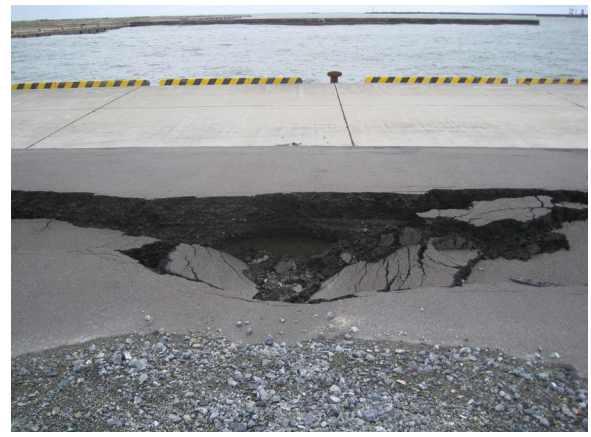
Figure 46: Subsidence of quay wall and under-flown liquefied sand

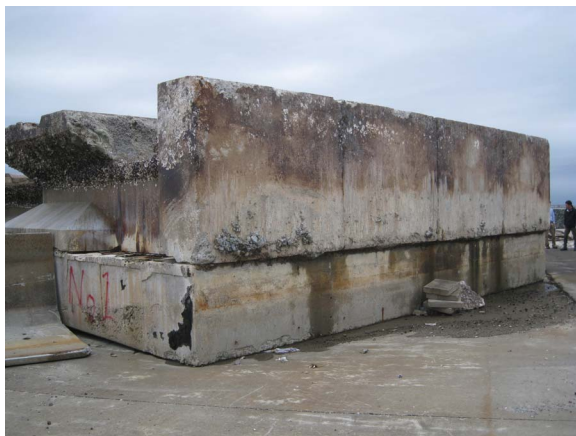
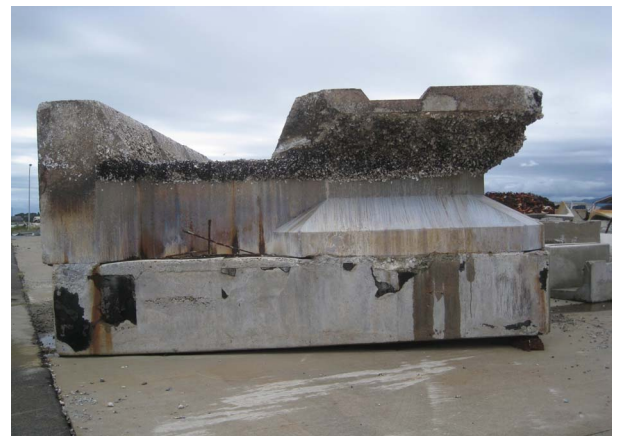
Figure 47: Overturned quay wall elements

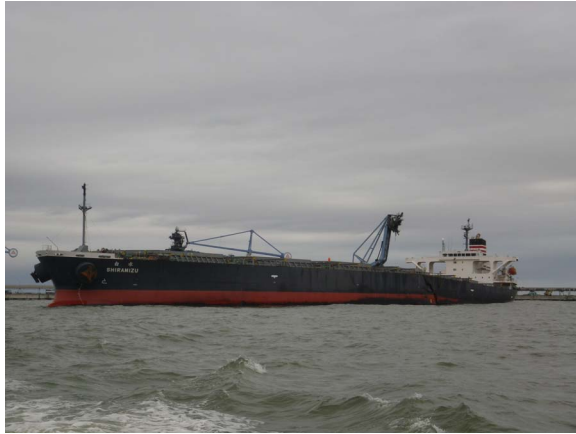
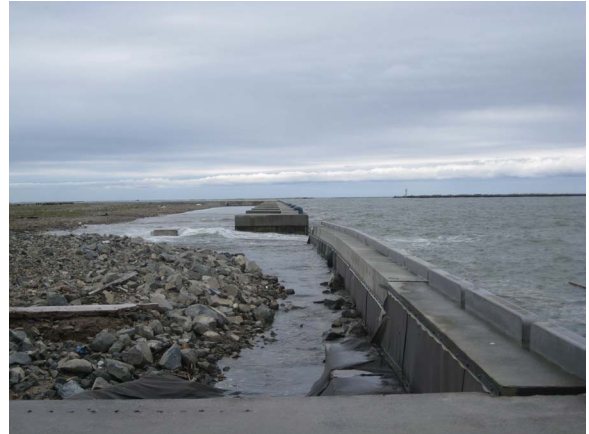
Figure 48: Left: Ship wreck within the port; Right: Breakage of wharf

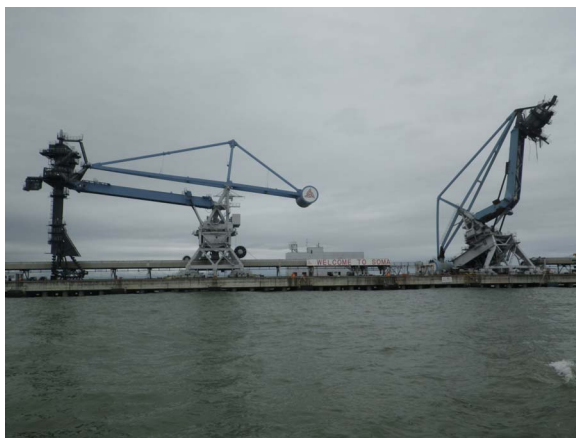
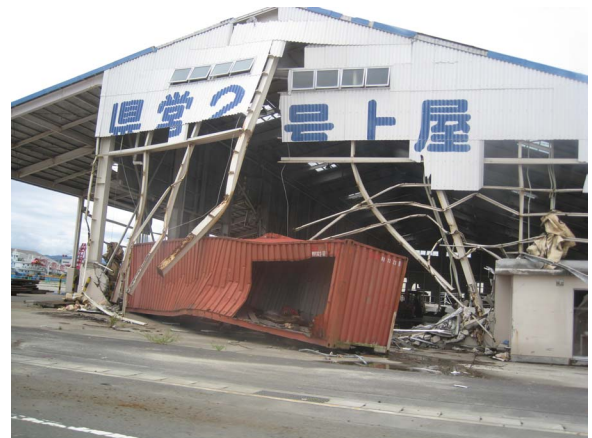
Figure 49: Left: Damage of cranes; Right: Destroyed warehouse
