Seepage analysis underneath the headwork of Chanda Mohana Irrigation Scheme, Sunsari, Nepal

Abstract

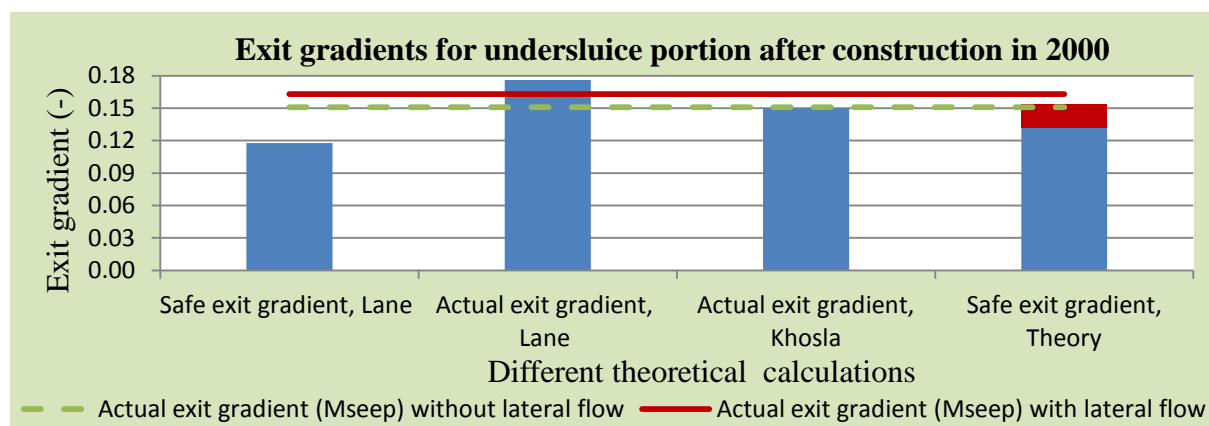
Figure 12: Comparison of exit gradients for under-sluice portion under Scenario-I

The exit gradient as per Lane is also greater than his safe recommended exit gradient. The red dark shaded area in Figure 12 for safe exit gradient, Theory is the maximum permissible exit gradient. Although the lower values of exit gradient are safe for structure, it increases the cost. The red shaded area is the range for economical constructions with safe structure. This shows that exit gradient without lateral flow is within the maximum safe limit. Exit gradient by Khosla does not consider the effect of lateral seepage flow. So, it is lower than the actual exit gradient. The actual exit gradient without lateral flow is almost same with the exit gradient by Khosla. As the maximum limit of safe exit gradient was exceeded with the lateral flow into the under-sluice portion, the structure might have failed due to piping action in 2000 during the commissioning period.

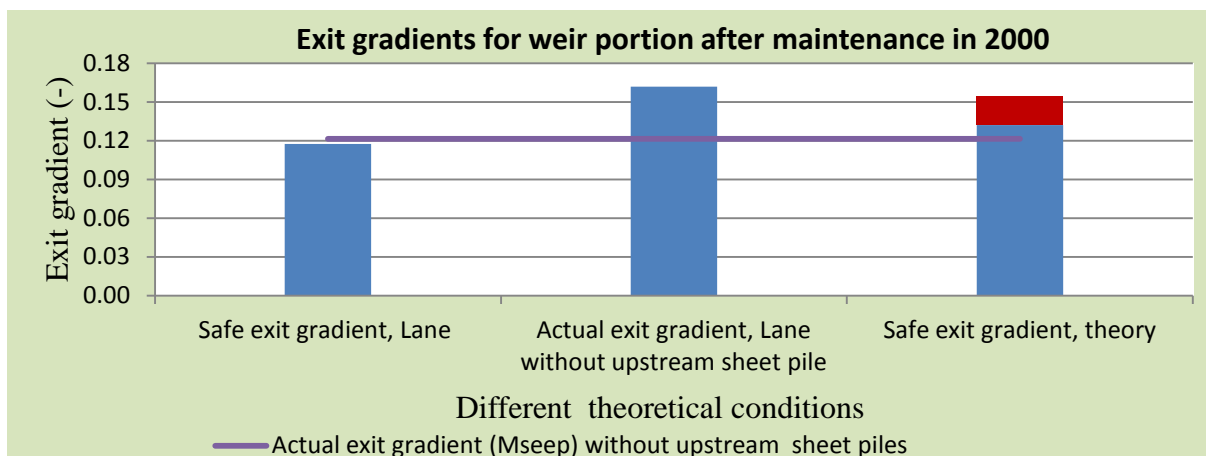
Figure 15: Comparison of exit gradients for weir portion under Scenario-II

From Figure 15, it is clear that the exit gradient, Lane is higher than recommended by him. In contrast, the exit gradient from model is within the safe theoretical permissible limit. It highly supports the site condition because the structure was functioning until 2009 after maintenance carried out in 2000. This illustrates that safe exit gradient by Lane assumes a high safety factor.

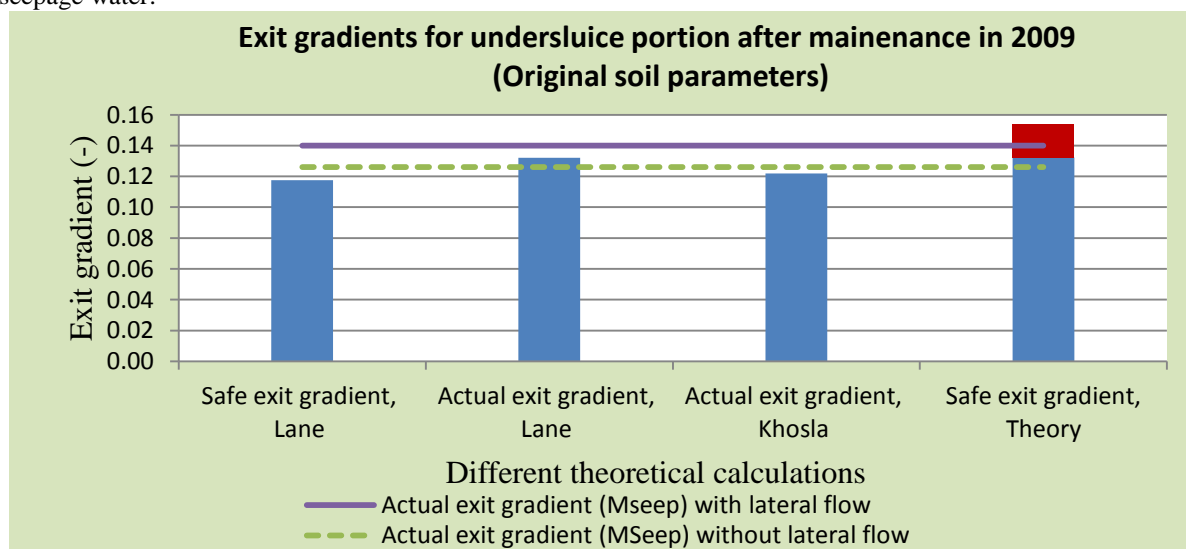
Figure 16: Comparison of exit gradients for under-sluice portion for Scenario-III (Original soil parameters)

As shown in Figure 16, the exit gradient should have decreased after maintenance in 2009 if the soil parameters were same as previous in 2000. An exit gradient by Khosla (0.122) is slightly lower than the exit gradient by MSeep without considering lateral flow (0.126), both being less than permissible theoretical exit gradient. The lateral seepage discharge and actual exit gradient might be $2E-5 \text{ m}^3/\text{s}$ and 0.140 respectively. Failure in 2010 should not have occurred in this situation as the exit gradient, 0.140 was within permissible limit. But, the headwork failure was seen in 2010 which indicates the change in soil parameters due to sub soil erosion by seepage water.

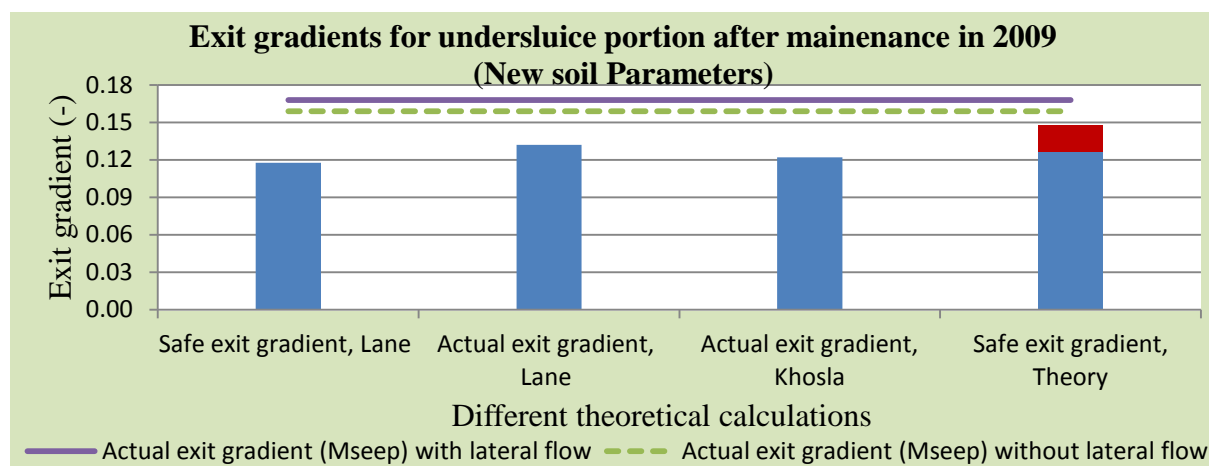
Figure 17: Comparison of exit gradients for under-sluice portion for Scenario-III (New soil parameters)

As a result of lateral flow, the head is increased and thus the exit gradient is increased to 0.168. Figure 17 shows that the exit gradient according to Lane is slightly greater than his safe recommended exit gradient. The exit gradient by MSeep without considering lateral seepage flow is much higher than exit gradient by Kholsa. This is due to the fact that Kholsa theory does not consider the effect of change in soil parameters like hydraulic conductivity, porosity. So, there is no change in exit gradient by Kholsa. Exit gradient with lateral flow (0.168) is above the maximum theoretical permissible limit (0.148). At site, the structure was failed in 2010 because of the exit gradient exceeded the maximum limit of safe exit gradient.

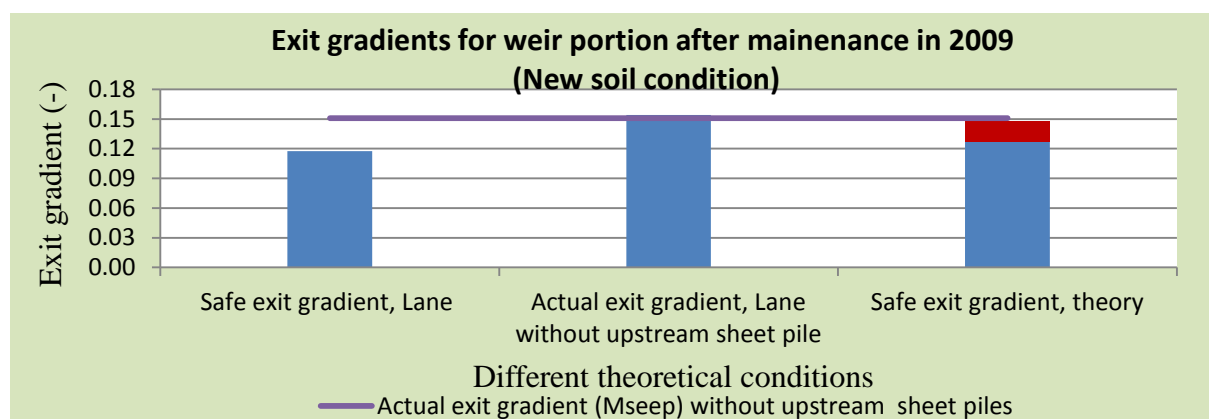
Figure 18: Comparison of exit gradients for weir portion for Scenario-III (New soil parameters)

Exit gradients for weir portion are shown in Figure 18. The exit gradient, Lane is higher than recommended by him. The exit gradient from MSeep (0.151) is also higher than the maximum theoretical permissible limit (0.148) which made the structure fail in 2010.

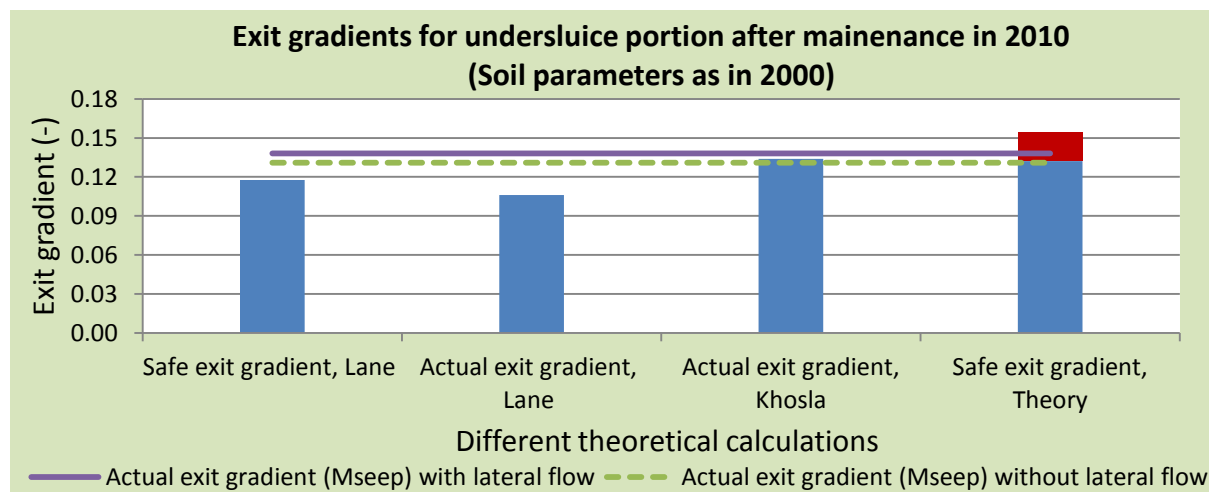
Figure 19: Comparison of exit gradients for under-sluice portion for Scenario-IV (Original soil parameters)

After the maintenance work of 2010, the hydraulic conductivity and porosity of sub soil decreases. Different exit gradients for under-sluice portion are shown in Figure 19 considering the soil parameters might have reached into original condition as in 2000. The graph shows that the structure is safe if the soil parameters have reached into original condition as in 2000. The structure is safe for all exit gradients. The exit gradient by MSeep without lateral flow (0.131) is almost same with exit gradient by Khosla (0.134) as the soil parameters are taken as in 2000. The exit gradient with lateral flow is 0.138.

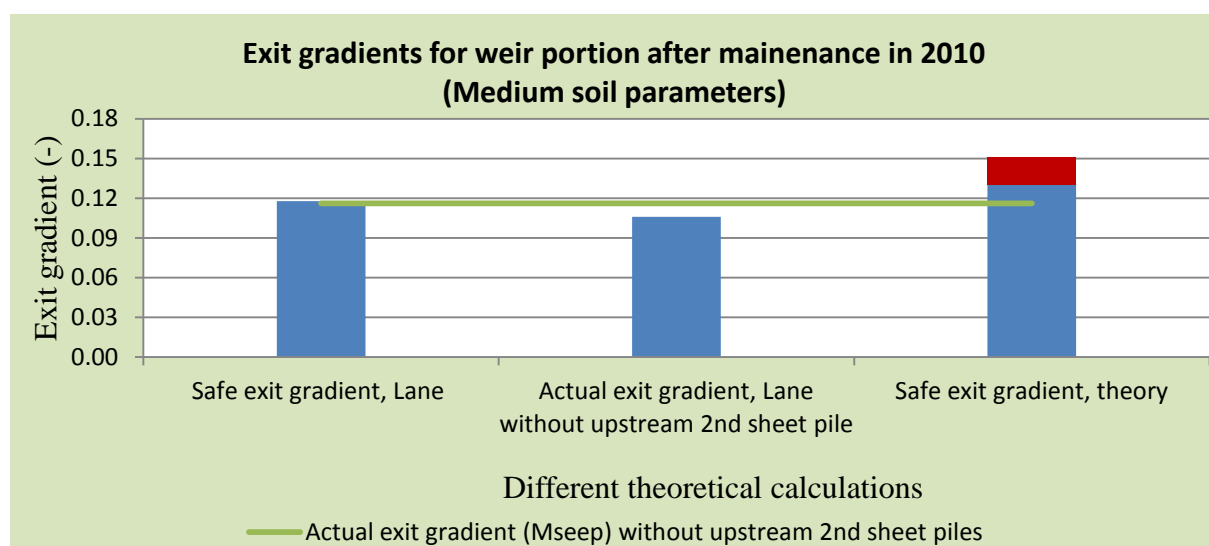
Figure 21: Comparison of exit gradients for weir portion for Scenario-IV (Medium soil parameters)

Figure 21 shows that exit gradient by Lane is less than the recommended exit gradient in the weir portion. In addition, exit gradient from MSeep is also less than theoretical permissible exit gradient after maintenance in 2010. This shows that further maintenance works are not needed for weir portion. So, no maintenance works are suggested for weir portion.
