MINISTRY OF AGRICULTURE—NATIONAL AGRICULTURAL LABORATORIES
KENYA SOIL SURVEY

REPORT OF A VISIT TO THE EXPERIMENTAL AREA
OF THE ISHIARA IRRIGATION SCHEME.

H.M.H. Braun and N.N. Nyandat

Dec. 1972.

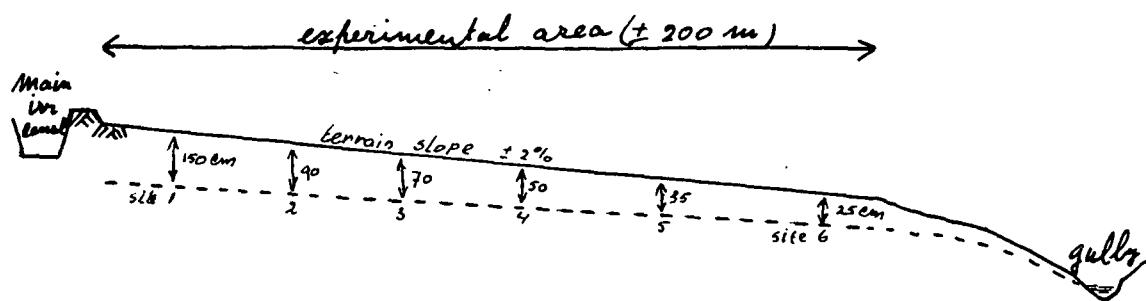
fig 1: Schematic section showing the depths of groundwater on 28/11/1972

No signs of salt were observed at the soil surface perhaps because the soil was in a moist condition. Several augerings were made and in all of them groundwater was found within 150cm depth (see fig 1). At sites 3 and 6 the electrical conductivity of the groundwater was measured. The readings obtained, 150 and 200 micromho respectively, indicate that the groundwater is non-saline. Electrical conductivity was also measured in two suspensions (1:5) of soil surface samples at site 3. The readings of 130 and 150 micromho indicate that the soil surface is non-saline. A pH value of 5.3 was found in these suspensions which suggests that the soils are also non-alkaline. At site 4 soil samples were collected for salinity/alkalinity analysis in the laboratory.

As indicated in fig 1 the depth of the groundwater table decreases from 150cm near the irrigation canal to 25cm. near the lower part of the experimental area.

In adjacent fields, belonging to private farmers, similar groundwater levels were observed. It is thought that over-irrigation and possibly also seepage from the main irrigation canal, combined with the absence of a drainage system have caused a gradual rise of the groundwater table which is believed to be deep under non-irrigation conditions. With abundant rainfall in October and November the ground water table has risen up to the soil surface.
