# Analysis of shipments of cut tulips in 12 reefer containers

Author: Leo Lukasse

Report 1626

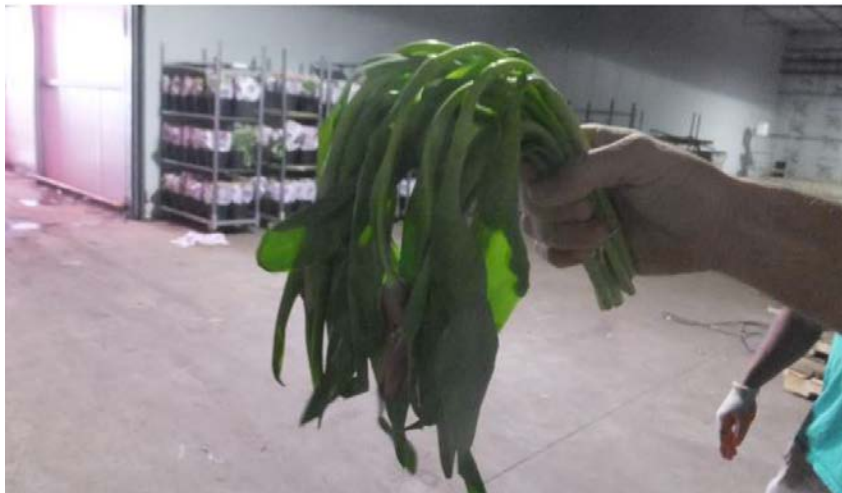
1. MNBU3183547 (K-services report no. 1783): 10 days delay in-transit on a trip that usually takes 10 ~ 12 days. Observed damage: primarily dehydration (Fig. 4), especially at door-end; mould formed on foliage tips; some freezing injury at top tiers.
2. MNBU3297853 (K-services report no. 1784): 10 days delay in-transit on a trip that usually takes 10 ~ 12 days. Observed damage: dehydration (especially at door-end), mould formed on foliage tips (Fig. 5), and freezing injury at top tiers.
3. MNBU3235511 (K-services report no. 1721): freezing injury (Fig. 3).

Fig. 4, dehydrated tulips delivered in MNBU3183547.

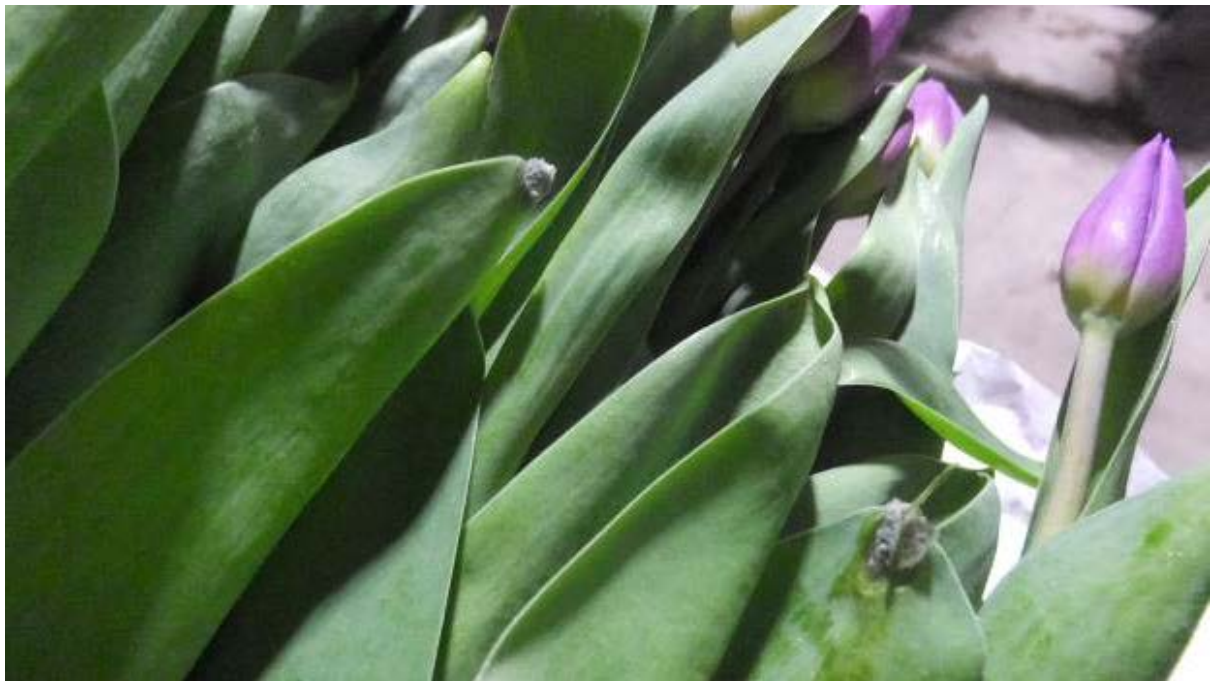
**Fig. 5, mould on leaf tips delivered in MNBU3297853.**

To limit mould growth it may help to use packaging materials and a stowage pattern allowing some air flow through the bunches of flowers instead of setting an RH set point.

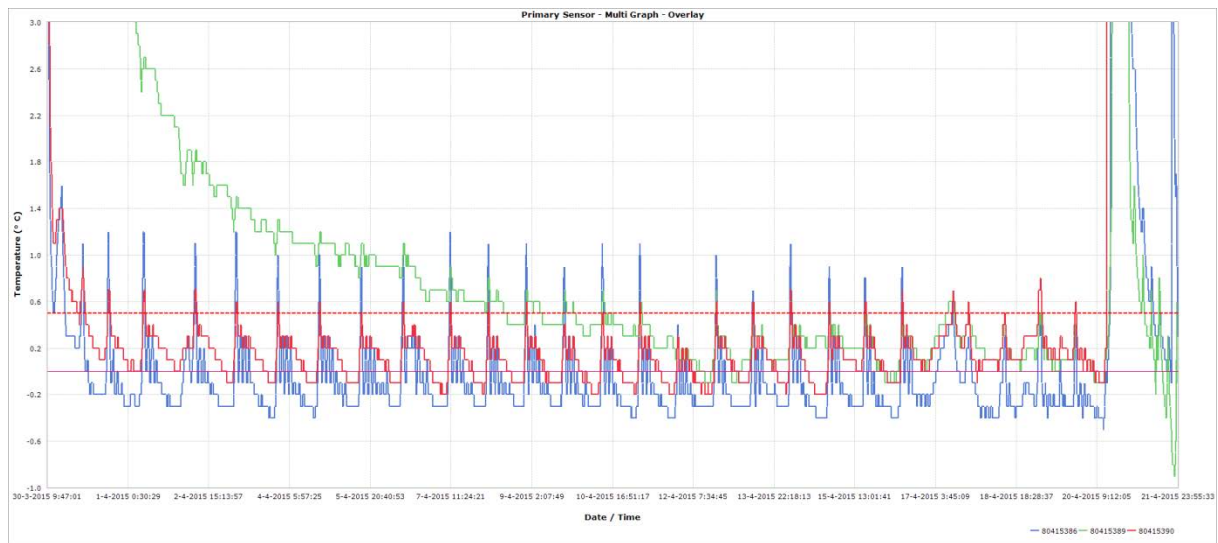
Fig. 7, MNBU3297853 shipper's temperature recorders.

The shipper's temperature recorders (e.g. Fig. 7, Fig. 11) drop to levels well below set point and those registered by the reefer units. Unfortunately their value is not too reliable in view of the preceding paragraph. But Fig. 11 shows measured temperatures more than 1.5 °C colder than set point, that is a deviation distinctly bigger than the ones reported in the calibration certificates. Moreover, why do temperatures in Fig. 11 after April 10 drop to approx. 0.5 °C lower than before that date?

The shipper's temperature recorders (e.g. Fig. 7, Fig. 11) exhibit a typical  $\pm 12$  hour periodicity. The periodicity equals the defrost interval automatically chosen by the reefer unit controller's auto-defrost (see how defrost spikes in Fig. 10 and Fig. 11 coincide). As a reference: in 'usual' chilled-mode reefer shipments the auto-defrost interval is larger than 48 hour, hence a 12 hour defrost interval is very short. It indicates a high rate of frost formation on the evaporator. That is no surprise: water easily evaporates from the tulips, while the unit is trying to maximally extract moisture from the air to reach the 65% RH set point.

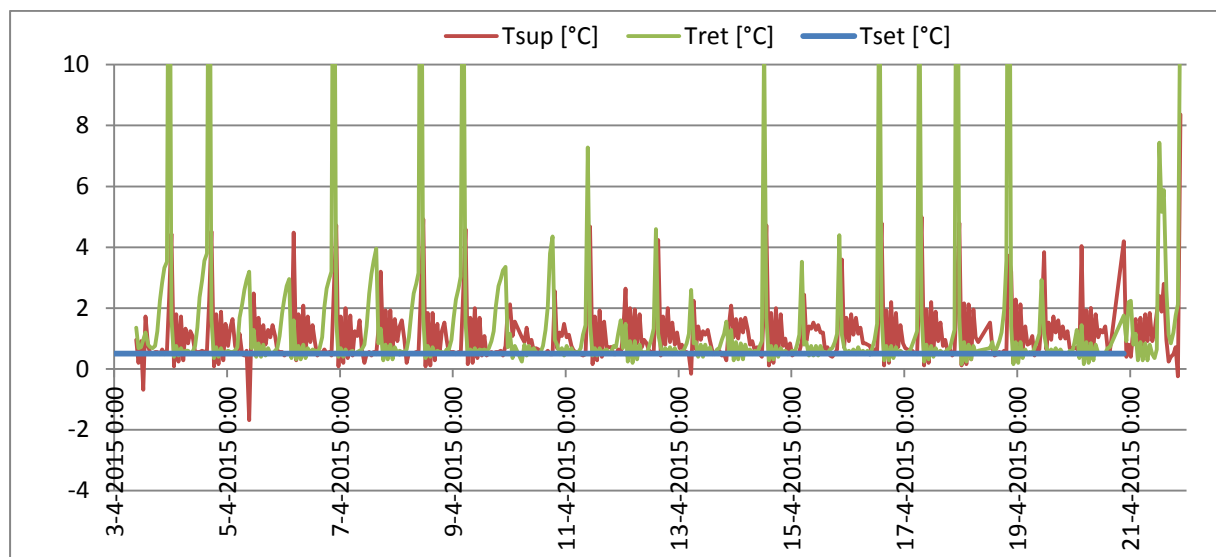
Fig. 10, MNBU3326099 reefer unit temperature data.

container no.	unit type	date shipped on board	comments on unit download
MNBU3326099	Starcool CIM6	10-4-2015	See Fig. 10 and Fig. 11. $T_{set} = +0.5\text{ }^{\circ}\text{C}$ . Temperature control pattern is non-Quest, so RH has been set. From April 4 (trip start) till April 10 $T_{ret}$ rises till approx. $3.0\text{ }^{\circ}\text{C}$ prior to defrosts (defrosts come a little late). After April 14 between defrosts mostly $T_{ret} = T_{set}$ , while $T_{sup} \approx T_{ret} + 1.0\text{ }^{\circ}\text{C}$ , this is a typical effect of evaporative cooling.
MNBU9028018	Starcool CIM6	8-3-2015	$T_{set} = +0.5\text{ }^{\circ}\text{C}$ . Temperature control pattern is non-Quest, so RH has been set. Between defrosts mostly $T_{ret} = T_{set}$ , while $T_{sup} \approx T_{ret} + 1.0\text{ }^{\circ}\text{C}$ , this is a typical effect of evaporative cooling.

Is the observed freezing injury caused by evaporative cooling? A reliable indicator of evaporative cooling in the load is when  $T_{ret} < T_{sup}$ . That indication is mildly present in some of the unit downloads (Fig. 10). Therefore the data do indicate that evaporative cooling has contributed to the freezing injury.

Fig. 10 and Fig. 11 show both the reefer unit temperature data and the shipper's temperature recorder. It is worth noticing that the slightly late defrost starts (Fig. 10) from April 4 till April 10 have no visible impact on shipper's temperature recorders. The signs of evaporative cooling visible in Fig. 10 (periods where  $T_{sup} > T_{ret}$ ) are strongest in the period where shipper's temperature recorders record the lowest temperatures.

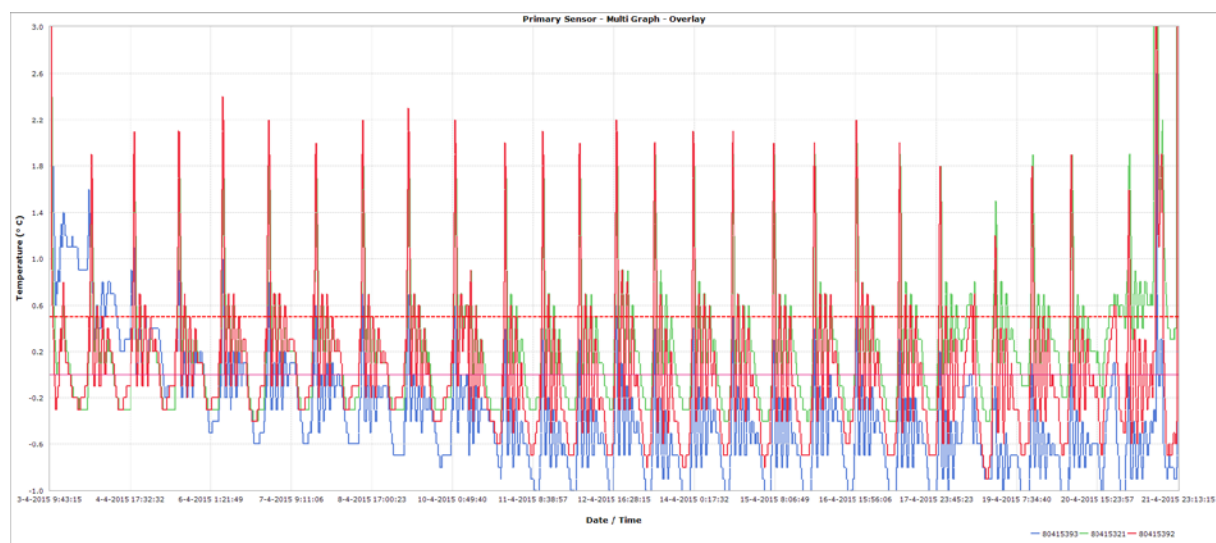
Fig. 11, MNBU3326099 - shipper's temperature recorders.

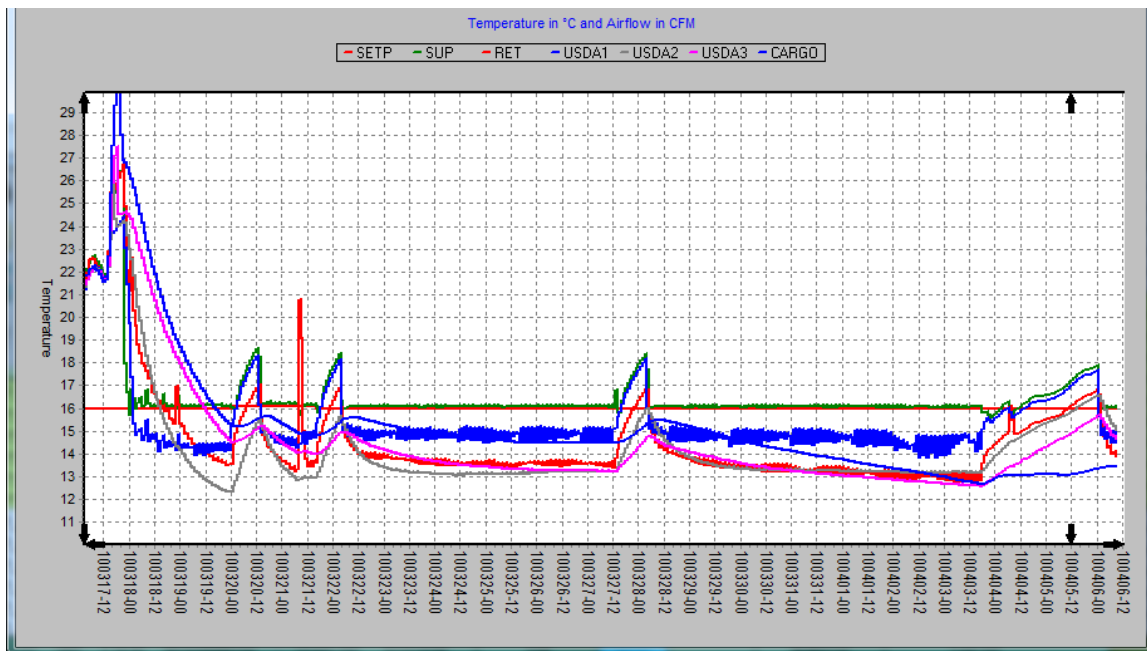
If water evaporates from a wet surface, that surface's temperature becomes colder than the (dry bulb) temperature of the air flowing over it. This is the phenomenon of evaporative cooling. The coldest possible surface temperature is the wet bulb temperature. Air of 0.5 °C dry bulb temperature and 50% RH has wet bulb temperature -2.5 °C. In shipments of leafy plants, especially when placed in crates with free water, this process may/will occur: lots of water available, and lots of leaf surface area from which evaporation can take place. As an example see the readings (Fig. 14) taken by the author in the load shown in Fig. 15: the load temperatures (USDA) and return air temperature are distinctly colder than supply air temperature due to evaporative cooling at  $T_{set} = 16$  °C and  $RH_{set} = 65\%$ .

Fig. 14, temperatures well below set point due to evaporative cooling in a shipment of palms.
