Carrier PrimeLine extended defrost software scrl9521.ml3 testing

Report 1677

Wageningen UR Food & Biobased Research

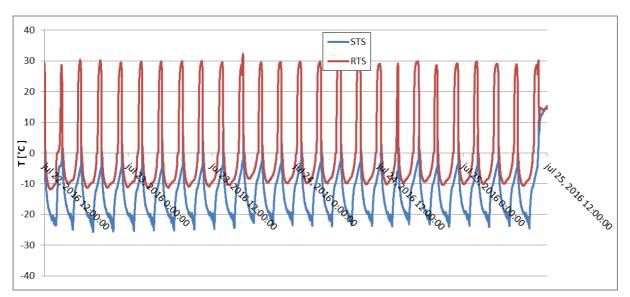
Fig. 12 and Fig. 14 present the unit's Tsup and Tret recorded during test 1 and 2. Note the perfectly repetitive pattern in Tsup and Tret. Fig. 13 presents all temperatures recorded during the last three defrost cycles of test 1.

Fig. 12, Tsup and Tret recorded during test 1 ($r_{hum} = 2 L/h$).

In both test conditions the extended defrost function suffices to completely defrost the unit. This is proven by the persistently repetitive temperature cycle during multiple days of testing (Fig. 12, Fig. 14). Extra evidence is provided by the images not revealing any frost at the end of one of the last defrosts (Fig. 16, Fig. 18, Fig. 20, Fig. 22).

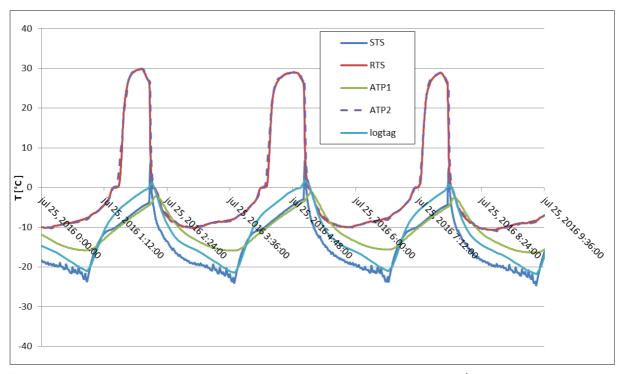
Fig. 13, all temperatures recorded during last 3 defrost cycles of test 1 ($r_{hum} = 2 L/h$).

Ice accumulation underneath the unit's rear panel is negligible (Fig. 26). Apparently all melt water reaching the drain gutters also reaches the drain pans and is expelled through the drain line. During the tests the recorded rear panel temperature ('LogTag' in Fig. 13) stays well below return air temperature RTS, and in-between defrosts even mostly below supply air temperature STS. In a stuffed reefer the rear panel temperature will be different due to thermal mass of product against the bulkhead, and much less air flow along the bulkhead. Yet the collected rear panel temperatures are no reason for concern.

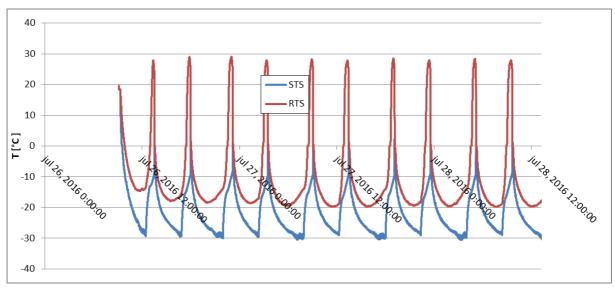
Fig. 14, Tsup and Tret recorded during test 2 ($r_{hum} = 0.25 L/h$).

Test 2 was a milder test than test 1. Also in test 2 no ice/frost accumulation in the air flow path occurred. The only difference worth noticing is the change in defrost pattern: the average defrost interval increased only a little (compare Fig. 12 and Fig. 14).

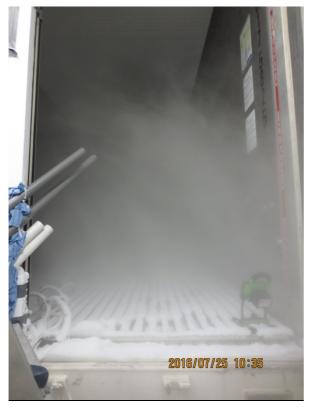
Fig. 25, snow covered floor at end of test 1.

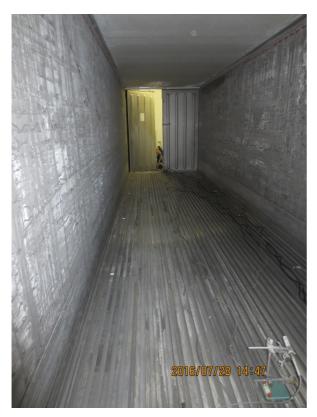
Just before the last defrost during test 2 the container floor is free of snow (Fig. 27), while the return air grid is frosted (Fig. 28). Right after that defrost the test is terminated. At that moment the drain pans, gutters, and unit components underneath the gutters were perfectly clean (Fig. 29, Fig. 30). Fig. 27).

Fig. 27, just before the last defrost in test 2 the floor is free of snow.
