Evaluation report quality carnation flowers from container shipment

Report 863

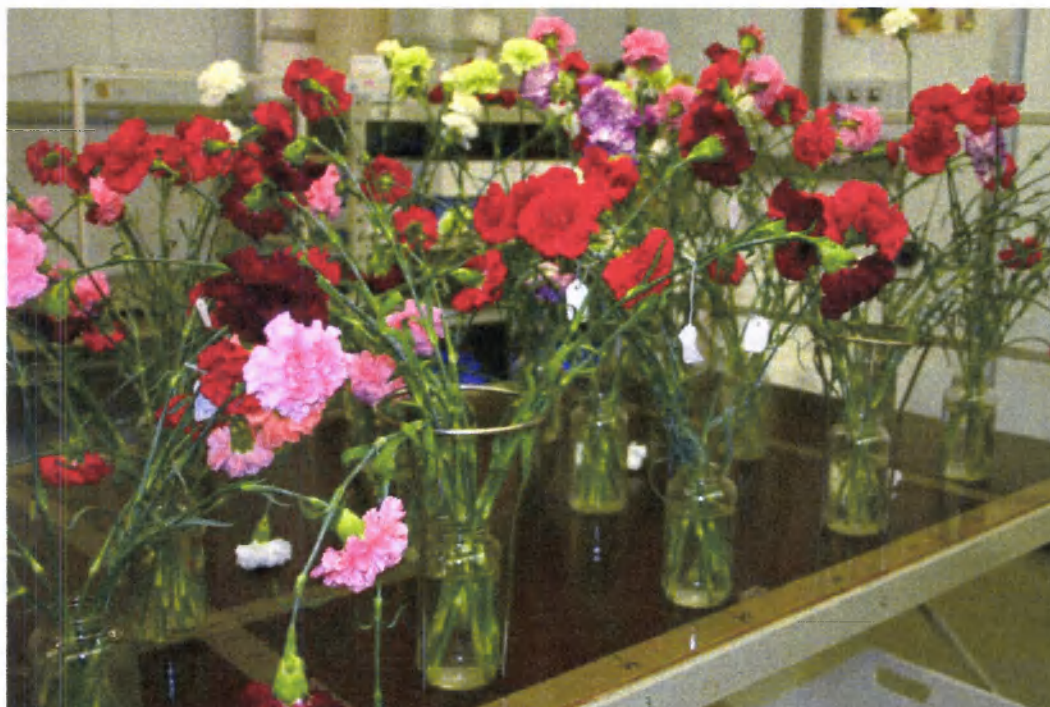
At arrival in Wageningen flowers generally were of good quality, although the stems were rather thin and in some bunched easily broke.

On the whole flower quality, especially after 2 weeks was poor. A better pretreatment of the flowers and/or after shipment treatments (re-hydration solution) may increase flower quality. Also it may be recommended to place flowers in a preservative solution during the vase life to increase flower opening. As observed already at arrival of the flowers, the stems were generally quite thin and tended to break or bent easily (figure 1), which hints to selecting a better quality carnation for future container shipments.
