# X-ray inspection for boreholes in intact trees

R.M.C. Jansen, J. Hemming

Rapport GTB-5006

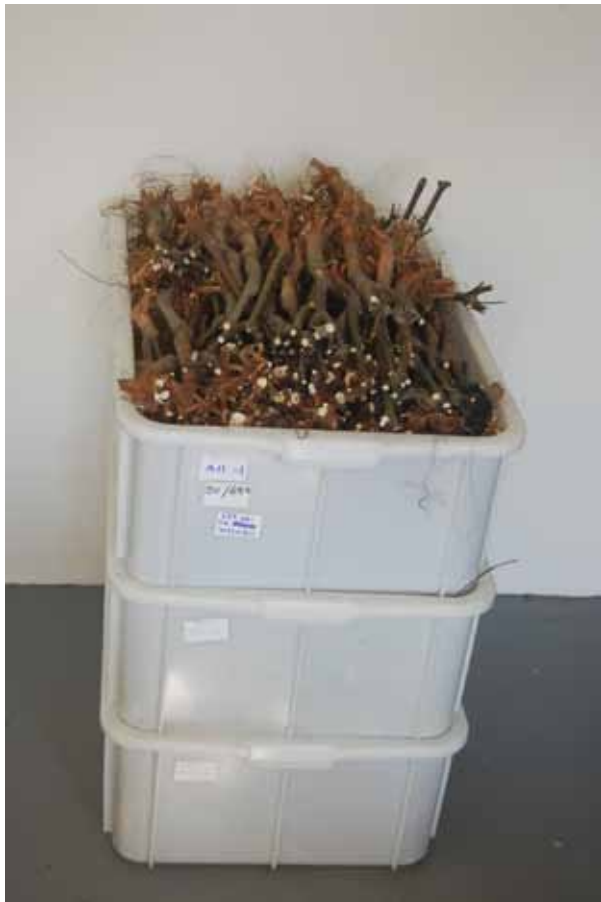
Fig. 2 Main stems of Japanese maple

Besides axles, main stems of Japanese maple (*Acer palmatum*) were analysed by X-ray (Fig. 2).

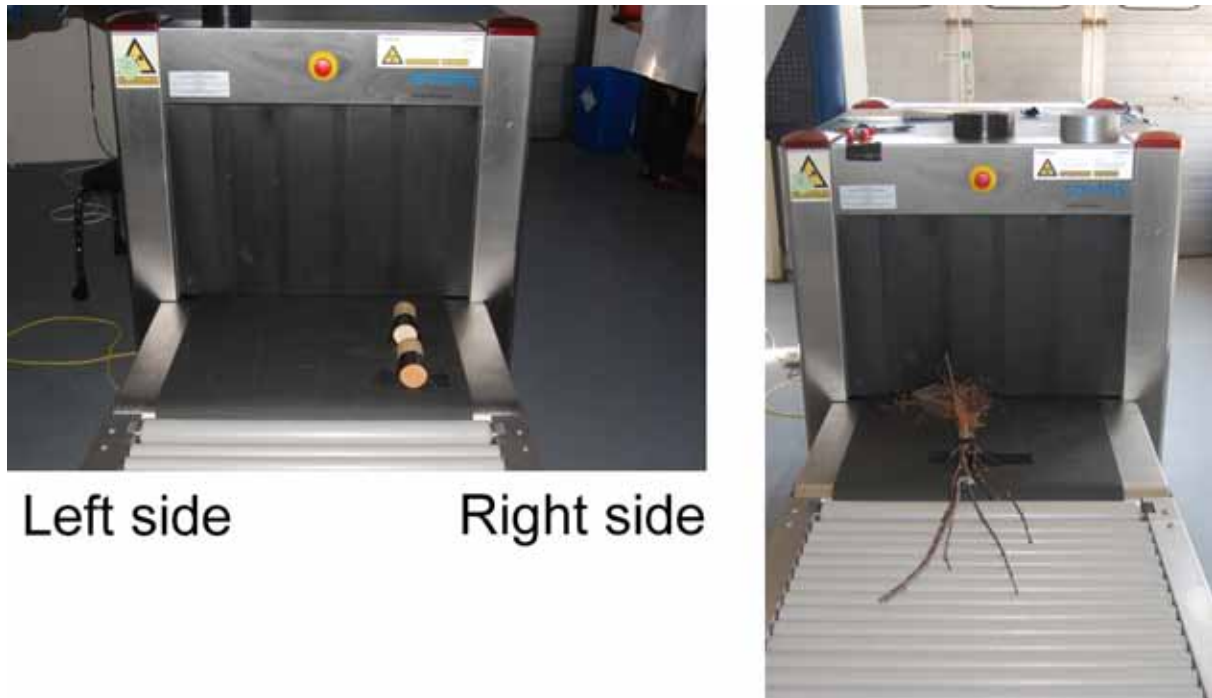
*Fig. 3 X-ray inspection system with a pre-drilled wooden axles or an intact tree fixed on the conveyer by tape*

X-ray images were recorded on a luggage X-ray inspection system (Hi-Scan 6040j; Smiths Heimann, Germany). Such systems are commonly used on airports for inspection of luggage. The X-ray tube —source of the electromagnetic radiation— was located on the right side of the system underneath the conveyor. Tape was used to fix the wooden axles, stems, and trees on the conveyor (Fig. 3). The conveyor speed was approximately 0.2 m/s. The tunnel dimensions are 620 mm (W) x 418 mm (H). The anode voltage of the X-ray generator was approximately 140 kV.

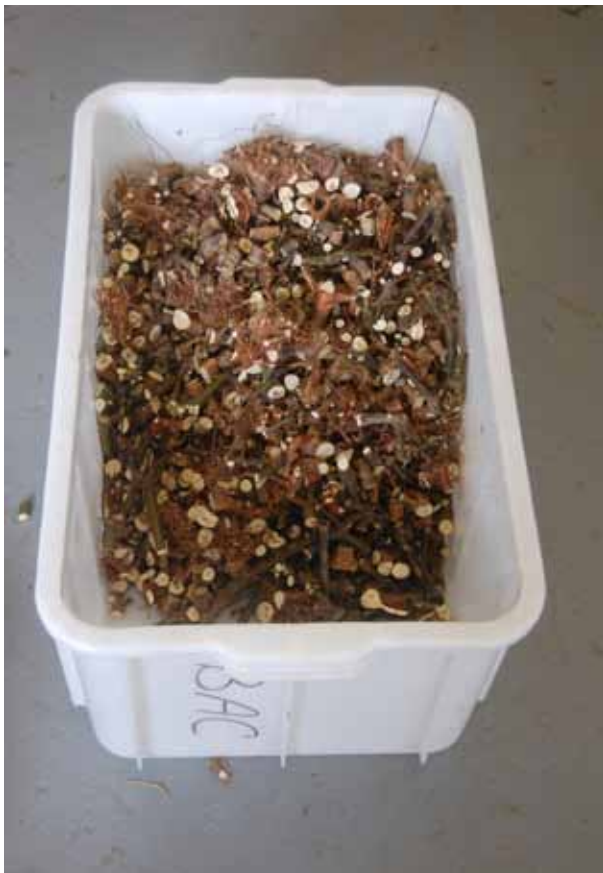
*Fig. 4 Wood pieces after destructive assessment to determine the number of boreholes per tree*

After X-ray analysis, the intact trees were cut into pieces of  $20 \pm 10$  mm to determine the number of boreholes per tree (Fig. 4).

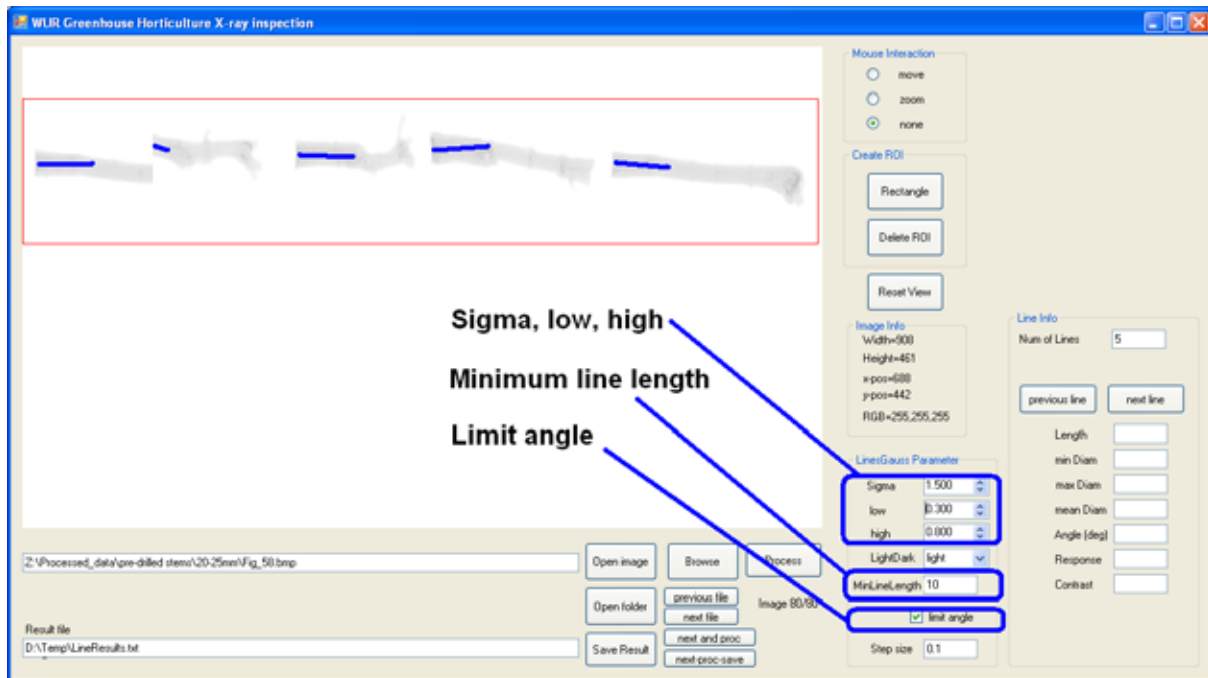
Fig. 5 Optimisation of the hole detection method. This X-ray image is derived from pre-drilled stems with an outer diameter of  $25 \pm 10$  mm. The holes were 5 mm in diameter and drilled into the centres of the stems. In this example, the 5 pre-drilled holes were detected.

The pre-drilled stems were used to optimise the parameters Sigma, Low and High. An example of this optimisation procedure is provided in Fig. 5.

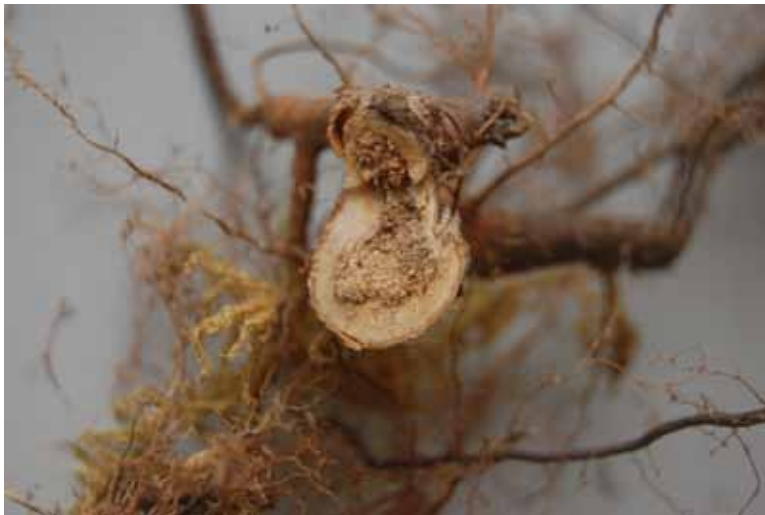
*Fig. 6 Borehole filled with boredust. This picture is derived from one of the X-ray analysed trees. The corresponding X-ray image is provided in Fig. 8. This borehole contained a larva of the long-horned beetle.*

As a result of larvae, holes may be filled with boredust (Fig. 6). Perhaps, this boredust effects the detectability of such holes. Experiment 2 was done to evaluate the effect of boredust on the detectability of boreholes. For this experiment, five stems with a diameter between 30-35 mm were randomly selected. Holes with a diameter of 5 mm were drilled into the centre of these stems. X-ray images of these stems were made before and after filling the holes with boredust. The effect of boredust on the detectability of holes was determined by visual assessment.

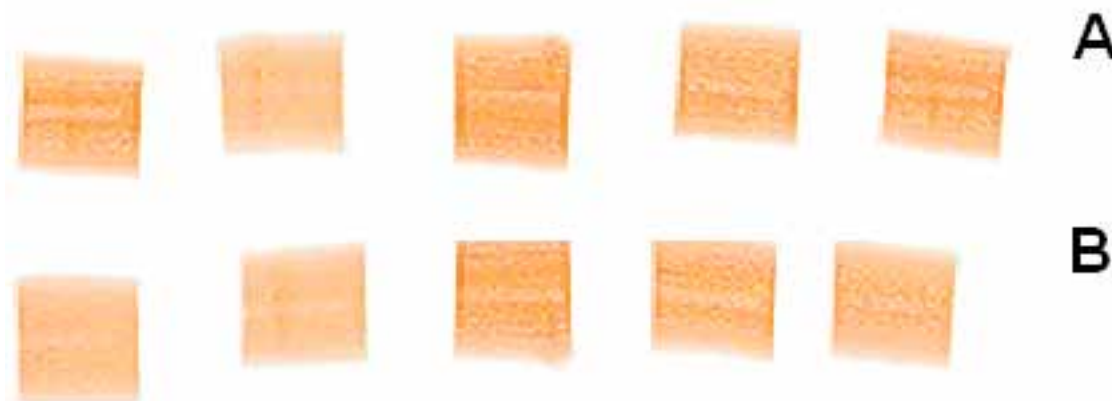
Fig. 10. The effect of boredust on the visual appearance of boreholes in X-ray images. Images are retrieved from maple stems with outer diameters of 30-35 mm containing pre-drilled holes of 5 mm: A) holes without boredust, B) same stems but holes filled with boredust

The presence of boredust did not seem to have a large effect of the visual appearance of boreholes in X-ray images (Fig. 10). In both cases, pre-drilled holes of 5 mm were clearly visible.

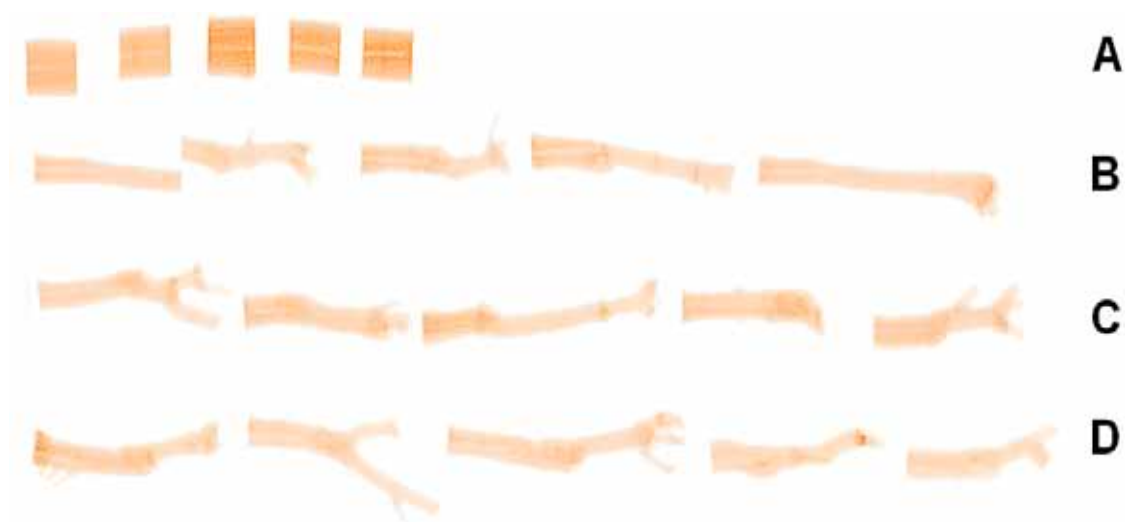
Fig. 13. The effect of stem diameter, pre-drilled hole diameter and hole position on the visual appearance of boreholes in X-ray images. A)  $d_{out} = 30-35 \text{ mm}$ ,  $d_{hole} = 5 \text{ mm}$ , State = A; B)  $d_{out} = 20-25 \text{ mm}$ ,  $d_{hole} = 5 \text{ mm}$ , State = A; C)  $d_{out} = 20-25 \text{ mm}$ ,  $d_{hole} = 3 \text{ mm}$ , State = A; D)  $d_{out} = 20-25 \text{ mm}$ ,  $d_{hole} = 5 \text{ mm}$ , State = D.

For this experiment, two diameter-groups were used. Group 1 consisted of stems with outer diameters of 30-35 mm. Group 2 consisted of stems with outer diameters of 20-25 mm. In both groups, pre-drilled holes with a diameter of 5 mm were visible on the X-ray images (Fig. 13A and Fig. 13B). To some extent, pre-drilled holes with a diameter of 3 mm were visible on images from both groups (Fig. 13C). Holes with a diameter of 2 mm were invisible on the X-ray images (data not shown). The stem diameter (Compare Fig. 13A with Fig. 13B) as well as the position of the hole (Compare Fig. 13B with Fig. 13D) seem to have an effect on the visibility of these holes.

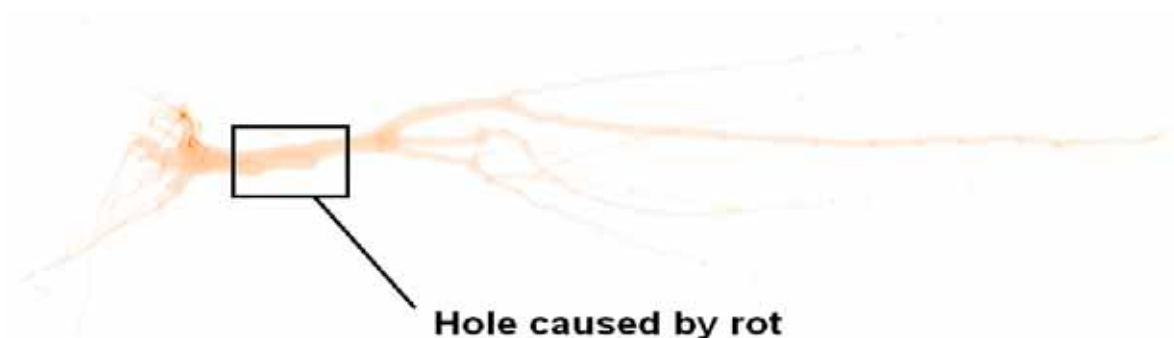
Fig. 15. X-ray image of an intact maple tree marked as suspicious. After destructive assessment of this tree, the hole turned out to be caused by rot.

After visual assessment of the 929 X-ray images, 5 trees were marked as suspicious. In these cases, the suspicious areas were located in the main stem. After X-ray images were made, all trees were cut into pieces of 20-25 mm to determine the number of boreholes. This destructive assessment confirmed that three of the suspicious trees contained boreholes (Fig. 14). Whether or not these boreholes were the result of long-horned beetles could not be confirmed. One suspicious tree turned out to contain holes caused by rot (Fig. 15). A second suspicious tree turned out to contain no hole at all; probably a hole was detected because this tree contained a groove in the stem. The destructive assessment also resulted in the detection of a borehole which was initially unseen on the X-ray images, but seen after doing visual assessment of the X-ray image once more. Whether or not this borehole was the result of a long-horned beetle could not be confirmed. A summary of the results of visual assessment is provided in Table 4.

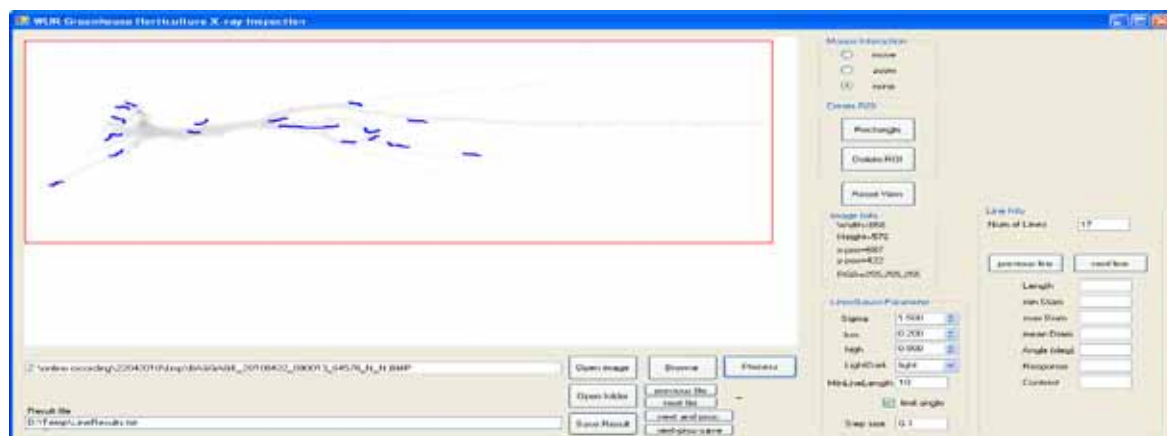
Fig. 17. Detection of a hole caused by rot by machine vision. Besides this hole, also 16 holes were recognised which were actually no holes.

In order to detect boreholes in intact trees, the average Sigma, High and Low values from Group 2 (Table 3) were implemented into the hole detection method. Based these values and applying machine vision on the 929 X-ray images of intact trees, a total of 3 true positives and 26 true negatives was detected. An example of a true positive is provided in Fig. 16. Furthermore, a total of 899 false positives was detected. These false positives were mainly the result of lines (in total 5966) detected in the rootzone and crown of the trees. The hole caused by rot was also detected by machine vision (Fig. 17). Also one false negatives was detected. The borehole belonging to this false negative was not the result of a long-horned beetle. A summary of the results of machine vision is provided in Table 5.
