Project acronym: Euro-limpacs

# Integrated Project to evaluate the Impacts of Global Change on European Freshwater Ecosystems

Report on the first year of sampling lowland streams

# Report on the first year of sampling lowland streams

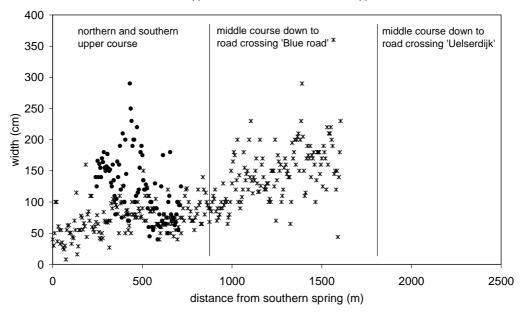
Figuur 3.2 Width of the Springendalse stream along its longitudinal course as recorded in 1995.

Comparing 2004 with 1995, the southern upper course became narrower at this section (Figure 3.2 versus 3.4). Along the first 250 m downstream of the spring the southern upper course widened up to twice the width of 1995. This could have been caused by a fall down of steep banks which were formed before 1995, at the time the stream cut itself deep in the landscape. Steep banks in such a sandy area are more quite instable and collapse at periods of high floods. But also the filling with clay in part of this section added to the widening. There was also a deeper section present in

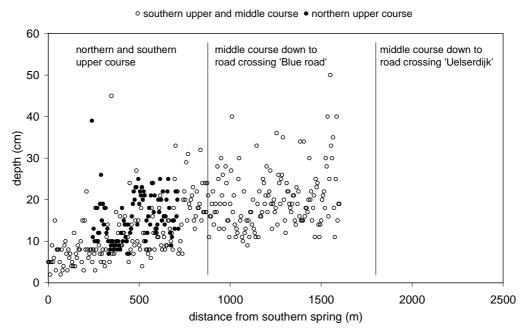
Figuur 3.3 Depth of the Springendalse stream along its longitudinal course as recorded in 1995.

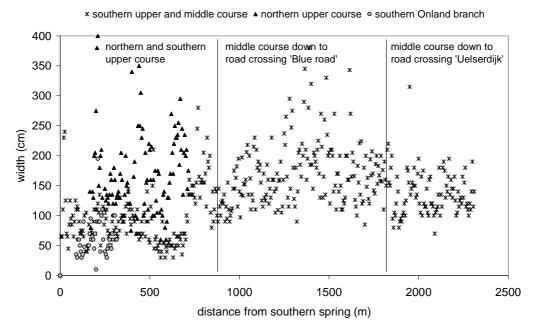
Figuur 3.4 Width of the Spingendalse stream along its longitudinal course as recorded in 2004.

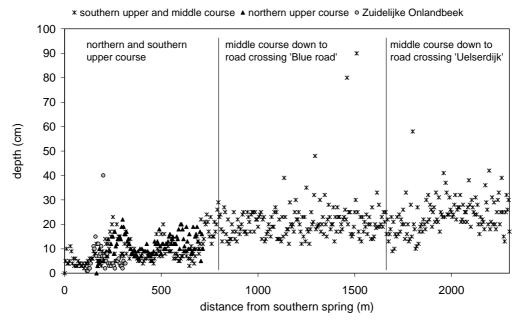
Figuur 3.5 Depth of the Spingendalse stream along its longitudinal course as recorded in 2004.

2004 at about 200 to 300 m downstream of the spring. Probably the clay filling caused a rise of the water level (deeper section). Further downstream a rise in bottom level is visible in 2004 (shallower section). This is due to the construction of gravel dams that led to this rise.

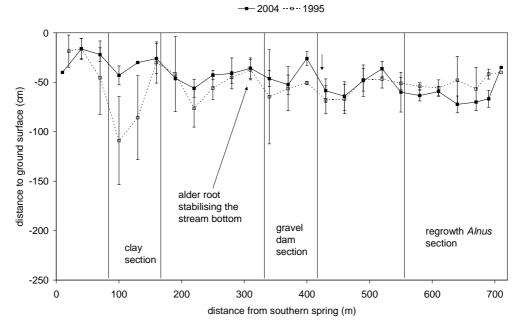
Figure 3.6 Average incision of the stream bottom of the southern upper course per 30 m. Error bars indicate the standard deviation. Data points without bars represent single measurements.

In Figure 3.6 the average distance between stream bottom and ground level per 30 m section of the southern upper course is illustrated for the years 1995 and 2004. In general, the stream bottom rose a little between 1995 and 2004. This did not account for the most downstream section where alder developed. At some section the stream cut itself in to more then 25 cm. This section also became more narrow (Figure 3.4). Furthermore, the bottom rise of about 65 cm due to the clay filling is visible in

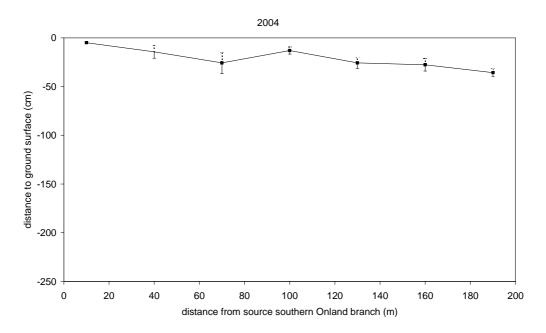
Figure 3.7 Average incision of the stream bottom of the southern Onland branch per 30 m. Error bars indicate the standard deviation. Data points without bars represent single measurements.

of the spring an old alder stabilized the stream bottom. This section did not change between 1995 and 2004. In Figure 3.7 the average distance between stream bottom and ground level per 30 m section of the southern Onland branch is illustrated for the years 1995 and 2004. This branch is not incised and showed little variation. The maximum incision is about 35 cm.

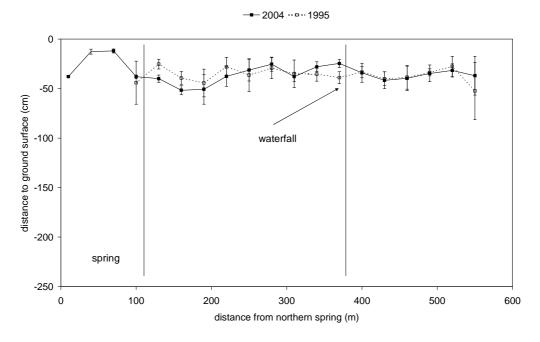
Figure 3.8 Average incision of the stream bottom of the northern upper course per 30 m. Error bars indicate the standard deviation. Data points without bars represent single measurements.

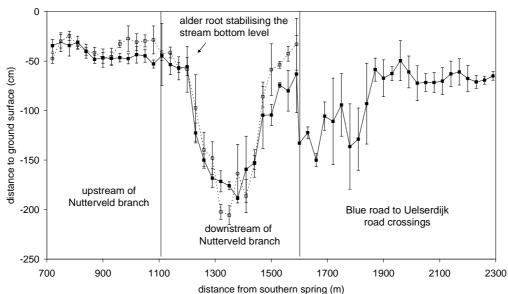
Figure 3.9 Average incision of the stream bottom of the middle course per 30 m. Error bars indicate the standard deviation. Data points without bars represent single measurements.

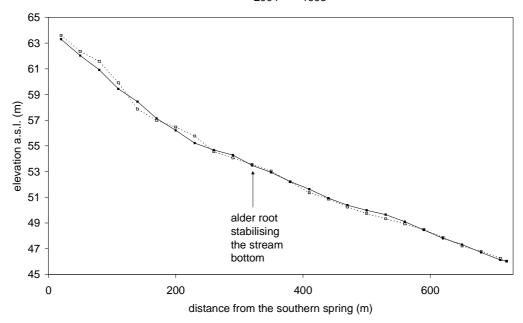
Figure 3.10 Slope of the southern upper course based on measurements over 30 m long sections.

The wet slope of the southern upper course was 17.28 m over a distance of 720 m. The slope became more regular, thus the physical profile stabilized, when comparing 2004 with 1995 (Figure 3.10). Hydrological measures taken prevent extreme discharge peaks that in the past led to dam formation and dynamic erosion-sedimentation patterns. The slope changed slightly along the first 260 m downstream of the spring due to the clay filling. The alder, 300 m downstream of the spring stabilized the slope. Also about 500 m downstream the spring the slope changed due to a mass development of *Berula erecta* which drove up the water.

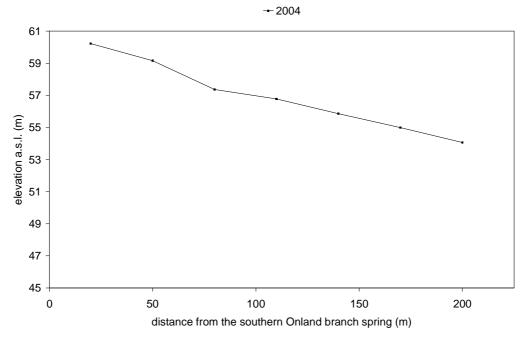
Figure 3.11 Slope of southern Onland branch course based on measurements over 30 m long sections.

The wet slope of the southern Onland branch was 6.15 m over a distance of 200 m. The waterfall at about 40 m downstream of the spring has a height difference of 1 m (Figure 3.11).

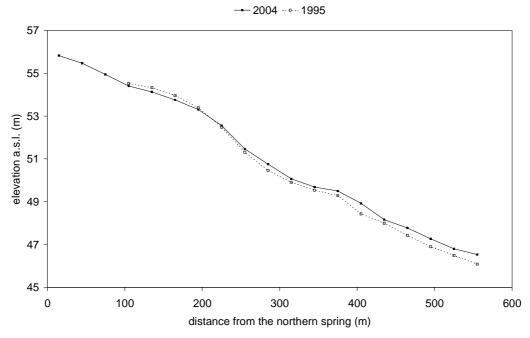
Figure 3.12 Slope of the northern upper course based on measurements over 30 m long sections.

3.12. Only in the downstream section the slope slightly decreased due to again a mass development *Berula erecta*.

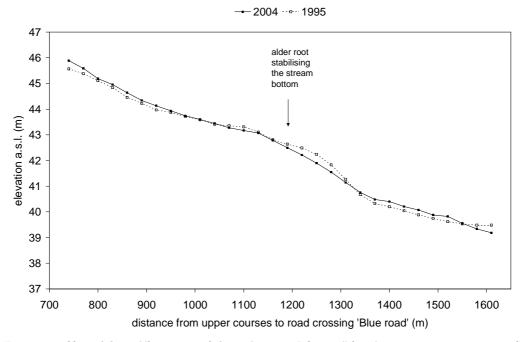
Figure 3.13 Slope of the middle course until the road crossing Blue road' based on measurements over 30 m long sections.

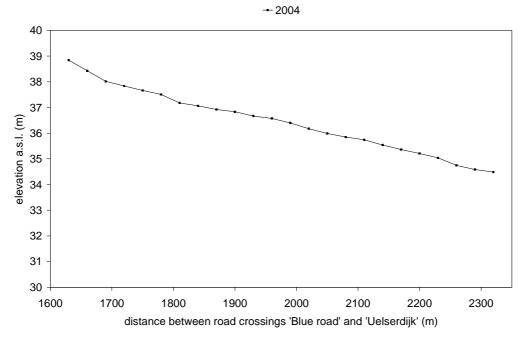
Figure 3.14 Slope of the middle course from the road crossing 'Blue road' to the road crossing 'Uelserdijk' based on measurements over 30 m long sections.

Downstream of the road crossing 'Blue road' the middle course wet slope is smooth (Figure 3.14).

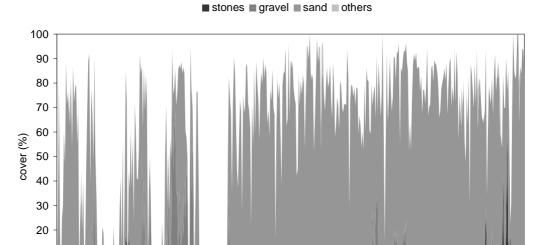
Figure 3.15 The distribution of mineral substrates along the southern upper course and middle course of the Springendal stream in 1995. Note that the most upstream 160 m and the most downstream 700 m were not recorded.

In 2004 the portion of gravel was reduced in comparison to 1995. Downstream of the confluence of southern and northern upper course this was due to the mass development of *Berula erecta*.

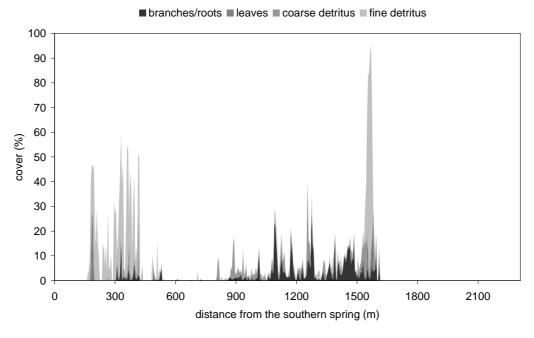
Figure 3.16 The distribution of organic substrates along the southern upper course and middle course of the Springendal stream in 1995. Note that the most upstream 160 m and the most downstream 700 m were not recorded.

The hydrological stability in the southern upper course caused an increased in organic substrates in 2004. Although, partly this difference can also be due to the fact that the surveys did not take place in the same season, namely in 1995 the survey was done in early summer and in 2004 in late autumn. Locally, clay and peat banks were found.

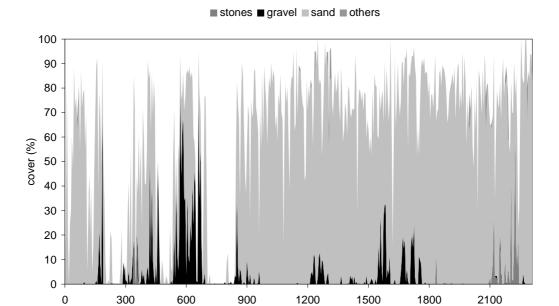
Figure 3.17 The distribution of mineral substrates along the southern upper course and middle course of the Springendal stream in 2004.

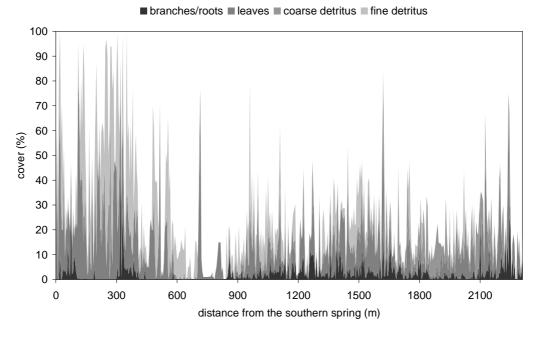
Figure 3.18 The distribution of organic substrates along the southern upper course and middle course of the Springendal stream in 2004.

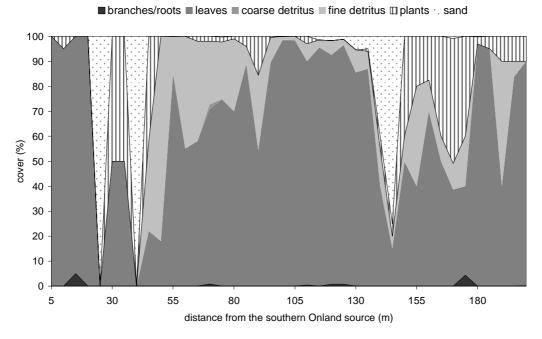
Figure 3.19 The distribution of substrates along the southern Onland branch of the Springendal stream in 2004.

The southern Onland branch is characterised as an organic stream (Figure 3.19). Mineral substrates more or less lack. Especially, coarse detritus prevailed.

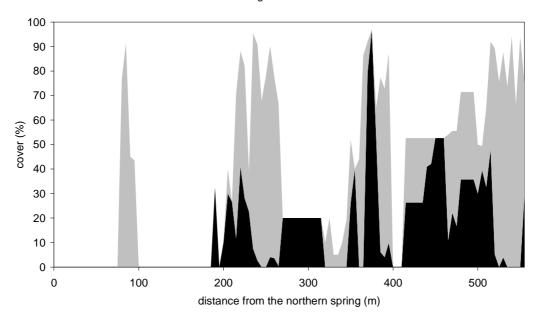
Figure 3.20 The distribution of mineral substrates along the northern upper course of the Springendal stream in 1995. Note that the most upstream 75 m were not recorded.

Also in the northern upper course the proportion of gravel decreased between 1995 and 2004 (Figure 3.20, 3.22). Again the expansion of *Berula erecta* was one of the main causes, but also the seasonal difference between both surveys plays a role. The proportion of leaves and other organic substrates were much higher in the 2004 survey due to season (Figure 3.21, 3.23). The proportion of fine detritus was low and indicates higher current velocities. Note that in between *Berula erecta* vegetation patches fine detritus accumulates. This fraction though was not taken into account.

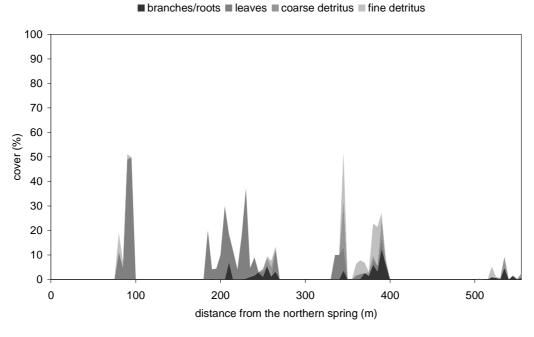
Figure 3.21 The distribution of organic substrates along the northern upper course of the Springendal stream in 1995. Note that the most upstream 75 m were not recorded.

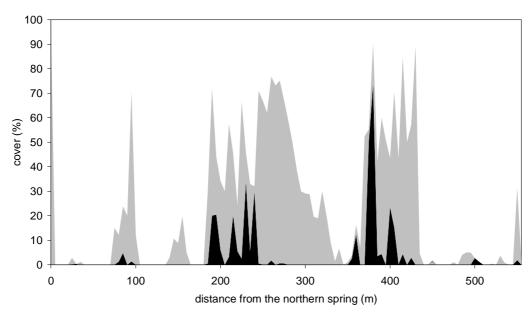
Figure 3.22 The distribution of mineral substrates along the northern upper course of the Springendal stream in 2004.

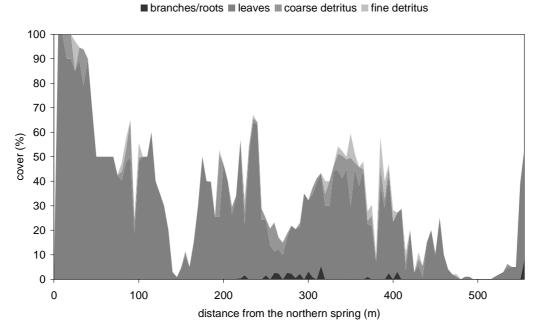
Figure 3.23 The distribution of organic substrates along the northern upper course of the Springendal stream in 2004.

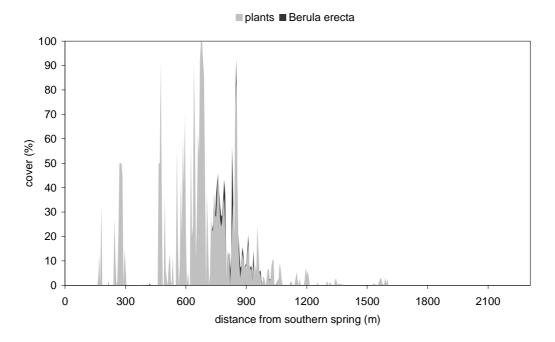
Figure 3.24 The distribution of Berula erecta along the southern upper course and middle course of the Springendal stream in 1995. Note that the most upstream 160 m and the most downstream 700 m were not recorded.

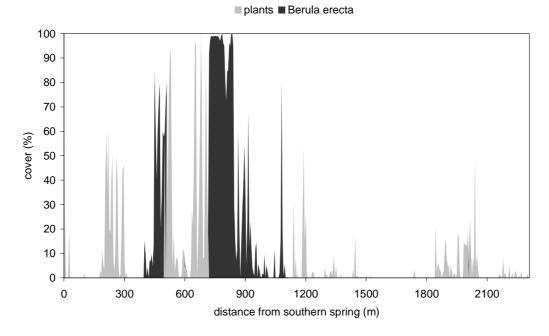
Figure 3.25 The distribution of Berula erecta along the southern upper course and middle course of the Springendal stream in 2004.

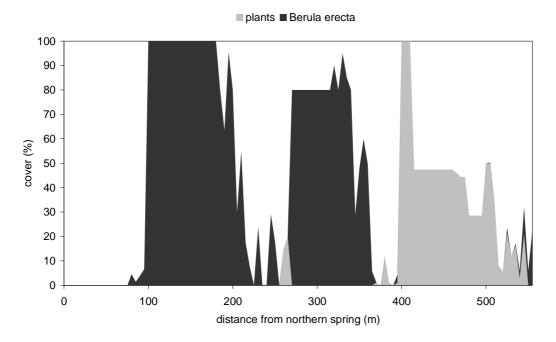
Figure 3.26 The distribution of Berula erecta along the northern upper course and middle course of the Springendal stream in 1995. Note that the most upstream 75 m were not recorded.

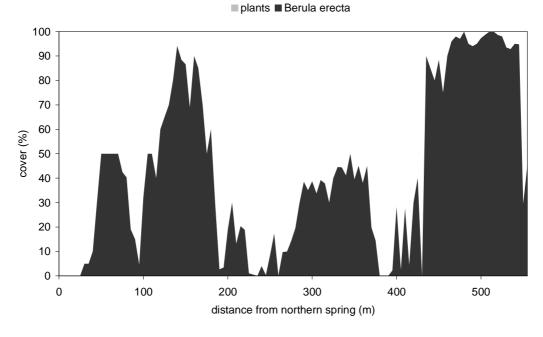
Figure 3.27 The distribution of Berula erecta along the northern upper course and middle course of the Springendal stream in 2004.

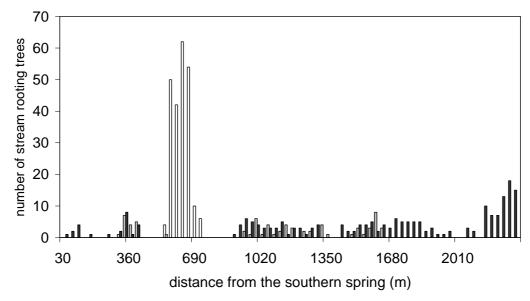
Figure 3.27 Number of in the stream rooting trees along the southern upper course and the middle course per 30 m section in 1995 and 2004.

During the surveys also trees rooting in the stream were noted per 30 m section. Locally, there were clear differences between 1995 and 2004 in the southern and middle course (Figure 3.27). These differences are most probably caused by the definition of rooting trees, which was differently interpreted between the two surveys. Still, in general 1 to 5 trees root in the stream along a 30 m stretch. Only in the downstream part of the middle course the tree density was higher (up to 18 trees per 30 m). In this stretch the stream runs through a wooded bank causing a higher tree density close to the stream bank.

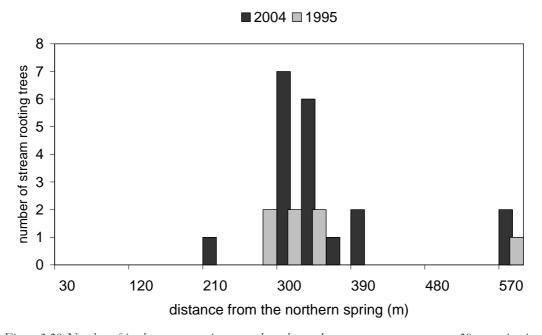
Figure 3.28 Number of in the stream rooting trees along the northern upper course course per 30 m section in 1995 and 2004.

The stretch along the southern upper course, where alder could develop, the number of rooting trees (though very young) was up to 60 per 30 m. Along the northern upper course up to 7 rooting trees per 30 m section were found. The differences between 1995 and 2004 were due to differences between observers (Figure 3.28).

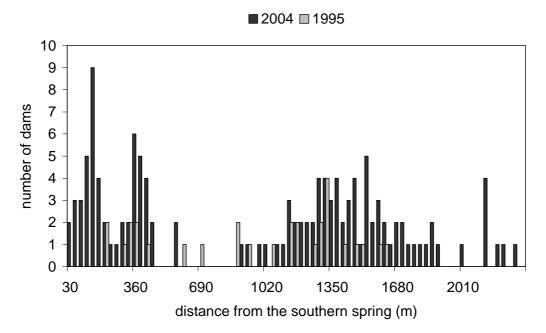
Figure 3.29 Number of organic dams along the southern upper course and the middle course per 30 m section in 1995 and 2004.

The number of organic dams increased between 1995 and 2004 (Figure 3.29). This could be caused by a seasonal difference in survey date. Most of these dams were noted from forested areas and such dams are formed amongst others by leave accumulation. In 1995 a maximum of four dams was found, in 2004 one section had even nine dams. On average in 1995 each 30 m section had one dam while in 2004 two to three.

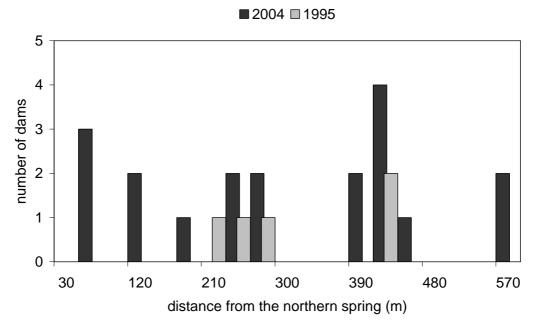
Figure 3.30 Number of organic dams along the northern upper course per 30 m section in 1995 and 2004.

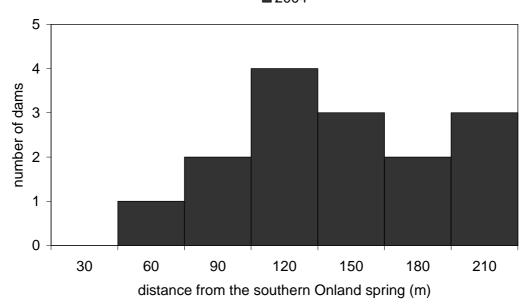
Figure 3.31 Number of organic dams along the Onland branch per 30 m section in 1995 and 2004.

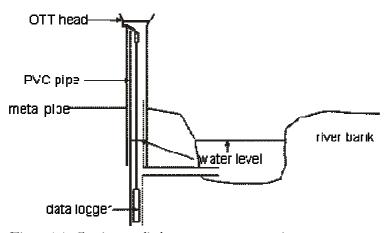
Discharge was recorded continuously by using an automated water level registration equipment linked to measure weirs. The weir provided a fixed profile in the stream. In fact not the discharge but the water level was measured continuously, using data loggers. These data loggers were constructed within a metal pipe which is situated in the river bank (Figure 4.1). A transversal pipe ensured the horizontal connection with the water column of the stream. Water moved from the stream into this pipe. The data logger recorded the pressure of the water in the pipe.

Figure 4.1. Continuous discharge measurement equipment.

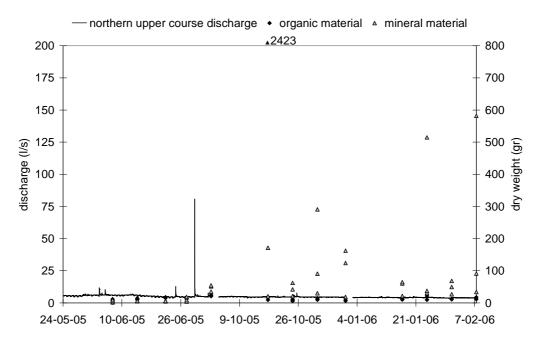
Figure 4.5 Continuous discharge pattern and material collected by means of the MOC's, during three periods of measurement (June 2005, October 2005 and January 2006).

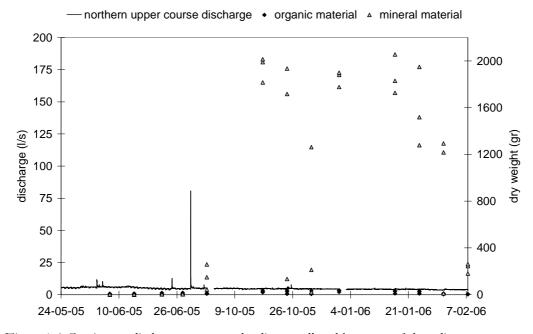
Figure 4.6 Continuous discharge pattern and sediment collected by means of the sediment traps, during three periods of measurement (June 2005, October 2005 and January 2006).

The substrate pattern changed quite drastically after the extreme June flood event. In one section (Figure 4.6) the flood washed the detritus and a large gravel bed appeared. In the second section the detritus was largely replaced by sand due to the extreme flood (Figure 4.7). In both other periods of measurement only gradual changes in substrate pattern occurred (Figures 4.7 and 4.8).

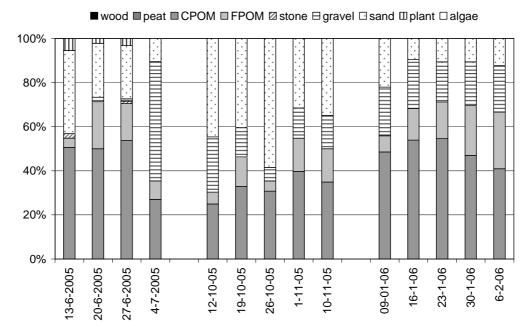
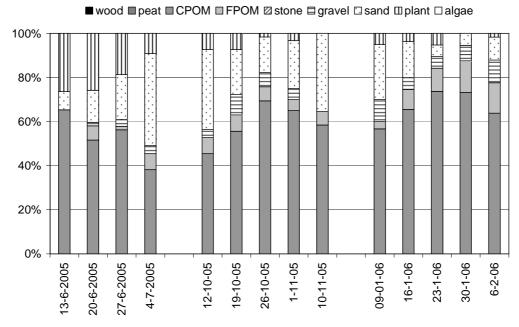
Figure 4.7 Relative substrate composition, during three periods of measurement (June 2005, October 2005 and January 2006).

Figure 4.8 Relative substrate composition, during three periods of measurement (June 2005, October 2005 and January 2006).

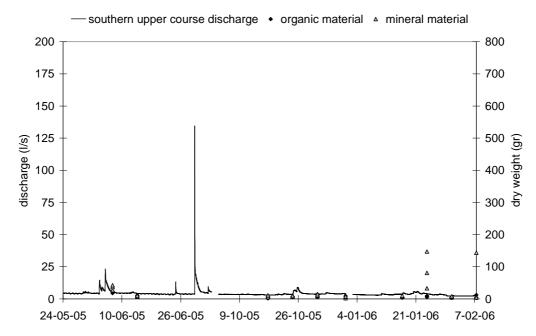
Figure 4.9 Continuous discharge pattern and material collected by means of the MOC's, during three periods of measurement (June 2005, October 2005 and January 2006).

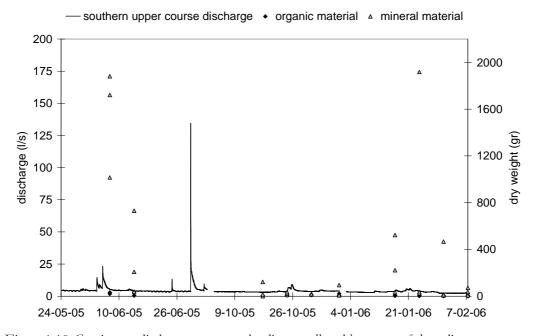
Figure 4.10 Continuous discharge pattern and sediment collected by means of the sediment traps, during three periods of measurement (June 2005, October 2005 and January 2006).

In both the October and January measurements little transport took place, except for the second date of measurement in January. This movement was caused by a small discharge increase in the week before. The moving bottom sediment traps regularly were filled. Most probably sand is rolling or moving over de stream bottom in irregular waves or mini-dunes (Figure 4.10).

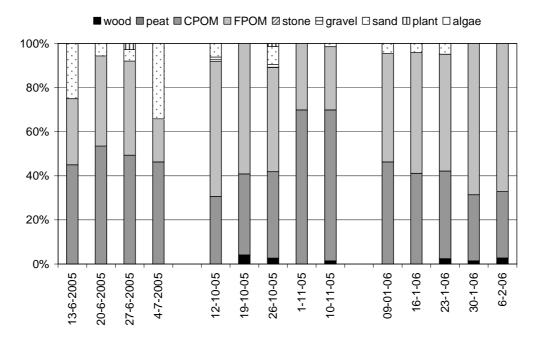
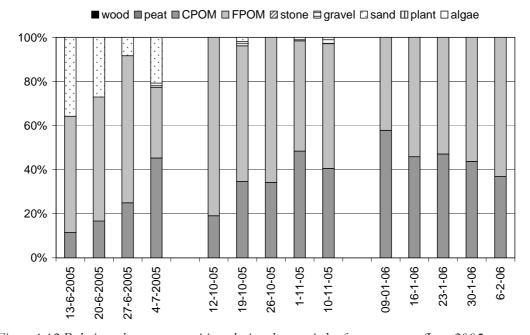
Figure 4.11 Relative substrate composition, during three periods of measurement (June 2005, October 2005 and January 2006).

Figure 4.12 Relative substrate composition, during three periods of measurement (June 2005, October 2005 and January 2006).

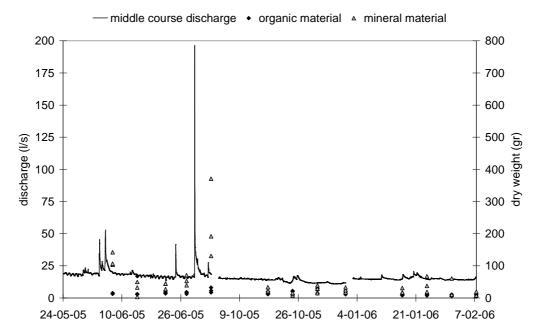
Figure 4.13 Continuous discharge pattern and material collected by means of the MOC's, during three periods of measurement (June 2005, October 2005 and January 2006).

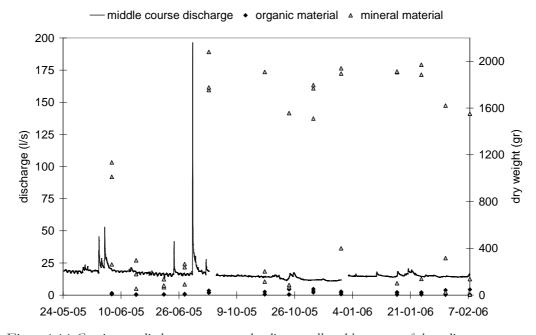
Figure 4.14 Continuous discharge pattern and sediment collected by means of the sediment traps, during three periods of measurement (June 2005, October 2005 and January 2006).

The sediment traps, on the contrary, collected reasonable amounts after the small June flood and large amounts after the large June flood (Figure 4.14). But during both the October and January period still large quantities of moving bottom material were collected. This is most probably also be due to the instability caused by the June flood?

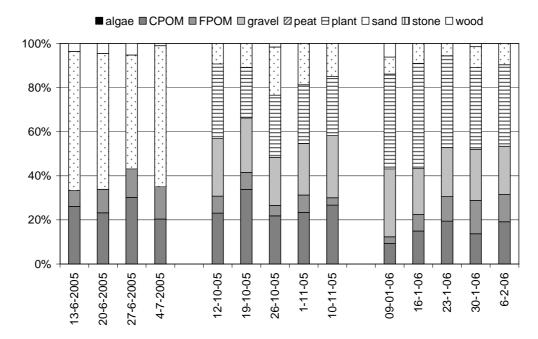
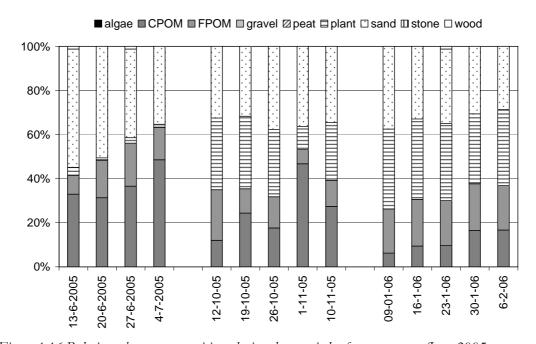
Figure 4.15 Relative substrate composition, during three periods of measurement (June 2005, October 2005 and January 2006).

Figure 4.16 Relative substrate composition, during three periods of measurement (June 2005, October 2005 and January 2006).

Surprisingly, both substrate sections did not show much change during each of the three periods of measurement (Figure 4.15 and 4.16). This indicates little impact of floods on the substrate composition of these stream sections, but confirms the MOC measurements. Both sand and plants presence covers up the moving sand as recorded by the sediment traps. The sand either moves over the large sand area present or in between the plants packets growing in these sections, and in both cases is thus not noticed.

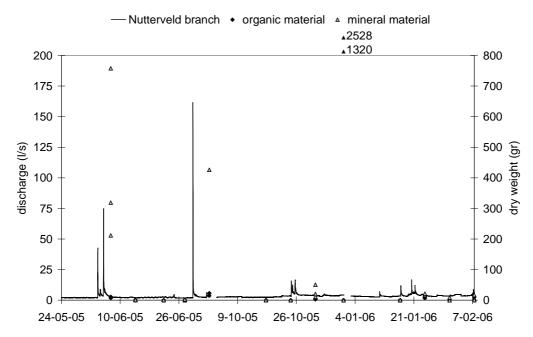
Figure 4.17 Continuous discharge pattern and material collected by means of the MOC's, during three periods of measurement (June 2005, October 2005 and January 2006).

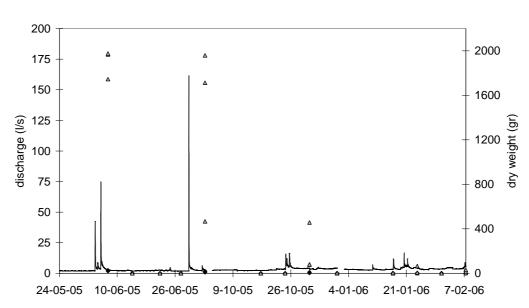
Figure 4.18 Continuous discharge pattern and sediment collected by means of the sediment traps, during three periods of measurement (June 2005, October 2005 and January 2006).

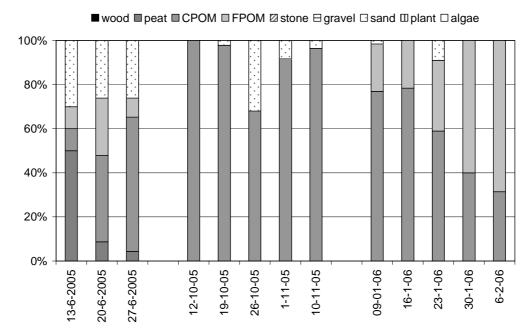
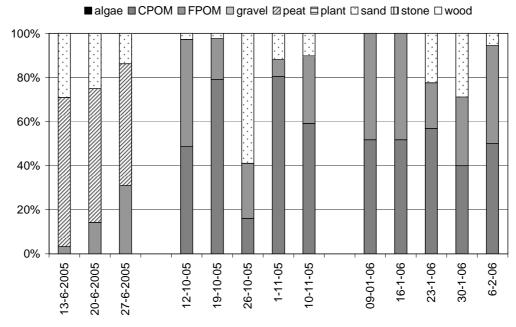
Figure 4.19 Relative substrate composition, during three periods of measurement (June 2005, October 2005 and January 2006).

Figure 4.20 Relative substrate composition, during three periods of measurement (June 2005, October 2005 and January 2006).

The first, smaller June flood did not change the substrate pattern (Figure 4.19 and 4.20). The extreme June flood effect was not recorded. On the other hand, the mid-October and mid-January floods had clear effects on both substrate patterns. In both sections organic material was replaced or covered by sand.

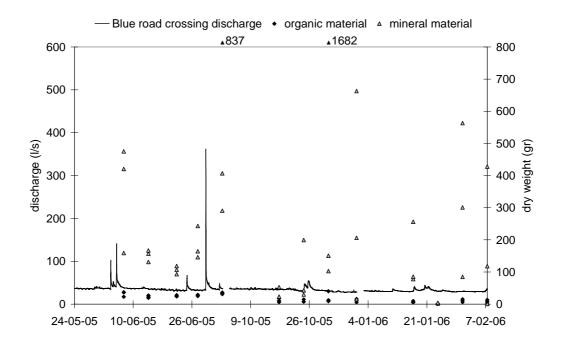
Figure 4.21 Continuous discharge pattern and material collected by means of the MOC's, during three periods of measurement (June 2005, October 2005 and January 2006).

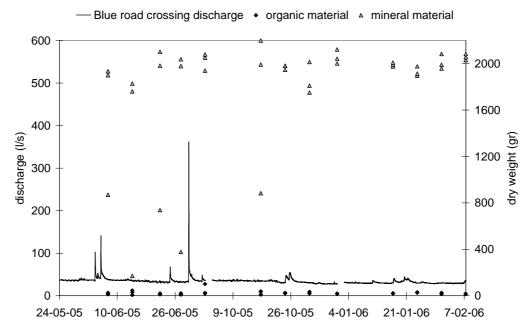
Figure 4.22 Continuous discharge pattern and sediment collected by means of the sediment traps, during three periods of measurement (June 2005, October 2005 and January 2006).

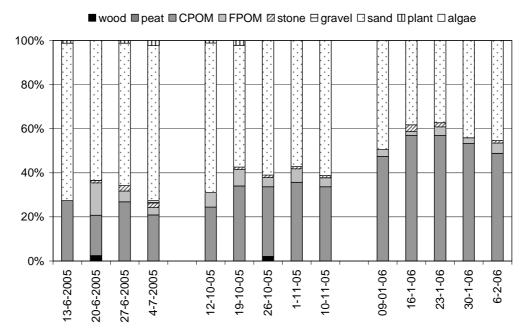
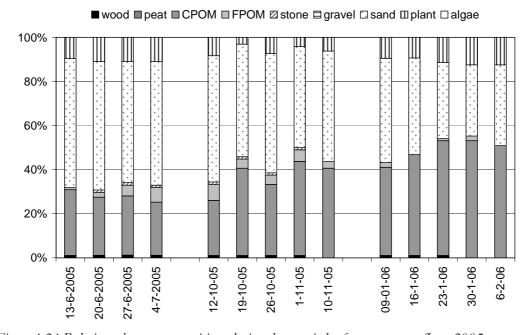
Figure 4.23 Relative substrate composition, during three periods of measurement (June 2005, October 2005 and January 2006).

Figure 4.24 Relative substrate composition, during three periods of measurement (June 2005, October 2005 and January 2006).

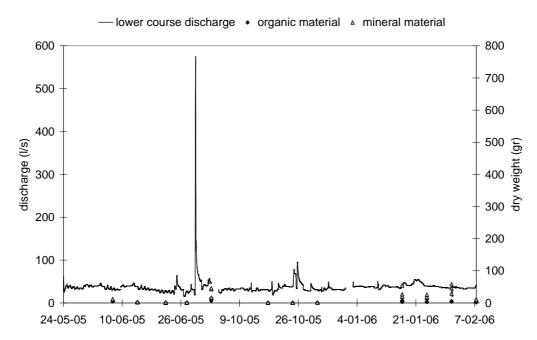
Figure 4.25 Continuous discharge pattern and material collected by means of the MOC's, during three periods of measurement (June 2005, October 2005 and January 2006).

The transport of suspended material in the lower course is small and only slightly responded to floods (Figure 4.25). The moving bottom transport showed to moments of increase, both related to higher discharge events (Figure 4.26). The substrate pattern remained quite constant per period, except for the last October measurement. In between the two last recordings the plants were removed by the water manager. This cleaning caused the substrate pattern to change (Figure 4.27 and 4.28).

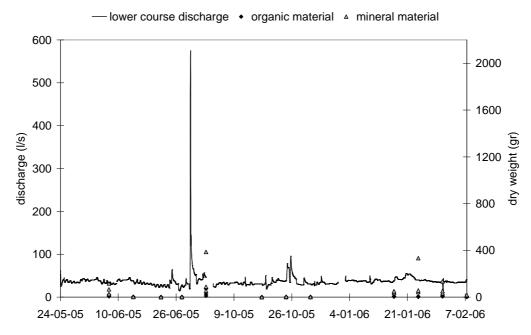
Figure 4.26 Continuous discharge pattern and sediment collected by means of the sediment traps, during three periods of measurement (June 2005, October 2005 and January 2006).

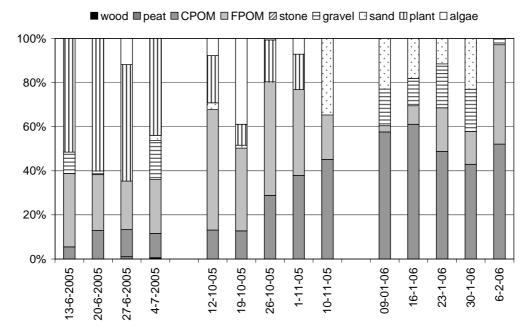
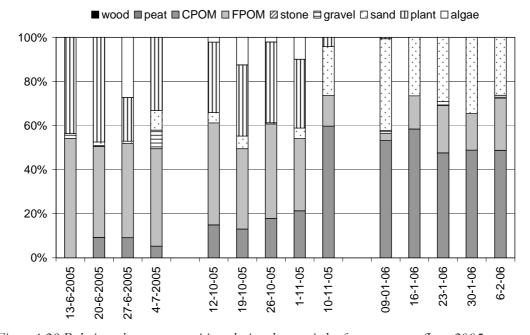
Figure 4.27 Relative substrate composition, during three periods of measurement (June 2005, October 2005 and January 2006).

Figure 4.28 Relative substrate composition, during three periods of measurement (June 2005, October 2005 and January 2006).

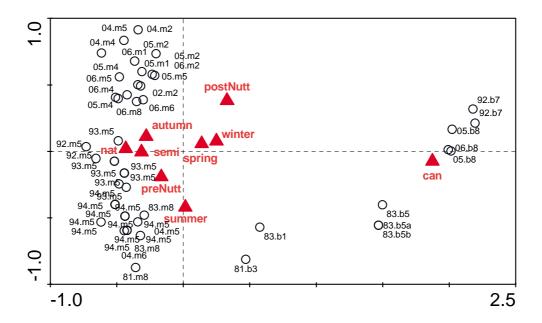
Figure 5.1 DCCA ordination diagram for the hydromorphological gradient analysis with the gradient, pre-post Nutterveld restoration, sample location, sample season and year variable groups included. The triangles represent the relative effects of the variables; the open circles represent each sample site. Sample sites are labelled by sample year and location. The variables sample location and year are included in the analysis, but illustratively suppressed in this diagram. The information on year and location can be obtained from the sample labels. The different hydromorphological gradients are indicated by: 'nat' for the natural stream section, 'semi' for the semi natural section and 'can' for canalized.
