Air tightness and heat leakage in insulated bodies

Report 586

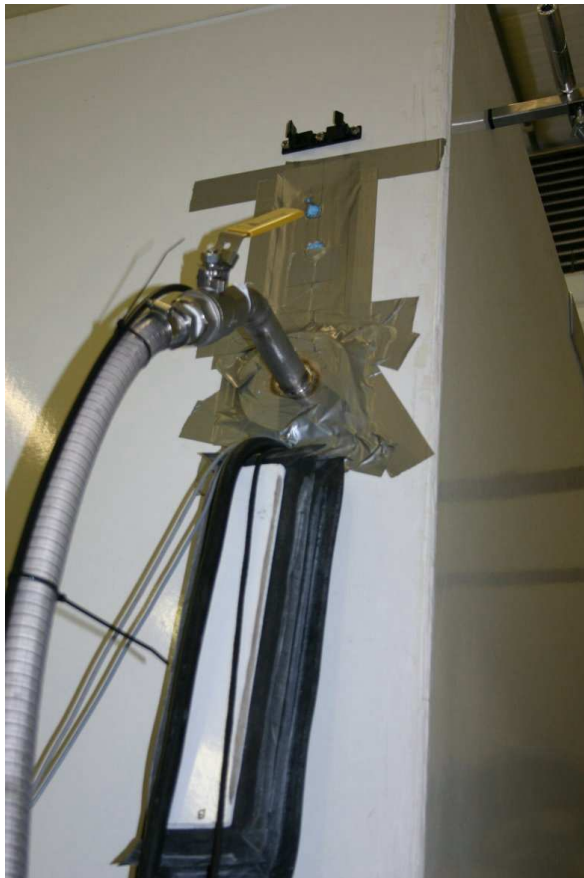
Fig. 2, holes drilled into vent opening (outside view).

An insulated FRC class vehicle (Table 2) has been placed in our ATP climate chamber. In the climate chamber both the K-value and the air tightness of the vehicle have been measured 4 times for 4 different degrees of air tightness. The degree of air tightness has been altered by drilling holes in the vehicle's vent opening (p. 9: Fig. 2, Fig. 3). The K-value has been measured according to ATP procedures with our standard ATP measurement equipment (Fig. 4, p. 9). Air tightness has been measured with our own brandnew air leakage measurement device at temperatures T_i = T_e = 16 °C using an internal underpressure. These test conditions comply with a mixture of the norm guidelines listed in Table 1.

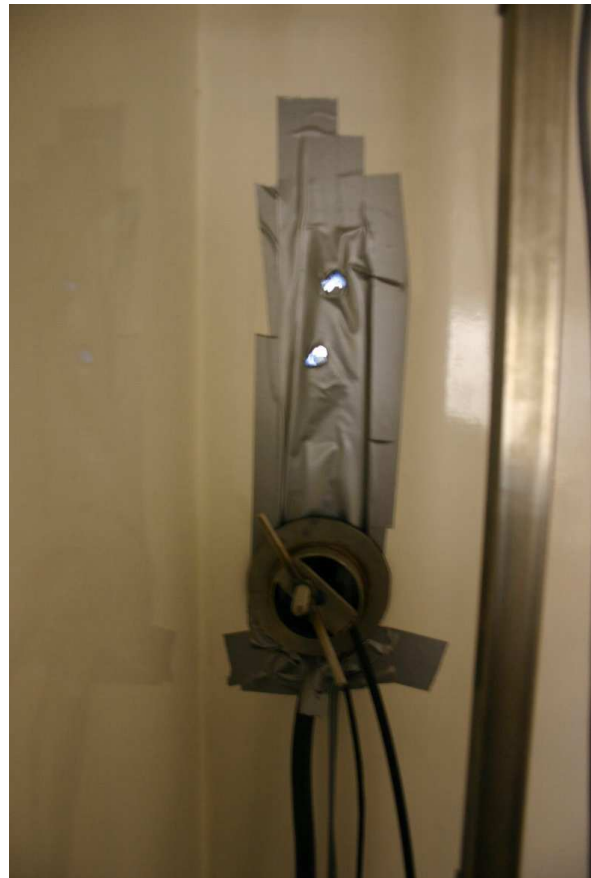
Fig. 3, holes drilled into vent opening (inside view).

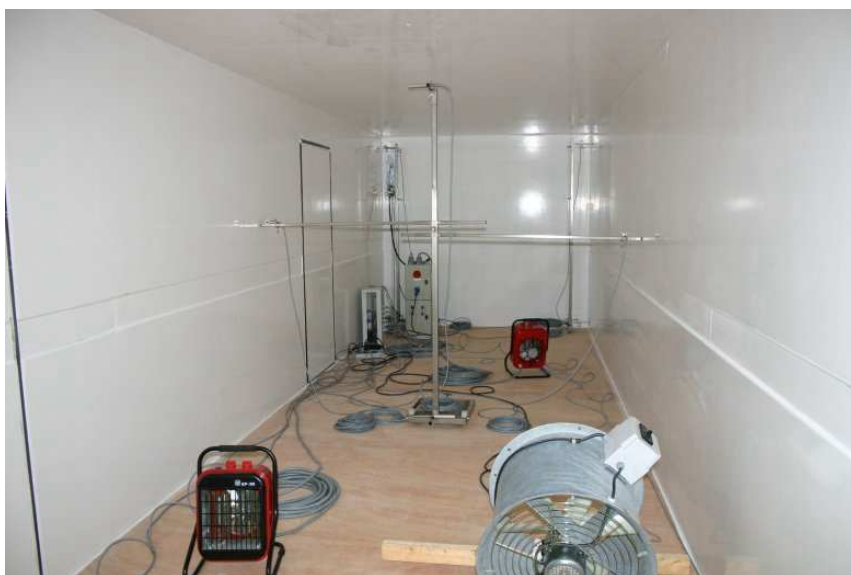
Fig. 4, K-value measurement equipment inside test body.

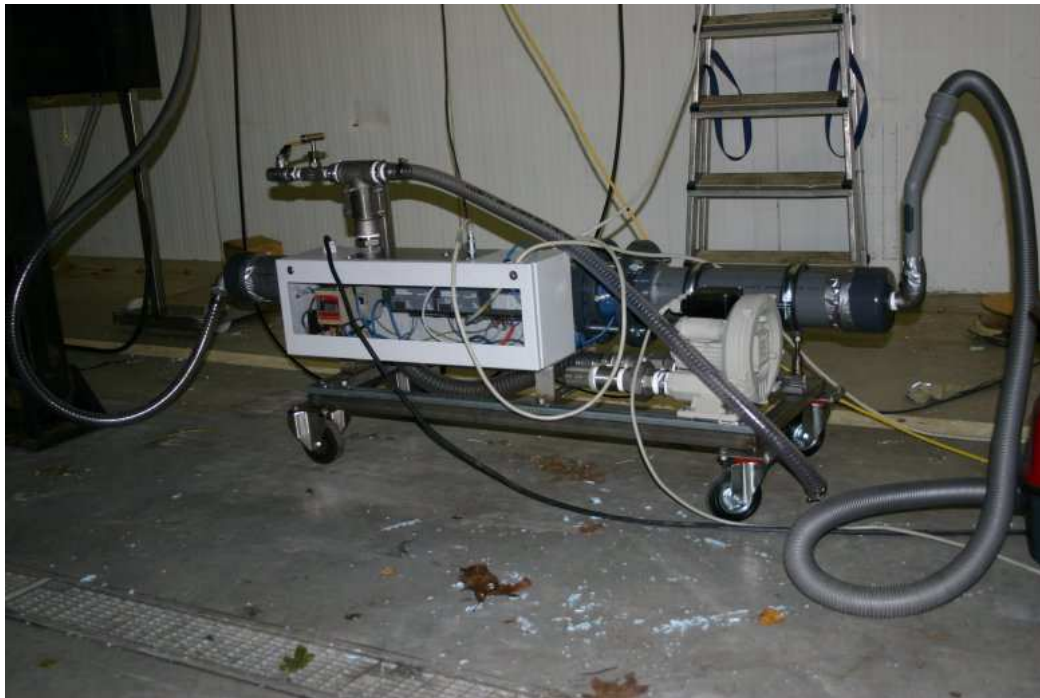
Fig. 5, air leakage measurement device.

For this project an air leakage rate measurement device has been built (Fig. 5, p. 10). In the design of the device the objective has been to develop a device which can easily be employed stand-alone in the field to measure the air tightness of any insulated vehicle in compliance with any standard in Table 1. In the design process the existing air leakage measurement device of Germanischer Lloyd served as an example. The basic components of the air leakage measurement device are a controllable air compressor, a vane anemometer to measure airflow, a pressure difference sensor and a logging unit to monitor pressure drop and air flow.
