Report 713

Evaluation Meyn Footpad Inspection System

December 2013

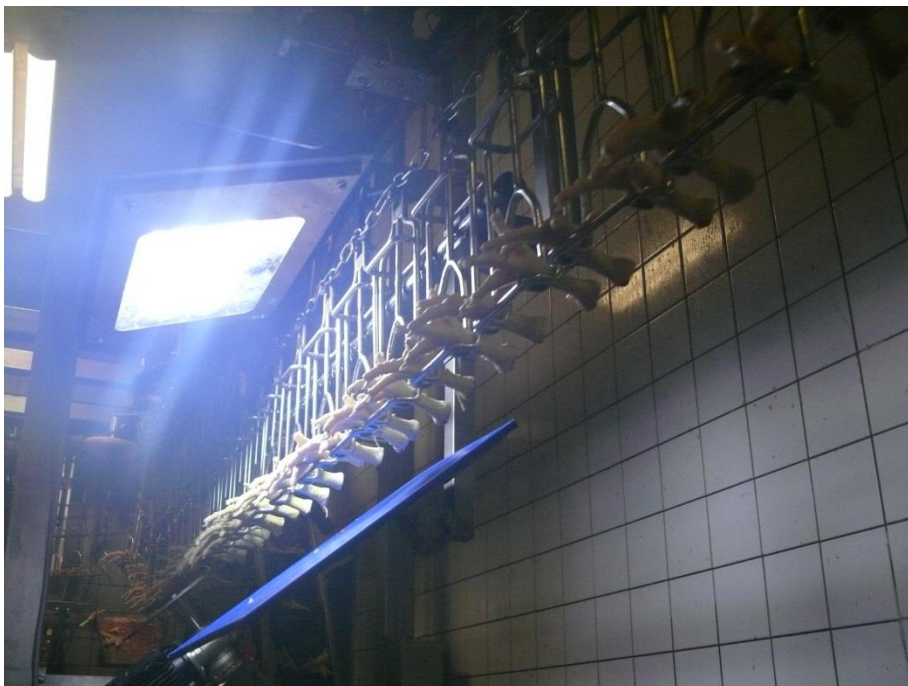
Figure 2 Camera set up at the slaughterhouse visited

The camera validation is conducted at a Dutch broiler slaughterhouse. For a description of the camera system, we refer to De Jong et al. (2011). The camera was installed to carry out measurements after the feet are cut off. To enable correct positioning of the feet within the camera image, a positioning unit was installed before the camera on the line (Figure 1). Figure 2 shows the camera as it was installed at the slaughterhouse. Figure 3 shows a camera image of the feet in the shackle during measurements and a screenshot of the system.

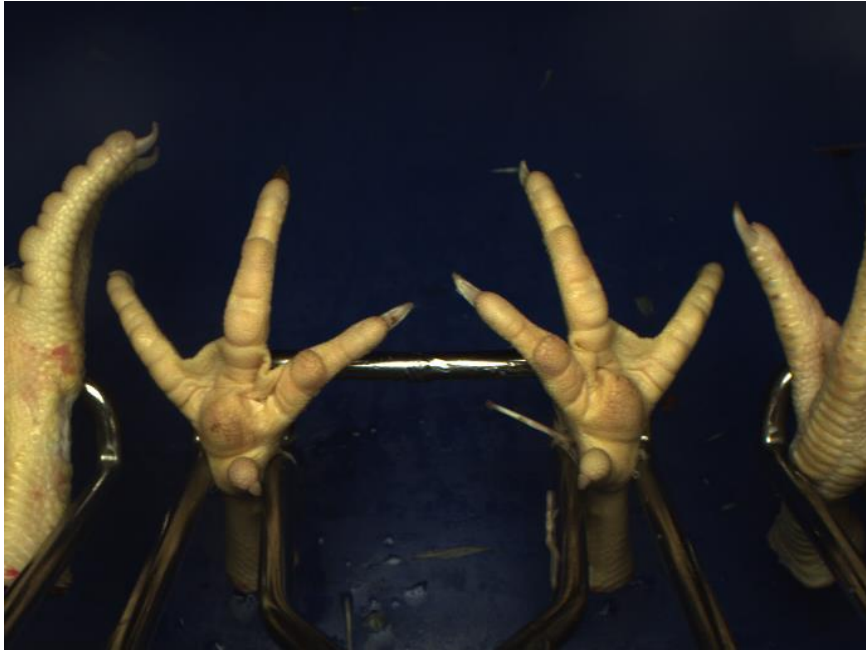
Figure 3 Above: camera image of the feet in the slaughter shackle during measurement (these legs were scored 0); screenshot of the system (below)

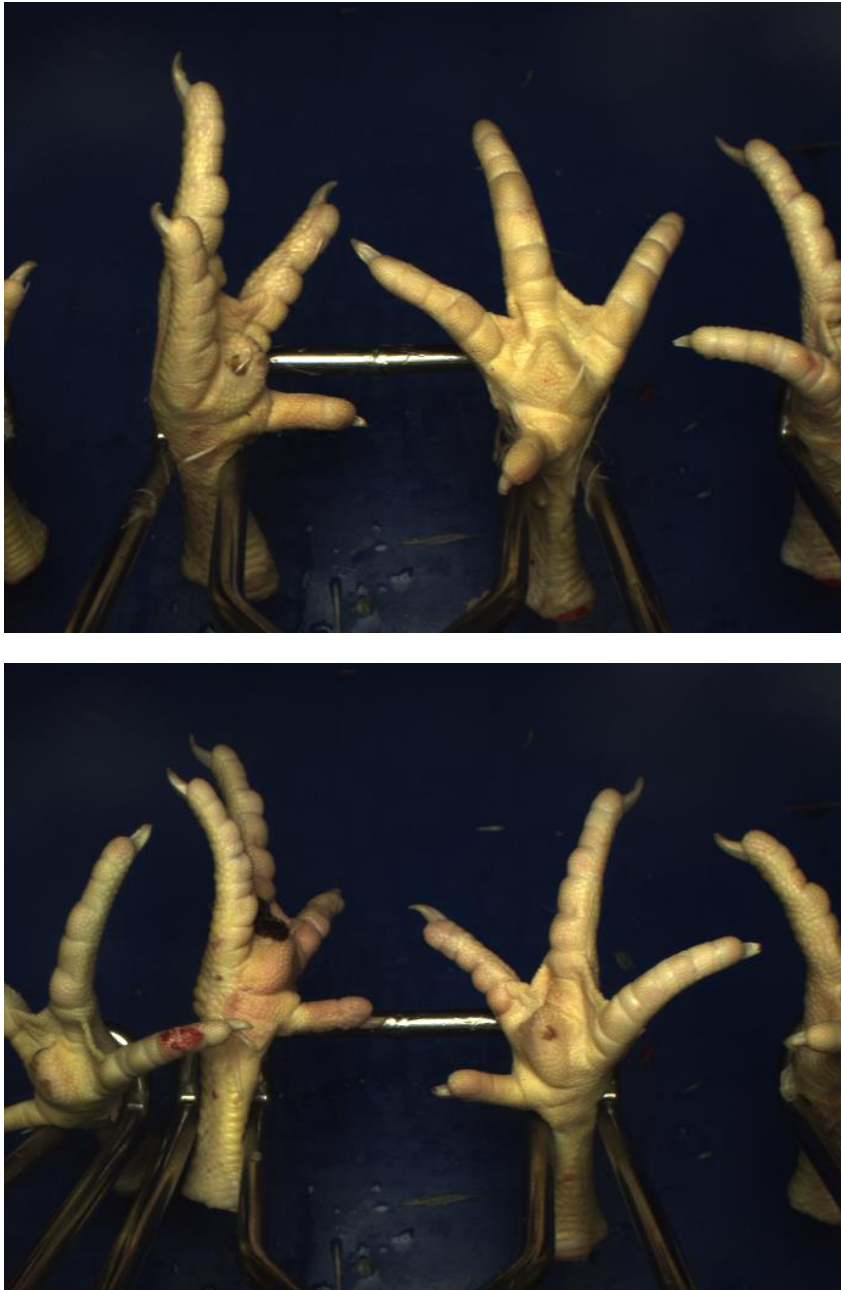
Figure 4 Camera image of feet which are severely rotated for the camera and so no score can be given (the left foot in both pictures). Due to the severely rotated position, the software excluded these feet from scoring. Both foot pairs were scored as class 0 (no lesion) despite the lesion on the foot in the bottom left picture.

The camera cannot score feet that are hanging tilted or rotated in the shackles. The software determines if the foot can be scored based on the number and position of the toes. When only one foot can be scored, that particular score is recorded for the pair. When two feet can be scored, the most severe score is recorded. Figure 4 shows an example of camera images where only one foot has been scored.

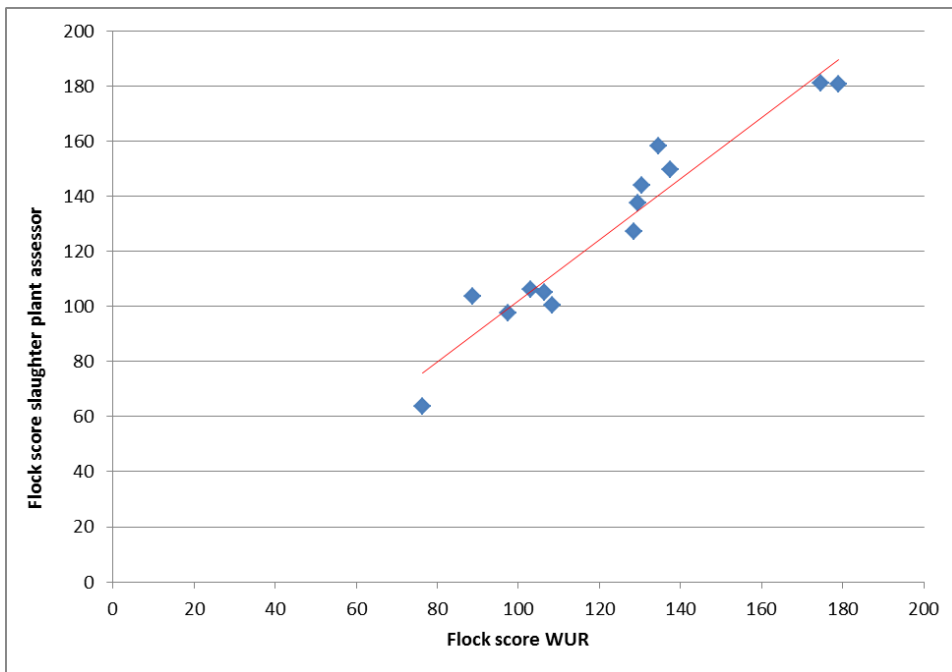
Figure 5 Relationship between the flock scores given by WUR-LR and the slaughter plant assessor

The slaughterhouse assessor is trained in scoring footpad lesions in the basic course offered by PTC+ (Expertise and Training Centre, Barneveld, the Netherlands). His flock scores were compared with those of the WUR-LR assessor and the correlation between the slaughter plant assessor and WUR-LR was high ($r_{sp} = 0.94$, $P < 0.001$) as shown graphically in Figure 5. Based on this, it was decided, for this evaluation, to also look at the correlation of the camera system scores per flock and the plant assessor scores per flock during the period between the 10th and 18th of June 2013. The camera system can then be evaluated based on a larger number of observations.

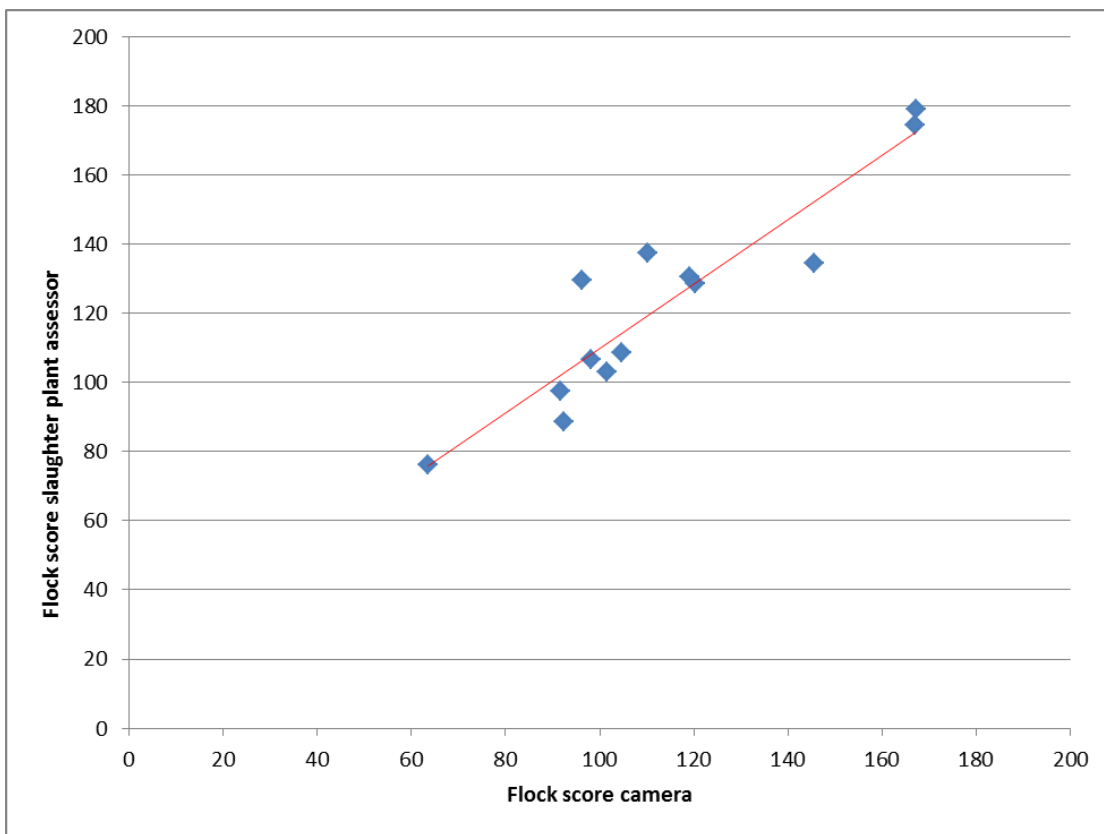
Figure 6 Relationship between the flock scores given by the camera and the slaughter plant assessor

Appendix 2 also shows the flock score by the camera, the slaughter plant assessor and the WUR-LR assessor for each sample. For three flocks, the flock score deviated from that of the WUR-LR assessor and the slaughter plant assessor by more than 20 points. Nevertheless, the correlation between the score from the slaughter plant assessor and the camera was high ($r_{sp}=0.88$, $p<0.001$, Figure 6) as was the correlation between the WUR-LR assessor and the camera ($r_{sp}=0.87$, $p<0.001$) (Figure 7).
