MORPHOLOGICAL PROCESSES IN LOWLAND STREAMS

IMPLICATIONS FOR STREAM RESTORATION

JORIS P.C. EEKHOUT

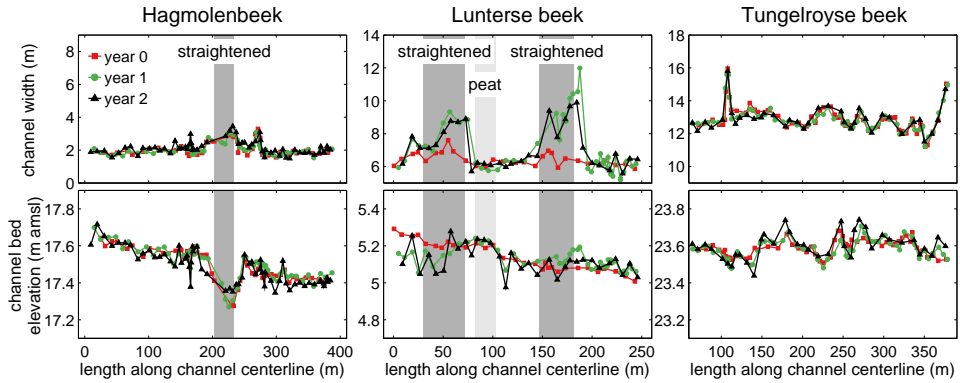
Figure 2.4 Channel width and channel depth along the channel centerline at year 0 (red squares), year 1 (green circles) and year 2 (black triangles). The location where the re-meandered channels cross the straightened channels are indicated with dark grey (Hagmolenbeek and Lunterse beek). The location of the peat deposit in the Lunterse beek is indicated with light grey.

Figure 2.4 showed that few changes in channel width were observed in the Tungalroyse beek. TCS1 shows the cross-section where the channel was constructed, with a channel width exceeding the rest of the channel; 15.7 m against an average of 12.9 m. At this location, located in a bend, channel incision of the outer bank and aggradation of the inner bank occurred. TCS2 shows point bar development in the inner bend. Here, sediment was deposited in the inner bend, resulting in a gradual increase amounting to 0.27 m in the first year and 0.22 m in the second year. TCS3 is located at the downstream end of the study reach and shows the channel bed gradually aggregated over the two-year period, by 0.23 m in the first year and 0.13 m in the second year.

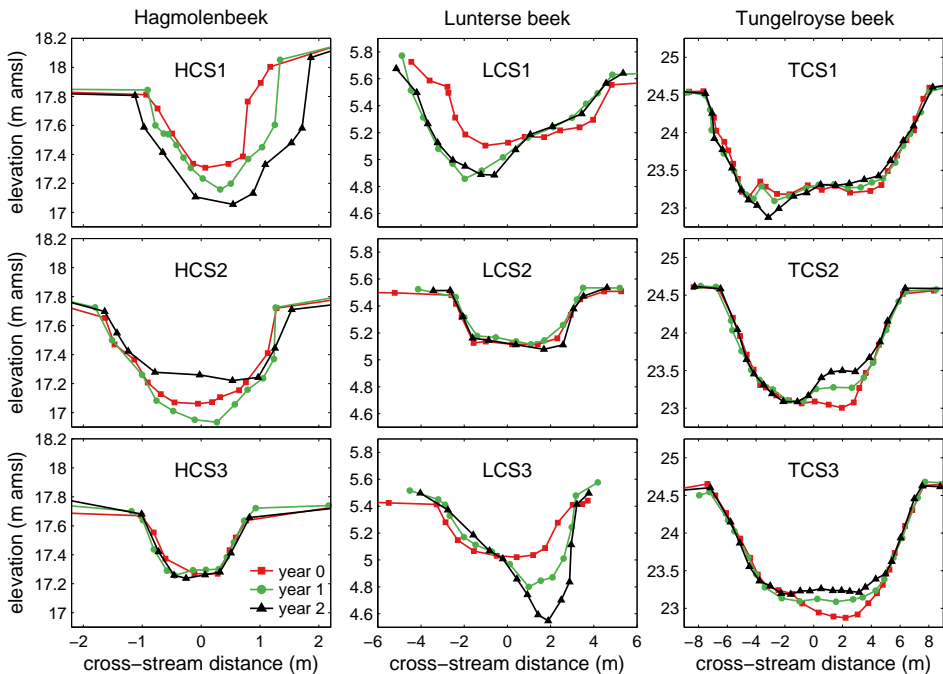
Figure 2.5 Three examples of the temporal evolution of cross-sections in the three streams at year 0 (red squares), year 1 (green circles), and year 2 (black triangles). The location of the cross-sections correspond to the locations as shown in Figure 2.2.

During the two-year survey period, hardly any changes in channel width were observed in the Tungalroyse beek. Changes were more apparent in the temporal evolution of the bed elevation. Channel incision occurred between streamwise coordinates 125 and 150 m. Deposition of sediment occurred around streamwise coordinates 175 m and 250 m, and downstream from streamwise coordinate 350 m. The latter is most evident for cross-section TCS3 (Figure 2.5).

In the Lunterse beek, channel widening and incision occurred on a larger scale. LCS1 shows a location along the channel where the re-meandered channel crosses the formerly straightened channel. It shows a cross-section where bank erosion occurred next to incision of the channel bed near the eroding bank. This resulted in a typical asymmetric cross-sectional shape, as found in meandering rivers. The upstream cross-section also shows that morphological adjustments mainly occurred in the first year. At this location, bank erosion amounted to 1.4 m (19% of the channel width). Channel incision amounted to 0.22 m (55% of the channel depth). LCS2 shows a cross-section surrounded by peat deposits. Few morphological adjustments occurred in this section of the channel. LCS3 shows that just downstream of the peat deposits, channel incision occurred. As opposed to other locations along the channel, here the morphological development took place gradually. In the first year, incision amounted up to 0.22 m and in the second year up to 0.25 m, reaching 130% of the channel depth in total.

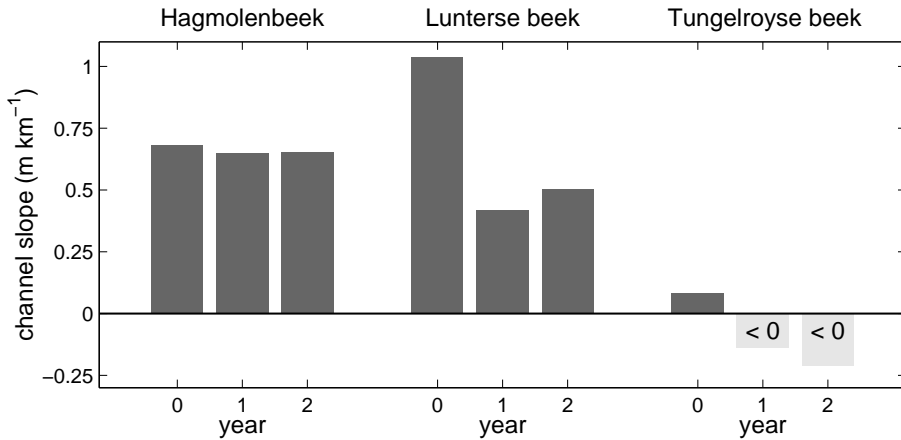
Figure 2.6 Channel bed slope (m km^{-1}) derived from the lower panels of Figure 2.4.

Figure 2.6 shows the channel slopes for each of the three surveys per stream. The channel slope in the Hagmolenbeek did not change over the two-year period. Both the Lunterse beek and the Tungalroyse beek show decreasing channel slopes over time. The decrease of channel slope in the Lunterse beek was most dramatic in the first year. This was mainly caused by channel incision at the upstream end of the study reach. In the second year, a slight increase of the channel slope was observed. The Tungalroyse beek featured negative channel slopes for the surveys after one and two years, which can be attributed to local channel bed adjustments.

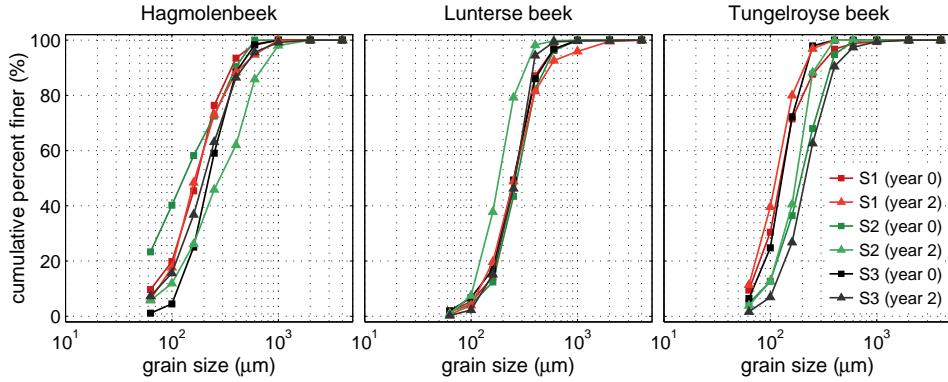
Figure 2.7 Grain size distribution taken during year 0 (squares) and year 2 (triangles). Samples were taken at three locations along the channel centerline: S1 (red), S2 (green) and S3 (black). The sample locations are shown in Figure 2.2.

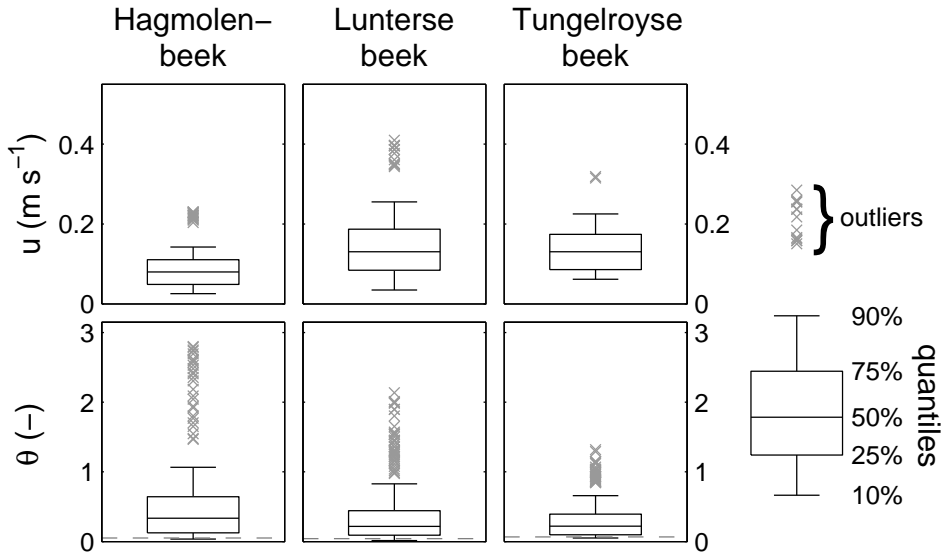
Figure 2.9 Box-and-whiskers plots (median, 25th and 75th percentiles within the box and 10th and 90th percentiles as whiskers) of the cross-sectional averaged flow velocity \bar{u} (m s^{-1}) and cross-sectional average Shields stress θ (-). The dashed lines in the lower plots indicate the Shields parameter. A value X is considered to be an outlier when the value is outside the range between $Q_{25} - w(Q_{75} - Q_{25})$ and $Q_{75} + w(Q_{75} - Q_{25})$, with $w = 1.5$. Outliers are plotted with grey crosses.

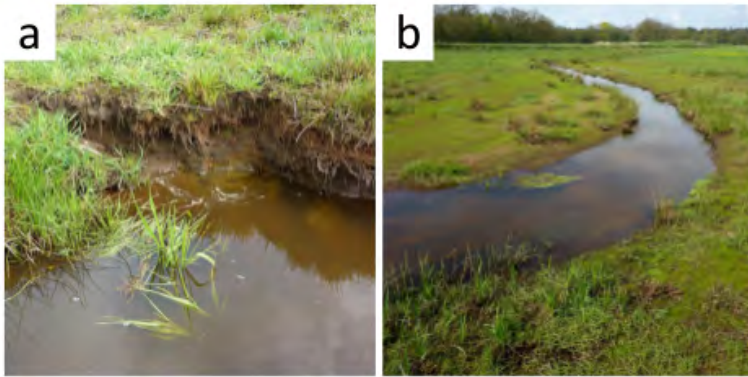
Figure 2.10 Photos from (a) the channel bank where extensive bank erosion occurred, and (b) a channel bend with similar curvature where no morphological changes occurred.

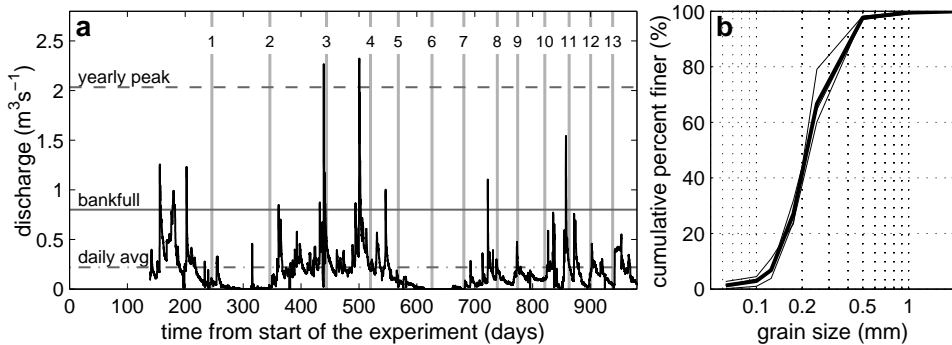
Figure 3.2 (a) Discharge hydrograph of the channel under study. The grey horizontal lines denote the yearly peak discharge (dashed), bankfull discharge under initial constructed channel conditions (solid) and daily average discharge (dash-dotted). The 13 surveys are indicated with the grey vertical lines. (b) Grain size distributions from bed material samples, taken at 3 locations in the experimental reach. The bold line denotes the average from all three samples.

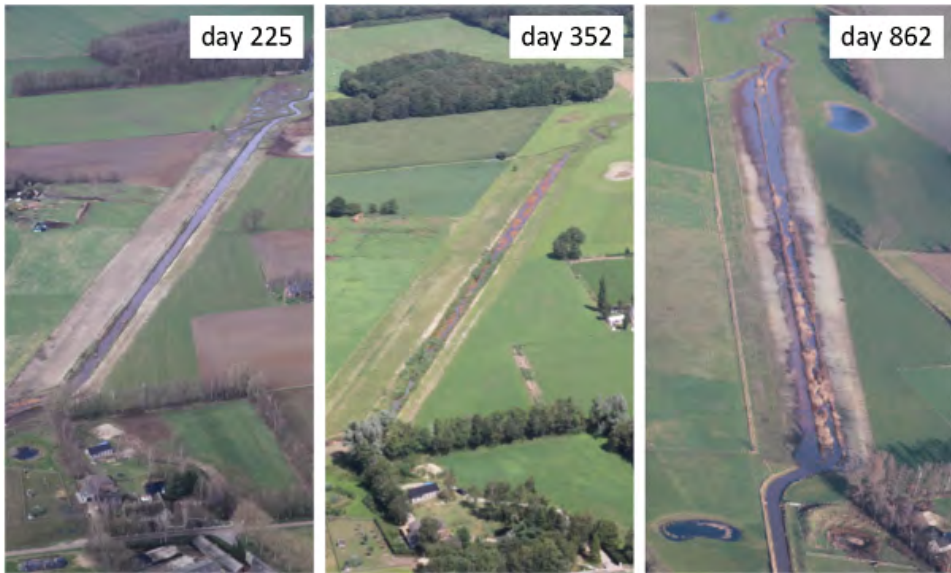
Figure 3.3 Aerial photos of the experimental reach, taken at 225, 352 and 862 days after the start of the experiment. Water is flowing from the bottom to the top. The middle photo shows a clear difference between the vegetated area (upstream) and the regular pattern of alternate bars (downstream).

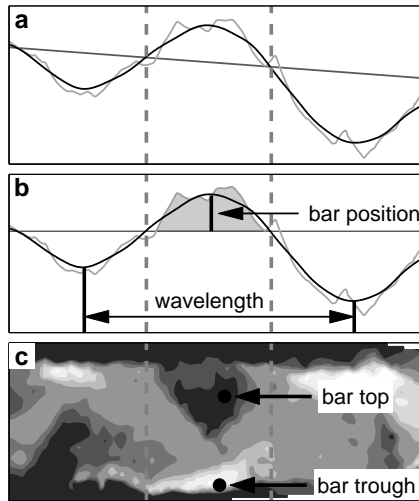
Figure 3.4 Definition of bar characteristics, with an example of the fifth field survey (day 520): (a) the measured longitudinal channel bed profile on the left side of the channel (light grey), the longitudinal channel bed profile after applying the LOESS regression (black) and the channel gradient (dark grey), (b) detrended longitudinal channel bed profile and (c) bed topography data. Panel (b) gives definitions for bar wavelength and bar position. Panel (c) gives definitions for the locations of bar top and bar trough, their difference being the bar amplitude.

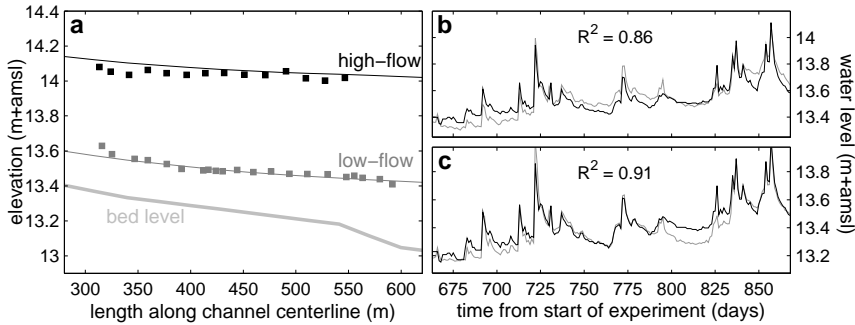
Figure 3.5 Results from (a) model calibration and (b and c) model validation. The squares in panel (a) denote the measured water levels during the survey and the lines the modelled water levels. The thick light grey line denotes the bed level. Panels (b) and (c) show the validation results for the water level gauges WL2 and WL3, located at $x = 325$ m and $x = 547$ m, respectively. The grey lines represent the measured water levels and the black lines represent the modelled water levels.

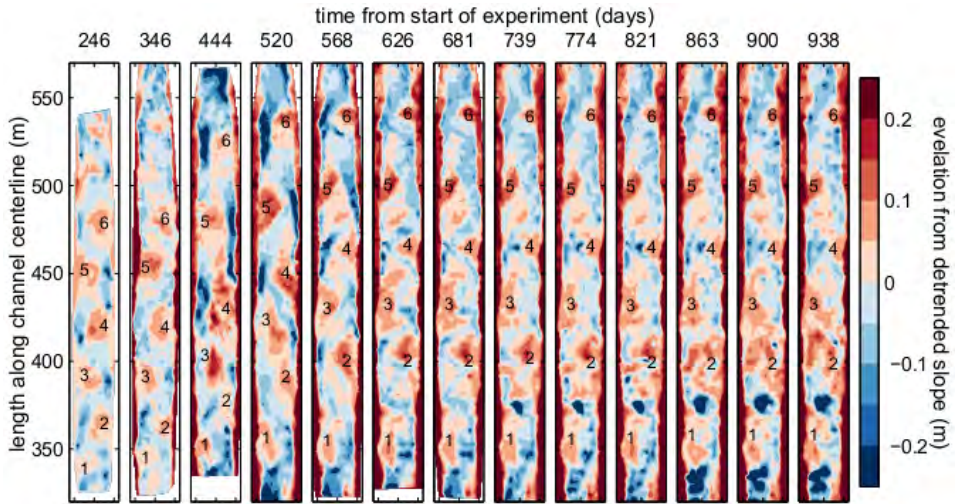
Figure 3.6 Detrended bed topography data from the 13 GPS-surveys. The numbers indicate the location of the six individual bars. Water is flowing from bottom to top.

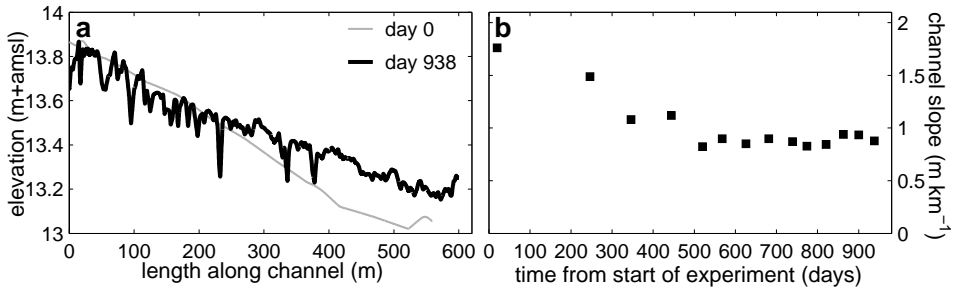
Figure 3.8 (a) The longitudinal channel bed profile just after construction (gray) and after 938 days from the start of the experiment (black). The black line shows increased bed levels in the downstream part of the channel, causing a reduction of the longitudinal channel bed slope. (b) The temporal evolution of the channel slope in the downstream part of the experimental reach.

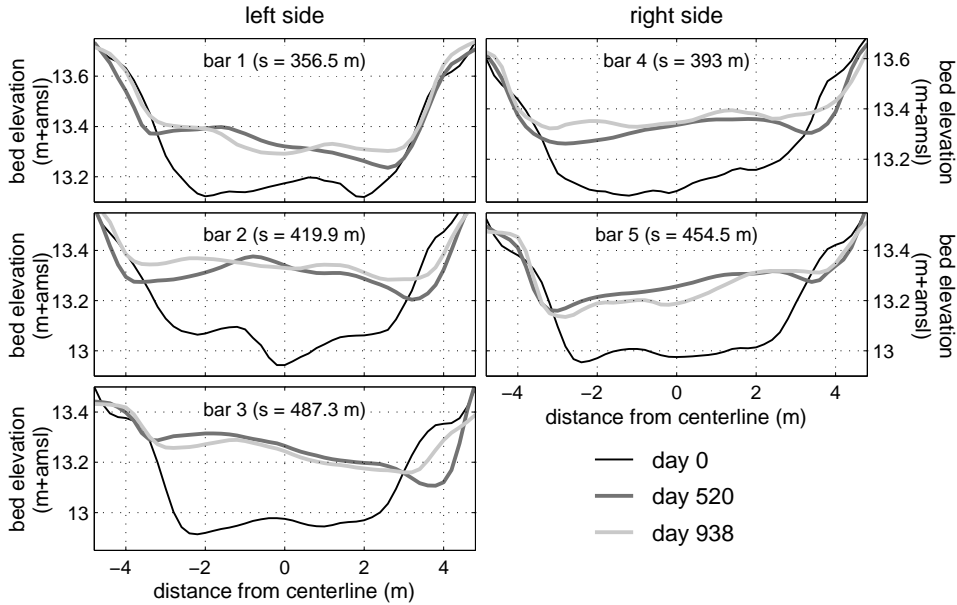
Figure 3.9 Channel cross-sections at each of the five bars from three surveys: just after construction (black), at day 520 (dark grey) and at day 938 (light grey). The figure shows sedimentation over the full width of the channel from the start of the experiment. Additionally, sediment is deposited in the bar troughs in the period between day 520 and day 938.

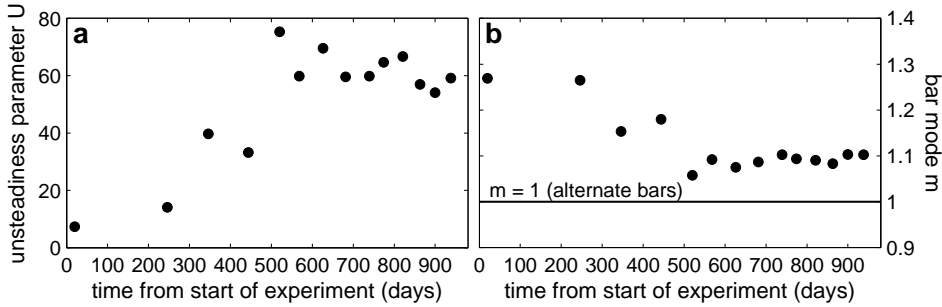
Figure 3.11 Temporal evolution of: (a) the unsteadiness parameter \tilde{U} and (b) the bar mode m .

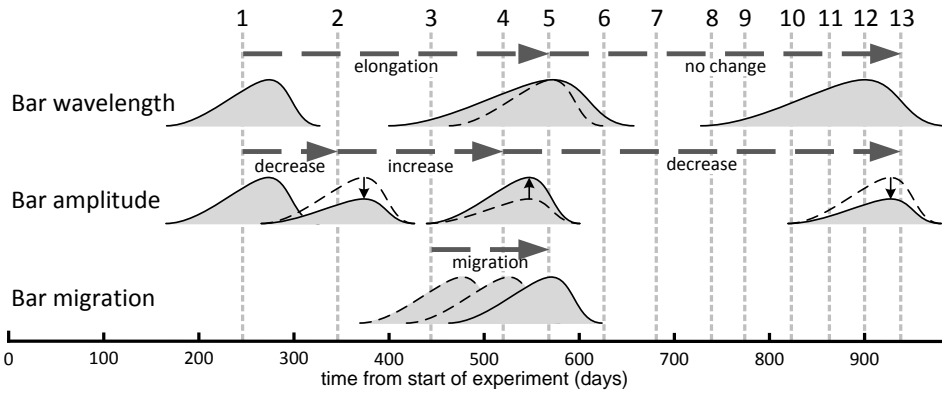
Figure 3.12 Schematic diagram of the temporal evolution of bar wavelength, bar amplitude and bar migration.

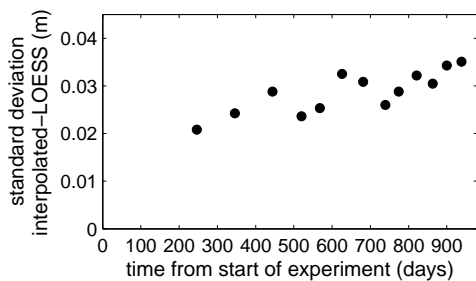
Figure 3.13 Standard deviation of the difference between the raw bed elevation data and corresponding LOESS filtered data.

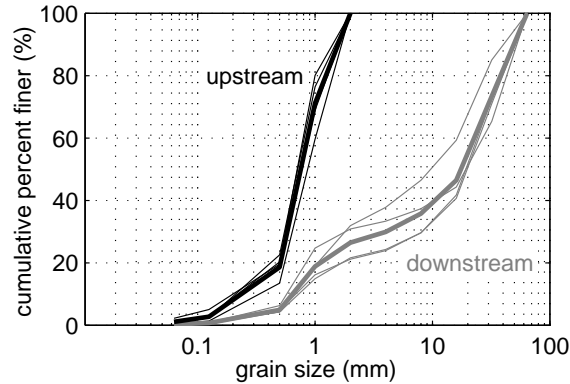
Figure 4.2 Grain size distributions from bed material samples from 4 locations in the upstream part (black lines) and 4 locations in the downstream part (grey lines). The thick lines denote the average for upstream and downstream samples, respectively.

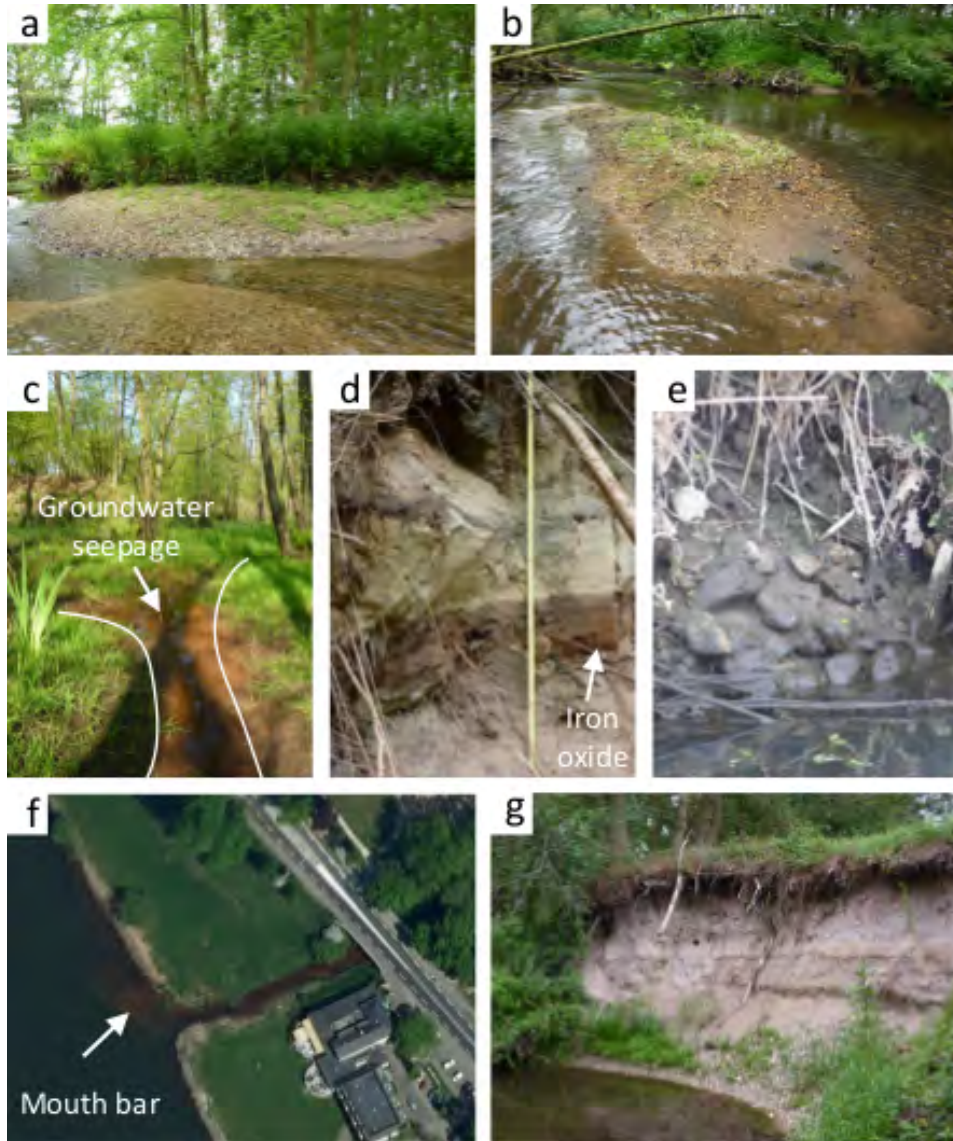
Figure 4.3 Photos of the study area, illustrating (a) a point bar, (b) a mid-channel bar, (c) the valley floor showing groundwater seepage, (d) a sedimentary succession showing a thick iron oxide layer (thickness: 0.20 m), (e) the remnants of the bank protection, (f) an aerial photo (2008) of the area surrounding the confluence of the Gelderns-Nierskanaal and the river Meuse showing a mouth bar at the downstream side of the channel outlet (Copyright Eurosense B.V. 2008) and (g) valley edge erosion (height of exposed sediments: 2.5 m). See Figure 4.4 for photo locations.

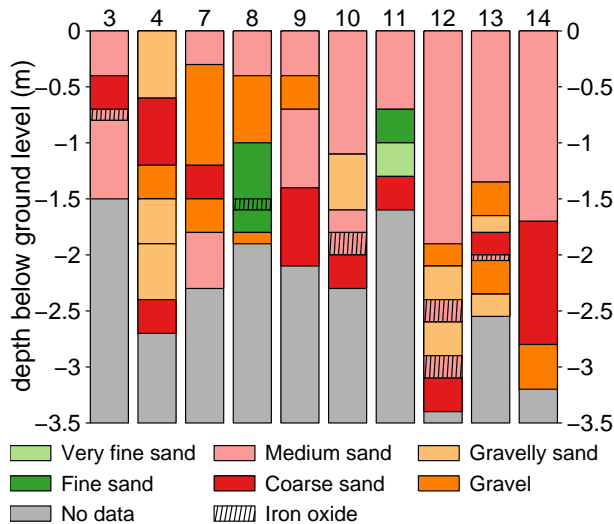
Figure 4.5 Sedimentary successions at 10 locations, see Figure 4.4 for the locations in the study area. Ground level corresponds to the level of the valley edge into which the channel has incised.

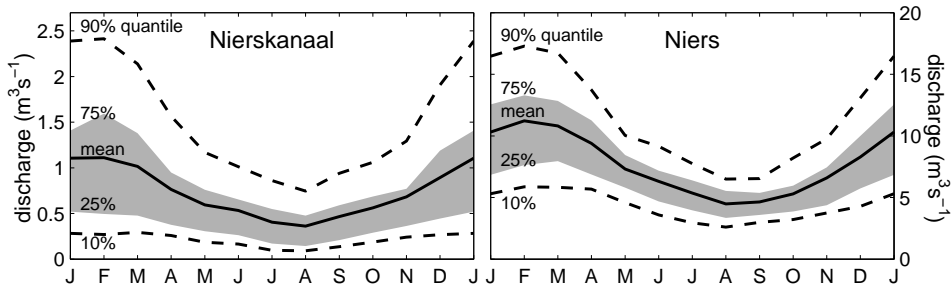
Figure 4.6 Monthly averaged discharge for the Gelderns-Nierskanaal (upper panel) and river Niers (lower panel). Indicated in gray are the 25% and 75% quantiles and with a dashed line the 10% and 90% quantiles.

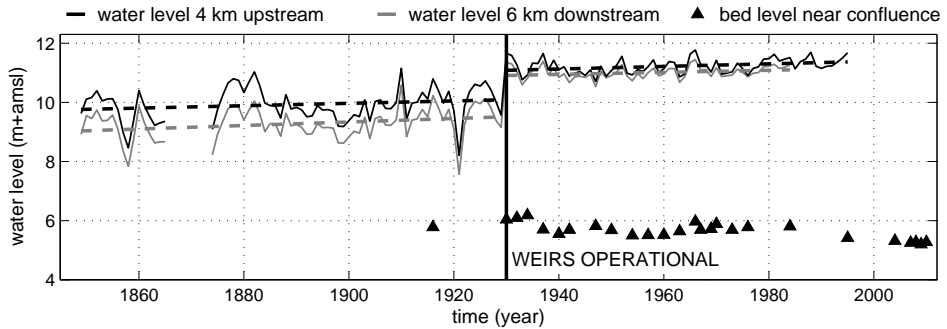
Figure 4.7 Historical yearly averaged water levels and bed levels from the river Meuse. The water level time series correspond to two locations near the confluence of the Gelderns-Nierskanaal, as indicated.

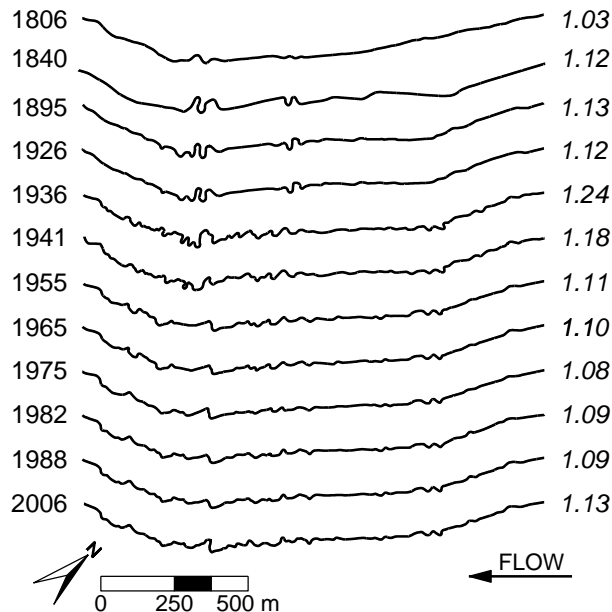
Figure 4.9 Channel centerlines derived from the 12 topographic historical maps. Values on the right-hand side quantify the sinuosity of the Dutch part of the channel.

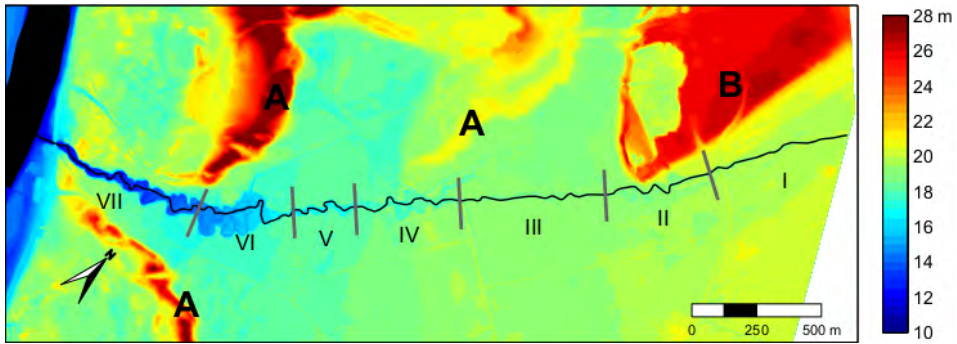
Figure 4.10 Digital Elevation Model of the study area, including the centerline of the channel in 2006. Elevation is shown in meters above mean sea level. Several geomorphological units are indicated, i.e. the parabolic sand dunes near the confluence with the river Meuse (A) and a Rhine terrace near the German border (B). The Roman numbers label the sections indicated in Figures 4.11 and 4.12.

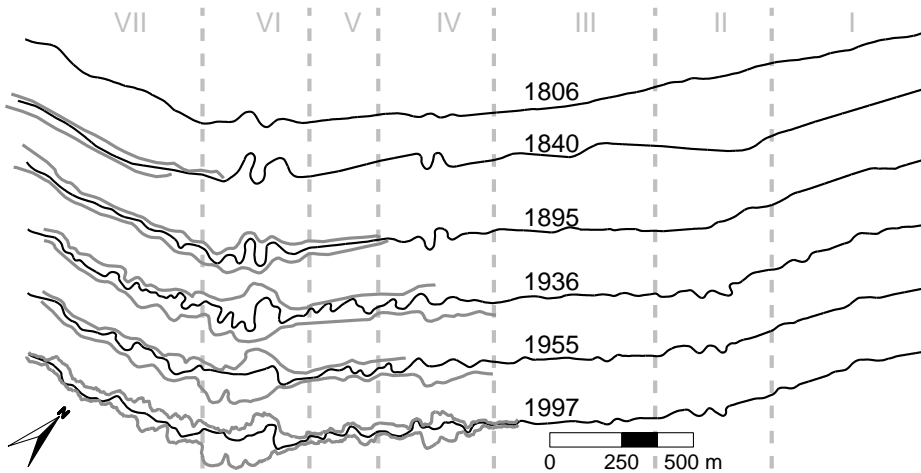
Figure 4.11 Evolution of the channel centerline (black) and valley edge (grey). The valley edges from 1840, 1895, 1936 and 1955 are derived from topographic maps. The valley edge of 1997 is derived from the LiDAR data set. The Roman numbers label the sections in Figure 4.12.

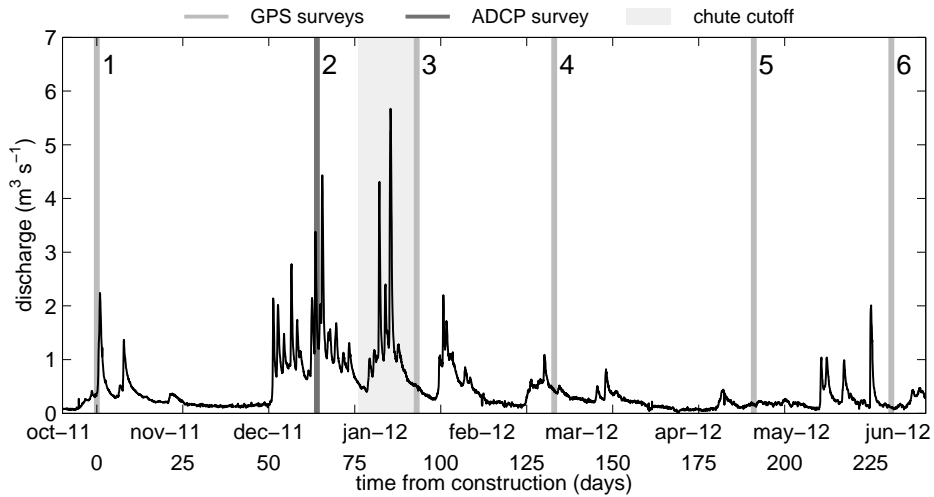
Figure 5.3 Discharge hydrograph for the channel under study. The morphological surveys are indicated with the grey and dark grey vertical lines for the GPS- and ADCP-surveys, respectively. The chute cutoff took place in the period indicated in light grey.

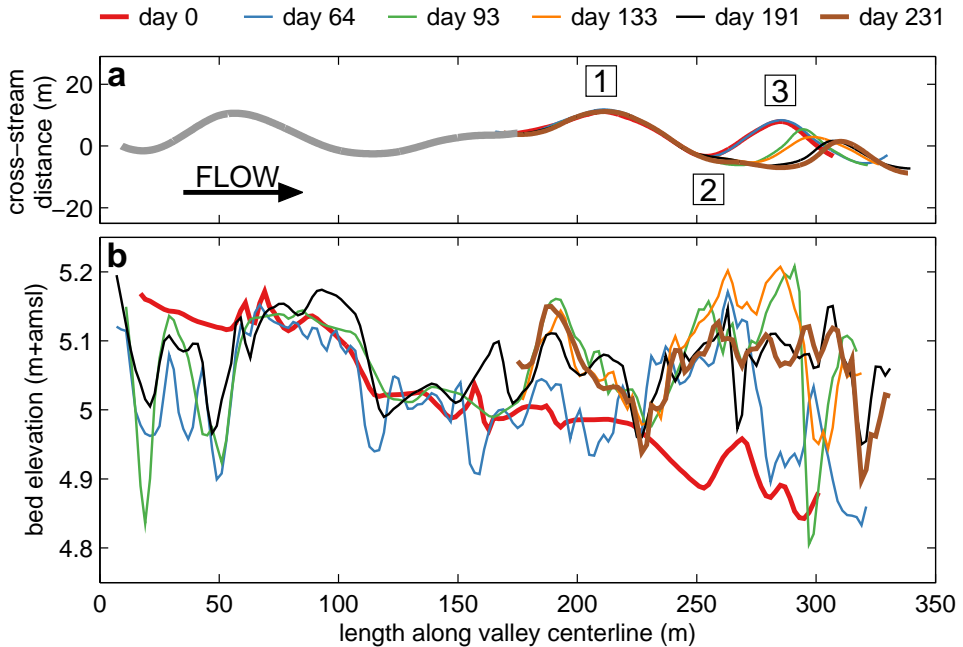
Figure 5.7 (a) Temporal evolution of the channel centerline, which has been derived from the morphological surveys. (b) Temporal evolution of the longitudinal bed elevation. Bed elevation is obtained at each channel cross-section by averaging the measured cross-sectional data over the width of the channel bed, between the channel banks.

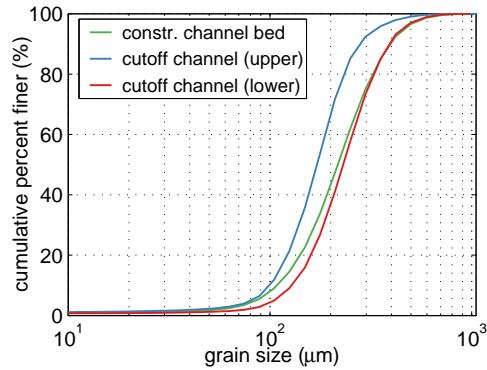
Figure 5.8 Grain size distributions, with in green the grain size distribution from the constructed channel bed, and in blue and red the average grain size distributions of the upper and lower half of the deposited sediment in the cutoff channel, respectively.

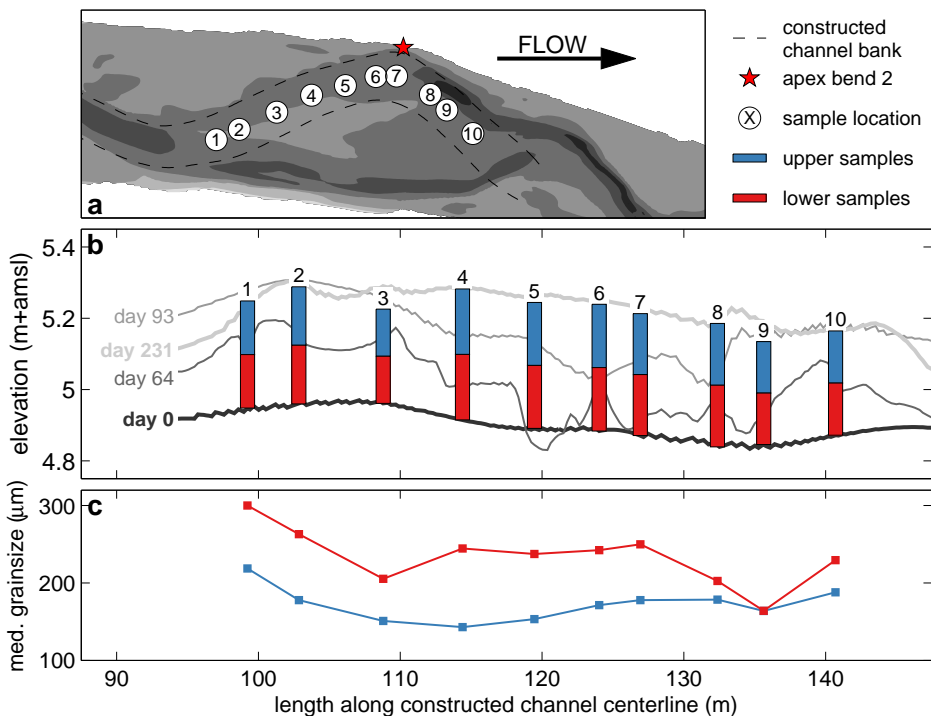
Figure 5.9 Results of the sediment sampling taken approximately 1 year after the construction had finished: (a) plan view of the locations of the 10 sediment cores, (b) longitudinal profile along the cutoff channel showing the locations of the upper (blue) and lower (red) sediment cores and the surface level derived from four morphological surveys, and (c) median grain sizes.

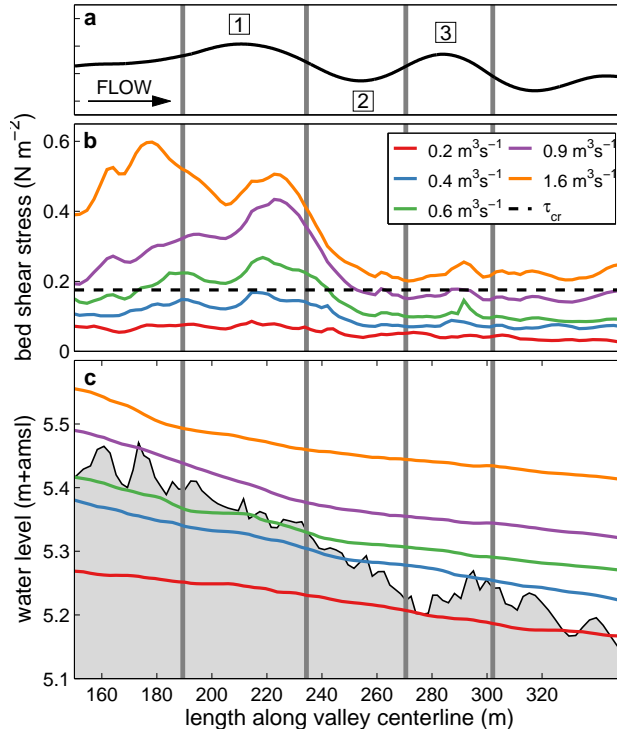
Figure 5.10 Results from the hydrodynamic model: (a) Constructed channel centerline. Vertical lines indicate the inflection points for the three bends. (b) Spatial distribution of the bed shear stress for five steady state simulations, corresponding to discharges amounting to 0.2, 0.4, 0.6, 0.9 and 1.6 m^3s^{-1} , respectively. The dashed line indicates the critical bed shear stress τ_{cr} (Equation 5.2). (c) The corresponding longitudinal water level profile, where the grey area indicates elevation below the channel banks.

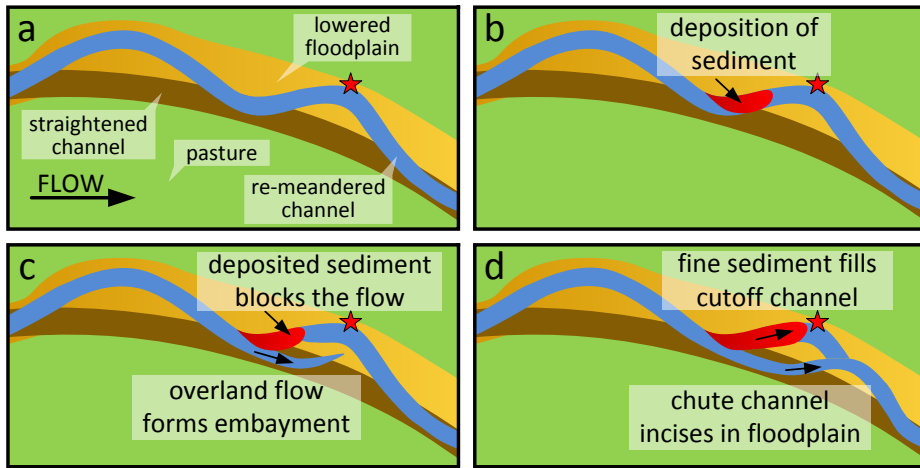
Figure 5.11 Conceptual model of the main morphological processes, showing four stages in the development of the chute cutoff: (a) study area after construction, (b) formation of a plug bar, (c) initial embayment formation, (d) incision of the chute channel into the floodplain.

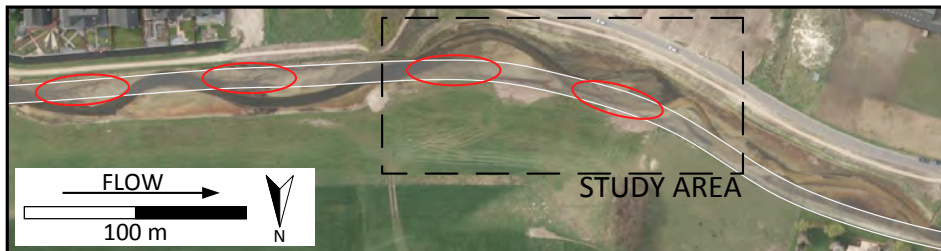
Figure 5.12 Aerial photo taken 188 days after construction of the re-meandered channel. The shaded area indicates the former straightened channel and the red ovals the four locations along the former straightened channel where erosion is observed.

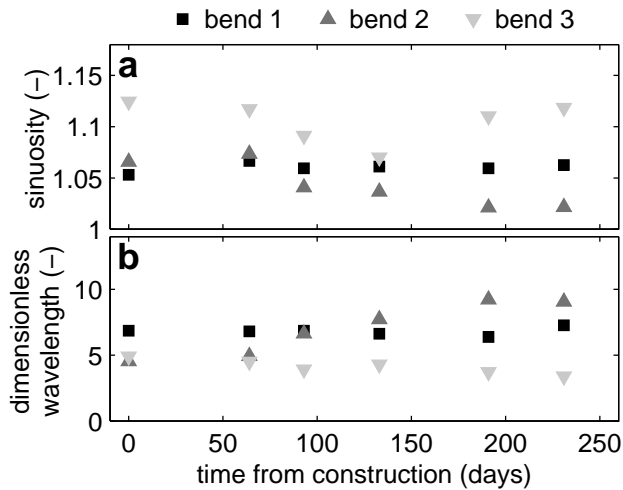
Figure 5.13 Temporal evolution of two bend characteristics for the three bands within the study reach: (a) sinuosity (-), and (b) dimensionless wavelength (-). The dimensionless wavelength is defined as the wavelength divided by the initial channel width.

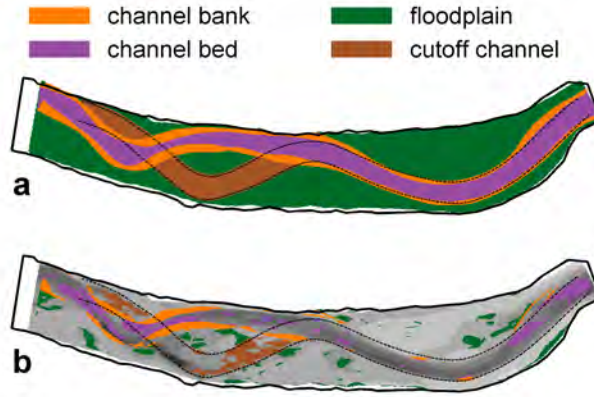
Figure 6.2 Segregation of geomorphic zones, for period (4-5). (a) Masks of each of the four geomorphic zones, including channel bank (orange), channel bed (purple), floodplain (green), and cutoff channel (brown). (b) Resulting segregation.

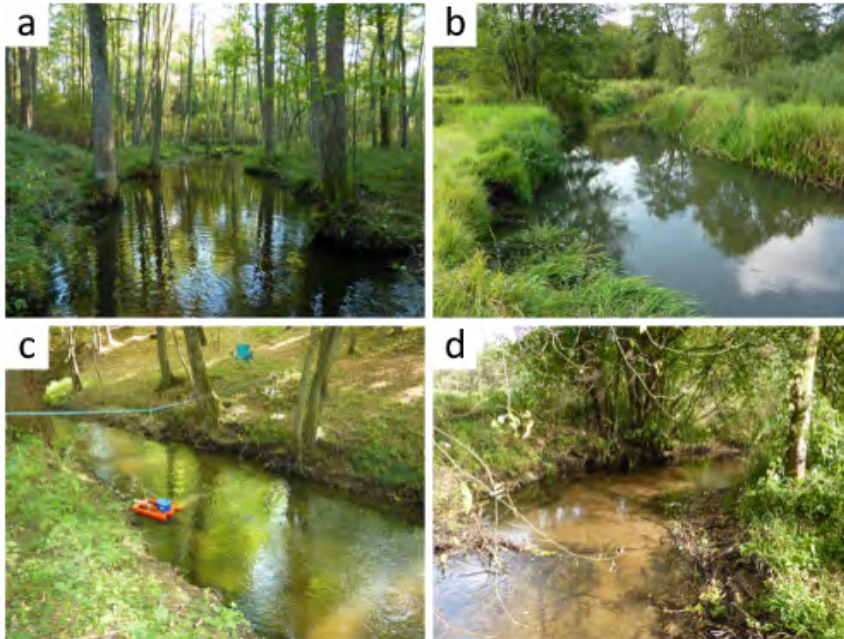
Figure 6.11 Photos from four morphologically undisturbed lowland streams in central Poland (Łódzkie region), with (a) Gać river ($51^{\circ} 36' 16''$ N, $20^{\circ} 7' 57''$ E), (b) Grabia river ($51^{\circ} 34' 1''$ N, $19^{\circ} 15' 46''$ E), (c) Korabiewka river ($52^{\circ} 0' 58''$ N, $20^{\circ} 12' 50''$ E), and (d) Słomianka river ($51^{\circ} 29' 29''$ N, $20^{\circ} 14' 27''$ E).

At longer time scales, shrubby and woody vegetation will most likely colonize the channel banks in lowland streams. In September 2011, four morphologically undisturbed lowland streams were visited in central Poland (Figure 6.11). Visual observations in these morphologically undisturbed lowland streams show that the channel banks are dominated by vegetation, including herbaceous (panel (a) and (b)) and woody vegetation (panels (a), (c) and (d)). Fully grown trees are observed on the channel banks, which may infer that lateral channel development is rare.

Evidence of lateral channel development was only observed in the Grabia river (panel (b)). On the lower part of the photo, emergent vegetation shows the location of several slump blocks, which are most likely a result of channel bank undercutting. These observations show that the herbaceous vegetation may affect channel bank stability of the top soil layer in lowland streams. Furthermore, the observations in the Korabiewka river and Słomianka river show that it is likely that the woody vegetation is able to stabilize the channel banks in lowland streams.
