Assessment Methods for
Structural and Hydraulic Properties of
Concrete Sewer Pipes

Proefschrift

ter verkrijging van de graad van doctor
aan de Technische Universiteit Delft,
op gezag van de Rector Magnificus prof. ir. K.C.A.M. Luyben;
voorzitter van het College voor Promoties,
in het openbaar te verdedigen op
dinsdag 26 januari 2016 om 15:00 uur

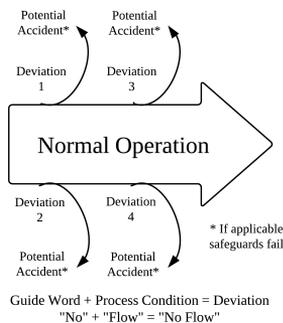
Figure 2.1: Schematic diagram of the HAZOP analysis.

The first task on risk analysis of urban drainage infrastructure is to identify the potential performance failures. One of the techniques for risk identification of sewer systems, HAZOP analysis, was used in this study. HAZOP analysis was developed in Britain by ICI (Imperial Chemical Industries, Ltd) in the late 1960s for risk identification in chemical plants. HAZOP is a well-established structured 'brain-storming' technique in engineering risk assessment (Frosdick, 1997; Kirwan, 1992). It uses special guidewords combined with process conditions to systematically consider all possible deviations from normal conditions (Figure 2.1).

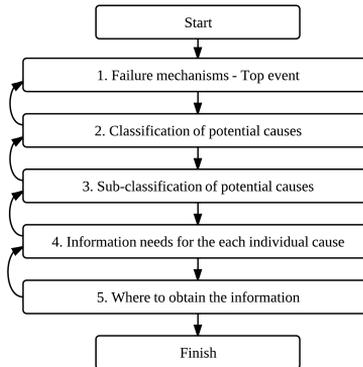
Figure 2.2: Procedural outline followed in sewer failure assessment.

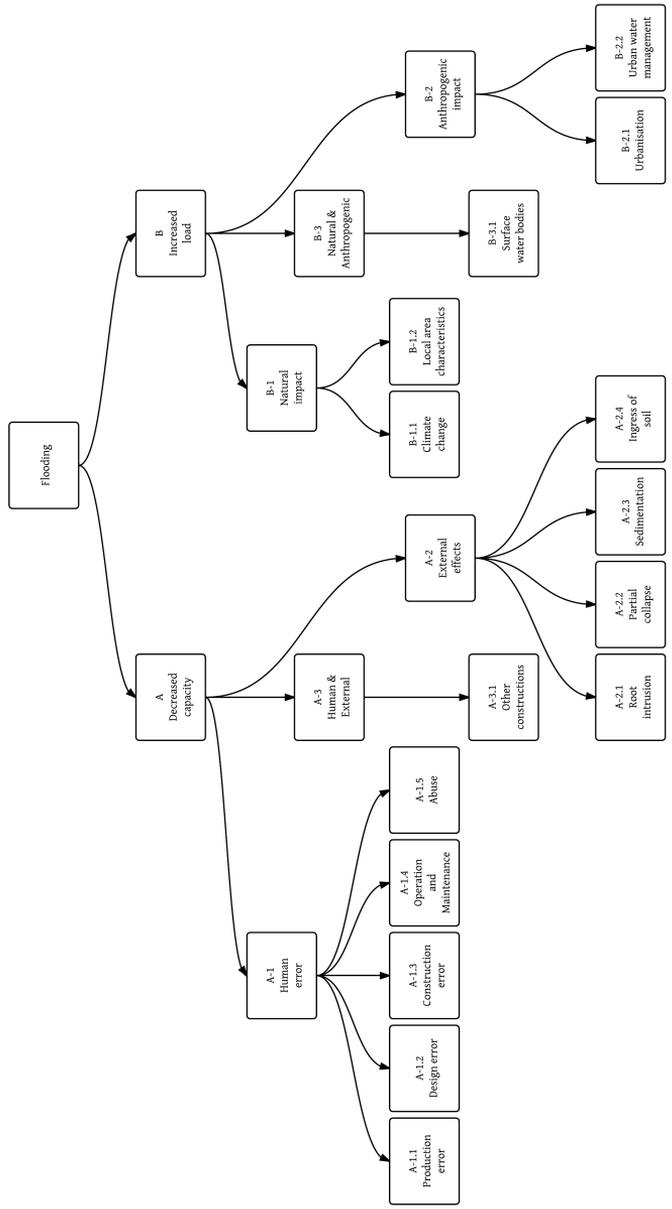
Figure 2.3: Classification of potential causes of flooding.

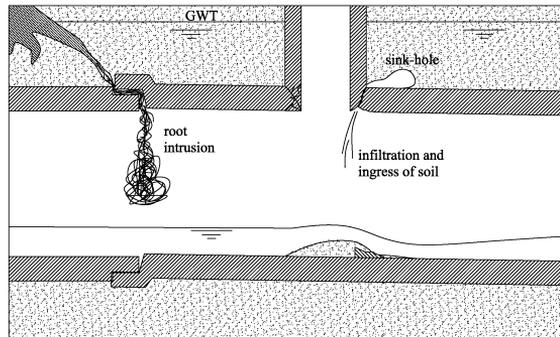
Figure 2.4: Sewer with root intrusion and ingress of soil.

Environmental factors (A-2.1.2.) can increase the root growth and thus increase the possibility of root intrusion. Soil characteristics, *e.g.* texture, structure, moisture, aeration, temperature, toxic material, bacteria, fungi and soil-inhabiting animals, may influence root growth (Feldman, 1984; Gregory, 1988; Waisel *et al.*, 1991). Atmospheric conditions, namely light intensity and amount of CO₂ in air, and their effect on the treetops can have indirect effect on the root growth. Furthermore, in case of a low groundwater table, roots will search for water and will eventually reach

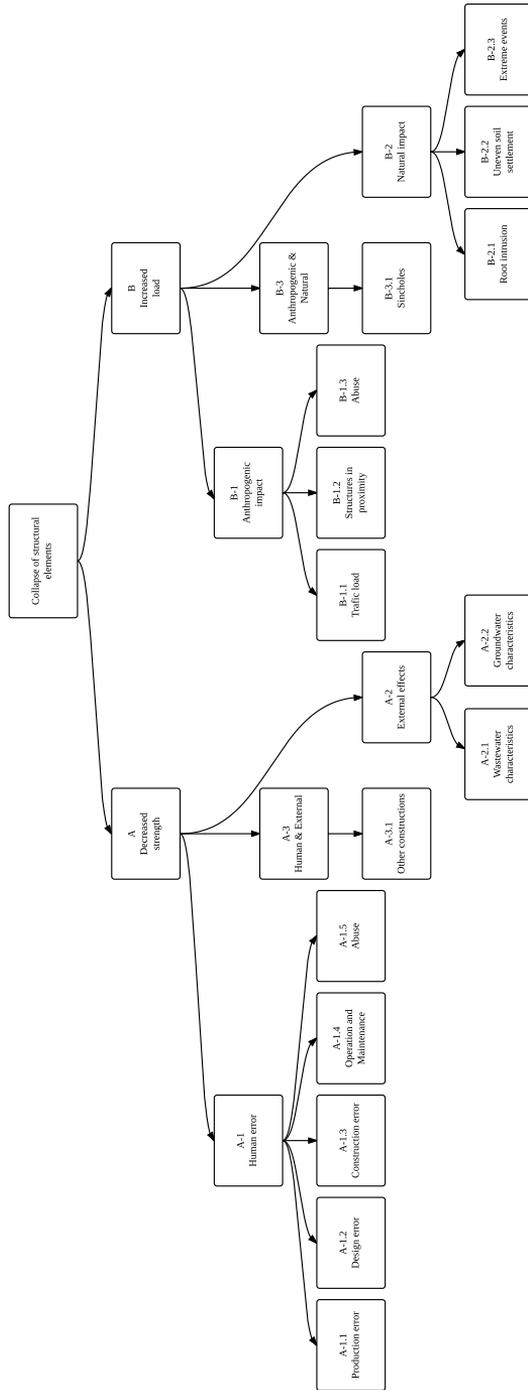
Figure 2.5: Classification of potential causes of collapse of structural elements.

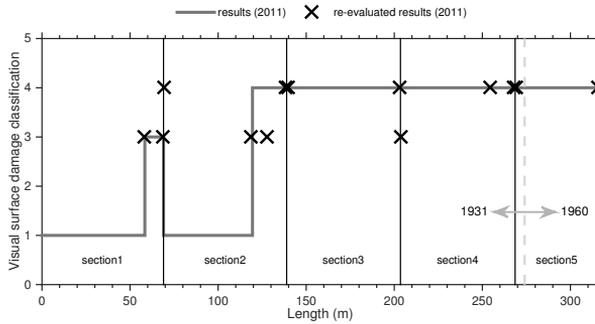
Figure 3.1: Classification (see Table 3.1) of visual impairment conditions using CCTV at the studied location as a function of time.

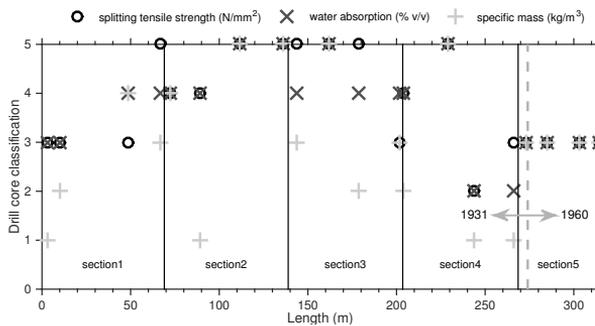
Figure 3.2: Classification (see Table 3.3) of the experimental results of core sample from the crown of the sewer.

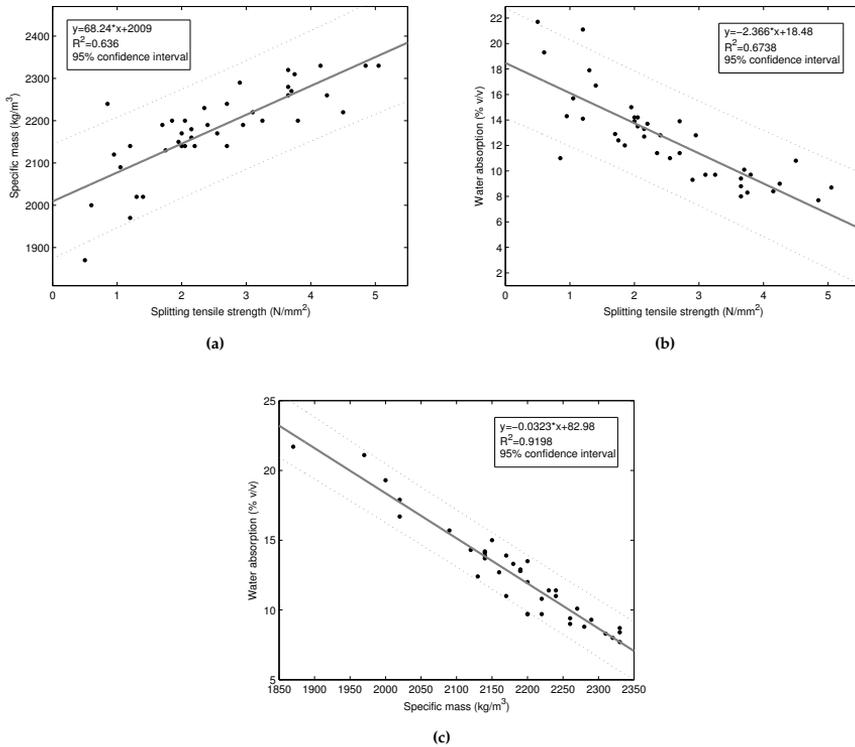
Figure 3.3: Correlation between: (a) specific mass and splitting tensile strength results; (b) splitting tensile strength and water absorption results; (c) specific mass and water absorption results.

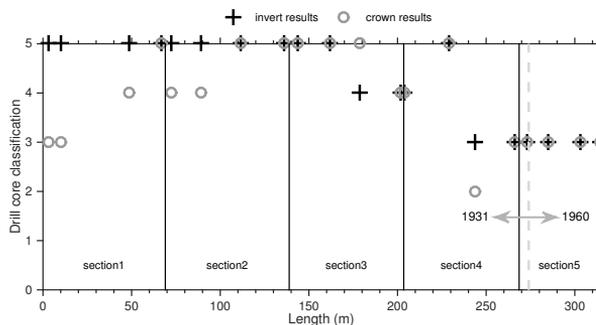
Figure 3.4: Comparison of drill core sample results from sewer invert and crown at the studied location.

It is noted that there is a difference in the condition assessment between the invert and crown pipe region (Figure 3.4). A general acknowledged assumption is that concrete in the crown region has a poorer quality than the concrete in the invert region, due to the classical H_2S -induced crown corrosion process (see, *e.g.* Bielecki & Schremmer, 1987), and based on this implicit assumption the current condition assessment is done in practice. Results showed that concrete conditions at the sewer invert were more severe than conditions at the crown. This contradicts the general idea that sewer corrosion caused by biological H_2S is the dominant degradation process. Consequently, more attention should be given to the sewer invert in future practice.

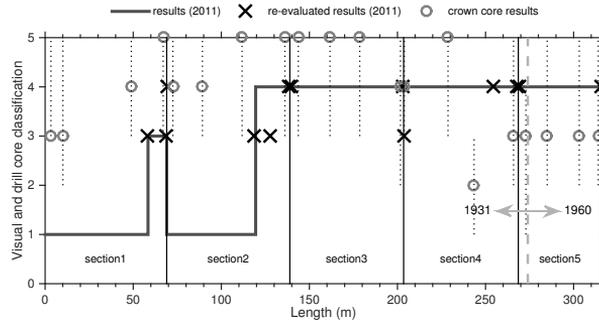
Figure 3.5: Comparison of visual inspection and drill core analysis results at the studied location. Dotted lines represent the error bar \pm sample uncertainty.

because the last 80% of the section is 29 years younger compared to the rest of the studied sewer. Further, dotted line on Figure 3.5 shows the core sample uncertainty; thus demonstrating once again the results unreliability. In addition, as mentioned earlier the probability of incorrect coding for CCTV is substantial. Moreover, re-evaluated CCTV results are not consistent with the drill core results, *i.e.* the relative severity of the sewer condition should be similar irrespective of the boundaries of the classes, but it is not. Overall, this study shows that the assumption that core sampling will produce results that are in line with the visual inspection results is not correct, due to uncertainties related to the application of both techniques.

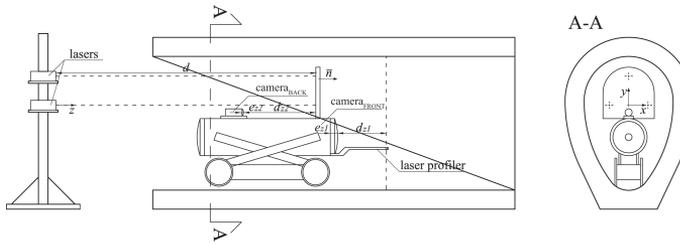
Figure 4.2: Sketch of the experimental set-up, details on the dimensions and materials used can be found in Tables 4.1 and 4.2.

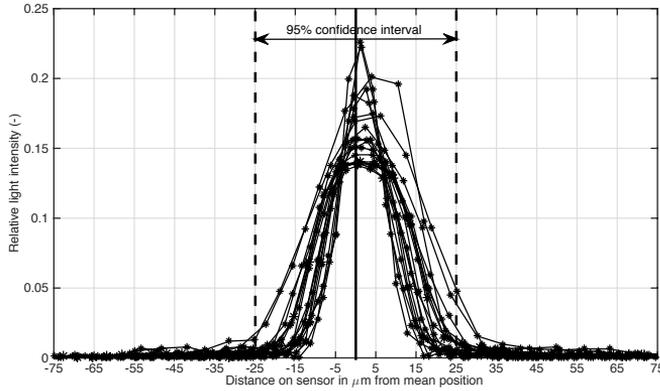
Figure 4.4: Distribution of the light intensity on the sensor of cam_{FRONT} , shown as normalised pixel intensity on the camera sensor.

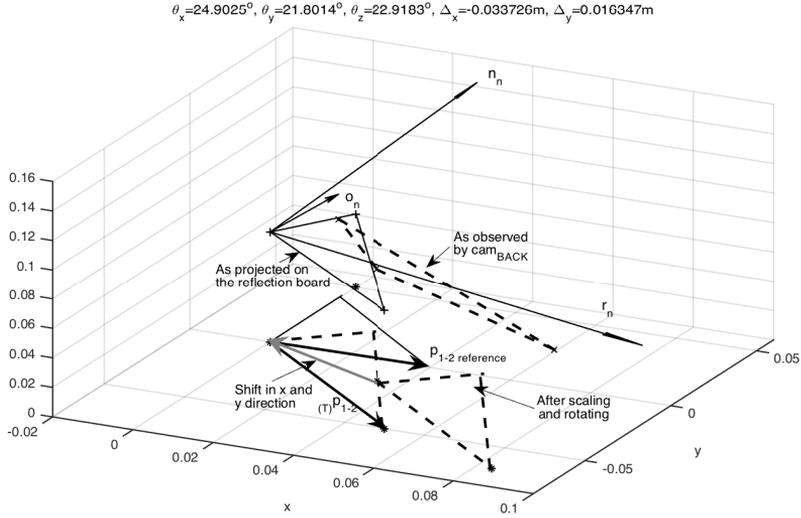
Figure 4.6: Successive steps in the calculation of orientation and shift.

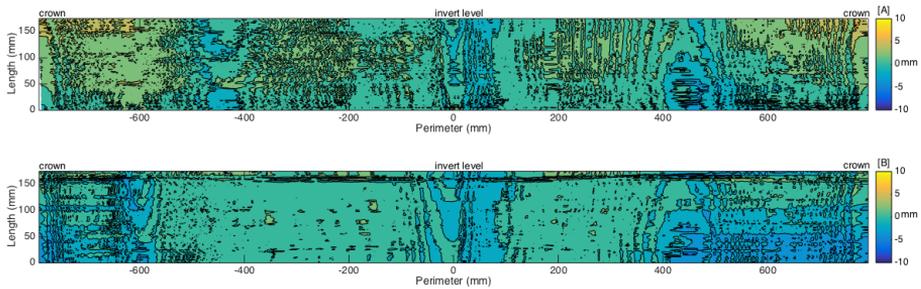
Figure 4.7: Difference between theoretical and measured geometry for the new pipe (Po1). The upper chart shows the uncorrected result, and the lower chart shows the result after correction for position and orientation of the measuring platform. [A] uncorrected; [B] corrected measurements.

Two concrete sewer pipes were subjected to the analysis as described before, one new egg-shaped pipe (*i.e.* Po1) with an inner nominal geometry of 400/600 mm^{iv} and one egg-shaped pipe - Po8 (400/600 mm) that was in service for more than 89 years in the municipality of the Hague, showing clear marks of crown corrosion and concretions of sediments at the sides.

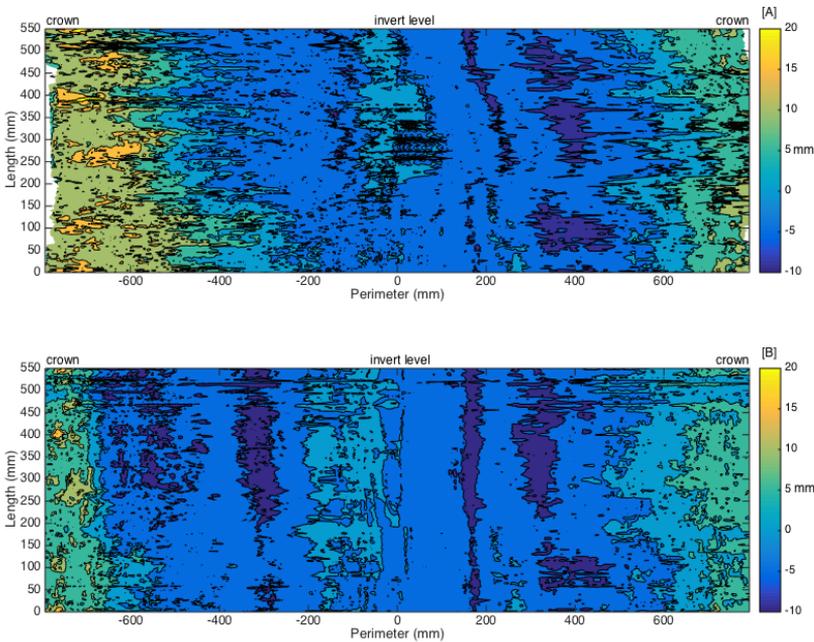
Figure 4.8: Difference between theoretical and measured geometry for the old pipe (Po8). The upper chart shows the uncorrected result, and the lower chart shows the result after correction for position and orientation of the measuring platform. A] uncorrected; B] corrected measurements.

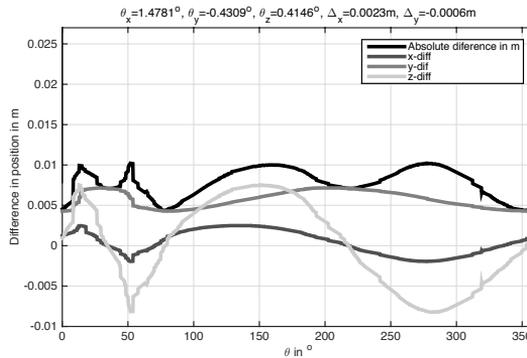
Figure 4.10: Difference between corrected and uncorrected profiles for one frame obtained from the new pipe.

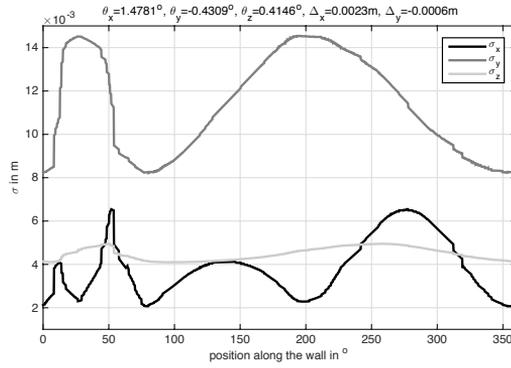
Figure 4.11: Standard deviation for the new pipe for one frame using $\sigma_{\text{misalignment}} = 2.5 \times 10^{-5}$ radials.

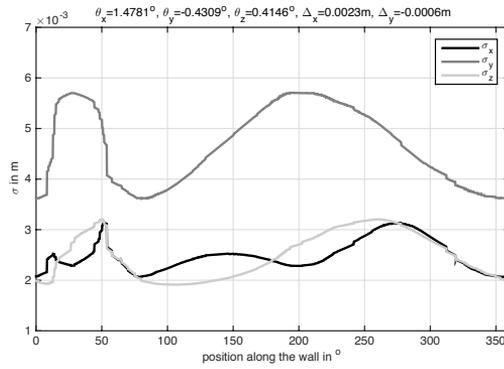
Figure 4.12: Standard deviation for the new pipe for one frame using $\sigma_{\text{misalignment}} = 8.3 \times 10^{-6}$ radials.

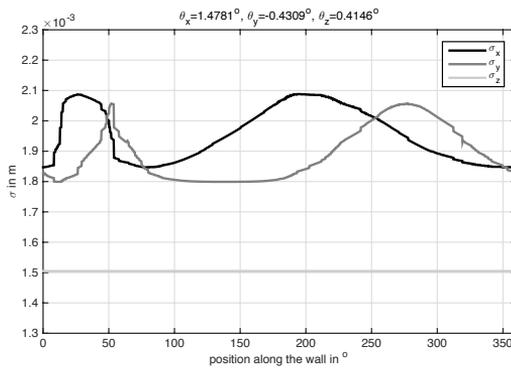
Figure 4.13: Standard deviation for the new pipe for one frame for the uncorrected profile.

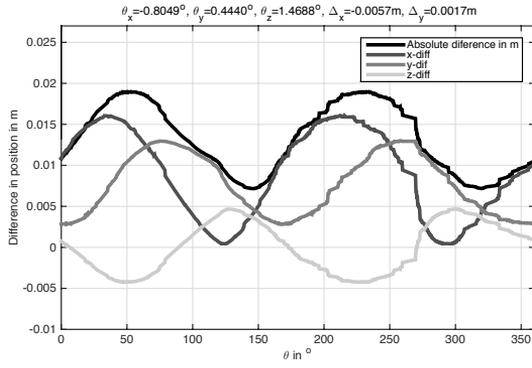
Figure 4.14: Difference between corrected and uncorrected profiles for one frame obtained from the old pipe.

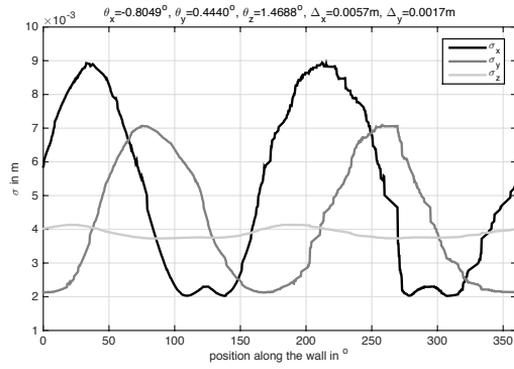
Figure 4.15: Standard deviation for the old pipe for one frame using $\sigma_{\text{misalignment}} = 2.5 \times 10^{-5}$ radials.

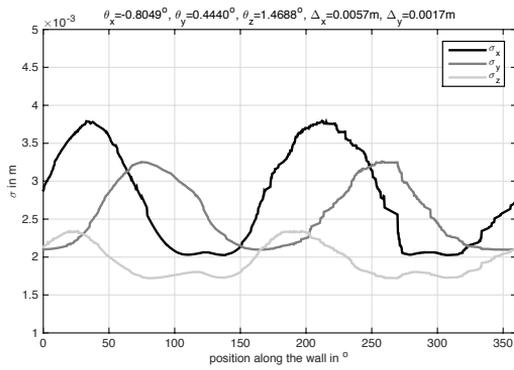
Figure 4.16: Standard deviation for the old pipe for one frame using $\sigma_{\text{misalignment}} = 8.3 \times 10^{-6}$ radials.

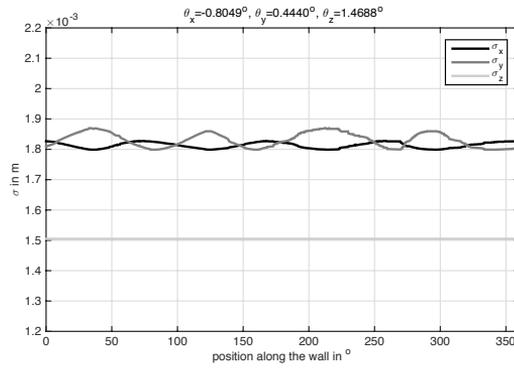
Figure 4.17: Standard deviation for the old pipe for one frame for the uncorrected profile.

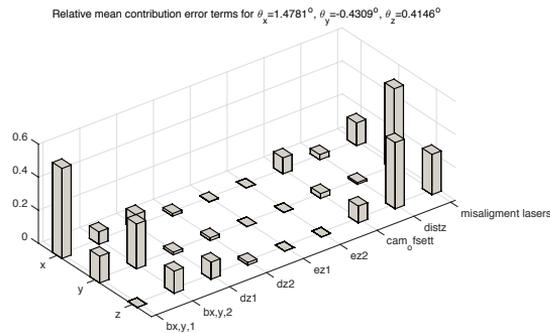
Figure 4.19: Relative contribution of the individual source of error to the overall measuring error in x, y and z positions for the new pipe with $\sigma_{\text{misalignment}} = 8.3 \times 10^{-6}$ radials.

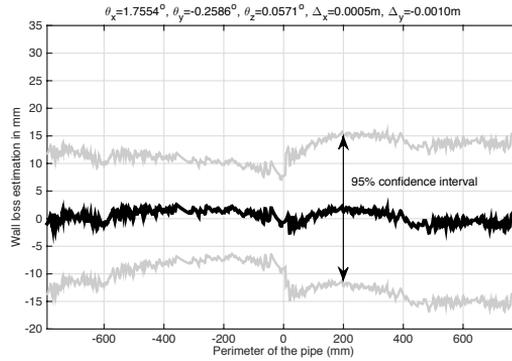
Figure 4.22: Difference between corrected measured and theoretical profiles for the new pipe.

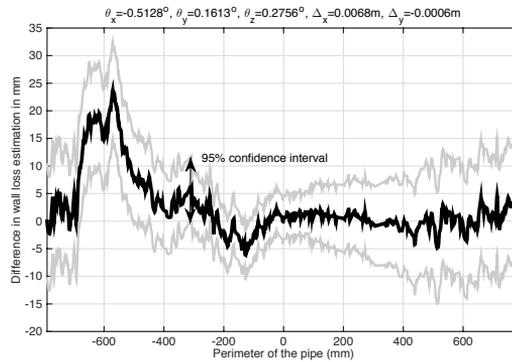
Figure 4.23: Difference between corrected measured and theoretical profiles for the old pipe.

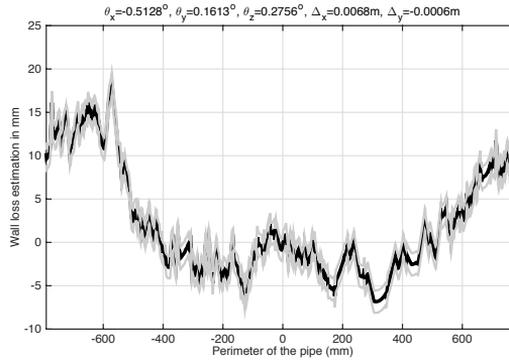
Figure 4.25: Difference between uncorrected and theoretical profiles for the old pipe.

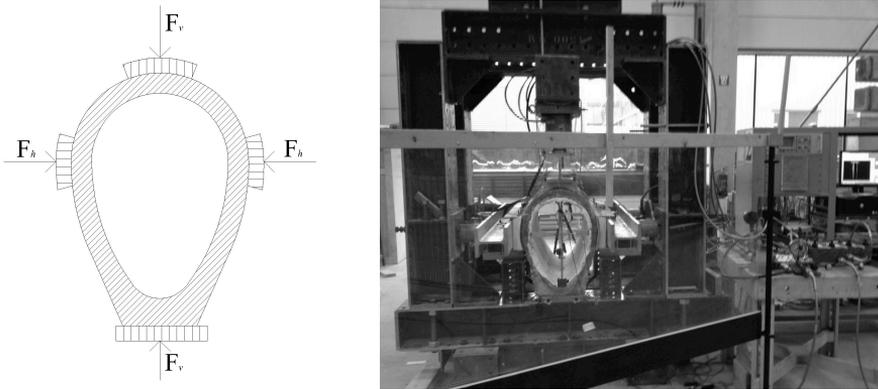
Figure 5.1: Schematic diagram of the adopted experiment principle (left) and actual experimental set-up (right).

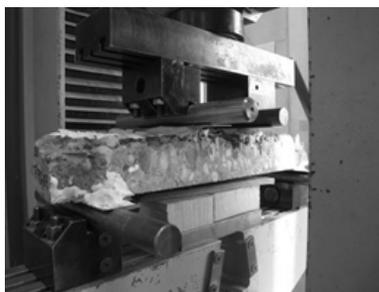
Figure 5.2: Test set-up used for four-point loading flexural tests.

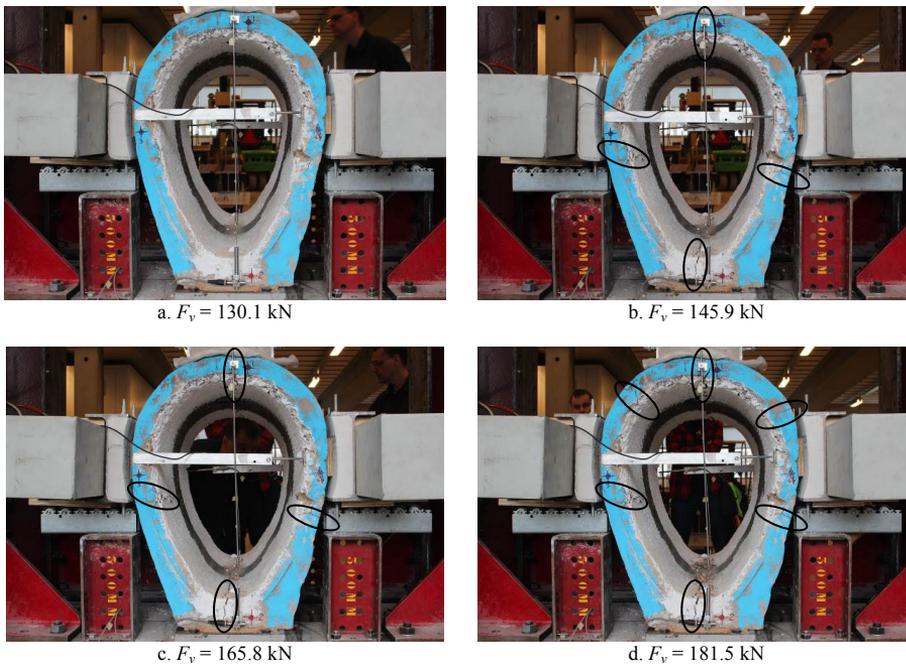
Figure 5.3: Successive stages in the test of a sewer pipe (Po8) from Municipality of The Hague during the experiment.

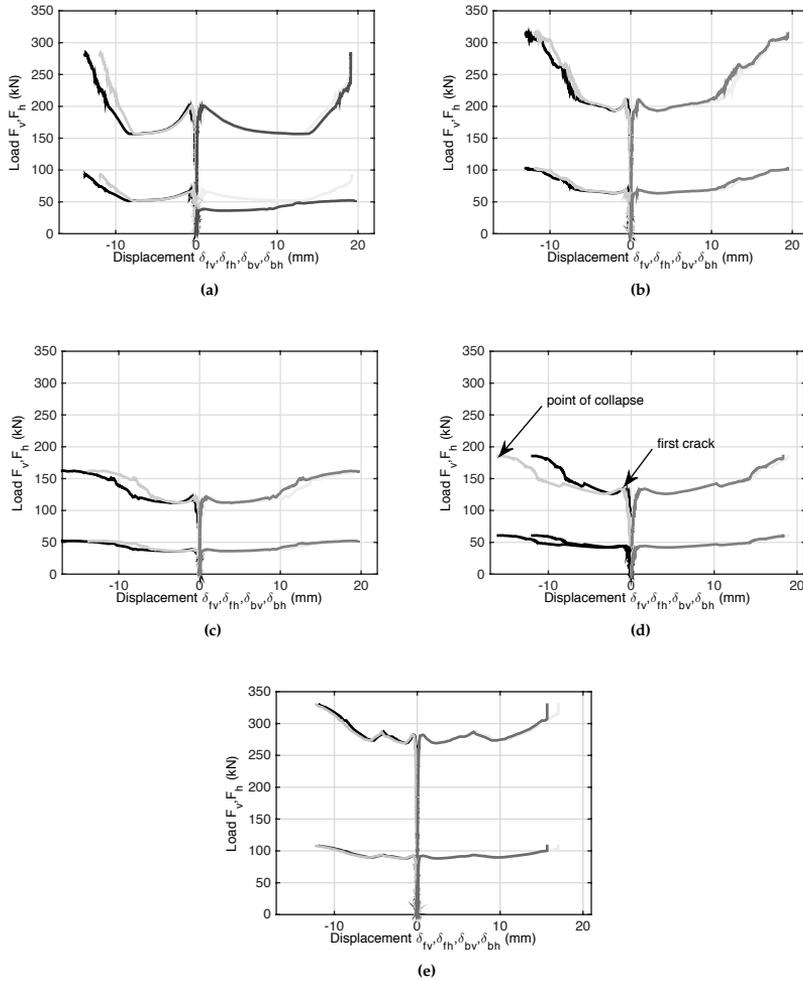
Figure 5.4: Force-displacement response for: (a,b) the 61 year old sewer pipes - Po2, Po6; (c,d) the 89 year old sewer pipes - Po8, P10; (e) the new sewer pipe - Po1. (Legend: F_v - vertical force; F_h - horizontal force; δ_{fv} - front vertical displacement; δ_{fh} - front horizontal displacement; δ_{bv} - back vertical displacement; δ_{bh} - back horizontal displacement).

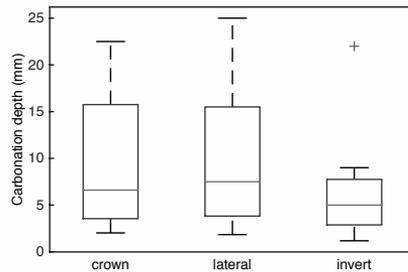
Figure 5.5: Boxplot for the carbonation depths at the inside for pipes Po2, Po6, Po8 and P10; discriminating between crown, lateral and invert positions. On each box, the central mark is the median, the edges of the box are the 25th and 75th percentiles, the whiskers extend to the most extreme data points not considered outliers (approximately $\pm 2.7\sigma$), and outliers are plotted individually.

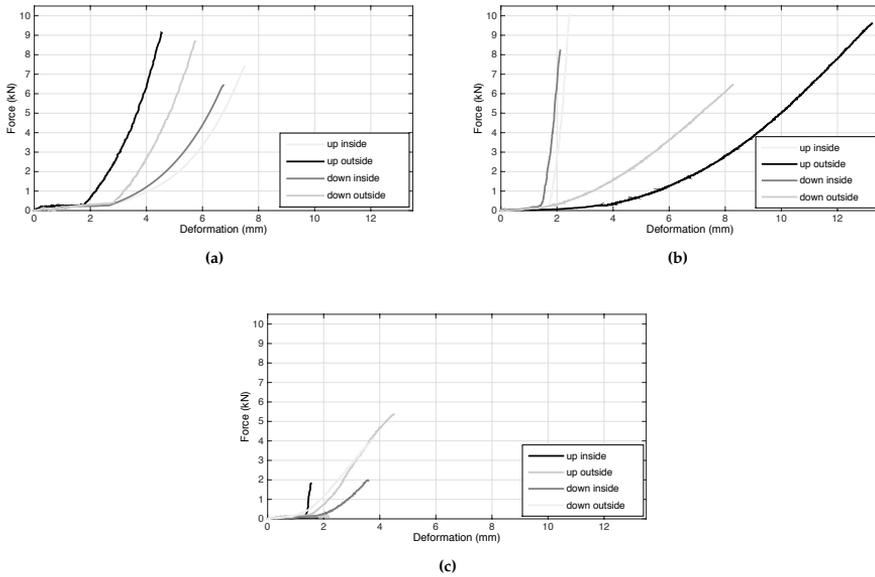
Figure 5.7: The four-pint flexural test force-deformation response for; (a) the new sewer pipe - P01; (b) the 60 year old sewer pipe - P02; (c) the 90 year old sewer pipe - P08.

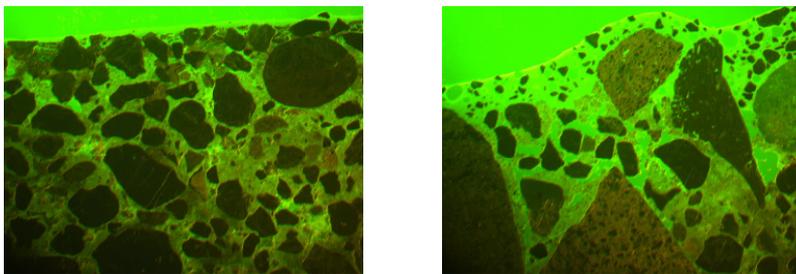
Figure 5.8: Examples of the studied thin section under the fluorescence light (P02 and P06).

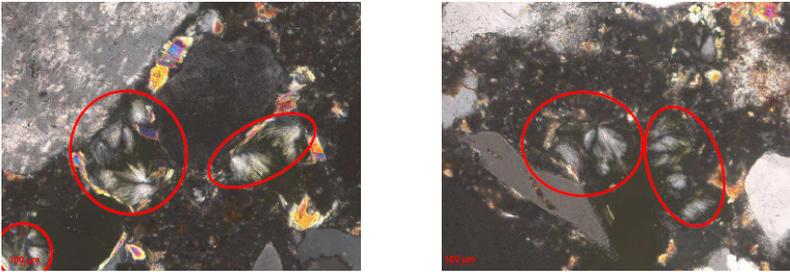
Figure 5.9: Examples of the studied thin sections under the polarized light with the highlighted ettringite (Po6 and Po2).

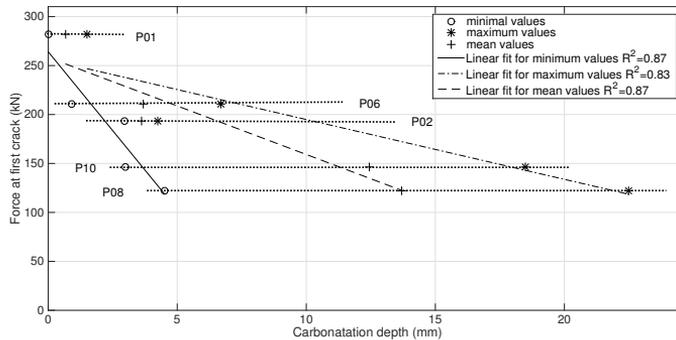
Figure 5.10: Relation between force at the first crack and carbonation depth at the inner wall of the pipes.

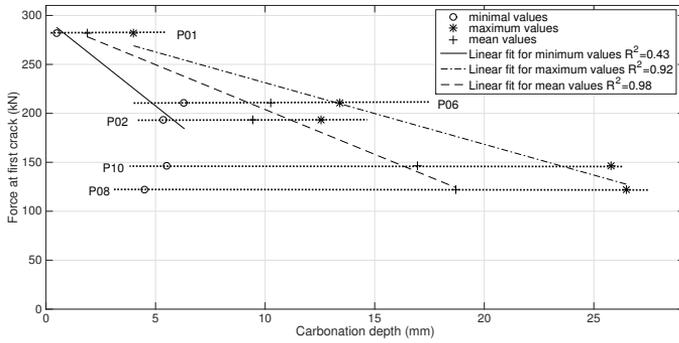
Figure 5.11: Relation between force at the first crack and the carbonation depth at the in- and outside wall of the pipes.

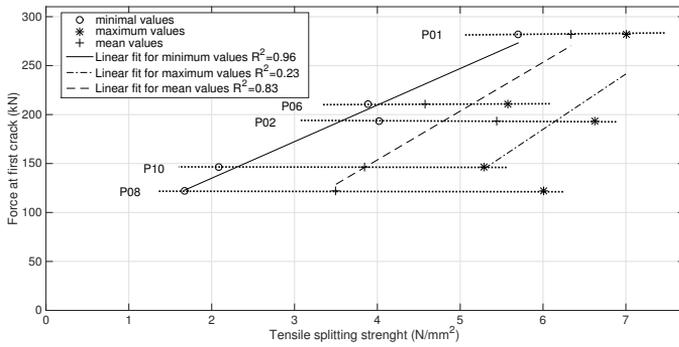
Figure 5.12: Relation between force at the first crack and the tensile splitting strength.

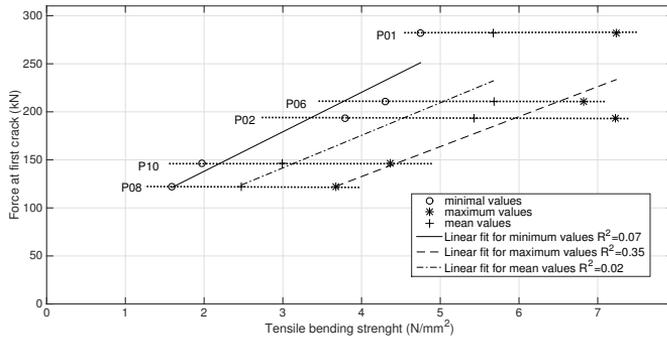
Figure 5.13: Relation between force at the first crack and the tensile bending strength.

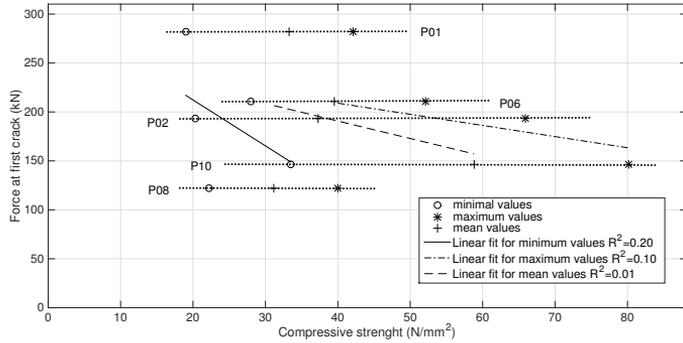
Figure 5.14: Relation between force at the first crack and the compressive strength.

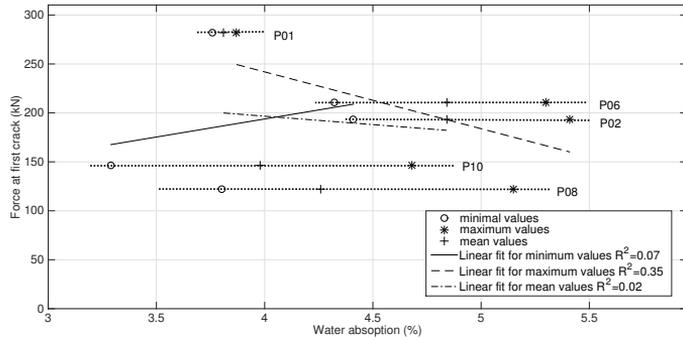
Figure 5.15: Relation between force at the first crack and the water absorption.

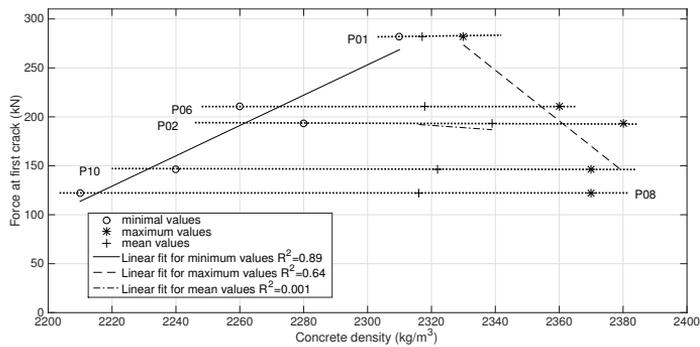
Figure 5.16: Relation between force at the first crack and the density of the concrete.

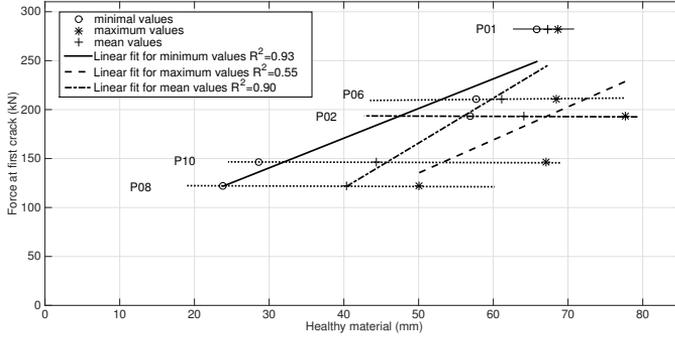
Figure 5.17: Relation between thickness of the remaining healthy material and force at the first crack.

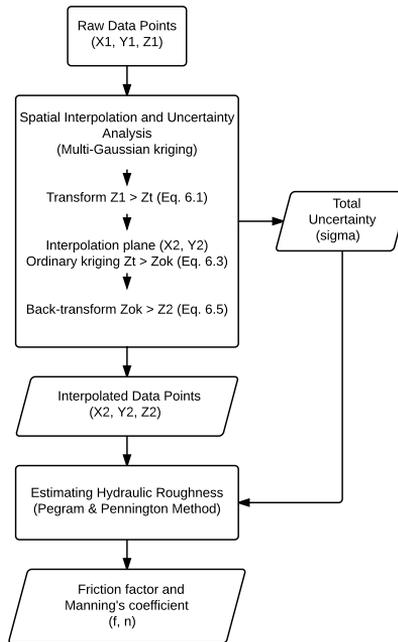
Figure 6.4: Data processing flow chart.

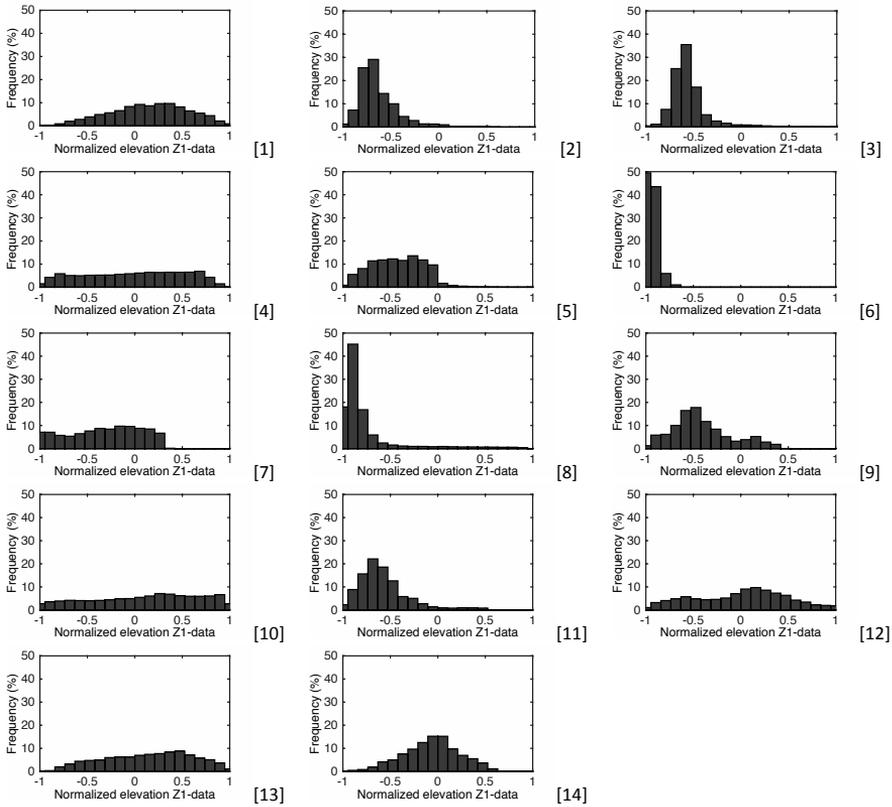
Figure 6.5: Histogram of elevation of sample: [1, 2, 3] Breda pipe - Po2 (invert, lateral and crown); [4, 5, 6] Breda pipe - Po6 (invert, lateral and crown); [7, 8, 9] The Hague pipe - Po8 (invert, lateral and crown); [10, 11, 12] The Hague pipe - P10 (invert, lateral and crown); [13] new pipe - Po1; [14] validation sample.

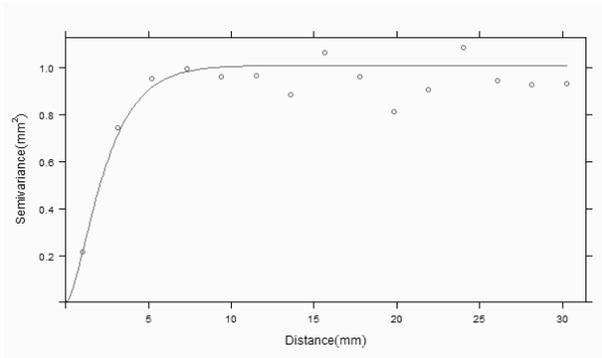
Figure 6.7: Semivariogram of the section of the sample from The Hague - P08. The circles represent the experimental semivariogram, and the black line indicates the fitted semivariogram model.

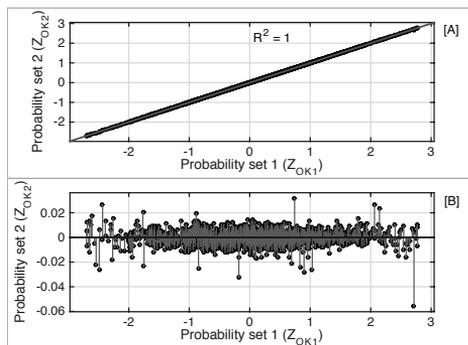
Figure 6.8: The probabilities of two independent Monte Carlo analyses: [A] scatter plot; [B] residual plot.

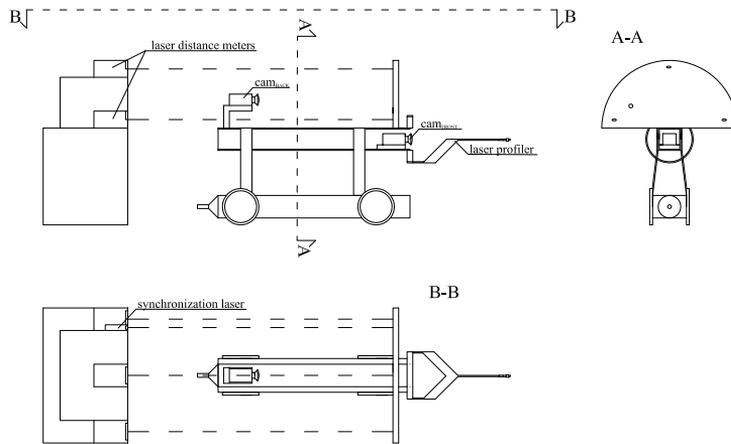
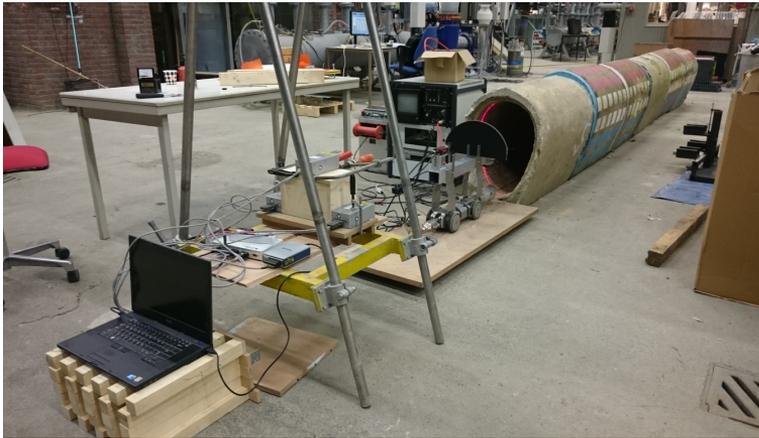
Figure 7.2: The experimental set-up: Sketch (top) and Photograph (down).

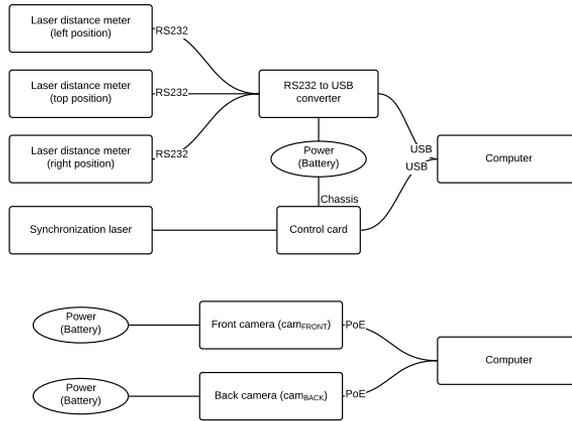
Figure 7.3: Data acquisition systems set up on the device: fixed (top) and moving (down) platform.

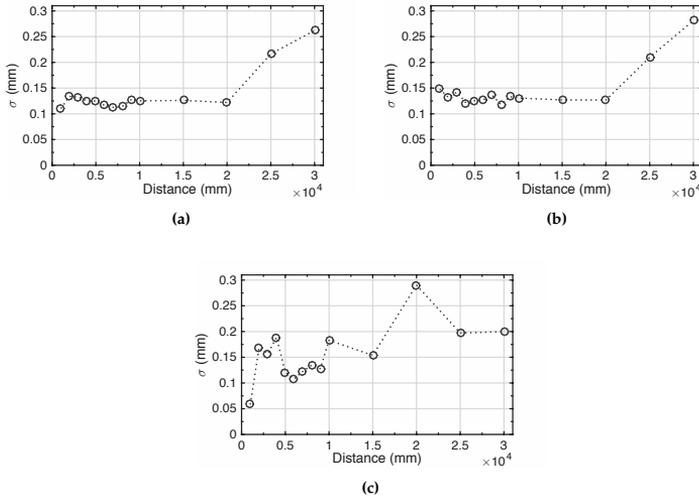
Figure 7.5: Standard deviation of distance measurement for: (a) left laser; (b) top laser; (c) right laser.

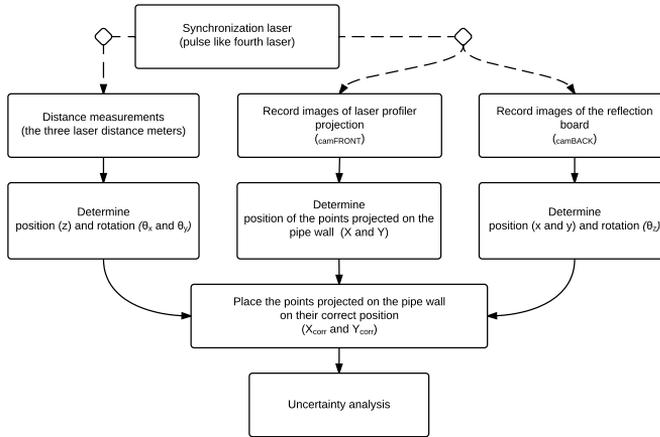
Figure 7.9: Data processing flow chart.

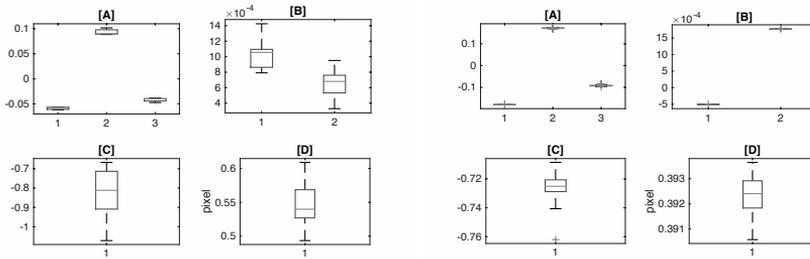
Figure 7.10: Boxplot of c a m F R O N T-LM₃NCM-2.4 (left) and c a m B A C K-LM6HC-1.8 (right): [A] Radial distortion; [B] Tangential distortion; [C] Skew; [D] Mean error in pixels; On each box, the central mark is the median, the edge of the box are 25th and 75th percentiles, the whiskers extend to the most extreme data points not considering outliers (approximately $\pm 2.7\sigma$), and outliers are plotted individually.

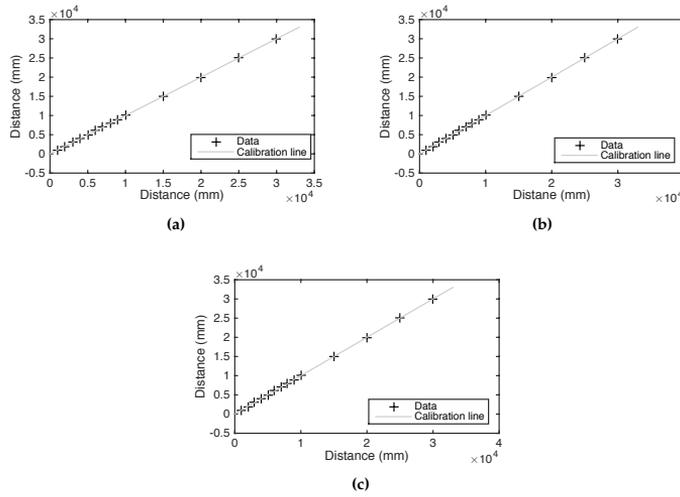
Figure 7.11: Distance meters calibration line for: (a) left laser; (b) top laser; (c) right laser.

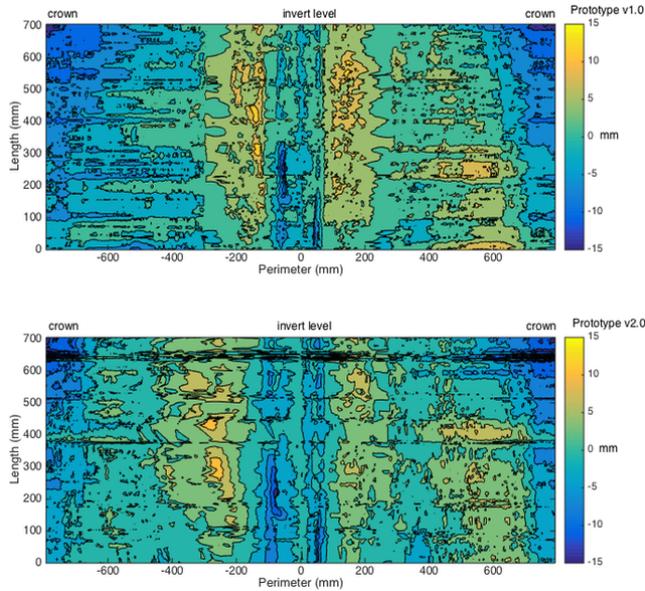
Figure 7.12: Difference between theoretical and measured geometry for the old pipe. The upper chart shows the result obtained from using the 1st (old) version of the apparatus, and the lower chart shows the result of the 2nd (new) version of the apparatus.

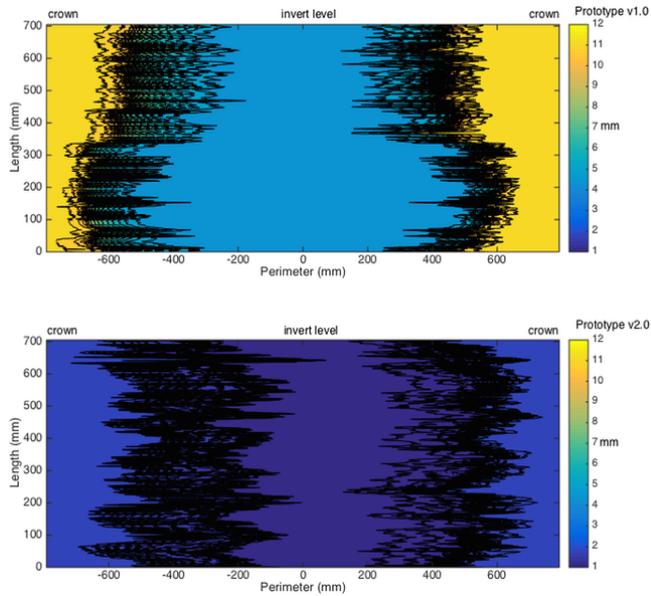
Figure 7.13: Difference between uncertainties associated to the estimation of the loss of wall thickness. The upper chart shows the result obtained from using the 1st (old) version of the apparatus, and the lower chart shows the result of the 2nd (new) version of the apparatus.

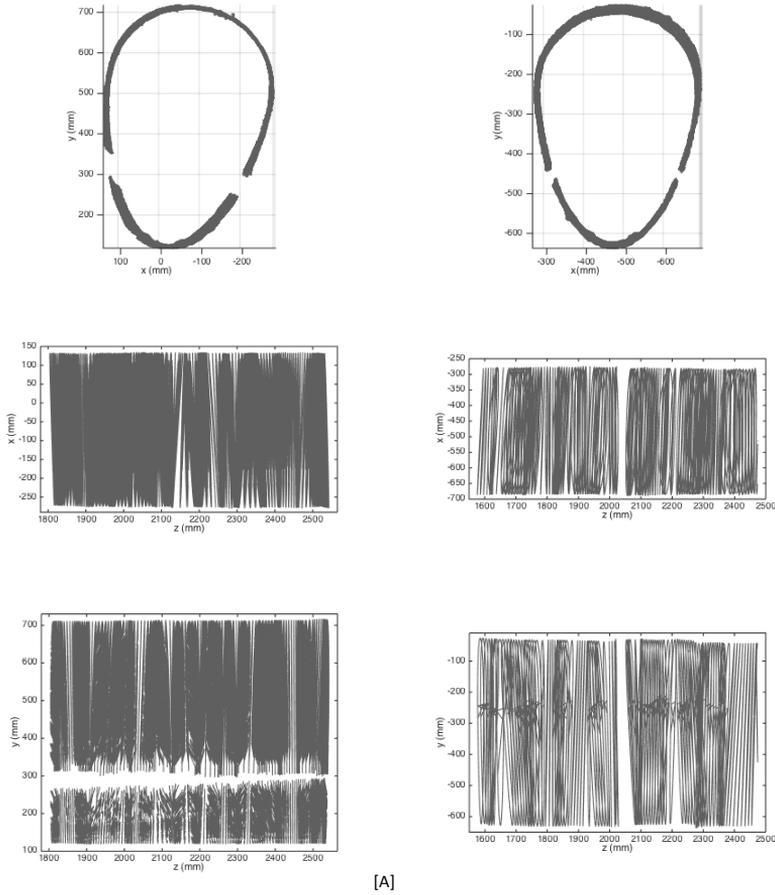
Figure 7.14: Front (first row), top (second row) and (third row) side view of the results of 3D reconstruction of the scanned pipe interior geometry using: [A] Prototype v1.0; [B] Prototype v2.0.

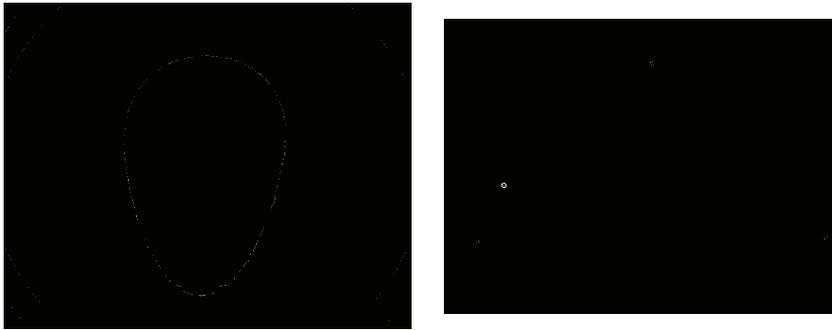
Figure 7.15: Deviation in repetitive image processing results for cam_{FRONT} (left) and cam_{BACK} (right).

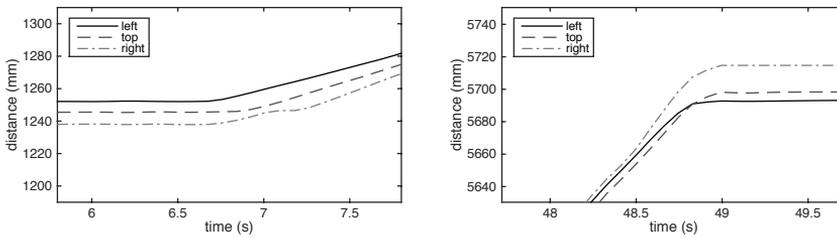
Figure 7.16: Examples of the synchronization problems between the three laser distance meters for the experiments over the whole sewer pipe stretch.

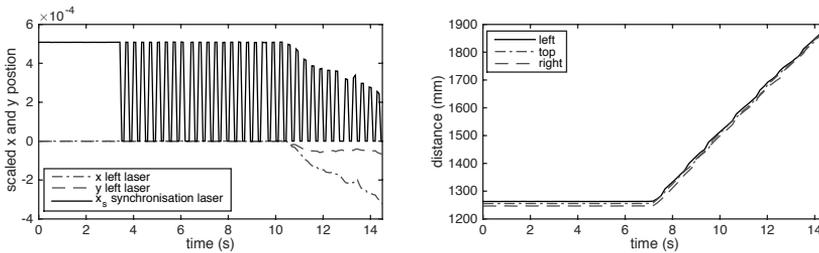
Figure 7.17: Synchronisation between moving platform (left) and fixed platform (right).

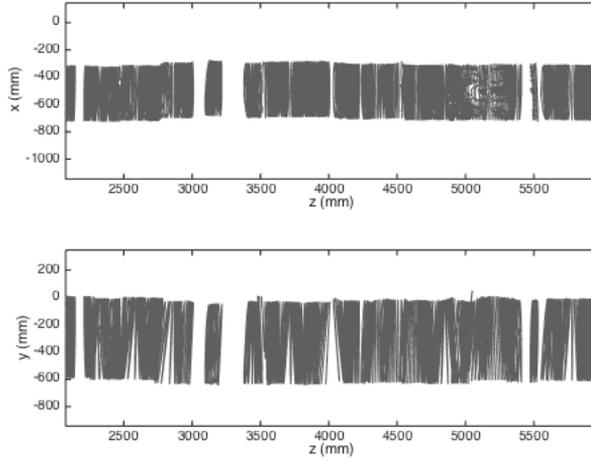
Figure 7.18: Top and side view of the results of 3D reconstruction of the scanned sewer pipe stretch.

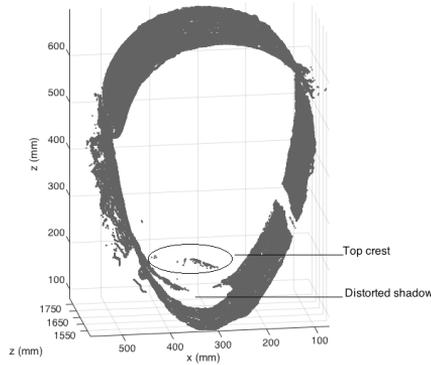
**Figure 7.19:** Glass bottle scanned by prototype.

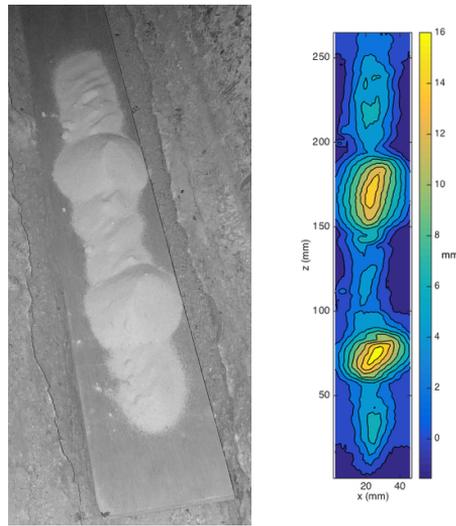
Figure 7.20: Quantification of the sand deposit volume: photo of the experiment (left) and scanned sand relief (right).

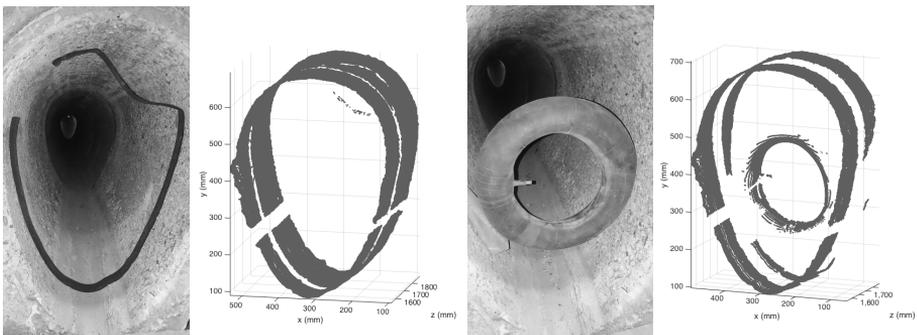
Figure 7.21: Displaced joint (left) and section reduction with one inner tube (right); picture and scanned data.

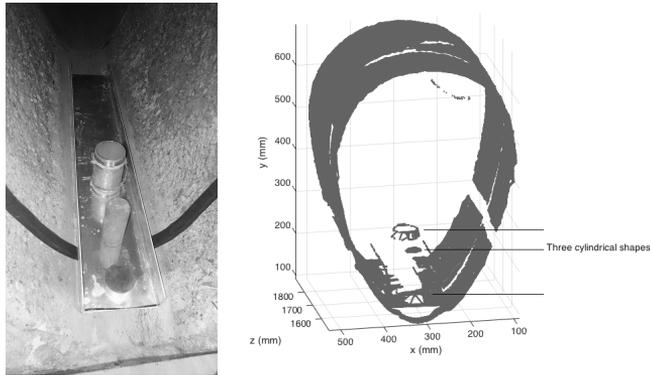
Figure 7.22: Various cylindrical shapes scanned with the device: photo (left) and scanned data (right).

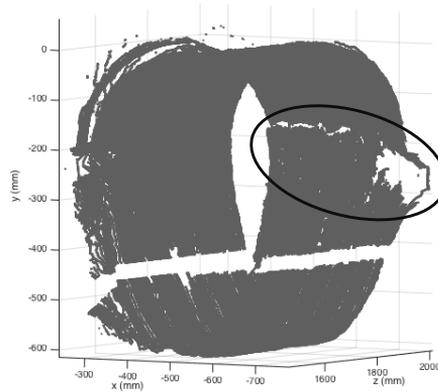
Figure 7.25: Fissures and break scanned by the prototype.

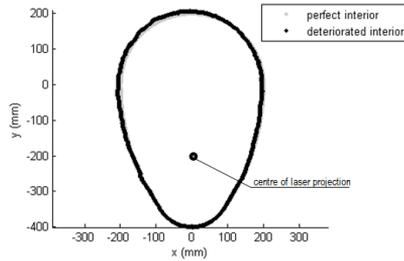
Figure 7.26: Example of the laser profiler results; deteriorated pipe cross-section vs. perfect pipe cross-section.

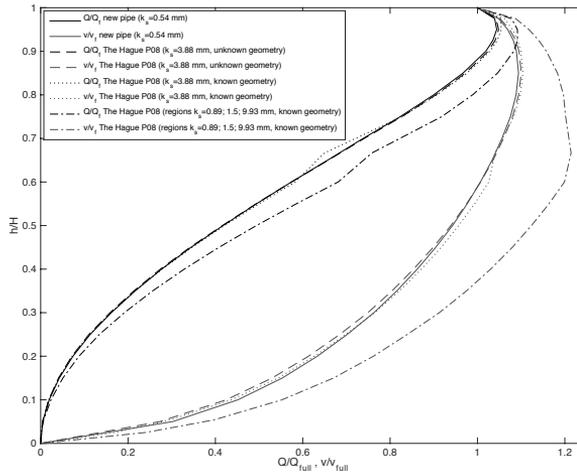
Figure 7.28: Velocity and discharge in partially filled egg-shaped pipe and the effects of the change of the physical roughness and the interior geometry.
