Investigating methods for assessing erosion and landform stability on rehabilitated mining waste dumps in the Pilbara region, Western Australia

Analysing the potential of remote sensing and
ground-based methods for erosion assessment with
GIS and modelling at the hillslope and gully scale

MSc thesis by Beatriz Nofuentes Martínez

Master thesis Soil Physics and Land Management Group
submitted in partial fulfillment of the degree of Master of
Science in International Land and Water Management at
Wageningen University, the Netherlands

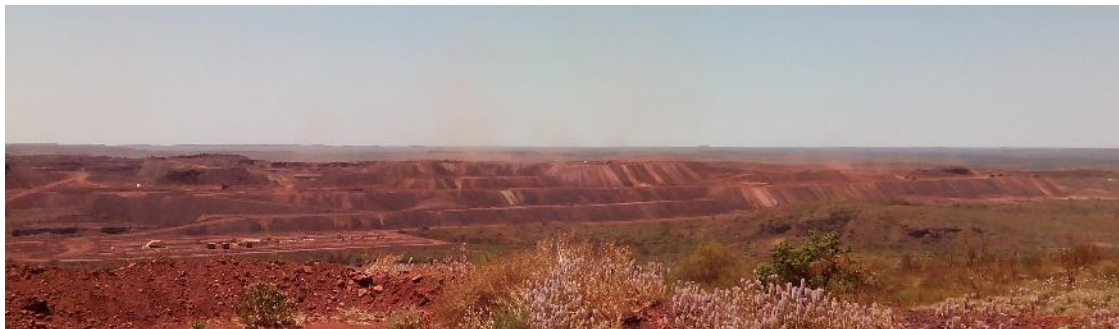
Figure 1: Non-rehabilitated waste dumps from the Pilbara region

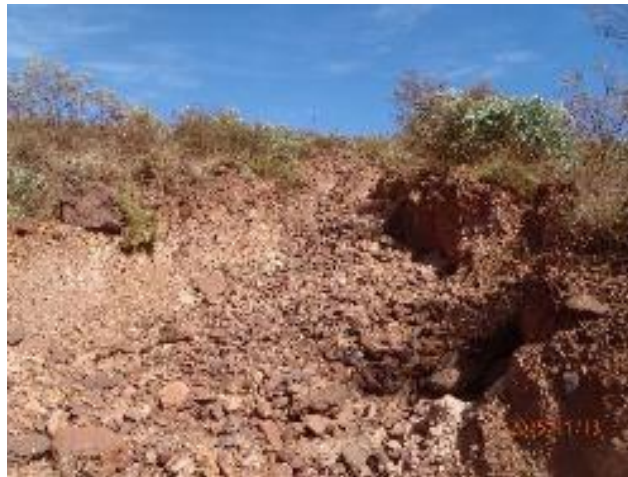
Figure 2: Study gully at rehabilitated waste dump

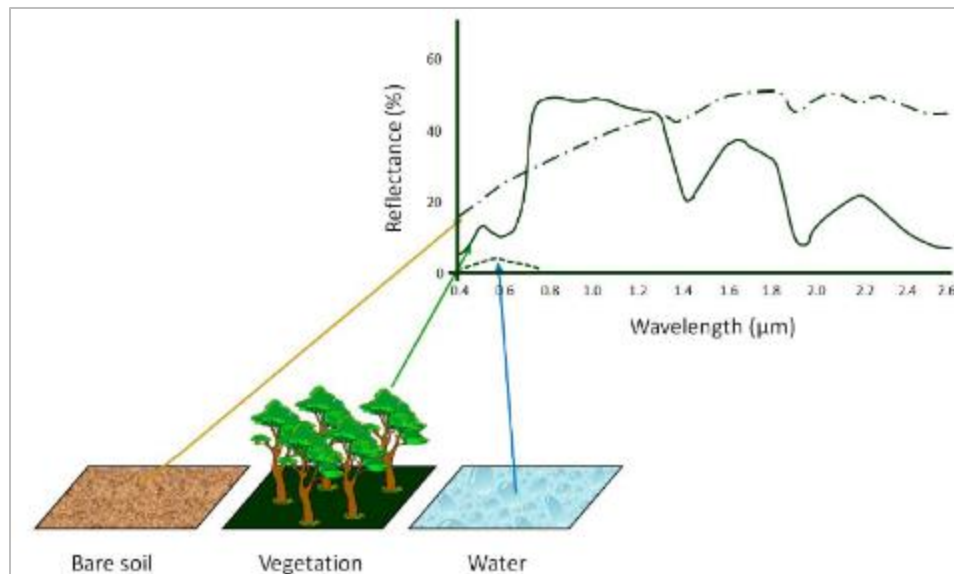
Figure 3: Spectral reflectance signatures for bare soil, vegetation and water

Satellite remote sensing can contribute to surface assessments by providing spatial data (Vrieling, 2005). Optical satellite images, such as Landsat, Ikonos, QuickBird or ENVISAT, have been and can be applied in erosion research for detecting eroded areas, determining their spatial range or assessing erosion factors (Miemiec, 2009). In Australia, there has been some important research undertaken by Raval, Merton and Laurence, who have been working on using satellite remote sensing techniques for assessing revegetation on mine sites since 2010. For instance, Raval and Laurence (Australian Centre for Sustainable Mining Practices (ACSMP), University of New South Wales (UNSW)), have used various satellite imagery for this purpose, especially WorldView-2 satellite imagery. “This satellite based approach clearly identifies subtle changes in vegetation composition and health across an otherwise homogenous revegetated surface and proves a valuable addition for mine rehabilitation management” (Raval et al., 2013: 200). There are other remote sensing techniques that are useful for assessing erosion. For instance, LIDAR can identify ephemeral erosion sites and produce slope estimates for use in erosion estimations (Minnesota Geospatial Information Office Minnesota Geospatial Information Office [MnGeo], 2001) and has the potential to quantify and monitor gully erosion (Perroy et al., 2010). Volumes of gullies can be calculated with UAV platforms and ArcGIS with the aim of creating a better understanding of long-term erosion rates (Verdonk, 2015).

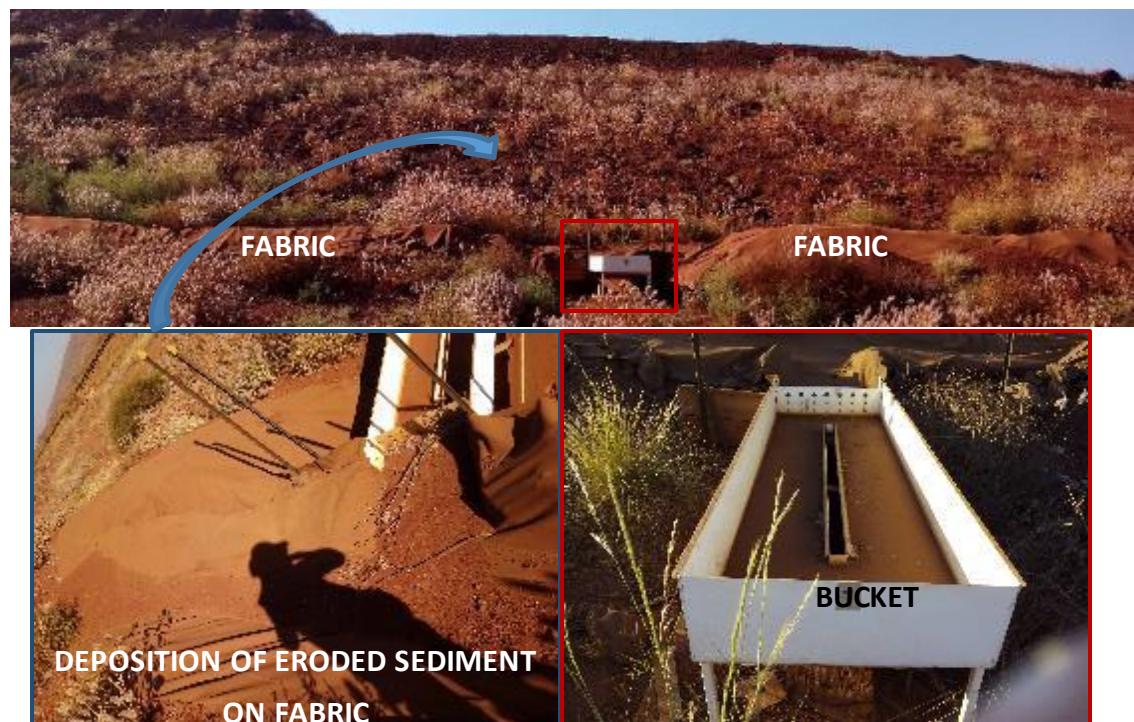
Figure 5: Erosion plot (H1) at MAC showing fabric and bucket for collecting erosion and runoff data

Data from the experimental erosion plots includes rainfall data, runoff, suspended and bed load, from which we obtain erosion rates for each of the 9 plots. Each plot has an approximate area of 1200 m². The erosion plot edges were built so that they are disconnected from the rest of the waste dump in terms of hydrological connectivity.

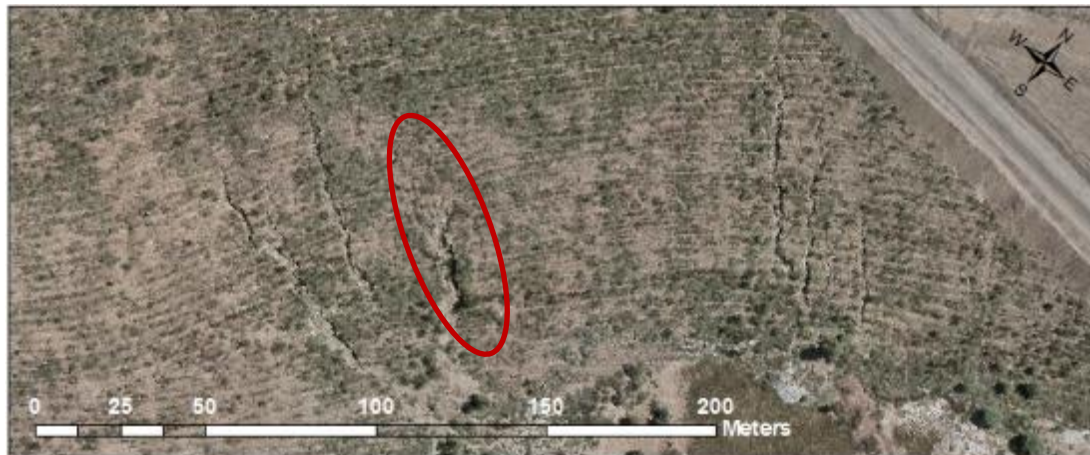
Figure 7: Satellite image of the study waste dump at MWB showing large erosion feature (G2 in red)

The section of hillslope selected for the study is heavily eroded (Figures 7 and 8). Only gully scale assessment was done at this waste dump due to limited time for the field work. In this case a 35x6 m long gully, G2, has been reconstructed and analysed (Figures 7 and 8). Despite the area not being characterised by steep slopes (12°) nor low vegetation cover, large erosion features can be found here.

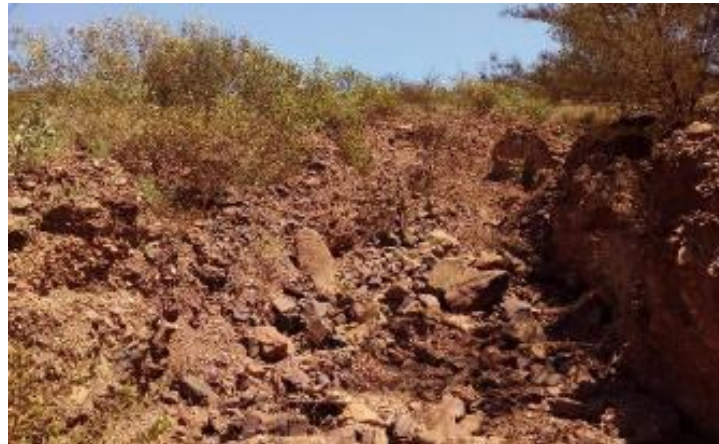
Figure 8: G2 from the bottom

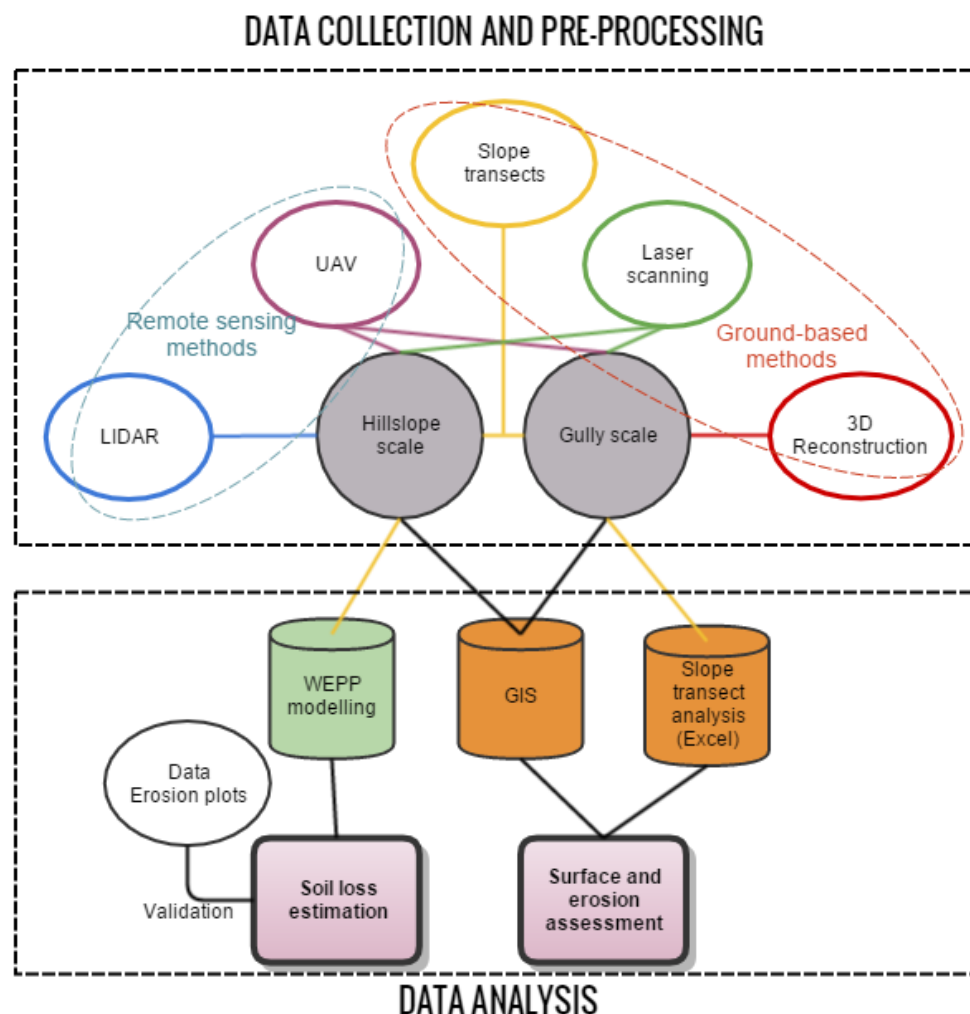
Figure 9: Overview of research methodology showing data collection and analysis

Figure 9 shows the methodology followed in the present research for data collection and analysis. While remote sensing data (UAV and LIDAR) was provided for the study, slope transects, laser scanning and 3D reconstruction (i.e. ground-based methods) were applied on site for the collection of surface data at the hillslope and gully scale (except 3D reconstruction, which was only focused at the gully scale). Other field measurements such as slope or rip line characteristics were also collected.

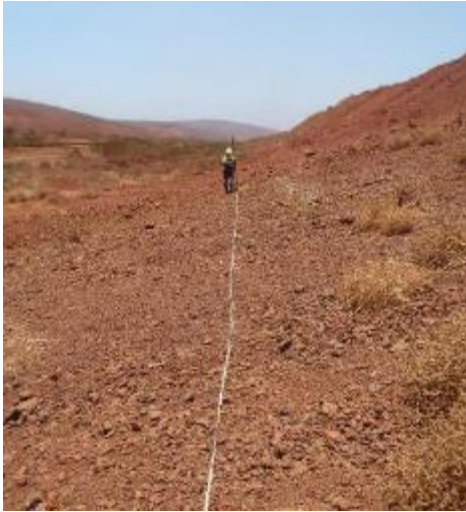
Figure 10: Slope transect method applied on site (Landloch)

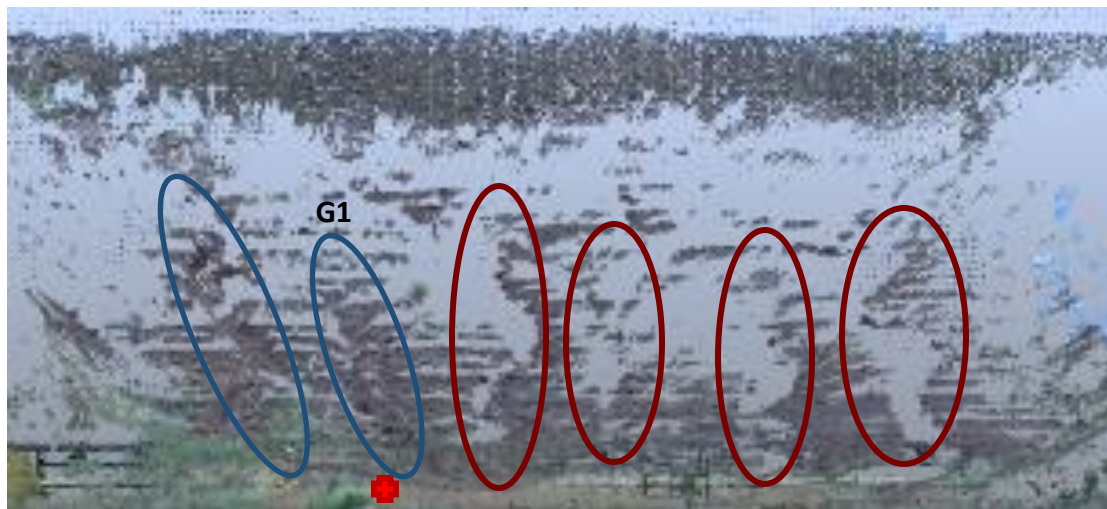
Figure 11: 3D view of point cloud generated from laser scanning at H1 in *Scene* showing gullies and the position of the laser scanner (red cross)

Various scans were made for H1, however the high density of points provided by one unique scanning results in considerable data for processing. For this reason, the point cloud used for surface assessment at H1 and G1 was created only from one scan (Figure 11). The point cloud was then scaled, georeferenced and edited through the software *Cloud Compare*, on the basis of the LIDAR elevation. It can also be appreciated how point cloud density (i.e. precision) of the laser scan is lower as it is further from the position of the scanner. Hence, whereas gullies in front of the scanner position (including G1) are mostly reconstructed (marked in blue), gullies marked in red in Figure 11 are visible because there is no elevation point data from their channel bed. For performing this technique and the 3D reconstruction, vegetation was removed from the erosion channels. This will not have an effect on future erosion, considering the low amount of canopy and ground cover to protect against water erosion provided by *Ptilotus* species, the dominant vegetation covering H1. At MWB, another scan was run for assessing G2.

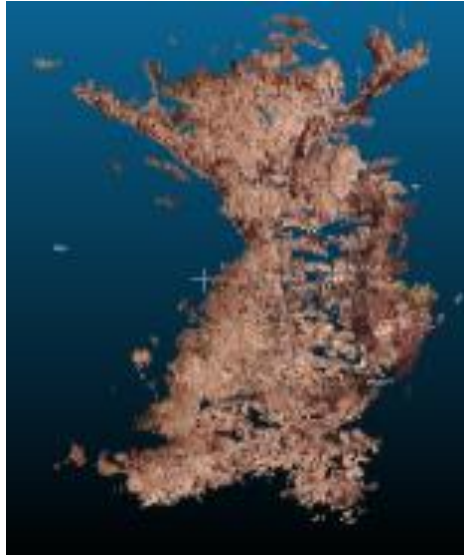
Figure 12: 3D reconstruction of G2 at MWB in Cloud Compare

This technique is based on creating a 3D reconstruction from pictures taken with a standard digital camera. The field work involved selecting specific gullies from the study waste dumps, implementing control points around the area reconstructed, determining their geographic location with GPS, and finally taking pictures of all the erosion features present in the area.

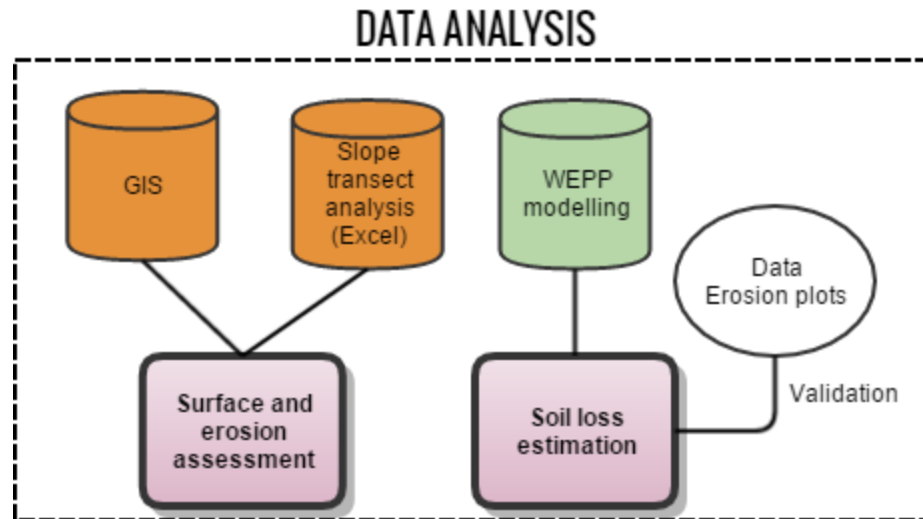
Figure 13: Overview of research methodology for data analysis

Two different approaches will be applied in order to assess soil surface alteration by erosion from the available elevation information obtained from data collection: erosion surface assessment with *ArcGIS* (*Excel* in the case of slope transect data), both at the hillslope and gully scale, and soil loss estimation modelling using WEPP (Figure 13).

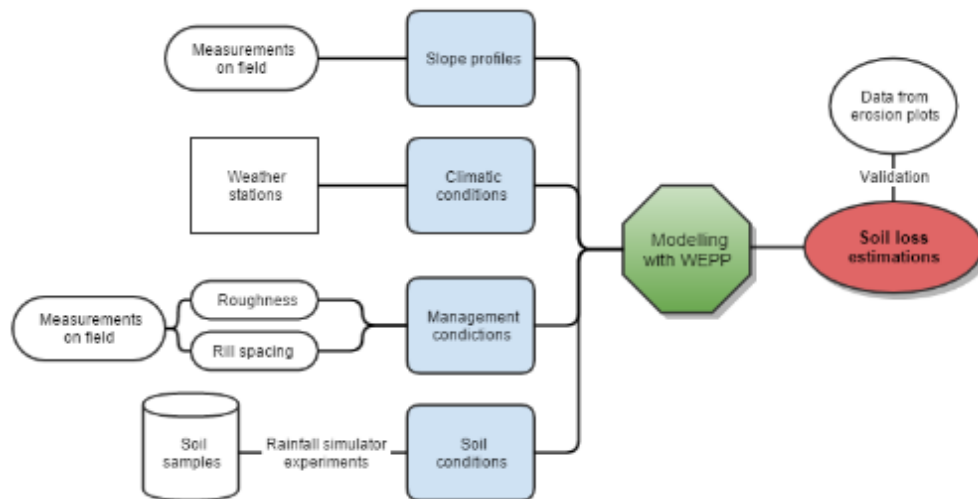
Figure 14: Overview of methodology followed for estimating erosion with WEPP

Modelling with WEPP requires a large number of input parameters, which are classified into four different groups: Climate, management, slope and soil (Figure 14). The synthetic climate data conforms to the same statistics as the observed data which were computed into a text file for predicting erosion; with available climatic data provided by BHP-Billiton from the MAC weather station, from July 2012 (when construction of erosion plots were completed) until April 2015. The climate input was created from daily climatic series data at 15-minute intervals, which is useful for modelling information about peak rainfall and intensity especially when estimating erosion.

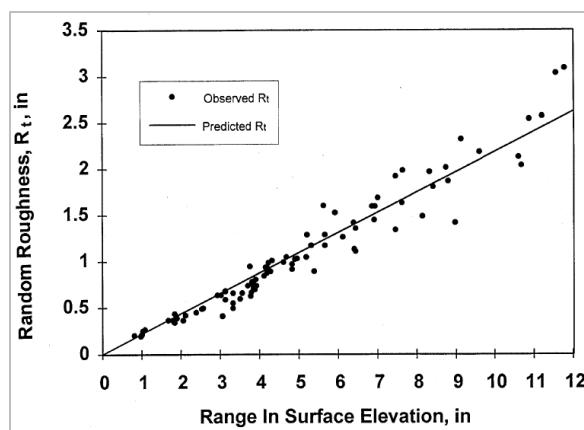
Figure 15: Random roughness versus range in surface elevation along a transect

Following these default conditions, it was essential to correctly define two parameters, as they are very sensitive in erosion assessment: random roughness, and rill spacing. Rill spacing was estimated as an average from the slope transect data collected on site. According to the model, the lower the spacing, the lower the erosion, as it assumes that less water is accumulated.

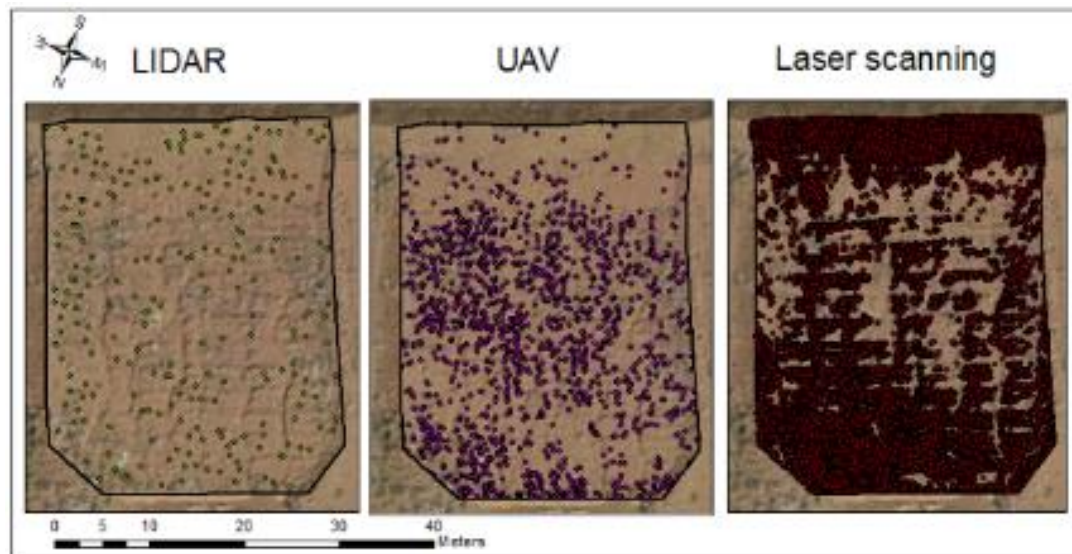
Figure 17: Comparison of LIDAR, UAV and laser scanning point clouds at H1

Figure 17 shows the elevation point clouds provided by LIDAR, UAV and laser scanning, in increasing order of point density. In the case of LIDAR, cloud density at H1 was 247 elevation points, whereas UAV was 2,340 and laser scanning 6,914,840 points.

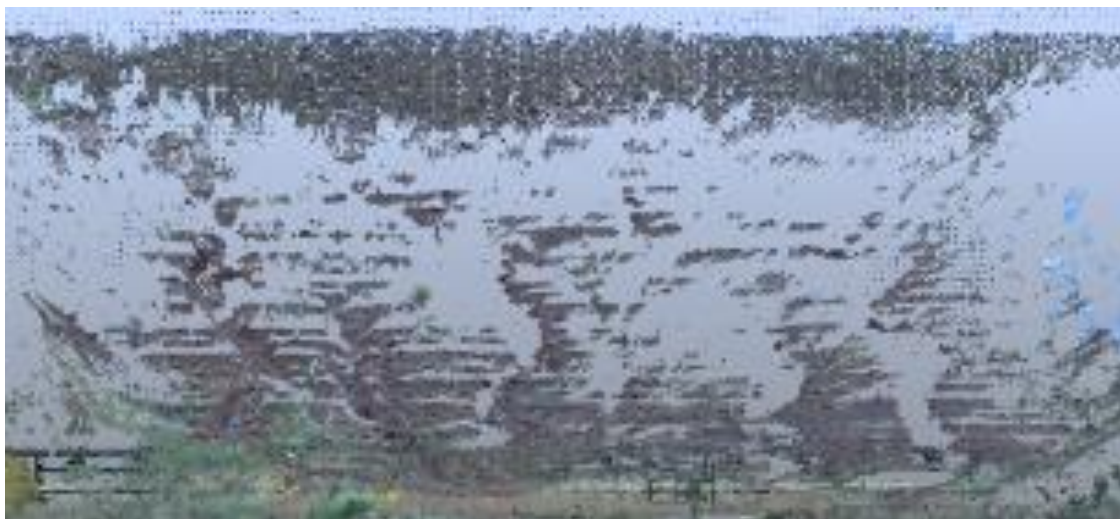
Figure 18: 3D view of point cloud generated from laser scanning from the bottom of H1 in Scene

The high density of laser scanning elevation point cloud allows one to sense where the erosion gullies or even where rip lines are, even before reconstructing the surface (Figures 17 and 18). Laser scanner (located at the northern corner of the plot when run) loses precision for assessing the surface with the distance, as it loses visibility of parts of the surface.

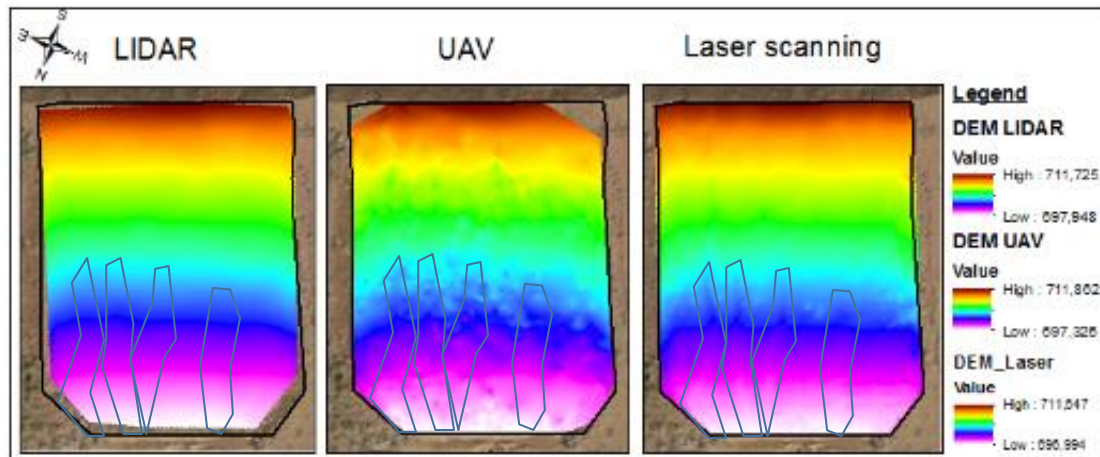
Figure 19: Comparison of LIDAR, UAV and laser scanning DEM at H1 showing erosion detected features from laser scanning

The Digital Elevation models (DEM) (Figure 19), generated from the point clouds above, are at the same altitude rank, varying from 697 to 711 masl, and follow similar elevation patterns. The east side of the plot is lower, being the northern corner and thus the lowest point of the plot.

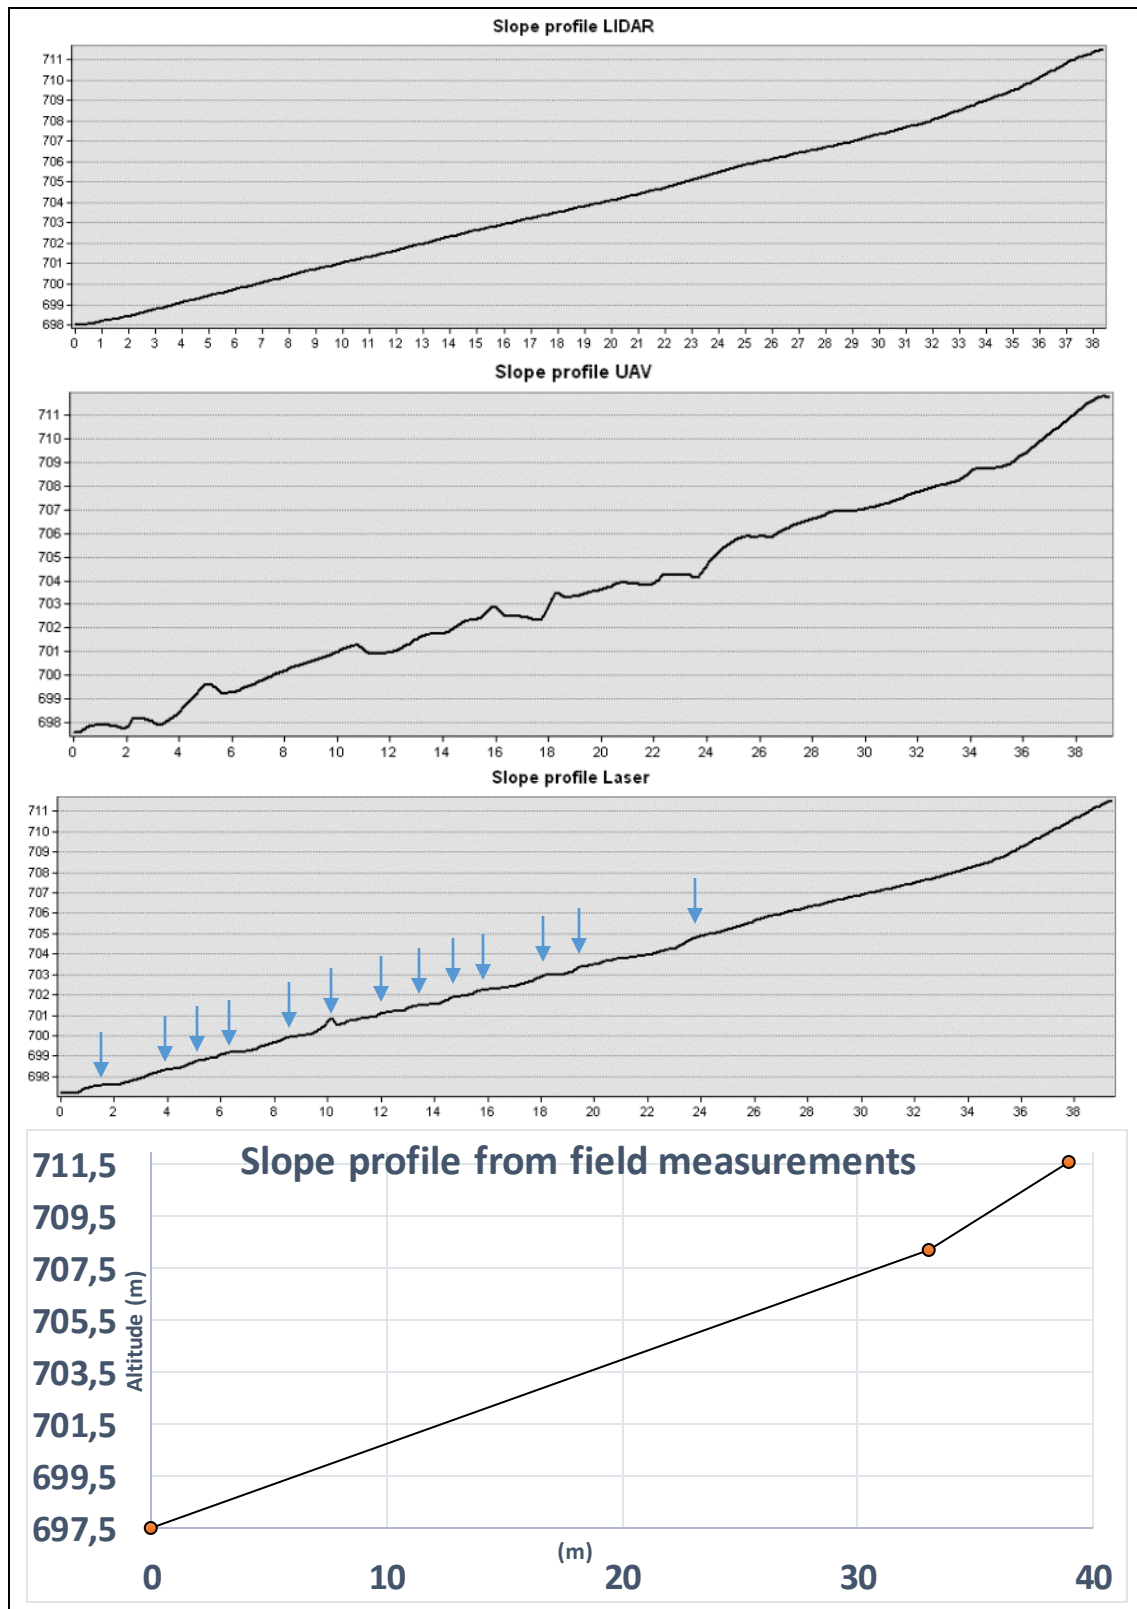
Figure 20: Longitudinal slope profiles derived from LIDAR, UAV, laser scanning and field measurements at H1, showing rip lines on laser scanning profile

Slope and transverse profiles were generated from the study DEM. Slope was also measured on site and compared to the generated slope profiles at H1. LIDAR, laser scanning and slope measured on site provided very similar profiles (Figure 20). Rip lines can be detected on the laser scanning slope profile, especially on the bottom of the hillslope. UAV provided an irregular slope which does not give an accurate hillslope profile. H1 is shaped by two different slopes, the main hillslope and a steeper top slope, 32.5% and 60% on average, respectively.

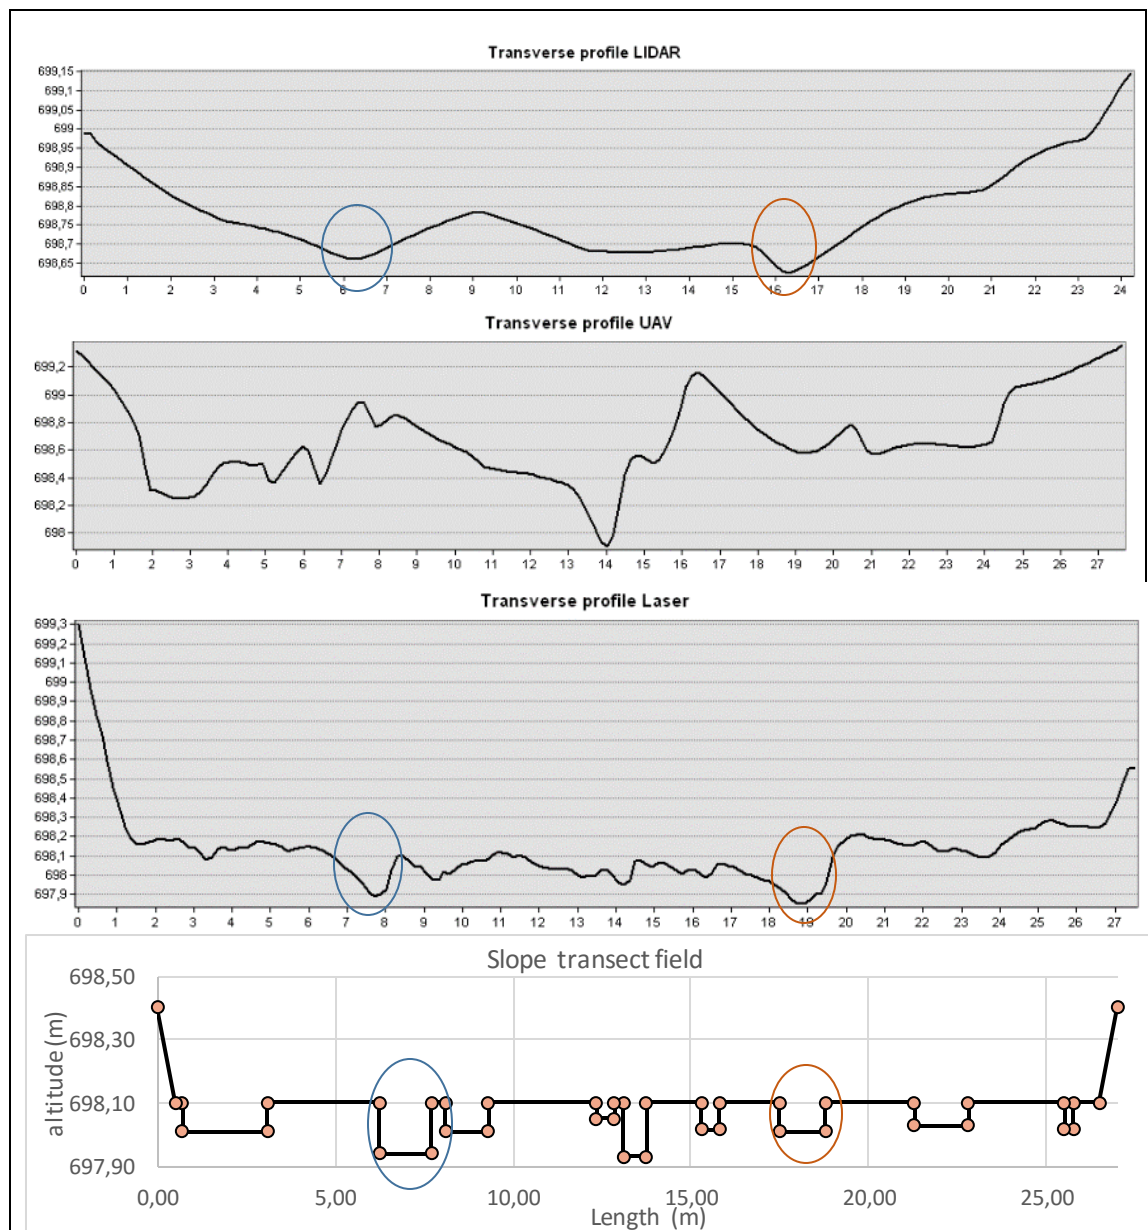
Figure 22: Transverse profiles from LIDAR, UAV, laser scanning and slope transects at H1 showing G1 in blue and another gully in red

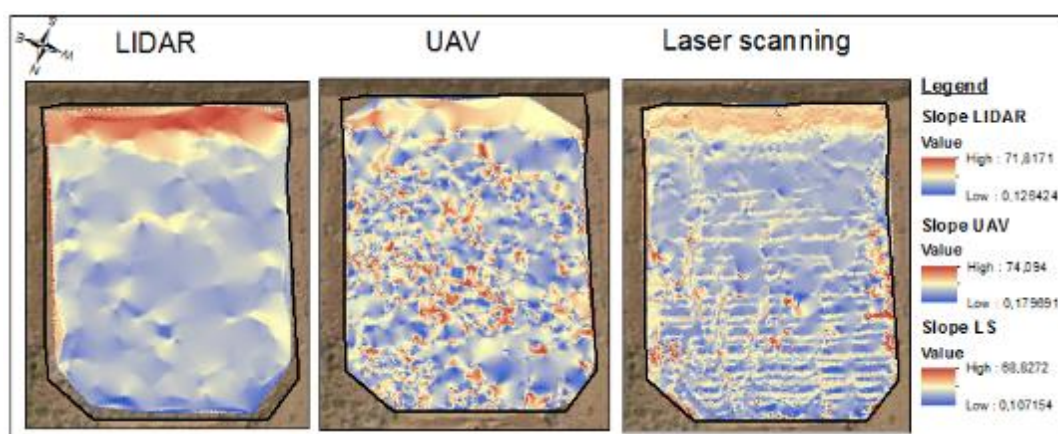
Figure 23: Comparison of LIDAR, UAV and laser scanning slope maps at H1 (degrees)

Slope maps (in degrees) were generated from the study DEM to indicate the steepness of the H1 surface. The resulting UAV slope map shows substantial noise (Figure 23), as happened with the profiles (Figures 21 and 22). LIDAR provides a slope which matches some elements, however, erosion features cannot be discerned. In the case of laser scanning, a precise slope map was obtained (Figure 23), which shows how a single laser scanning can clearly detect rip lines and erosion features.

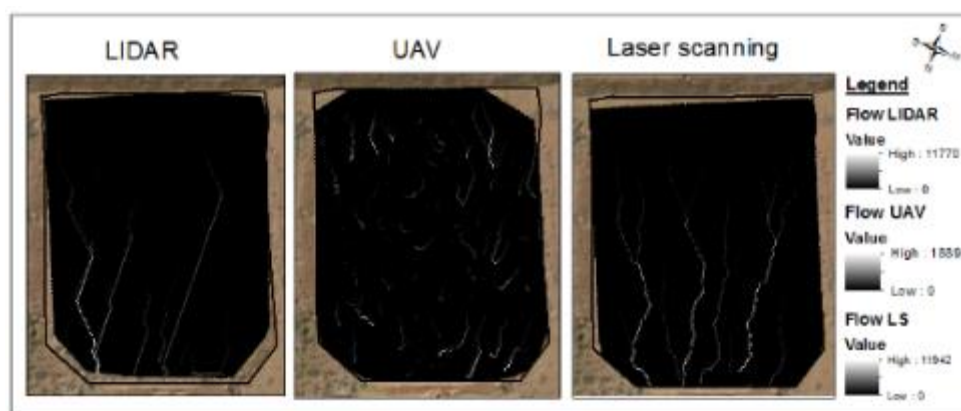
Figure 24: Comparison of LIDAR, UAV and laser scanning flow accumulation maps at H1

Different hydrological maps were generated in ArcGIS, including flow accumulation. Flow accumulation maps have been created from the direction water flows according to the study DEM. Water flows towards the lowest part of the plot, i.e. the northern corner of H1, accumulating on the erosion channels. Despite erosion features not being observed in the LIDAR slope map (Figure 23), water accumulates in areas where erosion features are and closely matches the laser scanning flow accumulation map (Figure 24). UAV, as in the previous analysis, does not provide an accurate hydrological assessment.

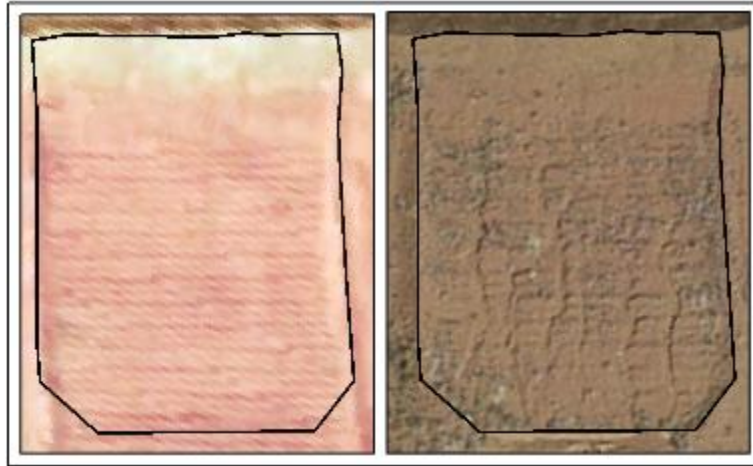
Figure 26: Orthophoto June 2012 (on the left) and satellite image September 2015 (on the right) showing how rip lines have been filled in since H1 construction

been completely filled in. Rip lines implemented on the hillslope have been considerably filled in over the last three years (Figure 26), but not completely. Therefore, erosion volume estimates from slope transect data have probably been overestimated.

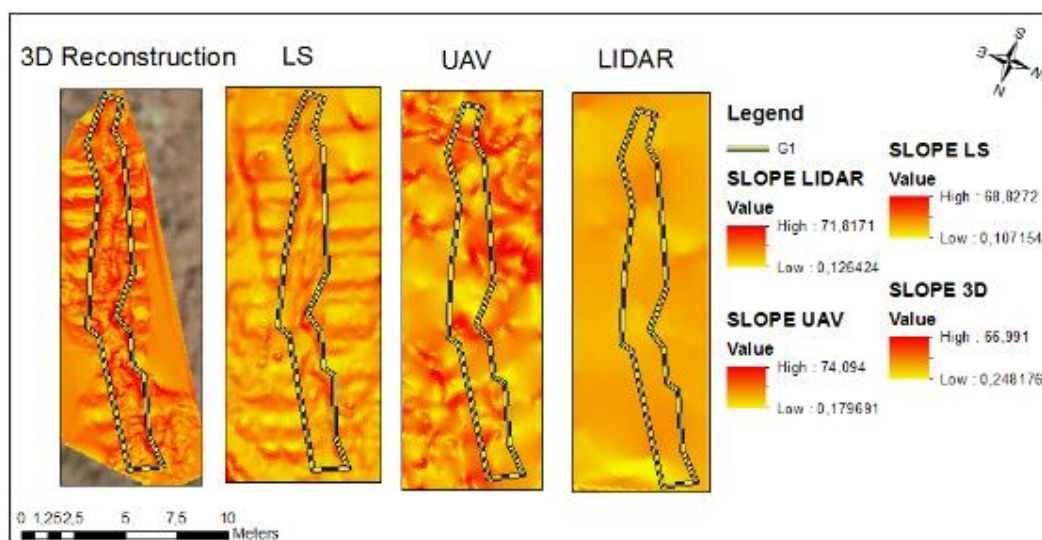
Figure 28: Comparison of slope maps derived from 3D reconstruction, laser scanning, UAV and LIDAR at G1 (degrees)

The slope maps provide a 3D picture in 2D of reconstructions for G1 and its surrounding surface (Figure 28). Despite its precision at the hillslope scale, UAV appeared to detect irregularities on the surface that could be useful for gully assessment, and will be further analysed. While LIDAR does not detect the gully channel or boundaries, laser scanning and 3D reconstruction provide a very accurate reconstruction showing G1 and rip lines around it (Figure 28).

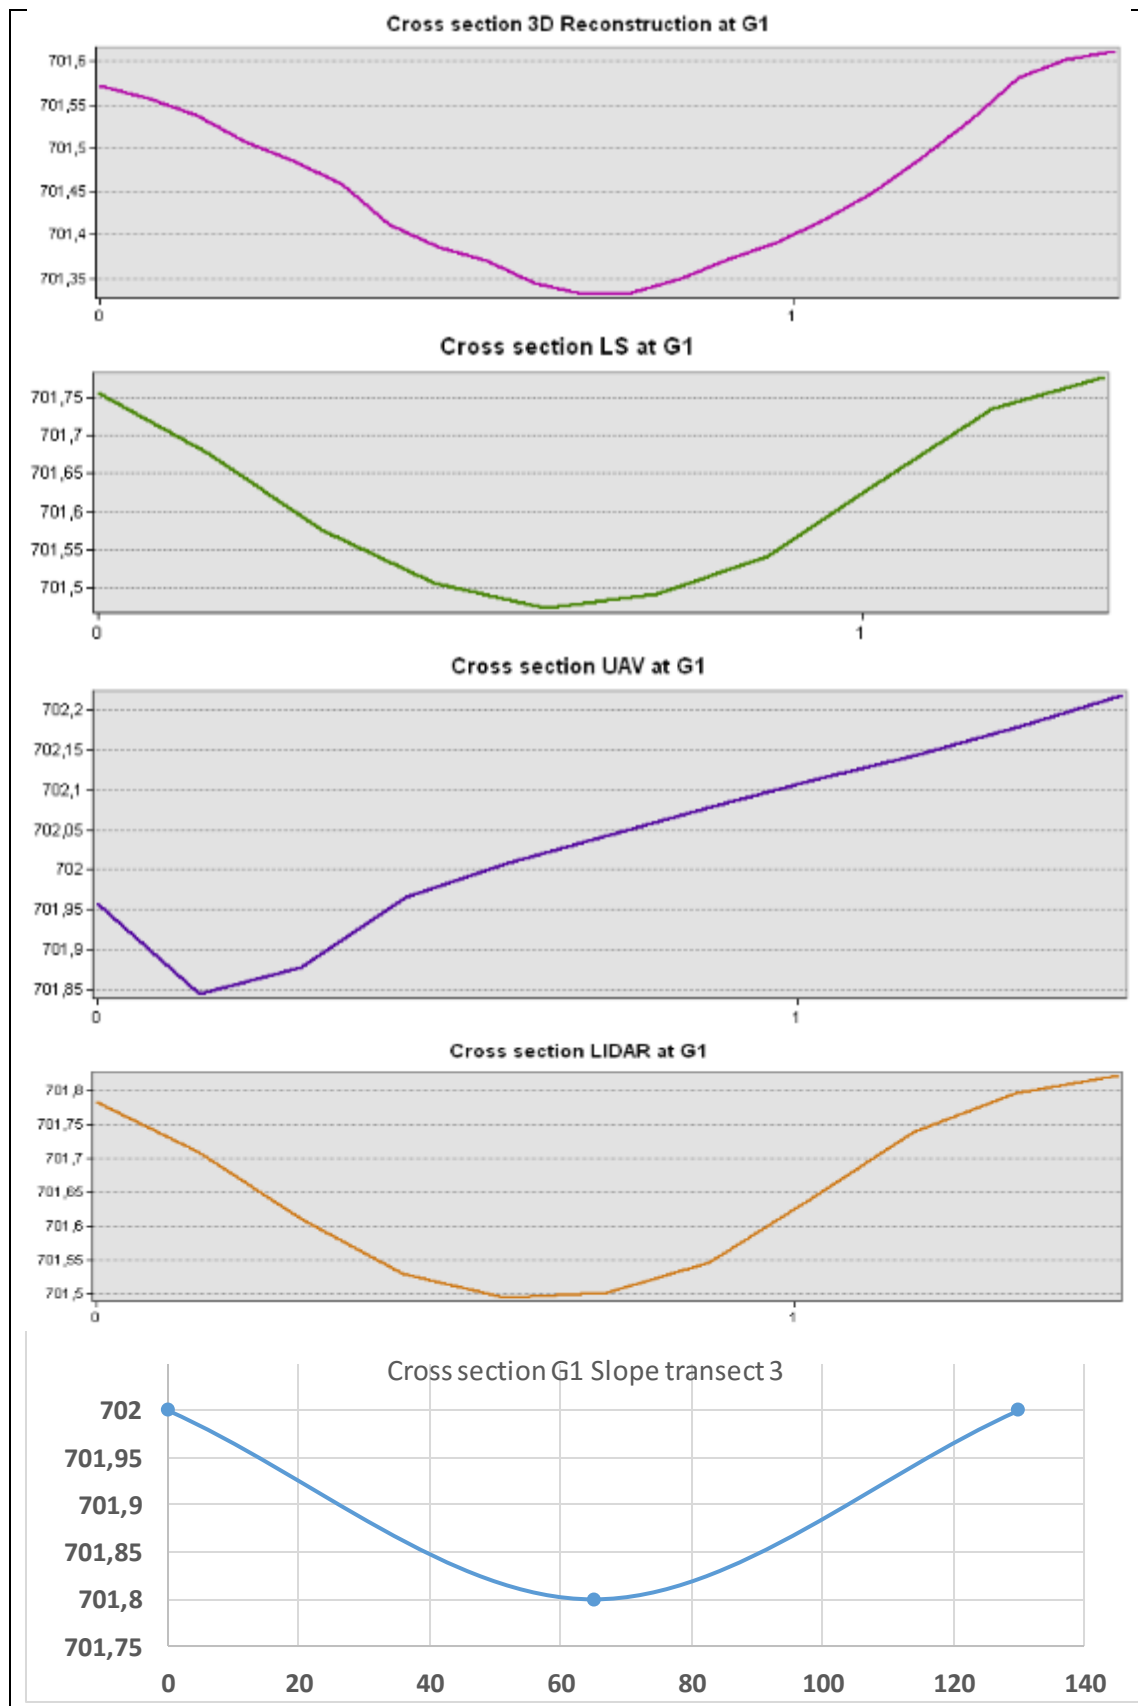
Figure 29: Cross section profiles derived from 3D reconstruction, laser scanning, UAV, LIDAR and slope transects at G1

slope transects. According to these profiles, G1 was 1.3 m width, except for 3D Reconstruction, which was slightly wider (1.4 m).

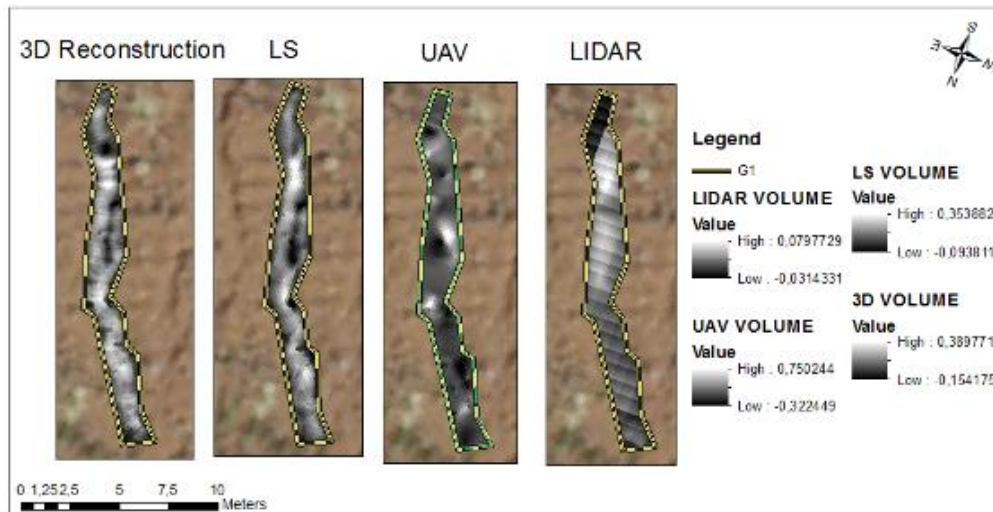
Figure 30: Comparison of volume maps created from 3D reconstruction, laser scanning, UAV and LIDAR at G1

Except for the slope transect, the volume of G1 was estimated from generated volume maps (Figure 30), in which whiter areas represent where more sediment has been eroded. 3D reconstruction and laser scanning provided fairly similar volume maps, showing the same erosion and deposition distribution patterns (Figure 30).

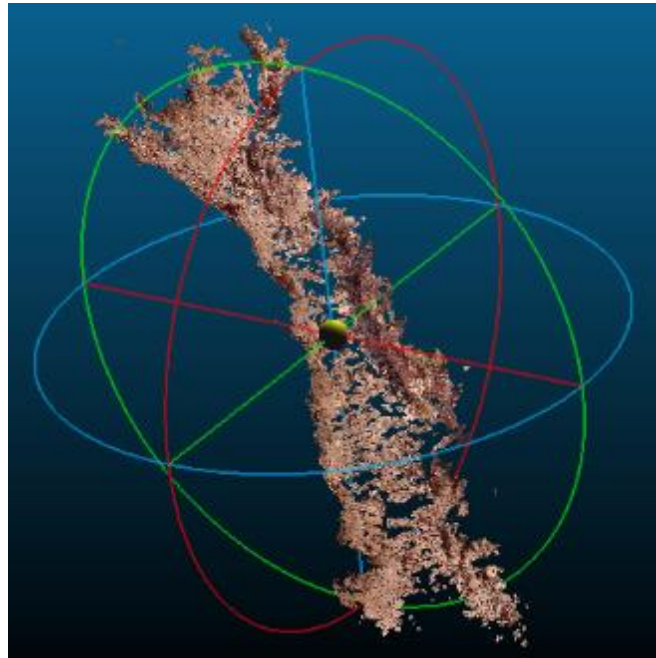
Figure 32: 3D view of point cloud generated from 3D reconstruction at G2, using *Cloud Compare* software

Elevation points generated from a single laser scanning and 3D reconstruction, as at the other study sites, were linked to the images taken, providing very precise coloured 3D point cloud reconstructions when data was preprocessed (Figure 32). As for G1, even stones just a few square centimeters in size can be observed from the 3D reconstruction point cloud.

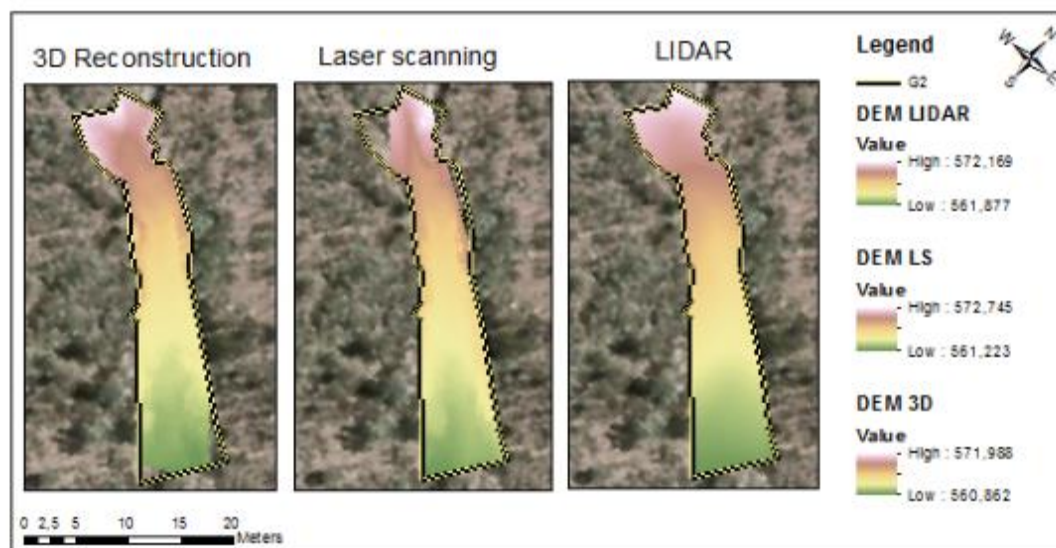
Figure 33: Comparison of DEM profiles derived from 3D reconstruction, laser scanning and LIDAR at G2

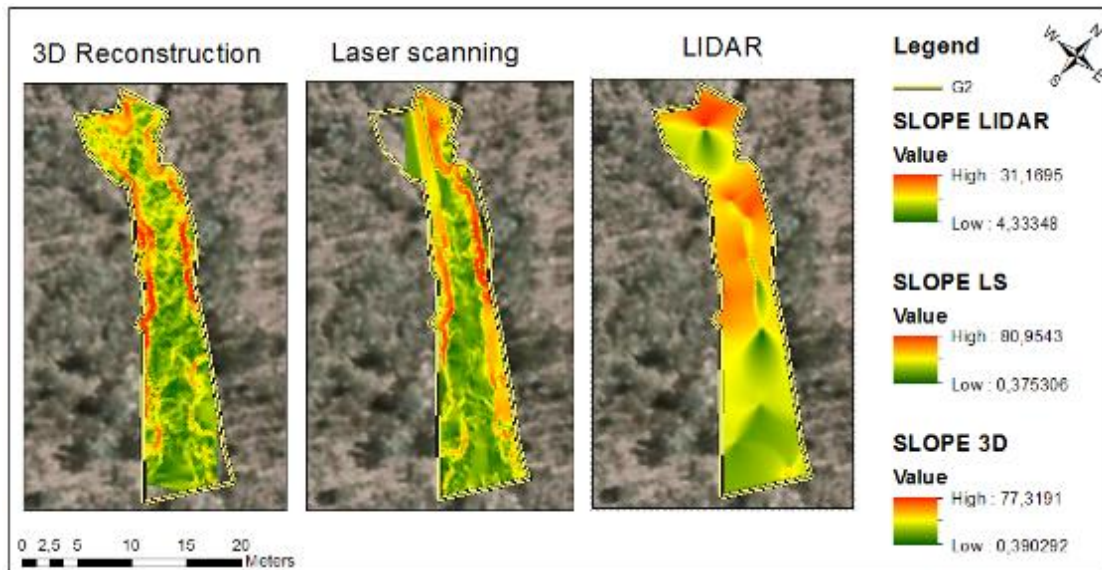
Figure 34: Maps of surface slope provided by 3D reconstruction, laser scanning and LIDAR at G2

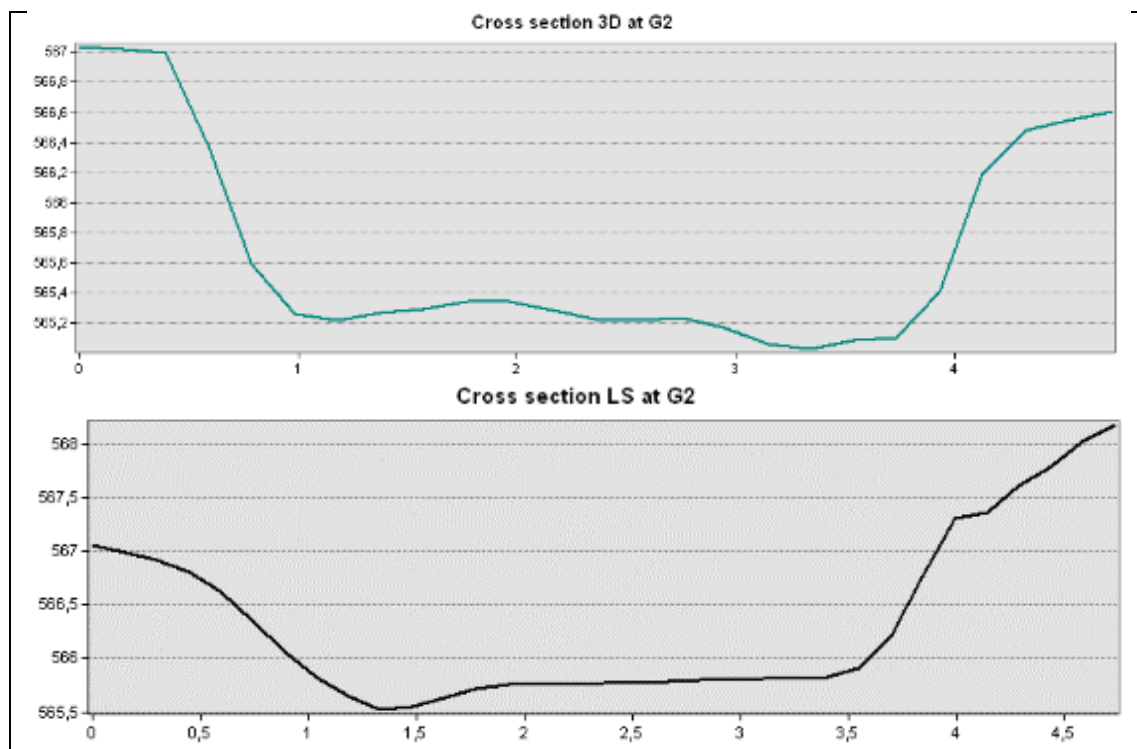
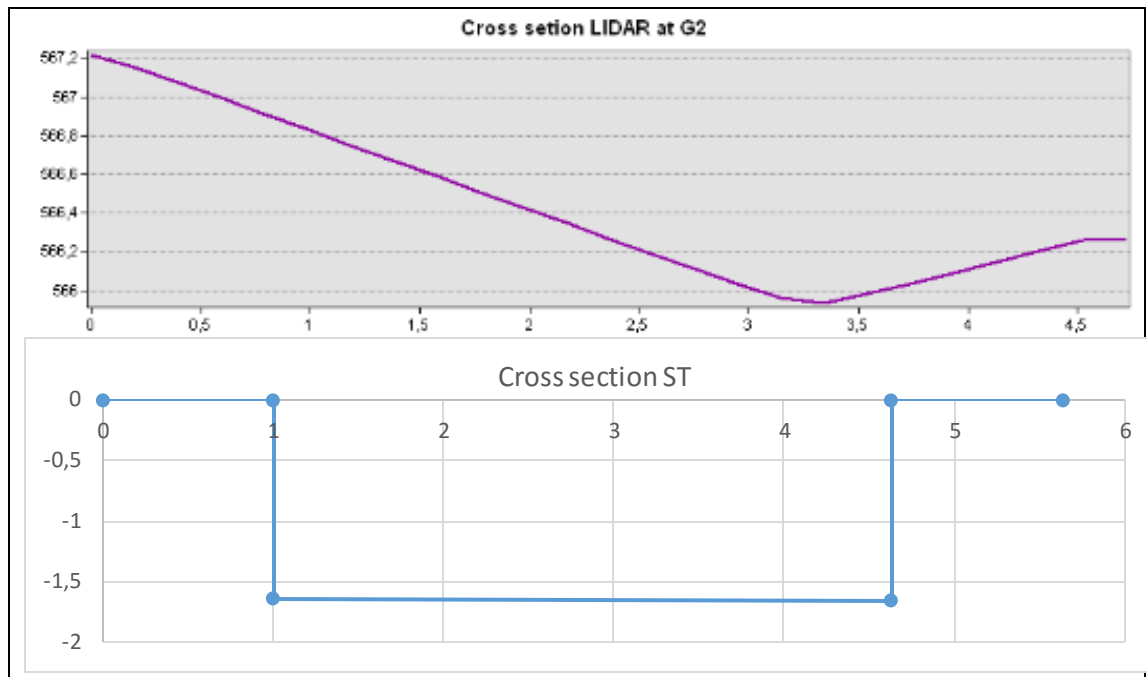
Figure 35: Cross section profiles derived from 3D reconstruction, laser scanning, LIDAR and slope transects at G2

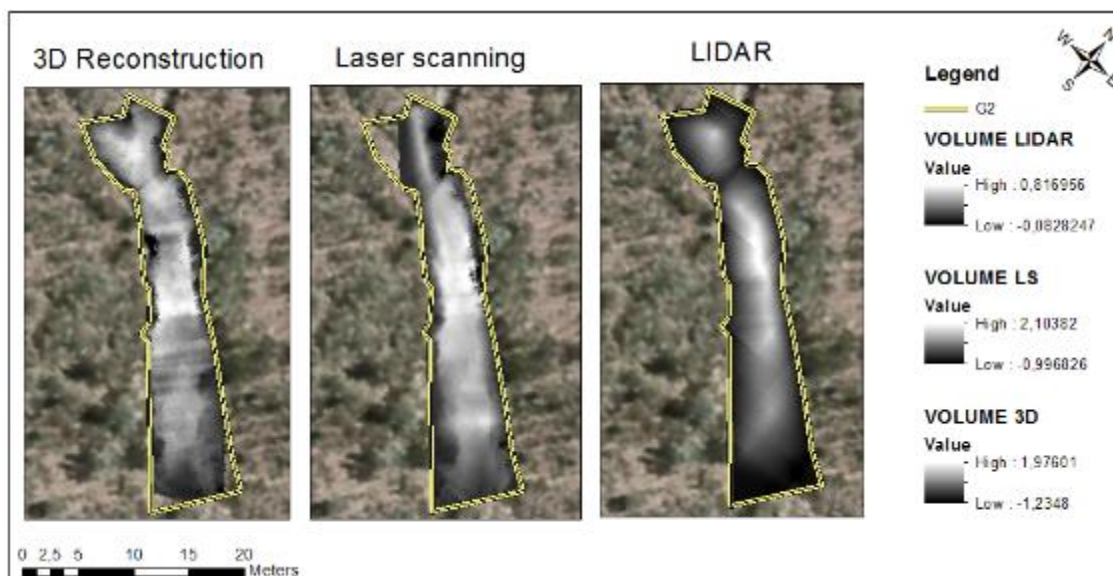
Figure 36: Comparison of volume map derived from 3D reconstruction, laser scanning and LIDAR at G2
