Investigating methods for assessing erosion and landform stability on rehabilitated mining waste dumps in the Pilbara region, Western Australia

Analysing the potential of remote sensing and
ground-based methods for erosion assessment with
GIS and modelling at the hillslope and gully scale

MSc thesis by Beatriz Nofuentes Martínez

Master thesis Soil Physics and Land Management Group
submitted in partial fulfillment of the degree of Master of
Science in International Land and Water Management at
Wageningen University, the Netherlands

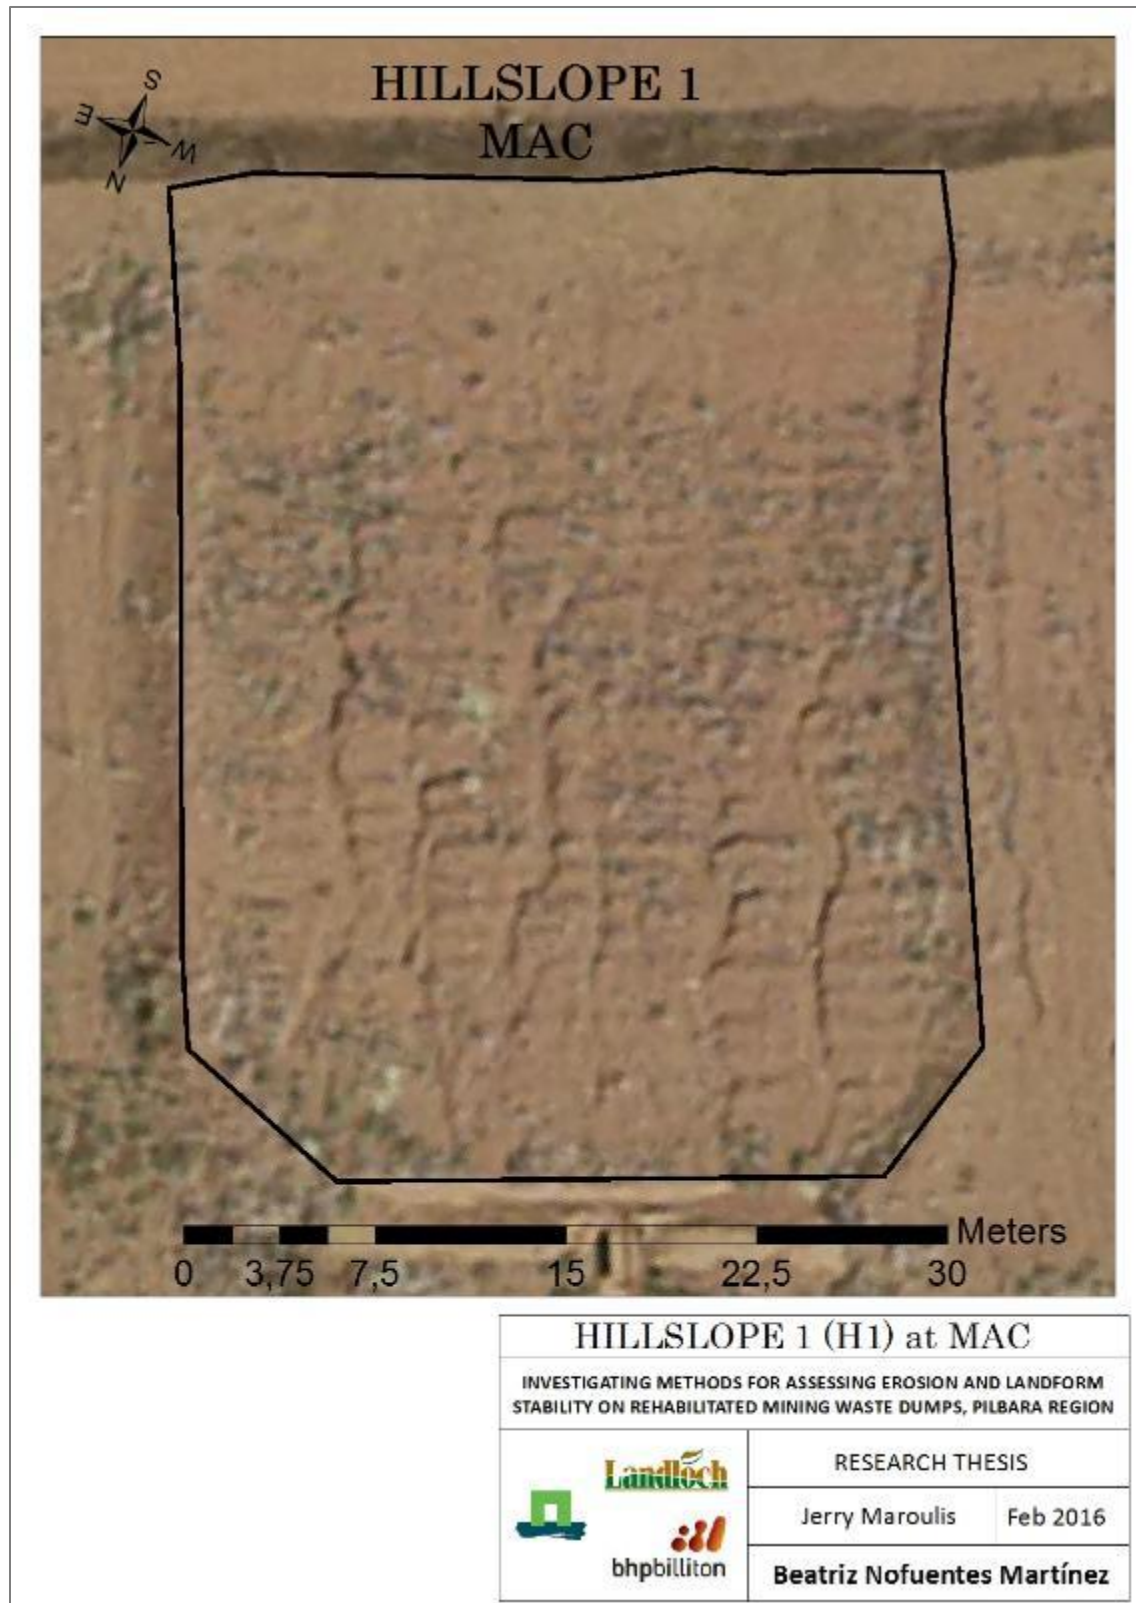
Plan 1: Hill Slope 1 (H1, MAC)

NOTE: Spatial image of H1 and its associated erosion features.

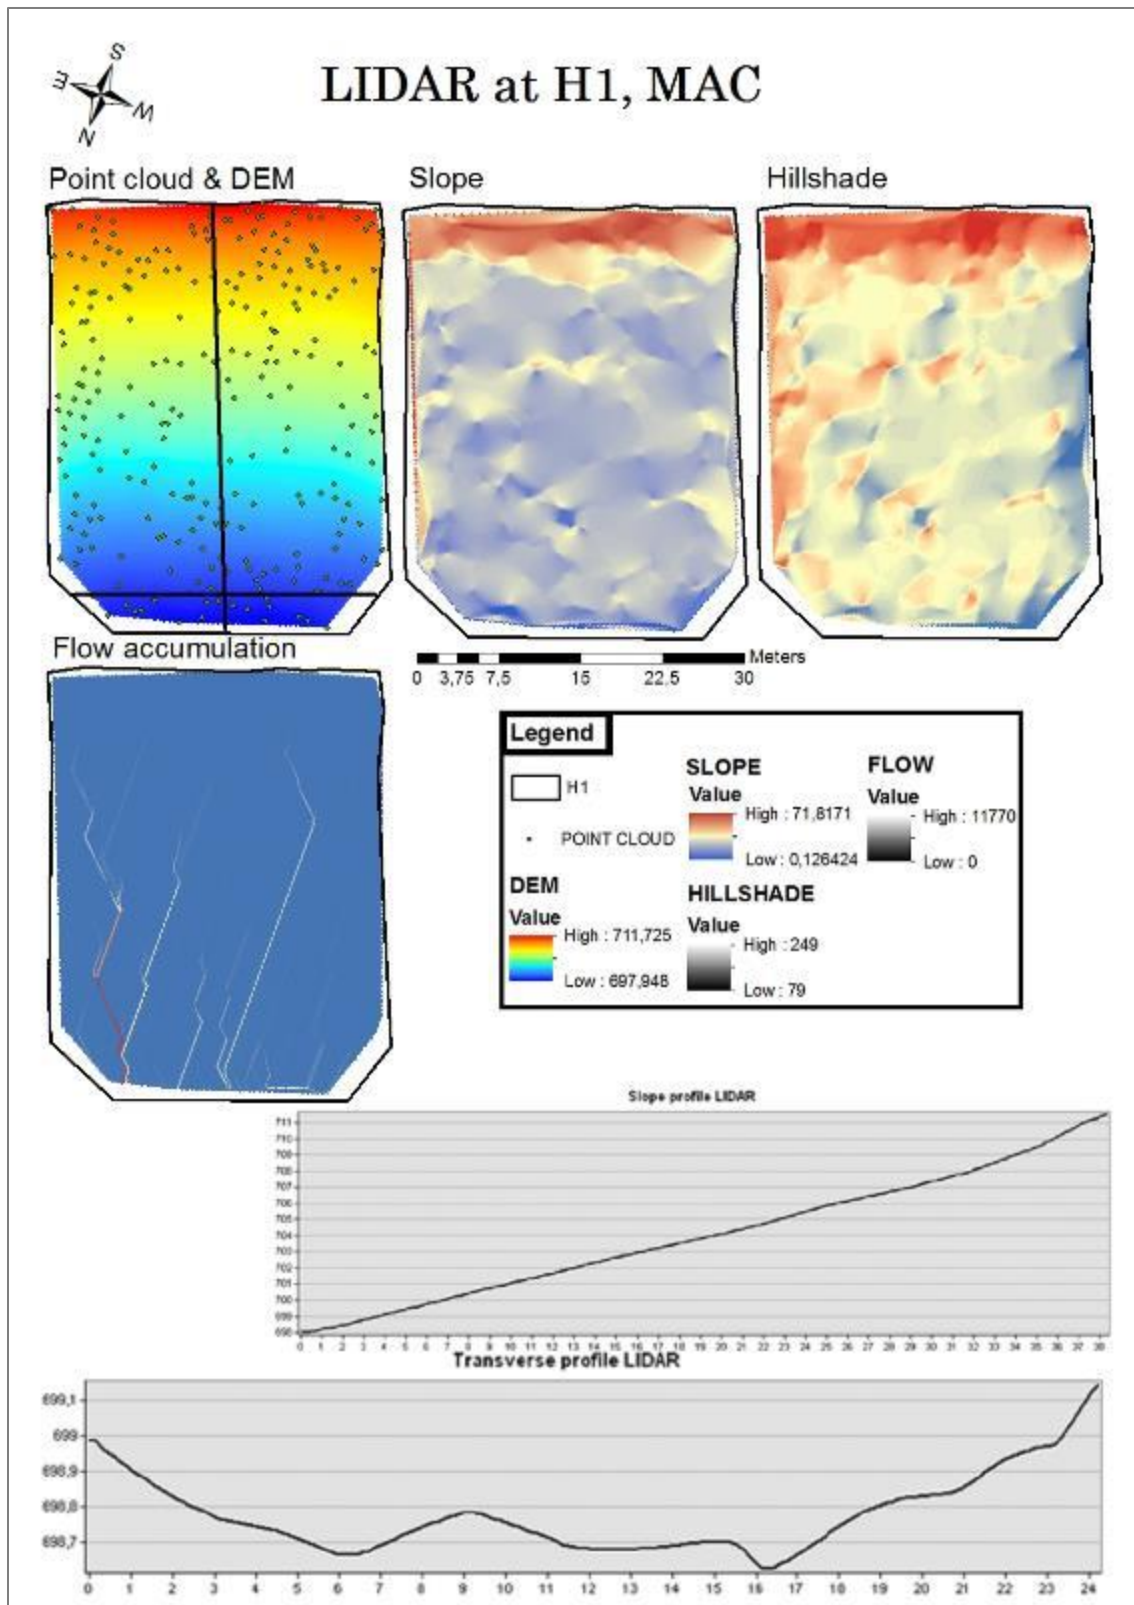
Plan 2: LIDAR surface assessment at H1 (MAC)

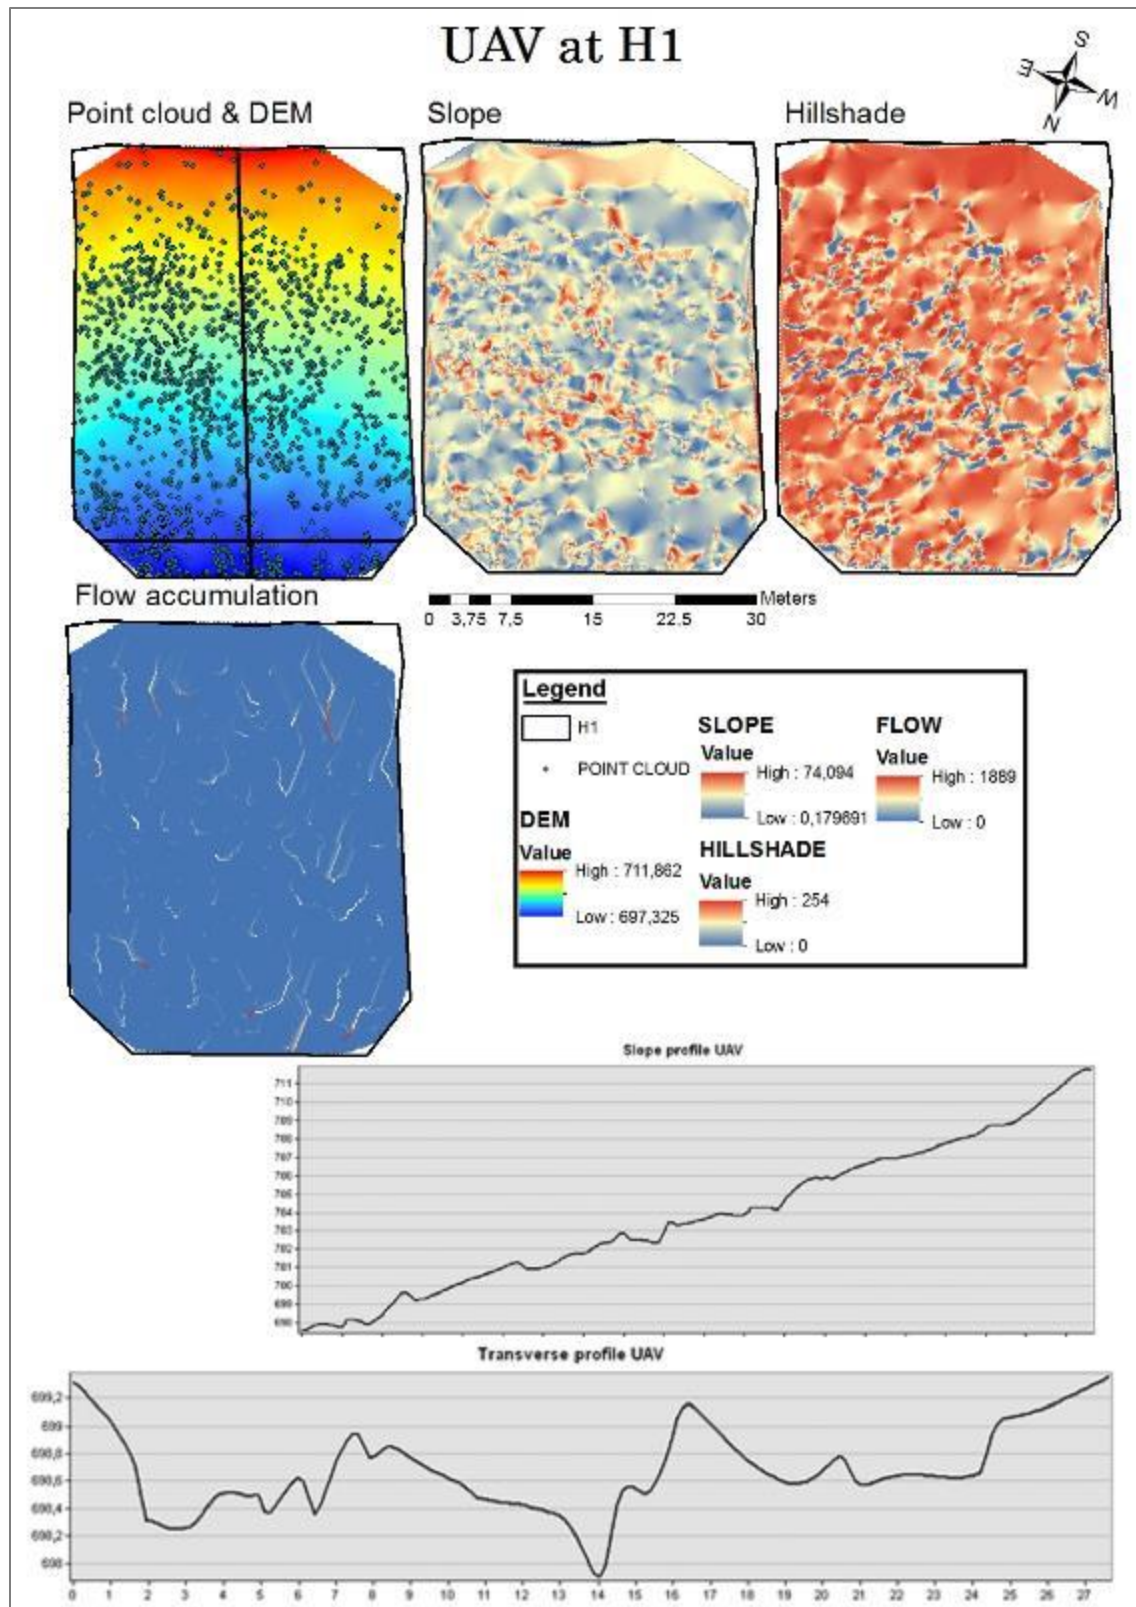
Plan 3: UAV surface assessment at H1 (MAC)

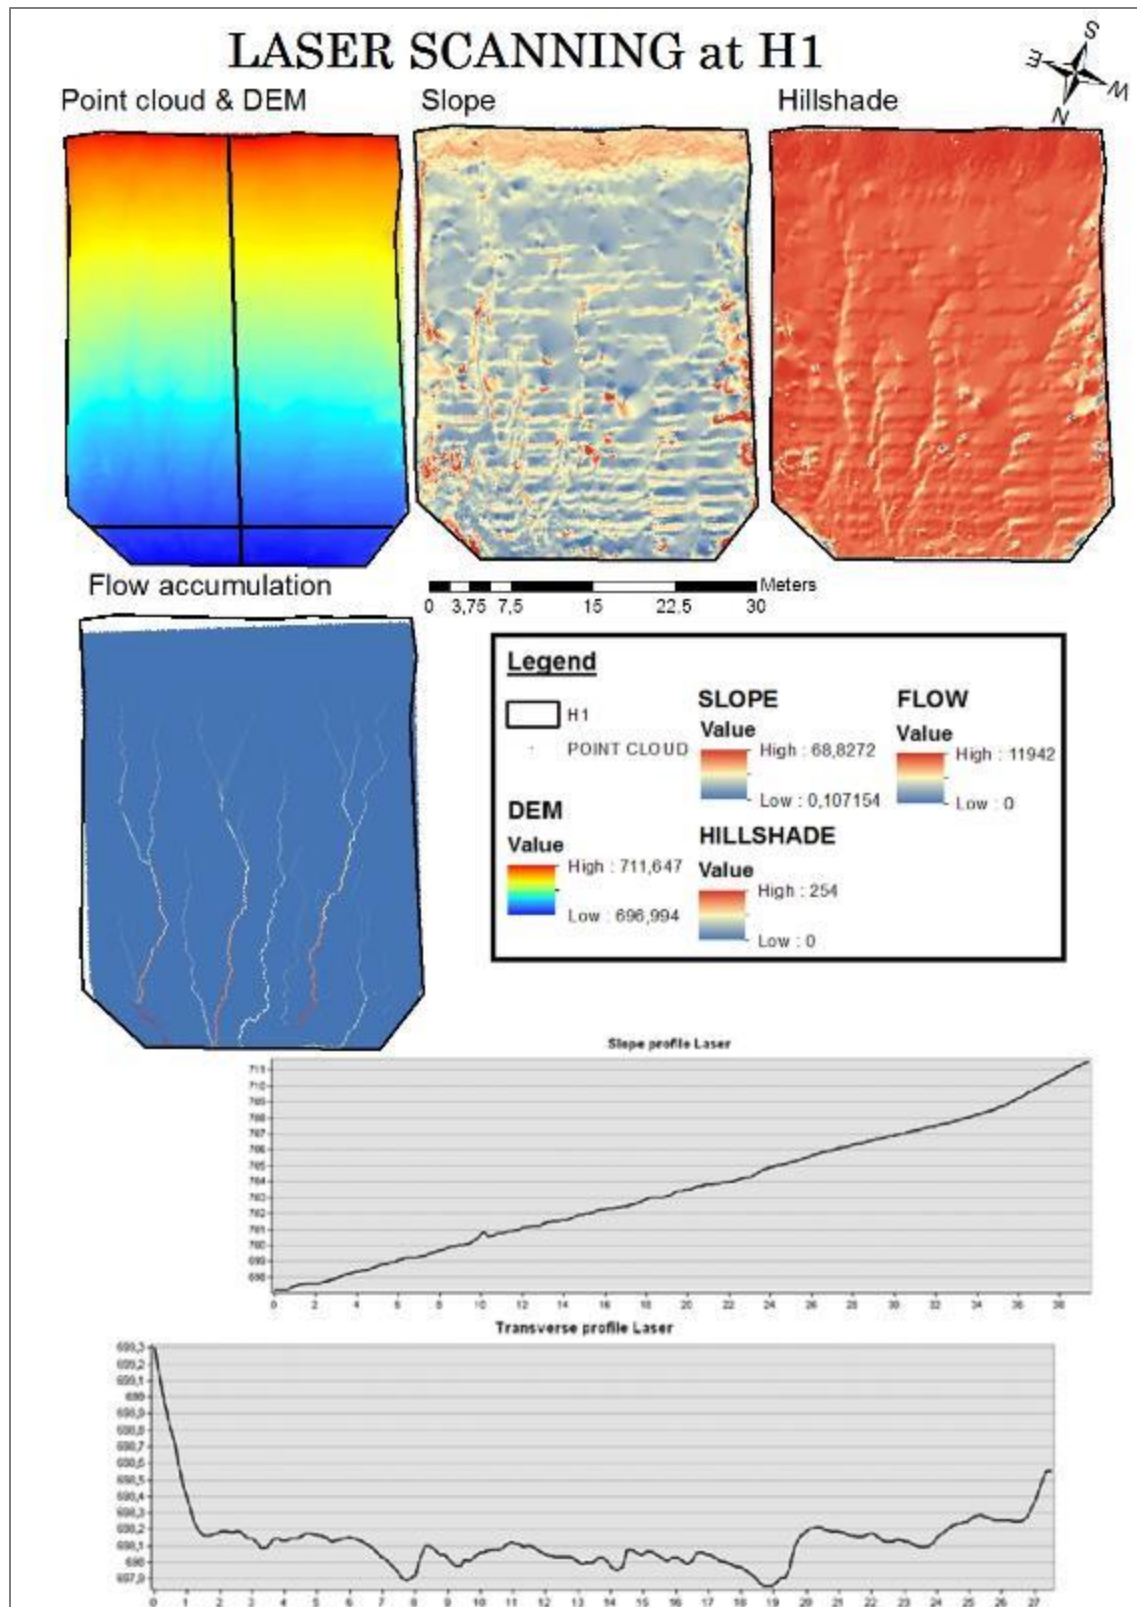
Plan 4: Laser scanning surface assessment at H1 (MAC)

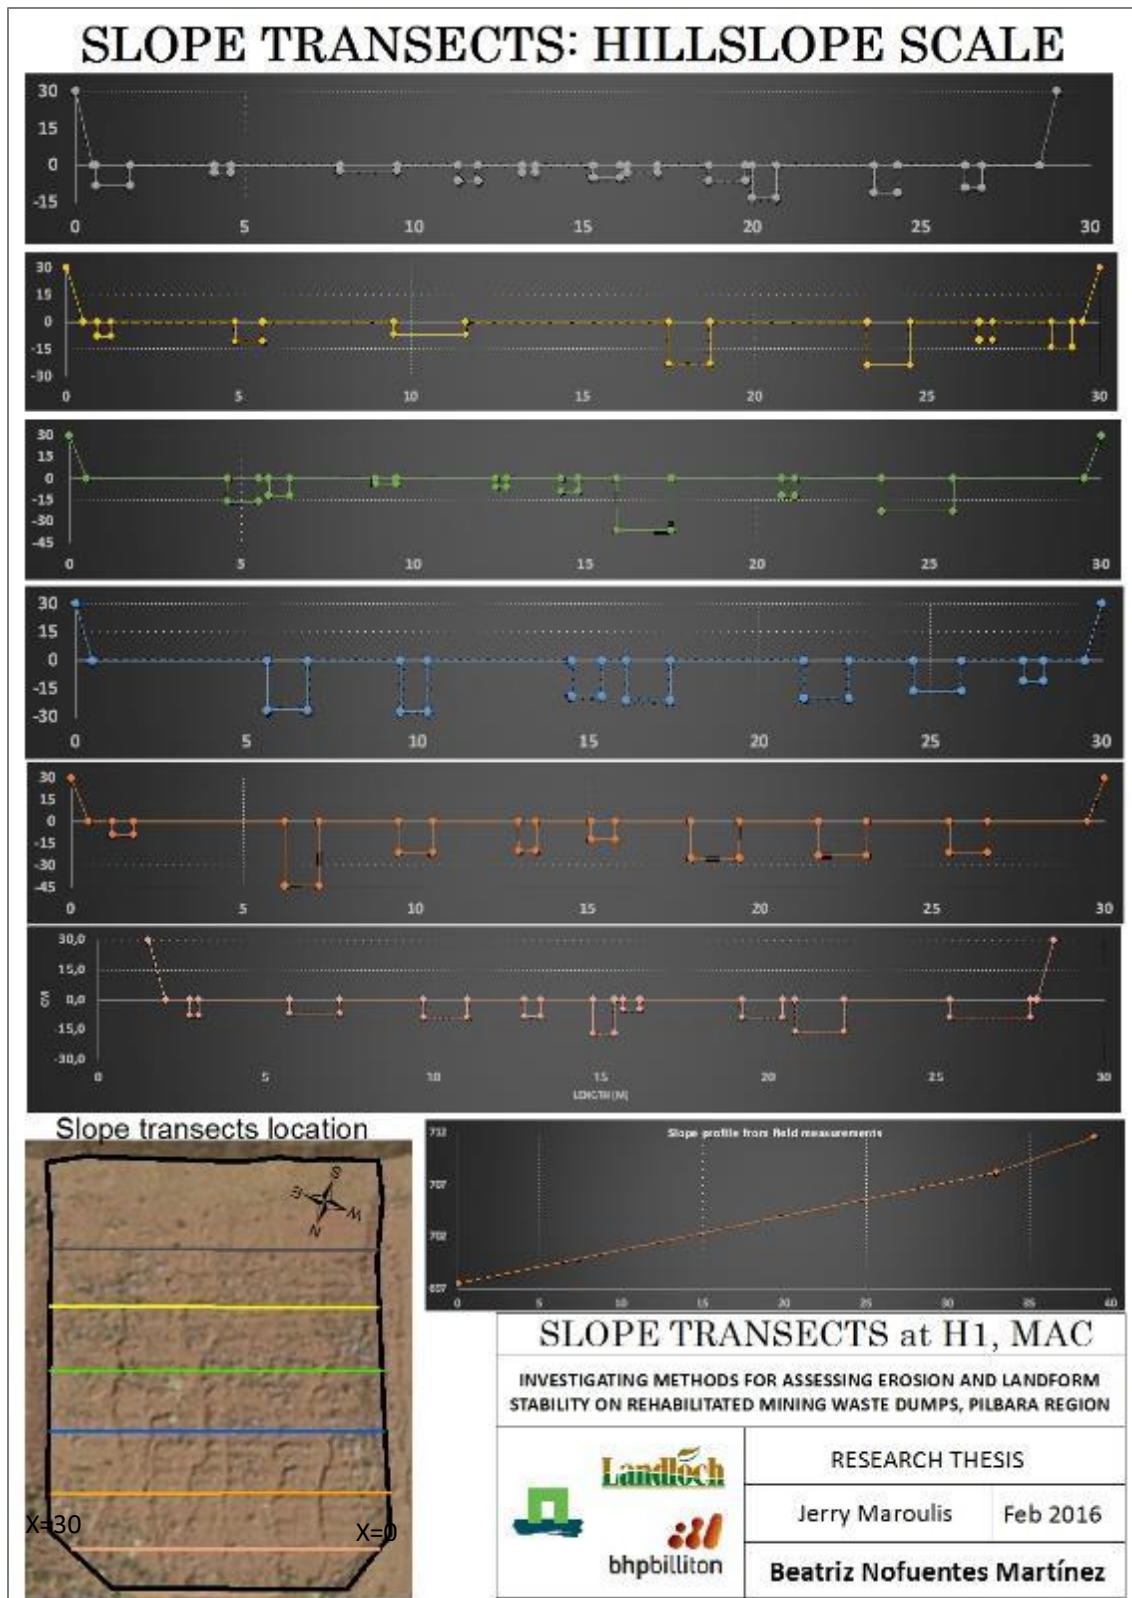
Plan 5: Cross sections from slope transect data at H1 (MAC)

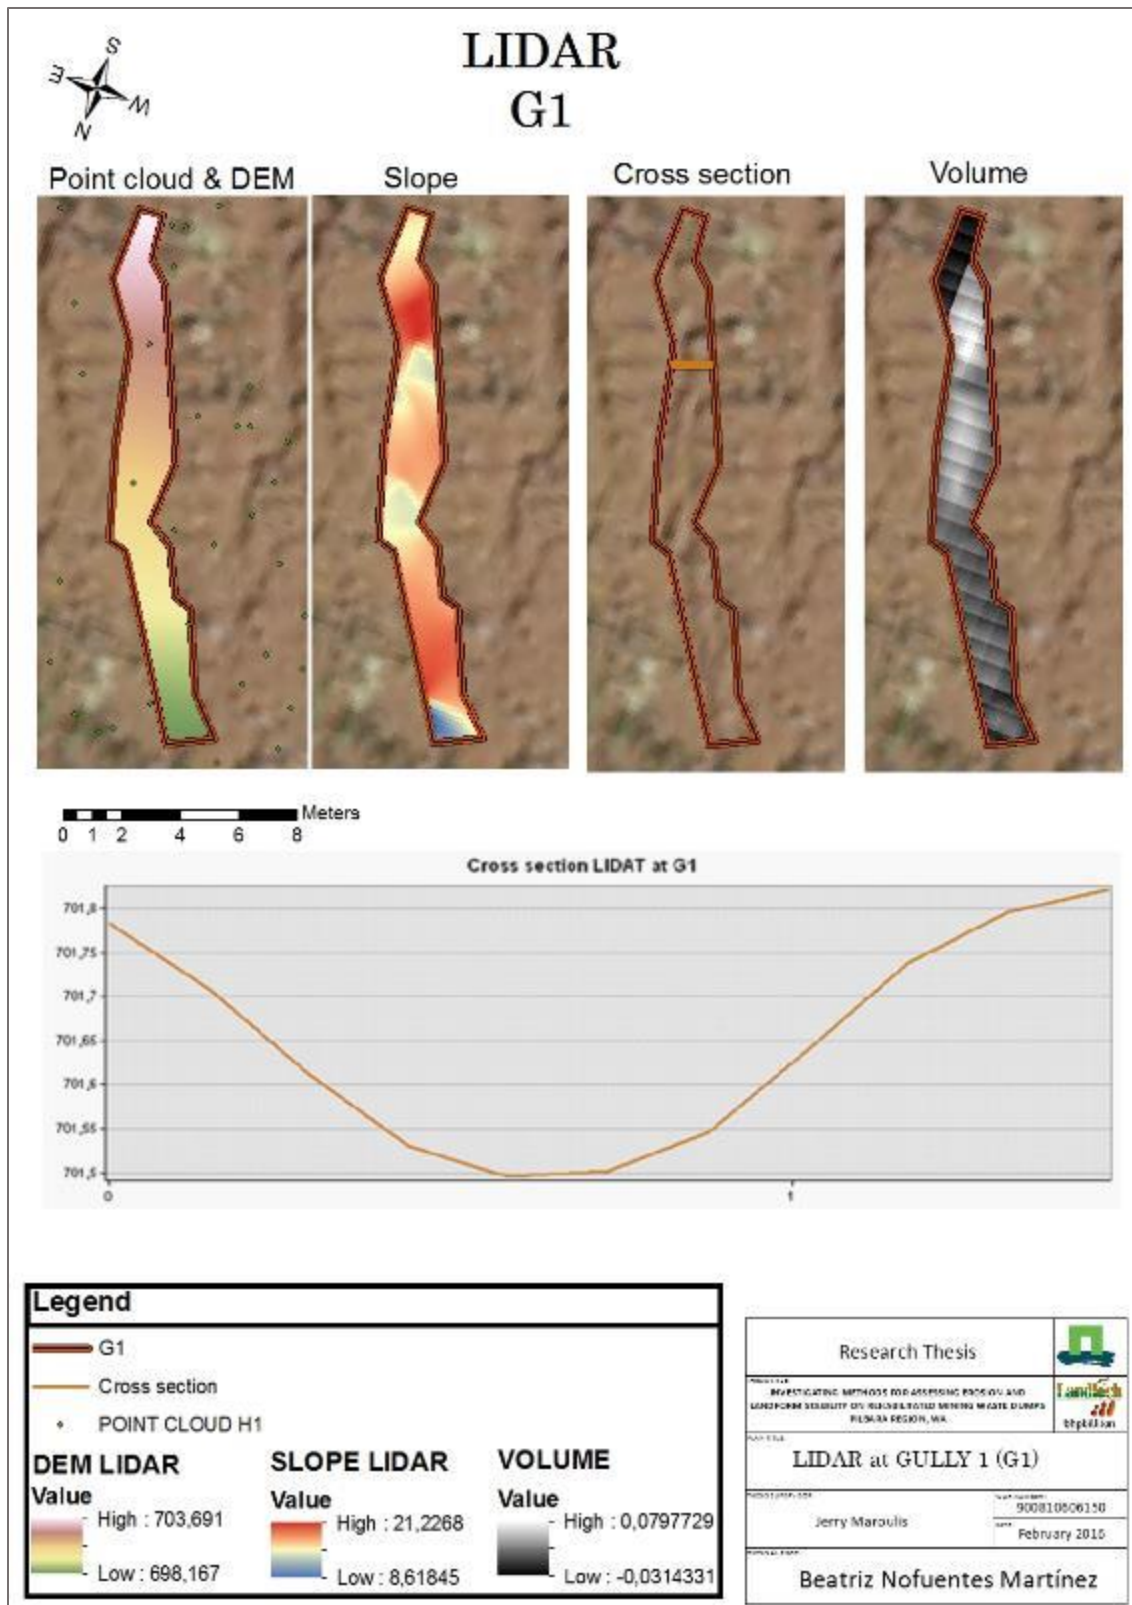
Plan 7: LIDAR surface assessment at G1 (MAC)

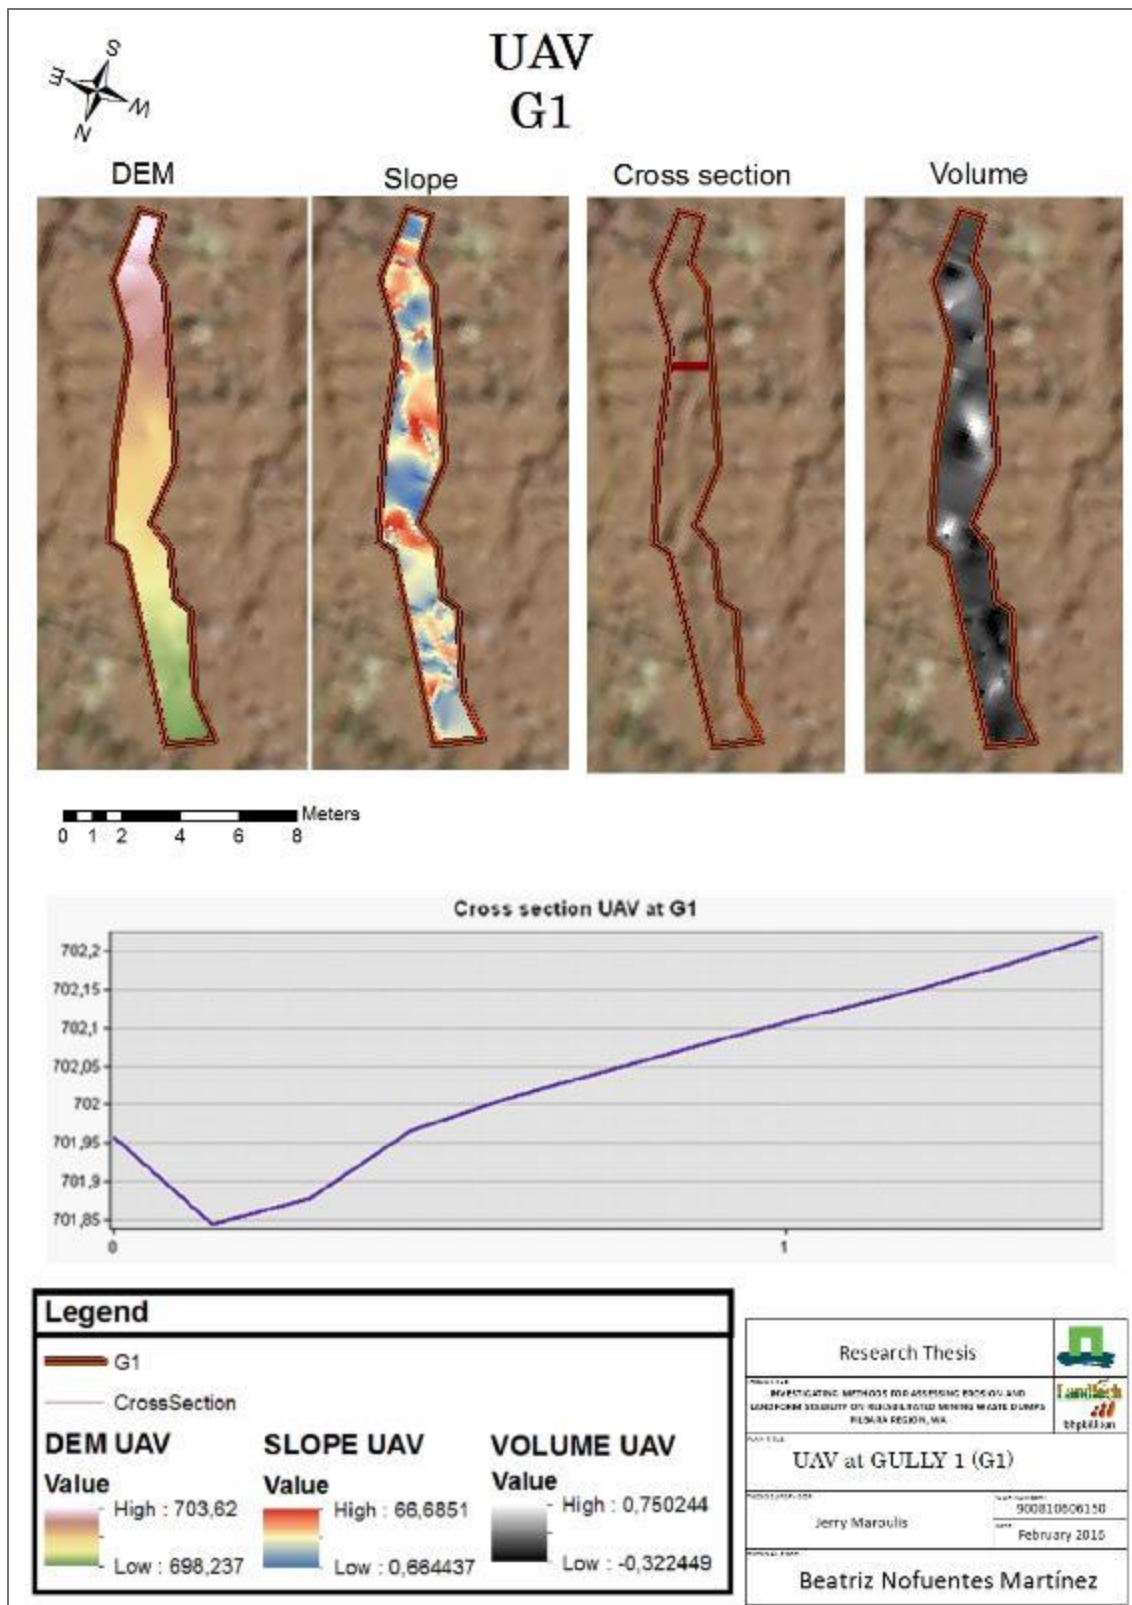
Plan 8: UAV surface assessment at G1 (MAC)

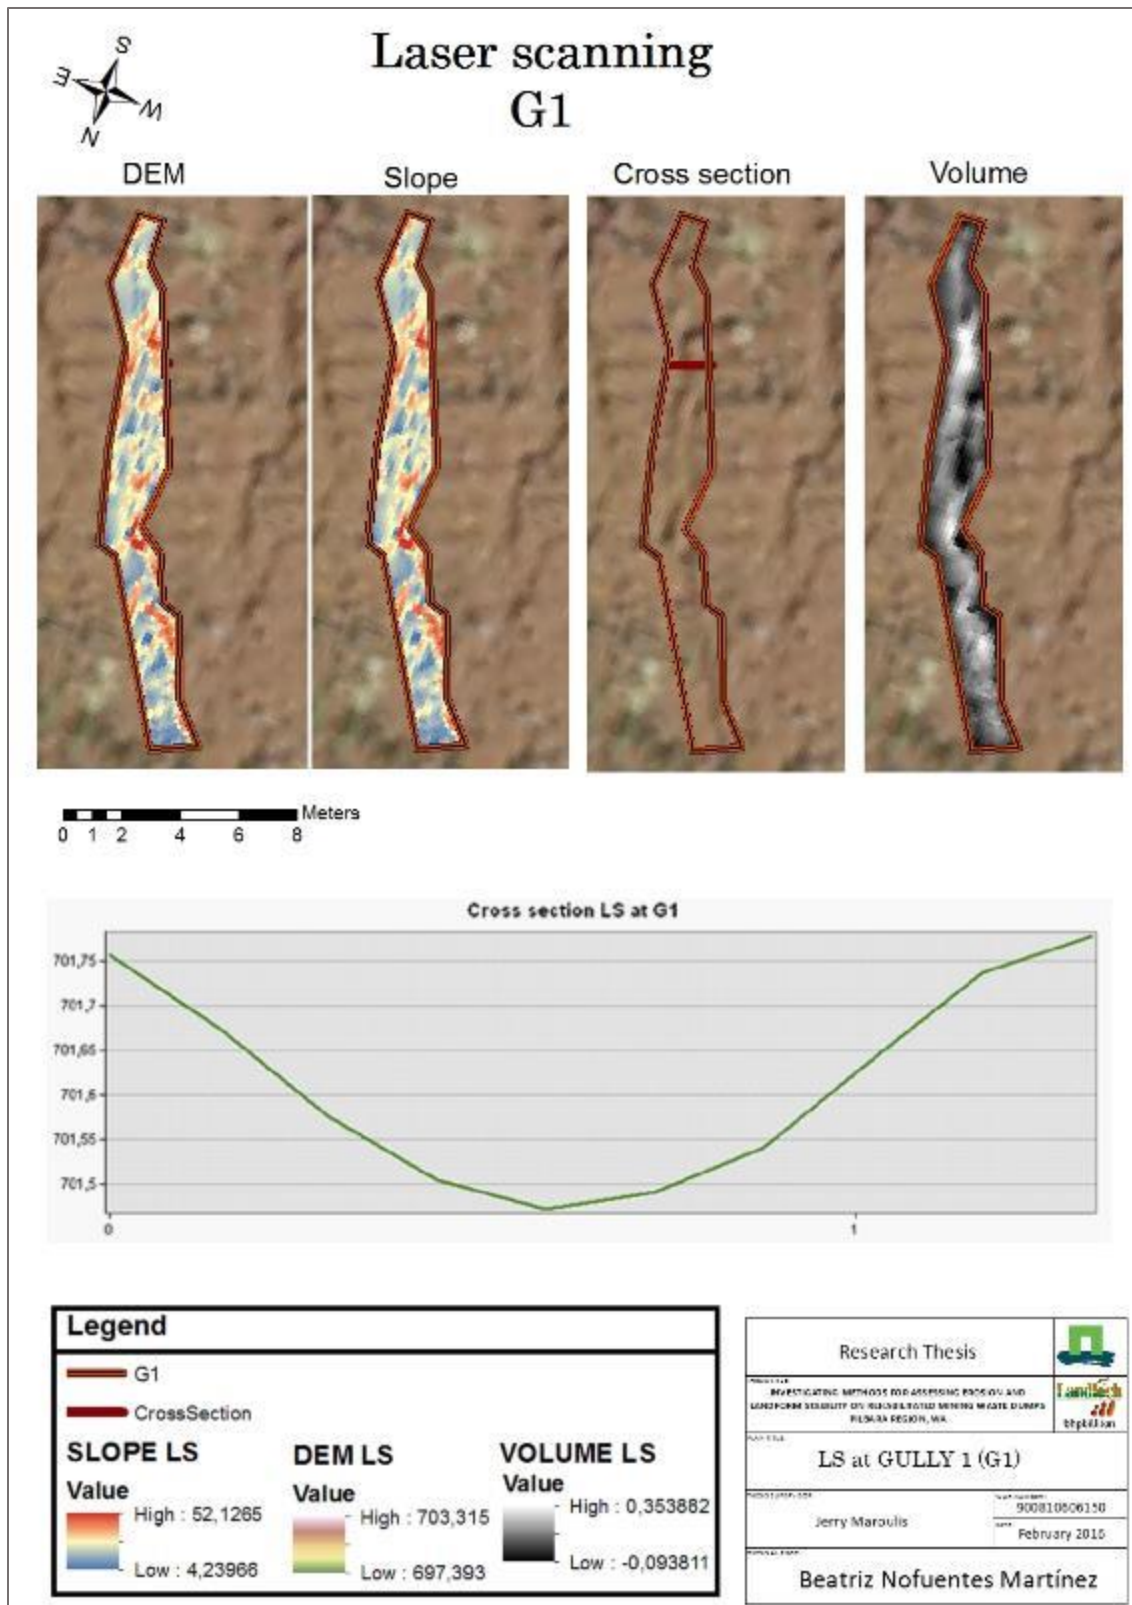
Plan 9: Laser scanning surface assessment at G1 (MAC)

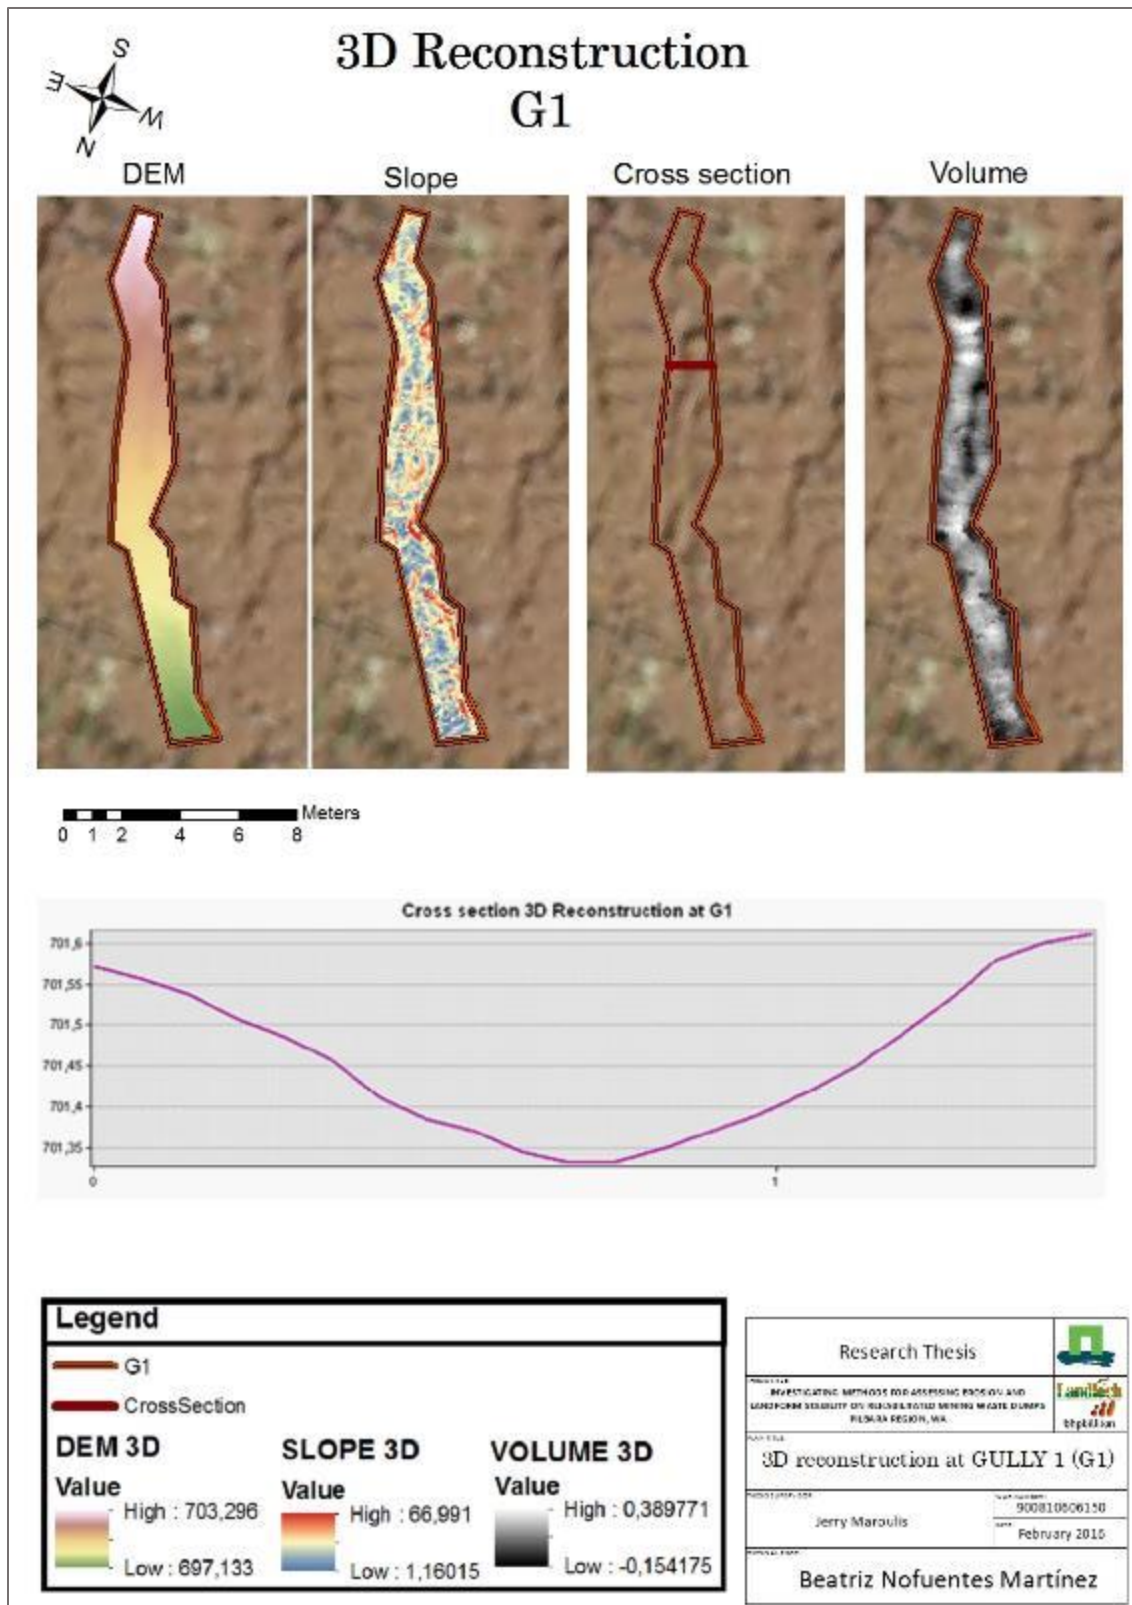
Plan 10: 3D reconstruction surface assessment at G1 (MAC)

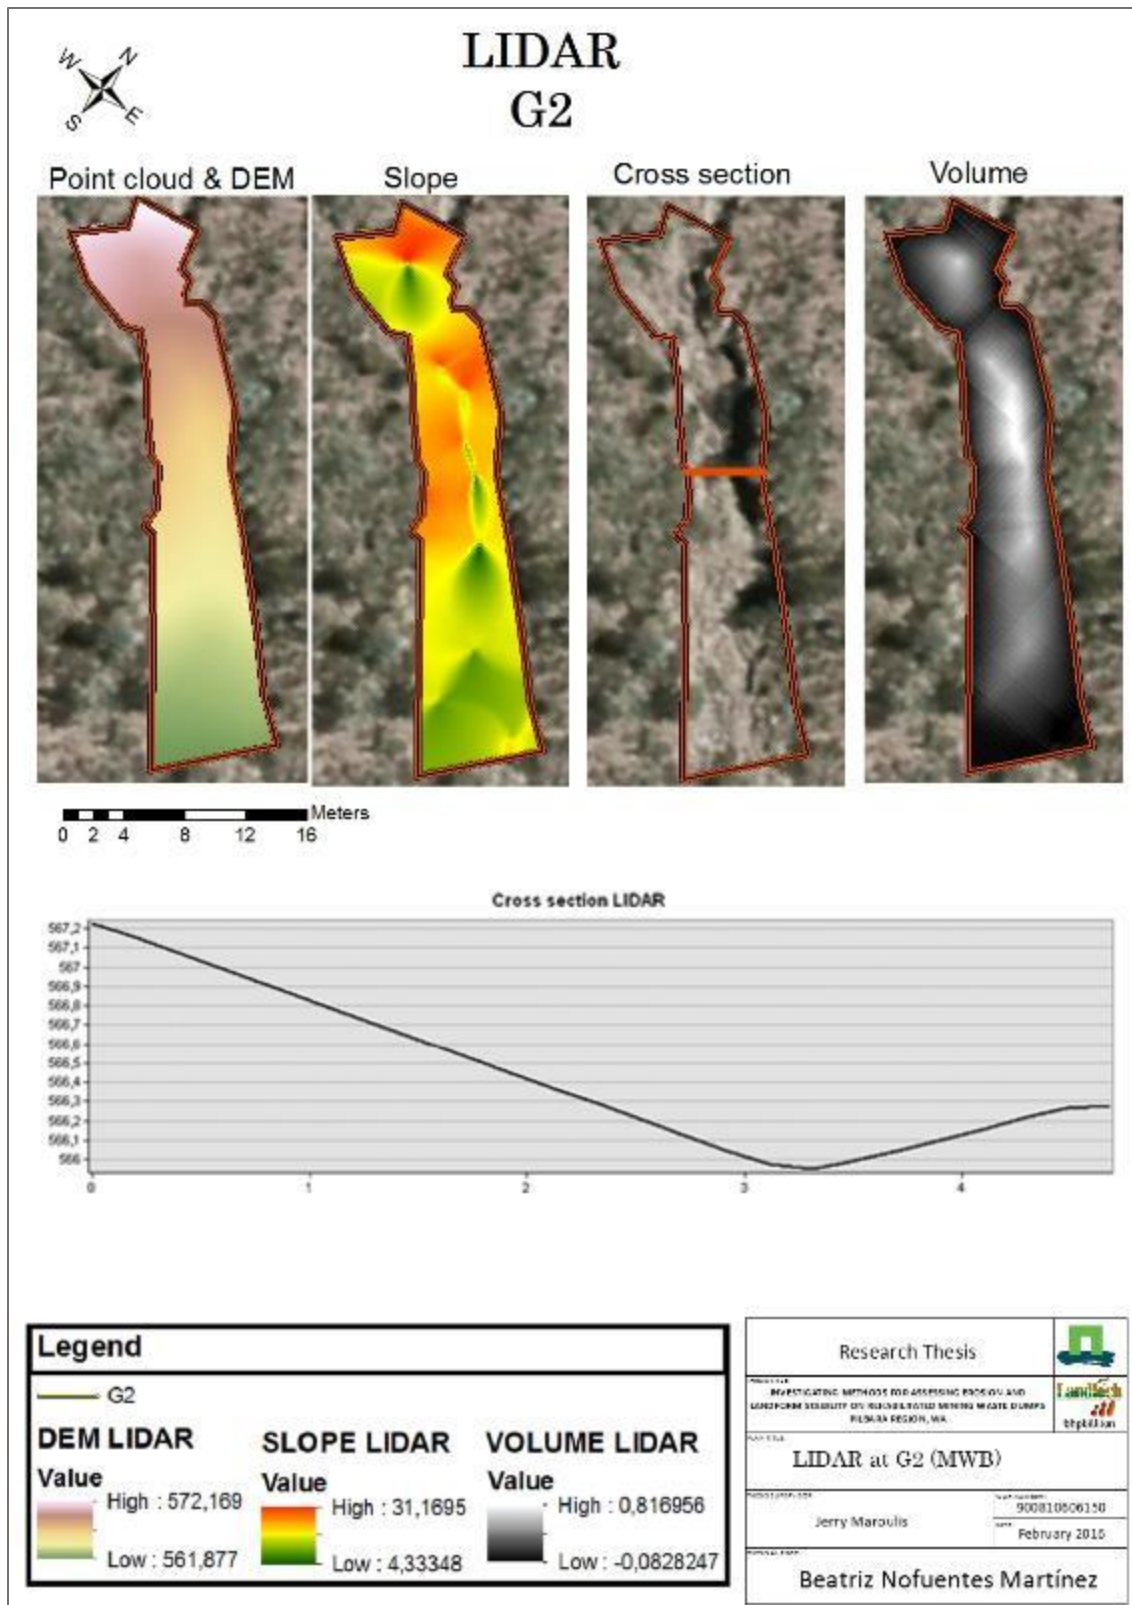
Plan 13: LIDAR surface assessment at G2 (MWB)

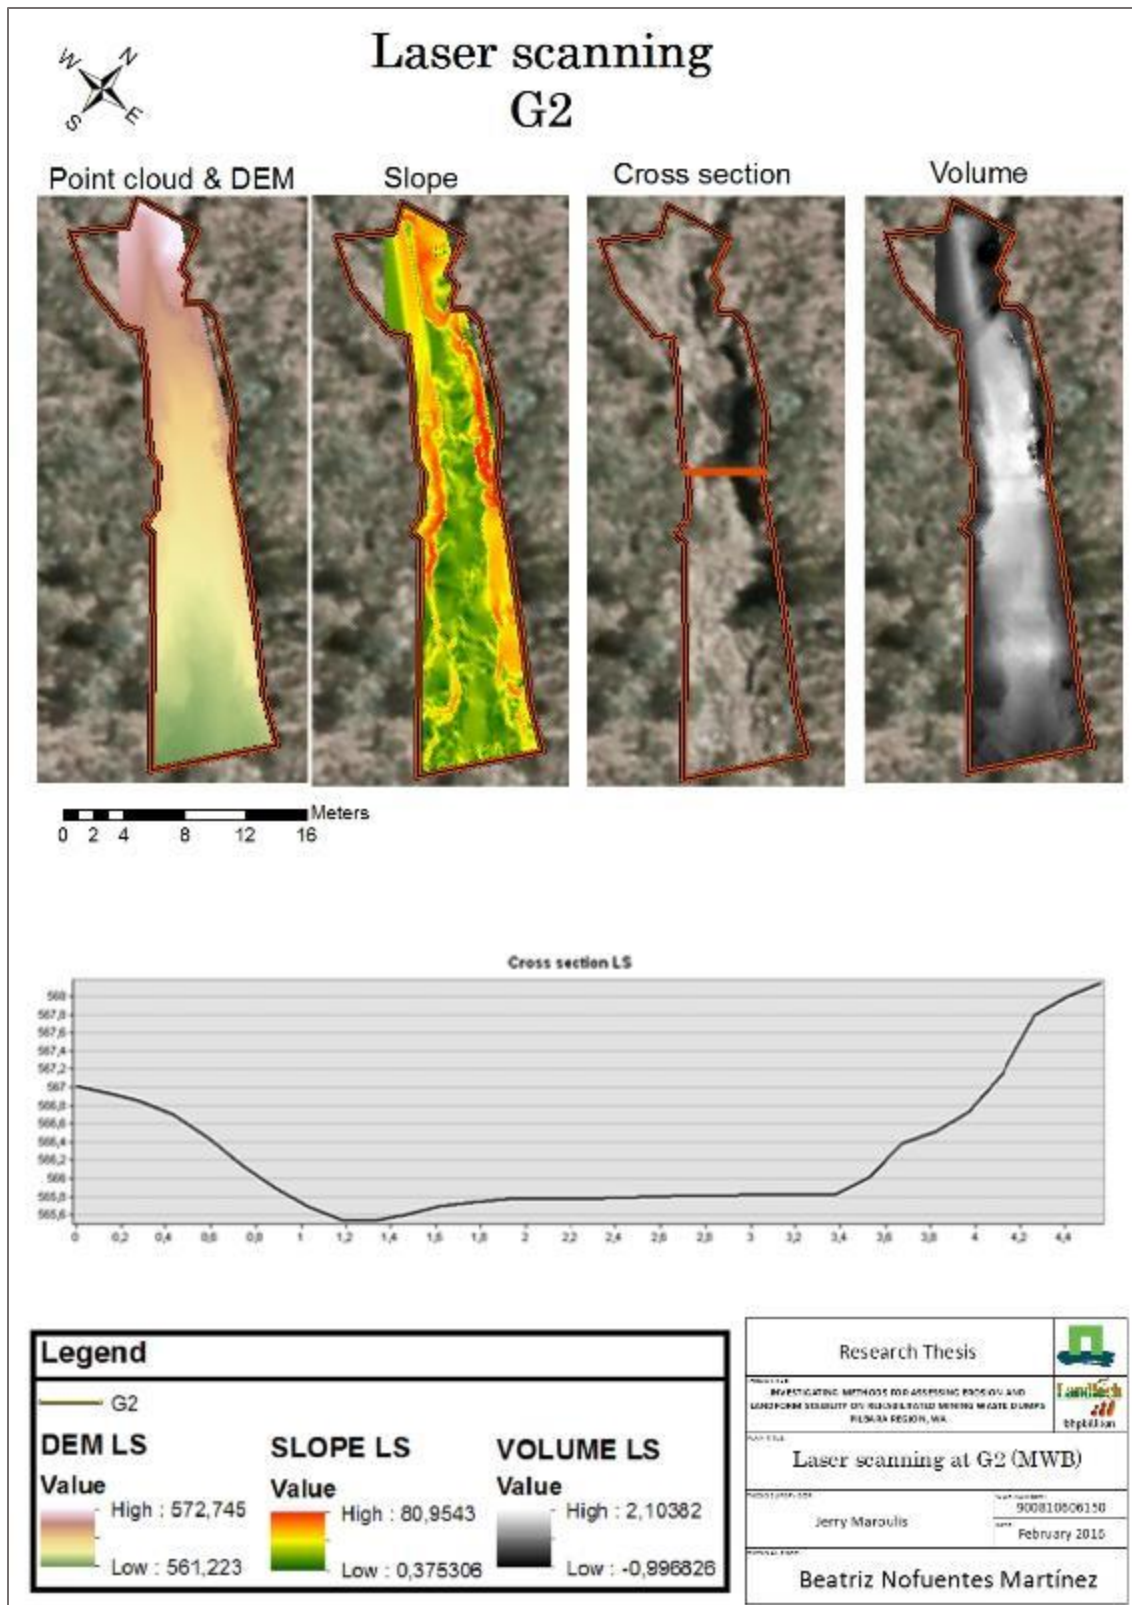
Plan 14: Laser scanning surface assessment at G2 (MWB)

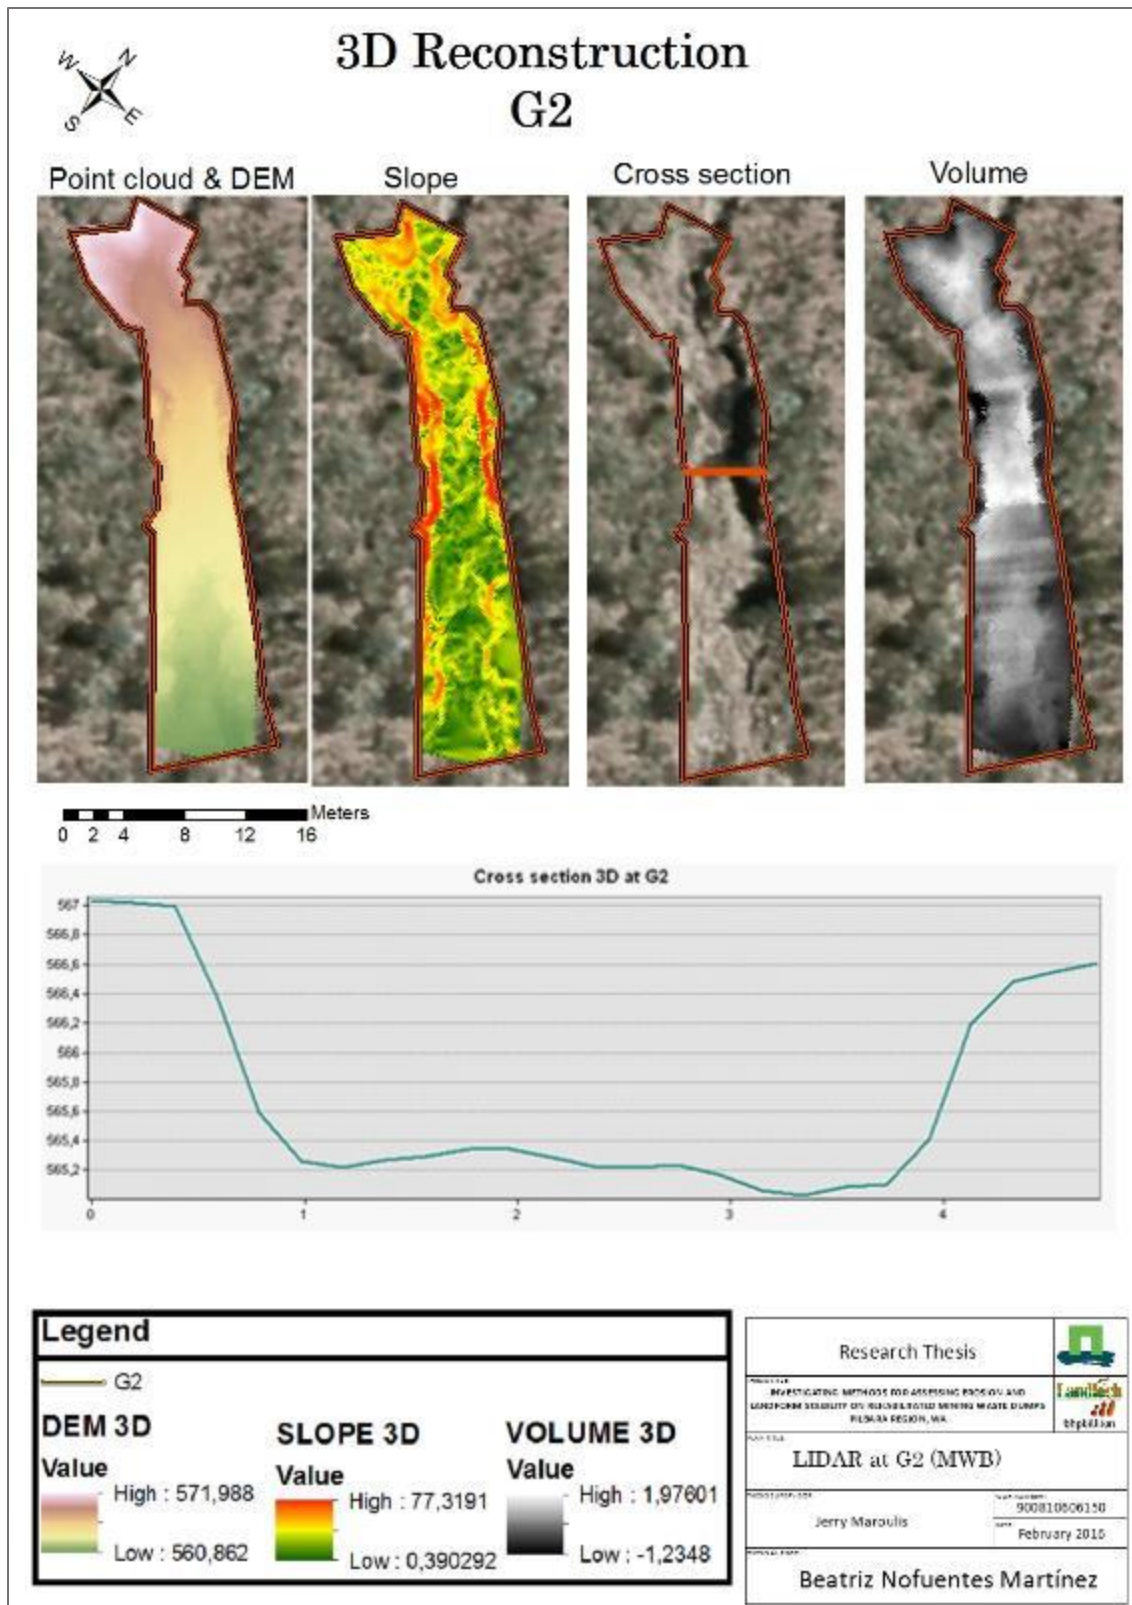
Plan 15: 3D Reconstruction surface assessment at G2 (MWB)

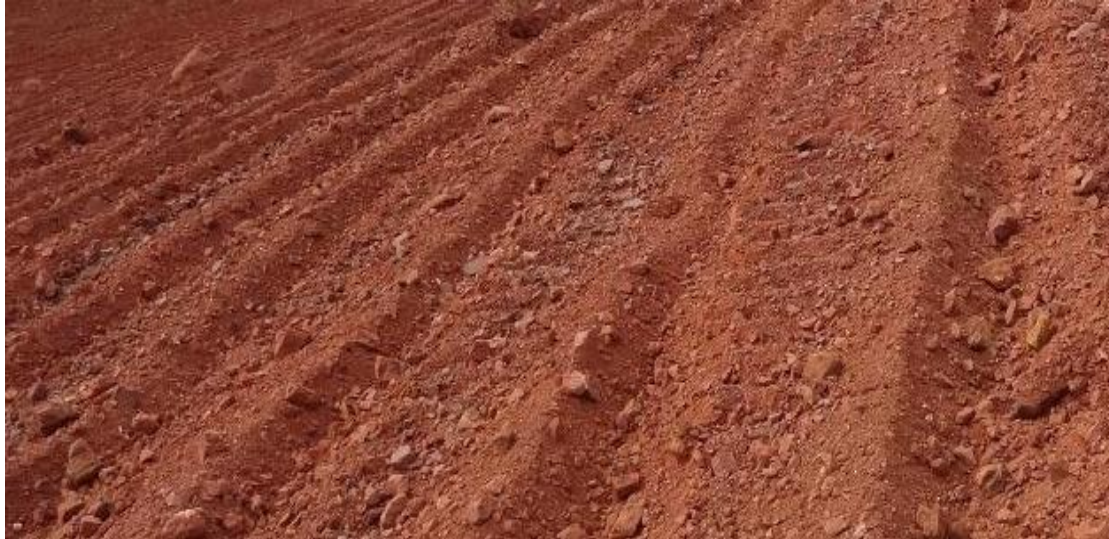
Picture 3: Rip lines implementation after waste dumps rehabilitation at MWB
