Investigating methods for assessing erosion and landform stability on rehabilitated mining waste dumps in the Pilbara region, Western Australia

Analysing the potential of remote sensing and
ground-based methods for erosion assessment with
GIS and modelling at the hillslope and gully scale

MSc thesis by Beatriz Nofuentes Martínez

Master thesis Soil Physics and Land Management Group
submitted in partial fulfillment of the degree of Master of
Science in International Land and Water Management at
Wageningen University, the Netherlands

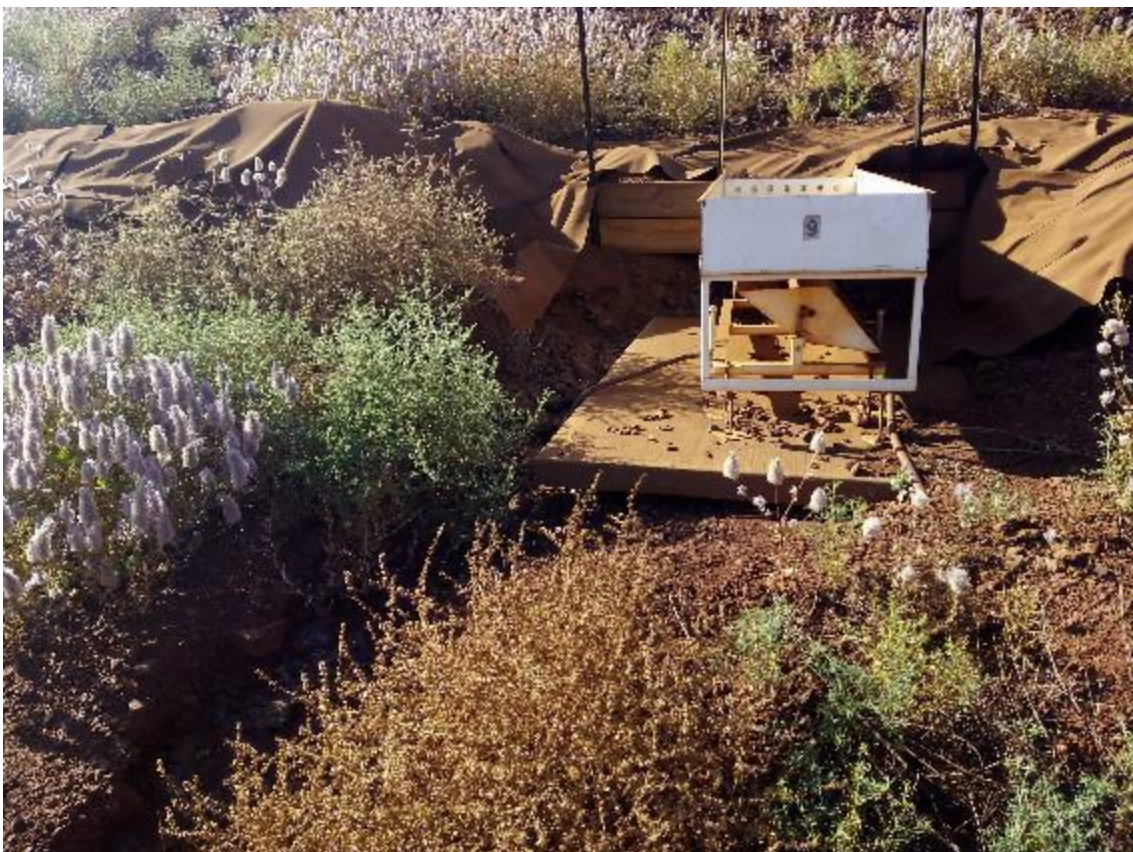
Picture 8: Erosion bucket at H1

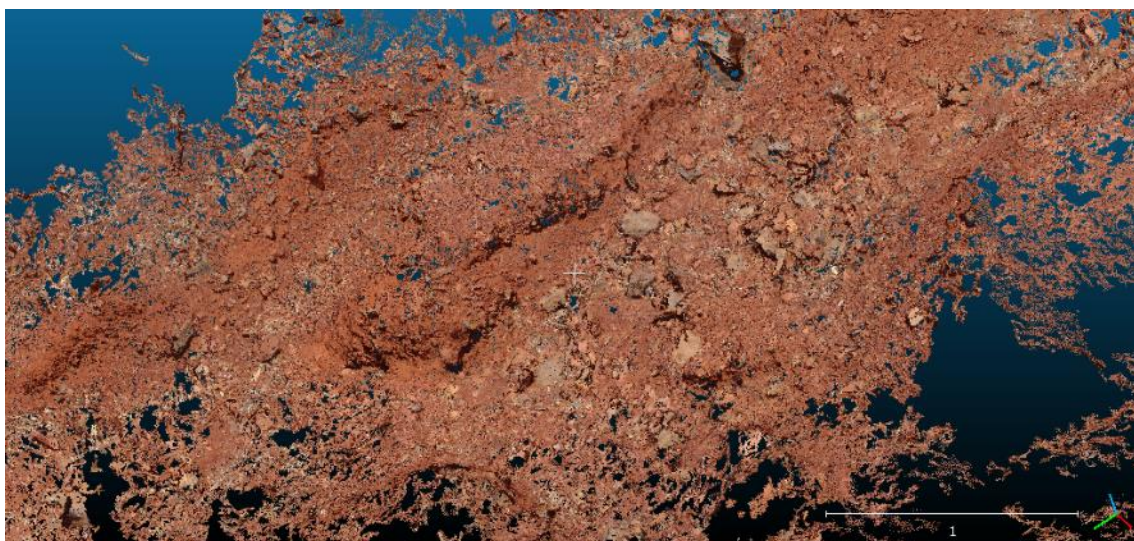
Picture 11: Precision of the point cloud generated from 3D reconstruction at G1
