River management and its morphological consequences

Influence of river management on river morphology of the Overijsselse Vecht
between AD 1750-1900

Master Thesis

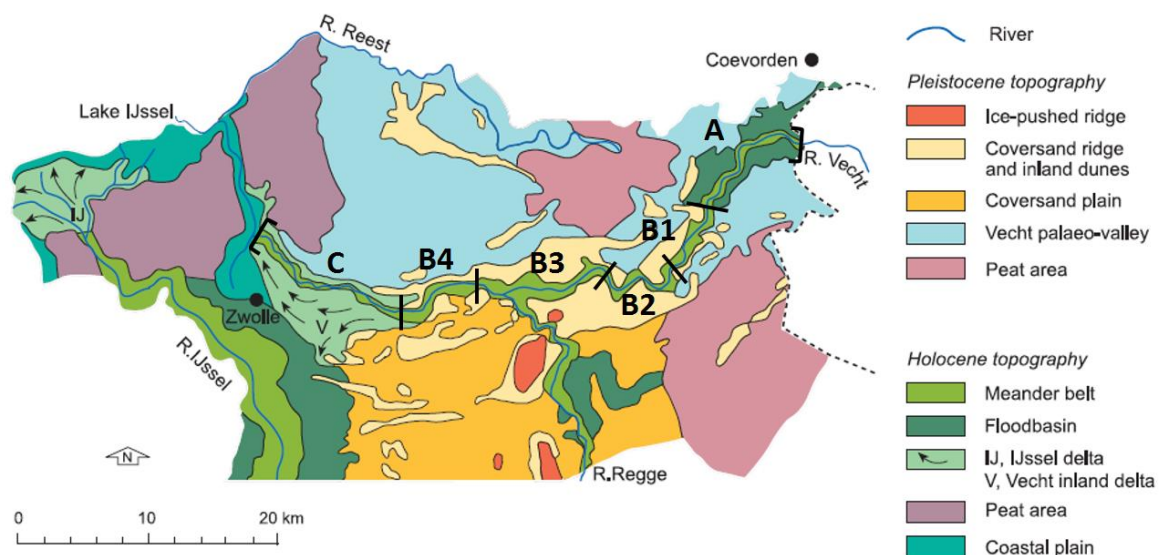
Figure 2.2 Geomorphological setting of Overijsselse Vecht [26] with sections based on geomorphology (Source: [3])

Wolfert et al. (1996) [5], distinguished different river sections based on their geomorphological setting (figure 2.2). Three main river sections can be distinguished and section B has been divided in 4 subsections. Below the river sections with a brief description can be found and Wolfert et al provides a detailed description of these river sections.

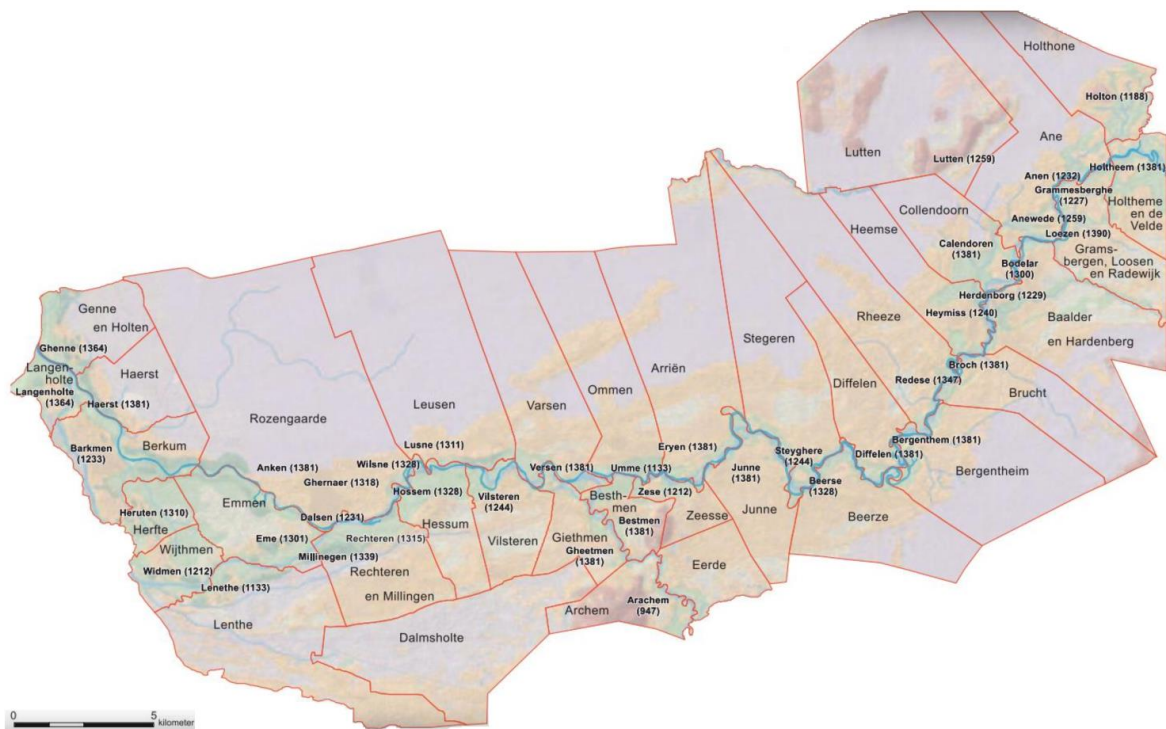
Figure 2.4 Map of the marken along the Overijsselse Vecht, including the first date of the first known record [10].

Marken are organisations where the members share the user rights of pieces of land, heather, meadows, peat, forest etc. [32] [33]. Members had rights to graze a particular amount of stock on their fields or to dig soil for fertilization and chop wood. How and when the marken exactly appeared is not clear, but the first historical mention of a marke is in 1207 [34]. In the following century we see that whole Overijssel is getting covered by marken and in 15th century marken were established in almost all provinces. Figure 2.4 gives an overview of all the marken that were established around the Overijsselse Vecht valley.

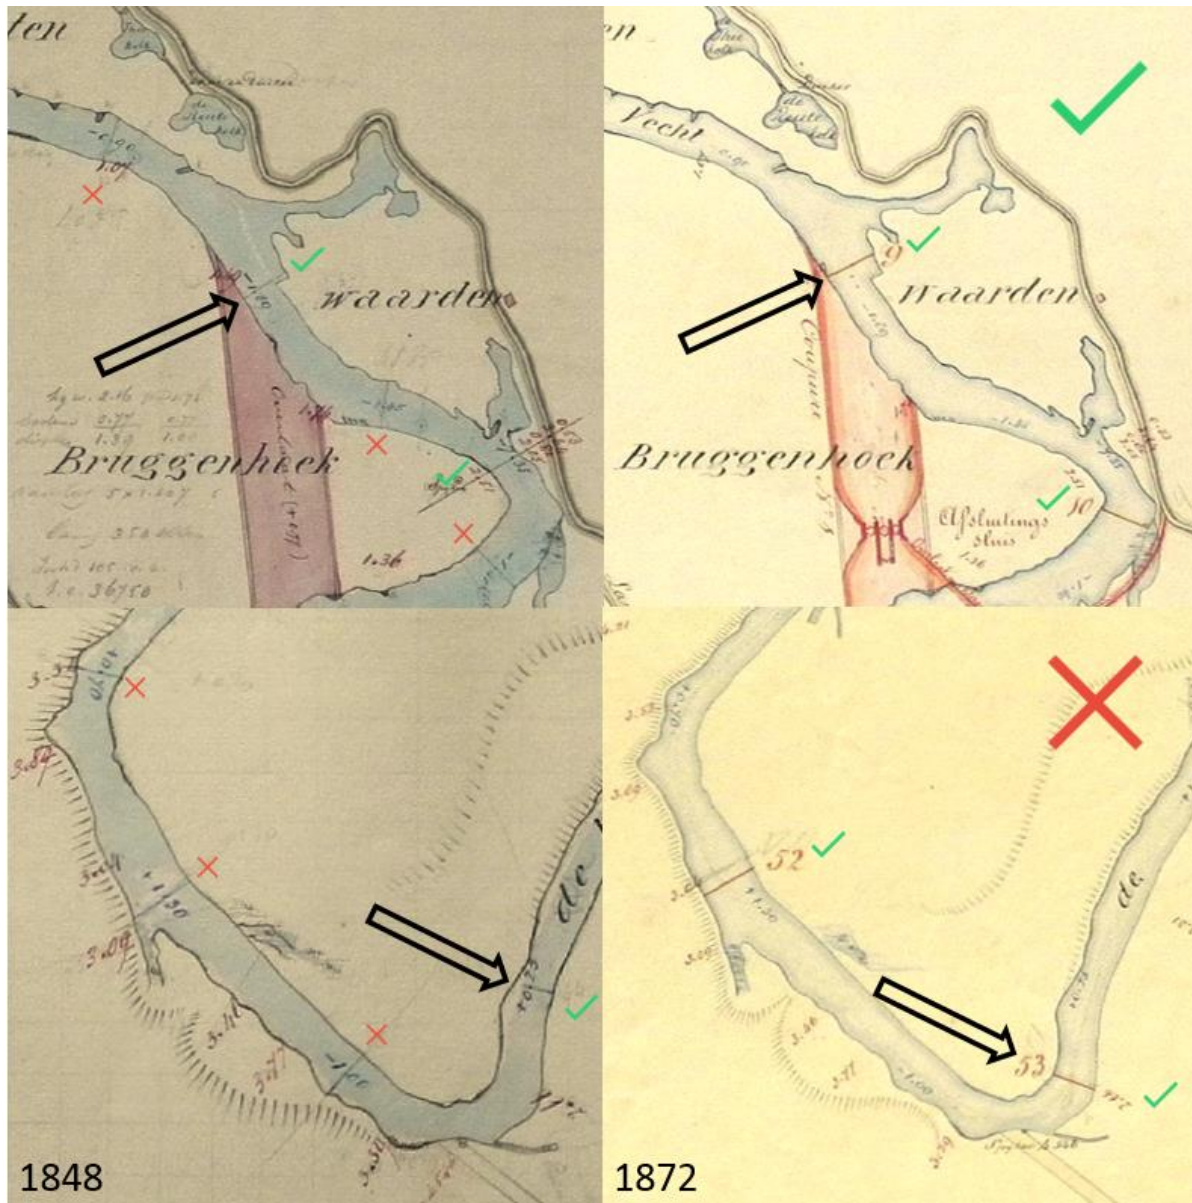
Figure 3.2 Example of when a measurement is accepted and when not. On the left side two examples of a map of 1848 is presented and on the right two examples of 1872. Check marks indicate when a measurement is available and a cross when this measurement is not available on an almost identical location. Therefore, these measurement were accepted for further analysis. Below it is visible that both measurement locations are relative close, but have different river width and are not in the same river situation. Measurement from 1848 is in straight river section and the measurement from 1872 in a river bend and are therefore not accepted.

Before data was collected, suitability of the measurements were checked in order to execute a proper comparison. Suitability of the measurement locations were determined by multiple aspects: the measurement location from 1848 and 1872 should be on a relative same location, both the measurement locations should be in the same river situation (straight or in the river bend) and they should have a comparable width. Figure 3.2 shows an example when a measurement is accepted and when not.

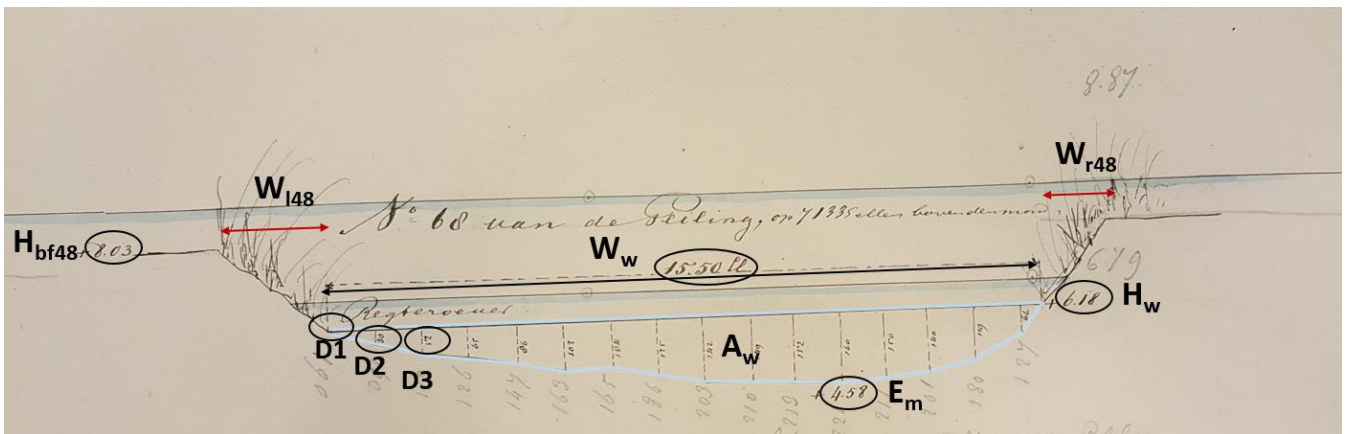
Figure 3.3 Example of a cross-profile of 1848 (N68). Within the profile the available data has been marked in black circles. The red lines present the measured width on the left and right side.

Data was collected from the chosen measurement locations and recorded in an excel file. Example of how data is presented on the cross profiles is visible in figure 3.3. H_w is the height of the at that moment water line, A_w is the cross-sectional area of the river channel based on the water line height, E_m is the lowest river bed elevation of the river channel, D1, D2 etc are depth measurements, H_{bf} is the bankfull height and W_w is the width of the waterline. Unfortunately, in most profiles, the total width, total area and the average depth of the bankfull river channel are not known. Because scales are known, a ruler was accepted to be used to measure the missing data. In figure 3.3 W_l (width left) and W_r (width right) are the measured values and are indicated with red arrows.

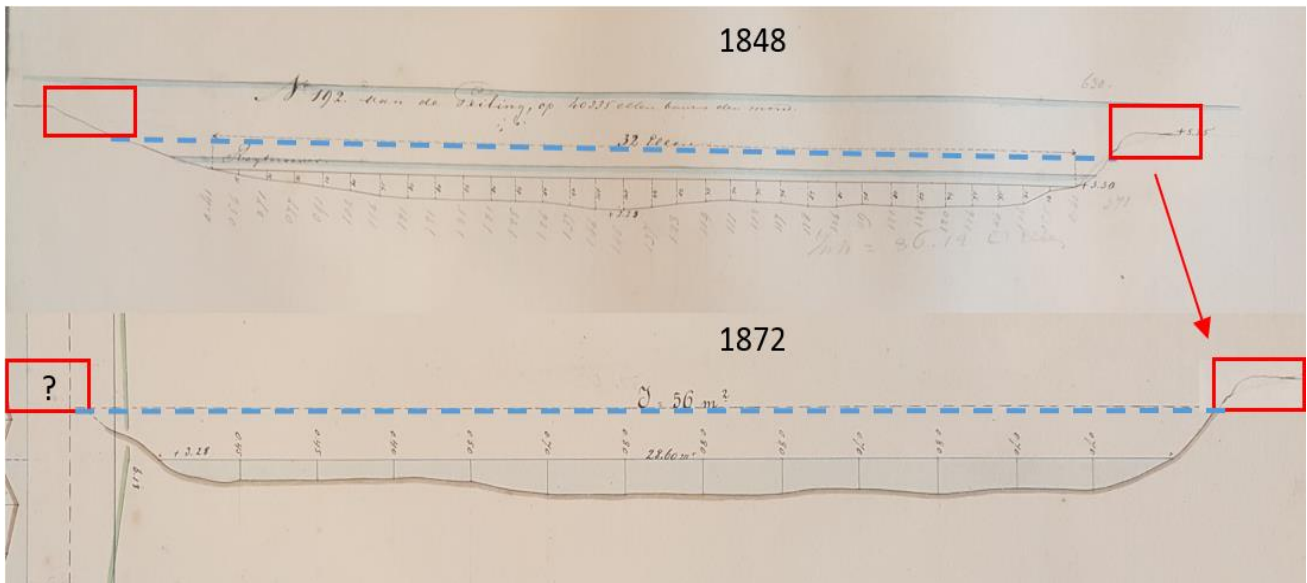
Figure 3.4 Projection of the left and right end from the 1848 cross-profile (top) on the 1872 cross-profile (bottom). On the left it is visible that in 1872 a part of the river cross-profile is missing. On the right is presented how the 1848 right end is projected on top of the 1872 cross-profile.

Lastly, the data presented by both different years was not uniform. Cross-profiles from 1872 did not show the whole cross-profile of the river, but showed it until a certain extent. This means that the bankfull height and the left and right end of the river channel of 1872 were unknown. In order to make a good comparison it was assumed that the left and right end of the river channel did not change in shape. Therefore, the left and right end of the river cross-profile of 1848 were projected on top of the 1872 cross-profile (figure 3.4).

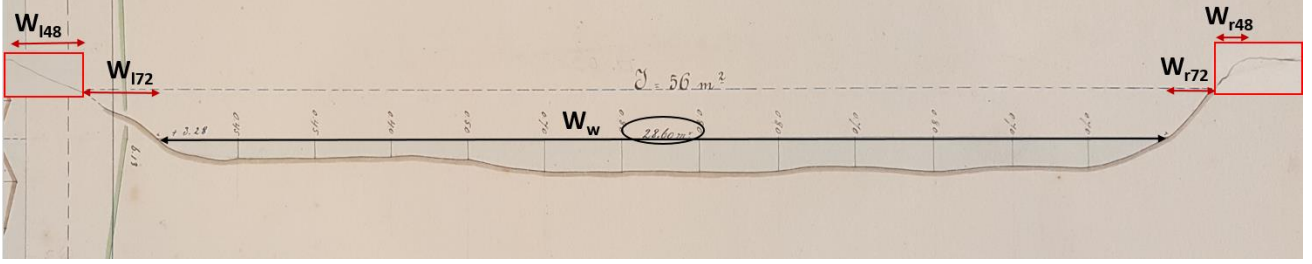
Figure 3.5 Profile of 1872 with in de middle W_w and on the left and right side the measured W_{l72} and the W_{r72} . The projected left and right side of the river cross-profile are indicated with red squares with corresponding 1848 widths (W_{l48} and W_{r48}).

Where W_{48} and W_{72} are the bank full width (m) in 1848 and 1872, W_r and W_l the measured missing width (m) on the right and left extent of the cross-profile profile (figure 3.3) and W_{r48} and W_{l48} (m) are the missing right and left side of the profile measured in the 1848 profile (figure 3.5).

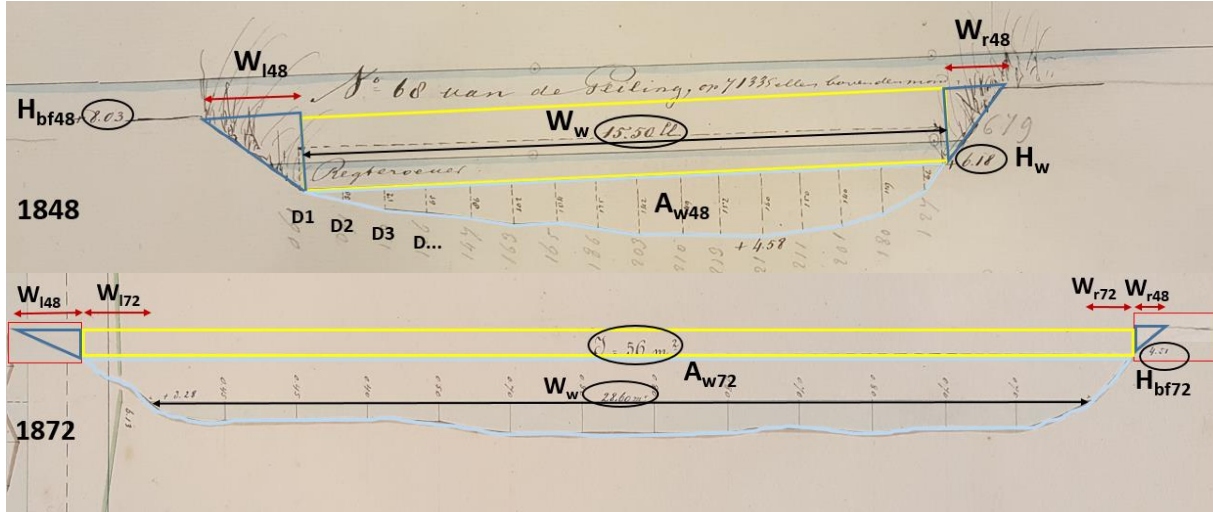
Figure 3.6 Area calculation of cross-profiles in 1848 (top) and 1872 (bottom). Light blue shape indicates the A_w , dark blue are the triangles, yellow indicates the rectangular shapes and the red squares in the 1872 cross-profile are the projected left and right end of the 1848 cross-profile.

W_w . A_{w72} is provided on the map itself. The second part of the equation is used to calculate the triangular shapes of the left and right end of the cross-profile and the third part is area calculation of the rectangular area above A_w . Calculating the A for 1848 is different from calculating the A for 1872.

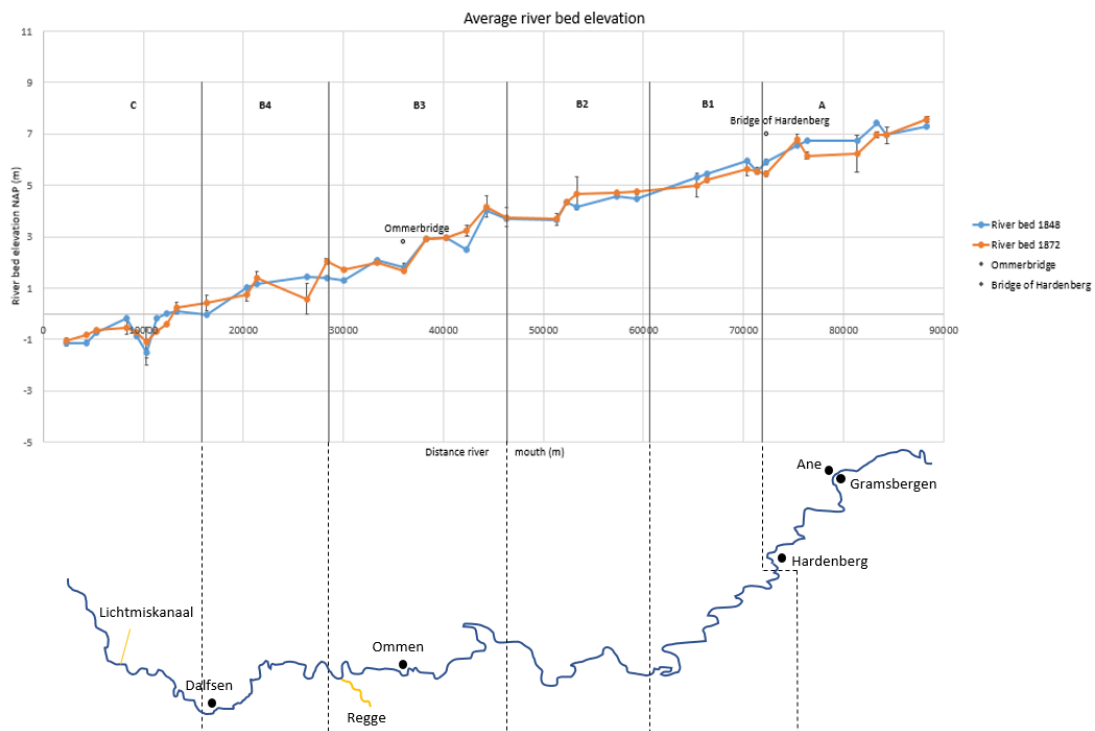
Figure 4.7 Average river bed elevation from 1848 and 1872.

In figure 4.7 the average river bed elevation (E_a) has been constructed and shows a steady decrease of river elevation from the German border. Both years have a similar slope of 0.0001. For the downstream part both slopes in 1848 and 1872 are 0.0001 and for the upstream part the slope in 1848 is 0.0001 and for 1872 0.00009. Comparing this with valley the slope, 0.00014, based on data of Staring and Stieltjes, calculated by H.P. Wolfert, we see that the channel slope is less. As an overall trend we cannot distinguish a significant change between both periods due spatial variation and the sometimes relative large error bars. Only in the very upstream part in section A there seems to be a deepening of the river channel. The average river bed elevation for the whole Overijsselse Vecht in 1848 is 3.14 ± 0.02 NAP (m) and in 1872 is 3.13 ± 0.05 NAP (m). The largest difference can be found at 26335 m from the river mouth and has a difference of 0.9 m. Only measurement Vechterweerd (1848), 20 (1872), at 10.300 m stands out with an extreme lower river bed elevation. Based on the map, this low river bed elevation might be explained by the influence of a harbour and short distance between the dikes. Narrower river channel causes larger flow velocities and therefore more erosion power and deepening.

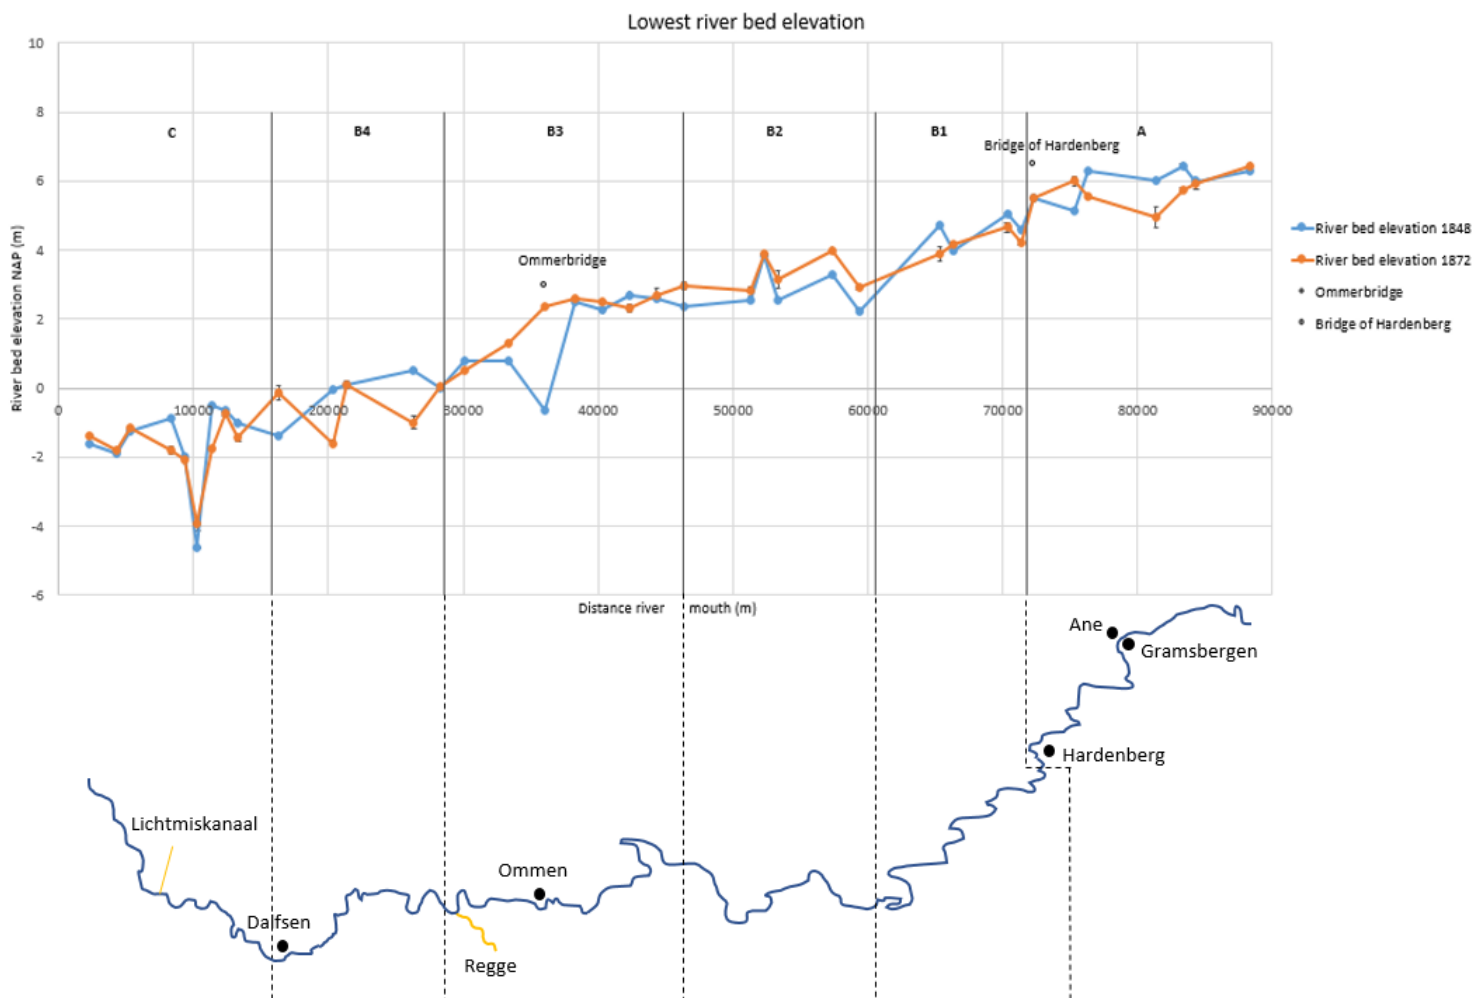
Figure 4.8 Lowest river bed elevation from 1848 and 1872.

The lowest river elevation (E_L) has been plotted in figure 4.8. As can be seen is that the tendency of the E_a is the same as the E_L , but values are now amplified and are generally deeper than the E_a . As an overall trend no distinction can be made between both periods. The same as for E_a , there seems to be a deepening in section A. in addition, in section B3, the deepest locations of the river bed seem to be elevated. Furthermore, it is visible that the Regge might has an influence and that the lowest river bed elevation makes a clear jump down. The average E_L Overijsselse Vecht in 1848 is 2.09 ± 0.00 NAP (m) and for 1872 is 2.11 ± 0.02 NAP (m). Looking at the difference between up- and downstream it is visible that the Regge might has an influence that that the lowest river bed elevation makes a clear jump down. Downstream the average E_L in 1848 is -0.80 ± 0.01 NAP (m) and in 1872 -1.05 ± 0.03 NAP (m). Upstream the average E_L in 1848 is 3.60 ± 0.01 NAP (m) and in 1872 3.76 ± 0.03 NAP (m). Based on the on average higher elevated lowest river bed elevation its seems that downstream the river has become deeper and that upstream, due to a decreased lowest river bed elevation, the river has become shallower

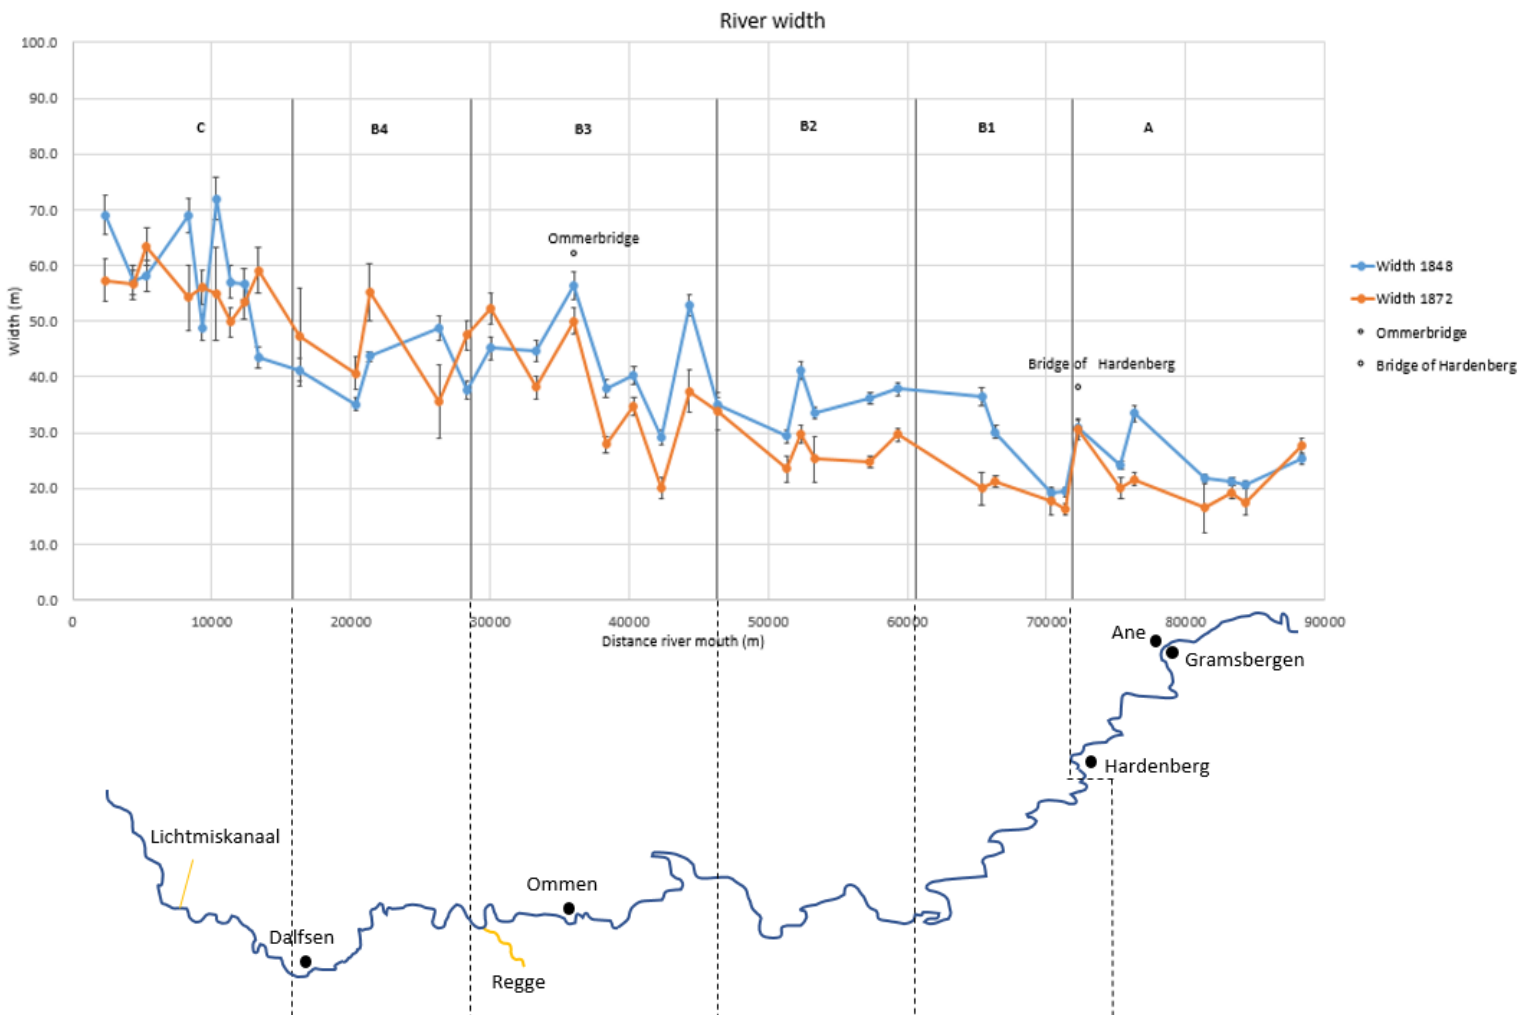
Figure 4.9 Reconstructed width from 1848 and 1872.

The reconstructed width-profiles show a clear widening towards the river mouth (figure 4.9). The differences between both years are well visible, but errors are large. This results in an average width of 39.59 ± 0.31 m in 1848 and an average width of 35.27 ± 0.57 m in 1872. Especially between the subdivision of the down and upstream Overijsselse Vecht differences are clear. Upstream the Overijsselse Vecht gets narrower due to the large sequence of narrowing locations. Downstream the tendency seems unclear and errors are larger. The average width upstream for 1848 is 33.63 ± 0.62 m and for 1872 is 27.07 ± 1.17 m. Variation between measurements in the same year are large. Especially from the river mouth till Dalfsen, but this might be explained by the presence of dikes which influence the natural levees. Furthermore, in T.J. Stieltjes indicates that in Hardenberg the bridge has remained the same and that in Ommen, between 1869 and 1870, the bridge has been renewed and has become wider [16]. This is nicely visible in the reconstructed width.

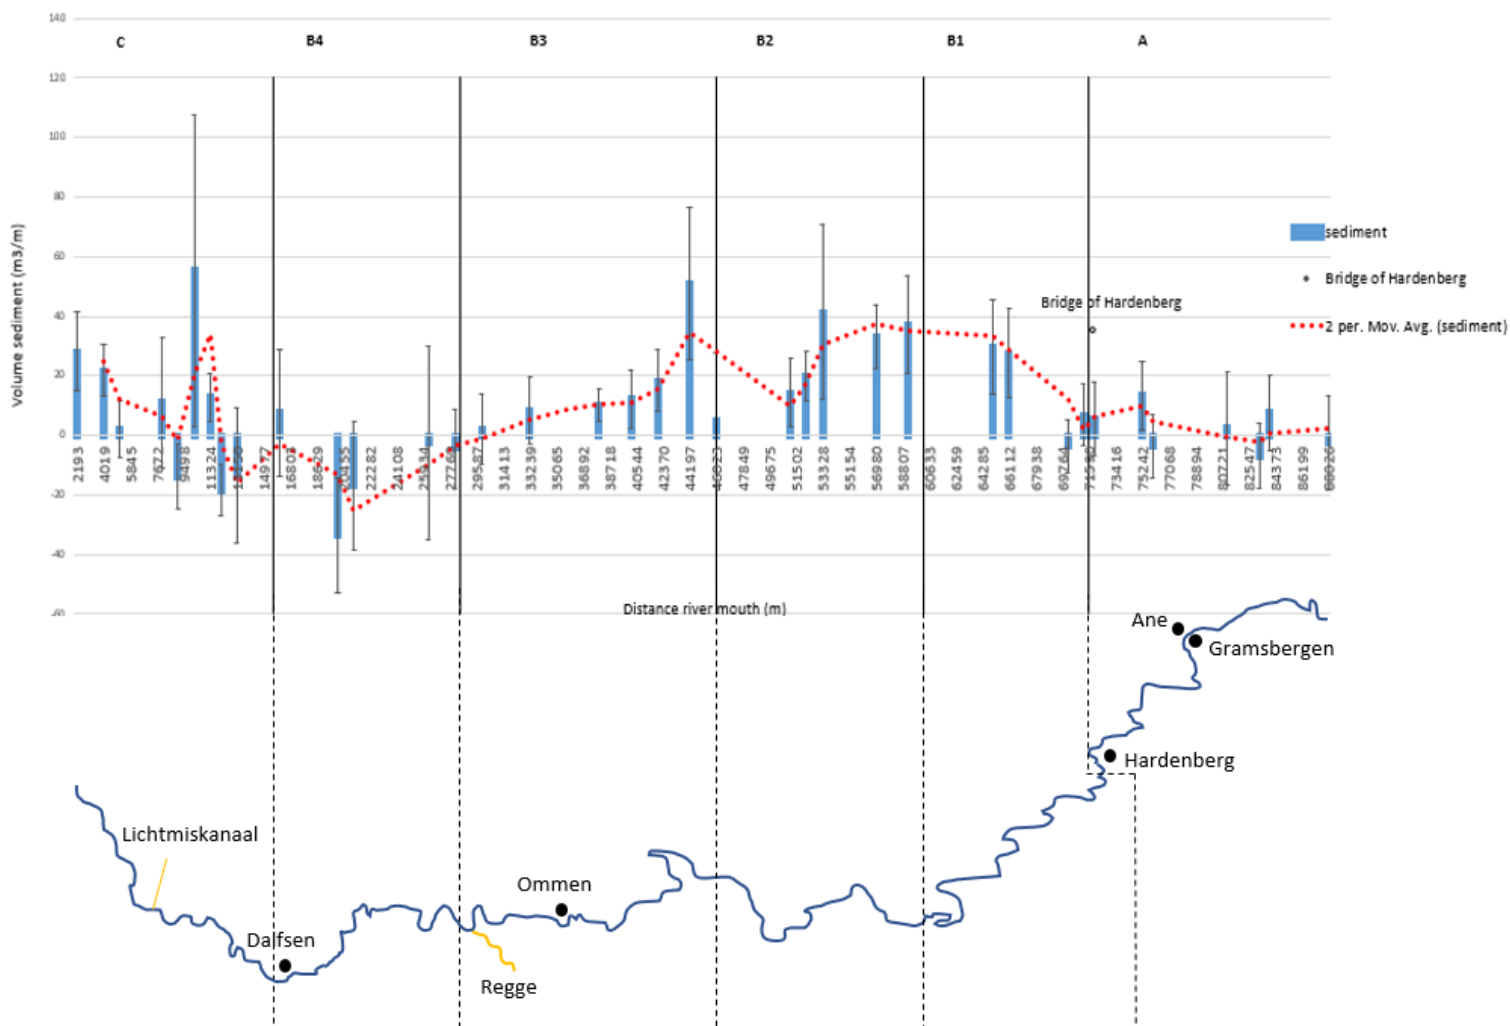
Figure 4.10 Volume of sediment that has been eroded or deposited on the particular measurement locations with a moving average.

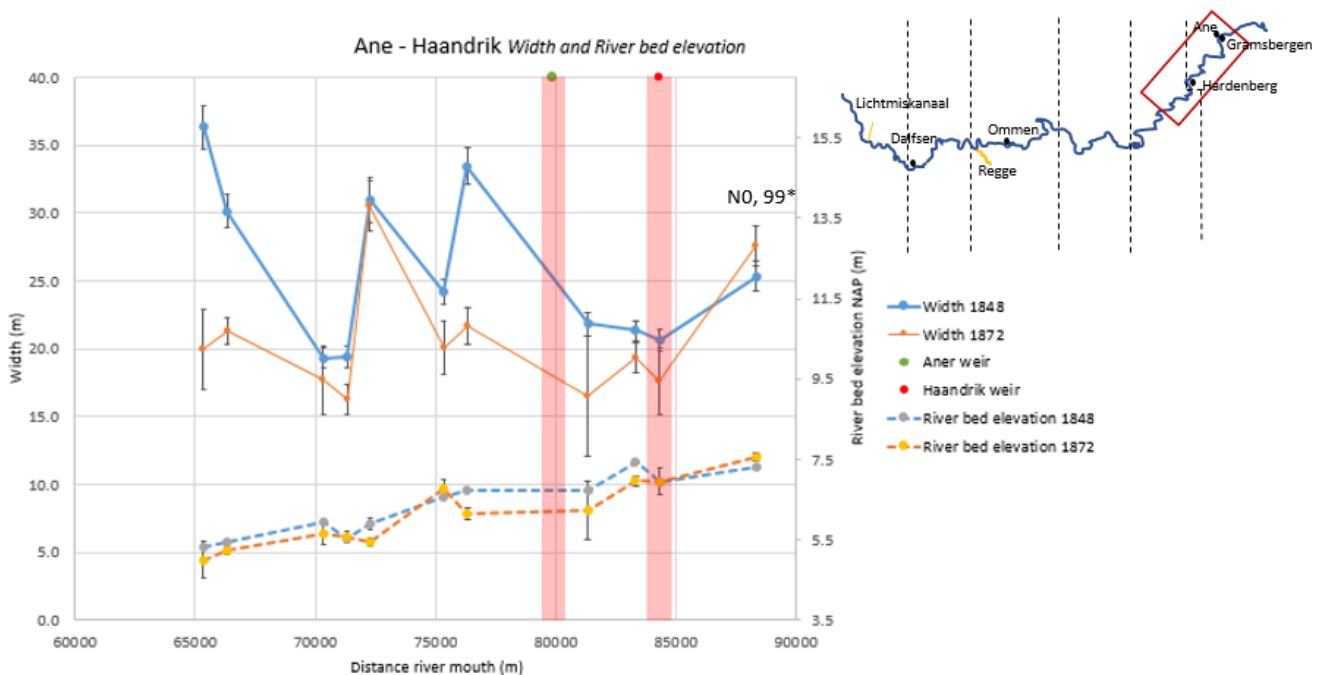
Figure 4.11 Changes in W and Ea in the section Ane – de Haandrik with the in 1853 constructed weirs indicated in red.

In 1853, commissioned by the province, a canal system with its necessary weirs was constructed by Overijsselse Canal Company. They constructed a weir at the location Ane for the canal the Dedemsvaart and a weir at the location the Haandrik for the Overijsselse canal system. In figure 4.11 the weirs are shown together the morphological changes in that section.

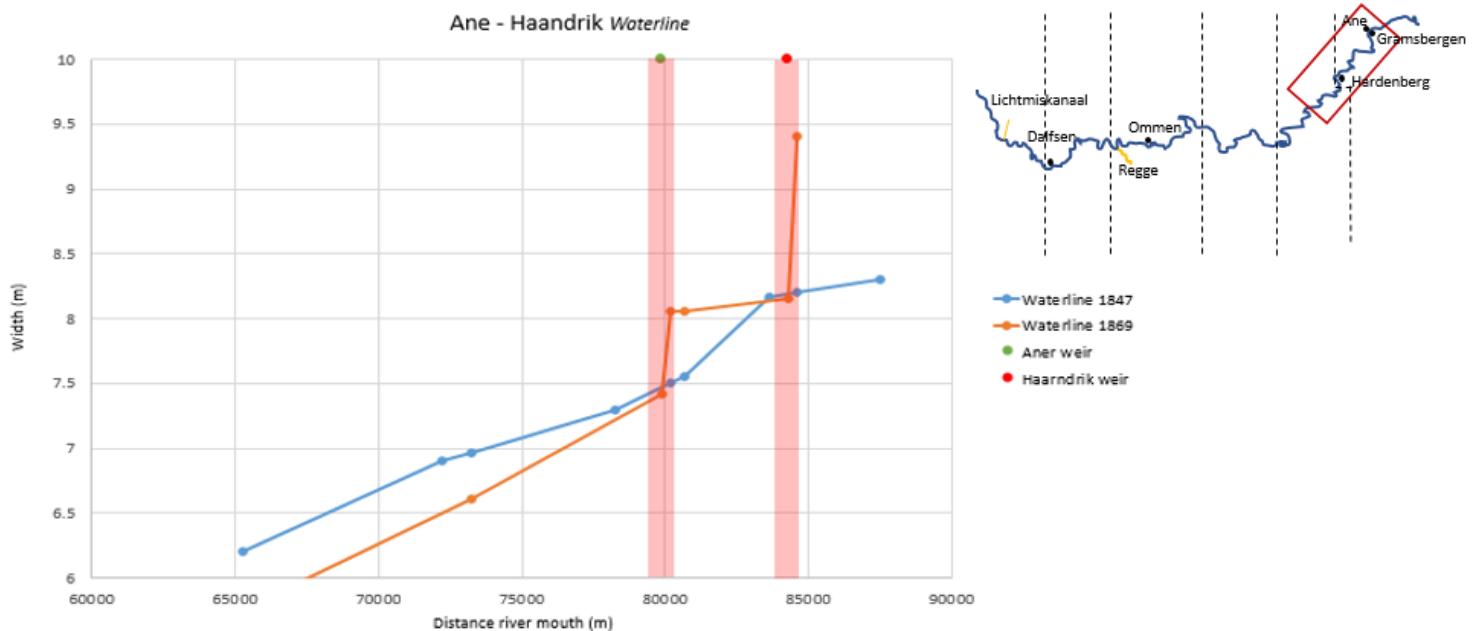
Figure 4.12 Changes in waterline in the section Ane – The Haandrik with the in 1853 constructed weirs indicated in red.

The weirs had the purpose to push the water to higher levels in order to supply the canals to retain sufficient water levels. The impact on the waters levels is presented in figure 4.12. Data came from Staring and Stieltjes who included water levels in their report 'Afwatering in Twente'. These water levels are described as normal water and is interpreted as average water levels resulting from annual average discharge.

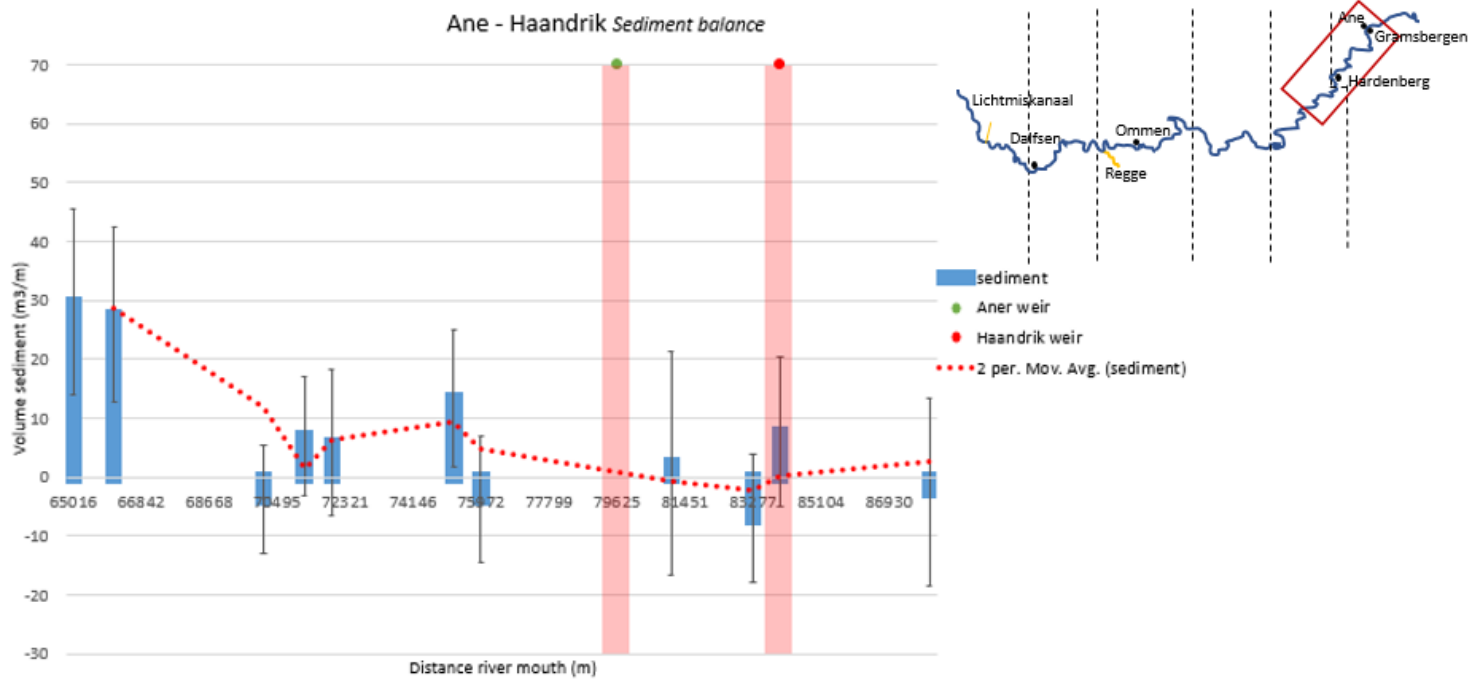
More downstream, 63 km from the Ane weir, the municipality of Dalfsen blamed the weirs Figure 4.13 Sediment volume change in the section Ane – de Haandrik with the in 1853 constructed weirs indicated in red.

The reconstructed sediment balance (figure 4.13) shows that upstream sedimentation or erosion tendency is not clear. Going more downstream of the canals there seems to be sedimentation.

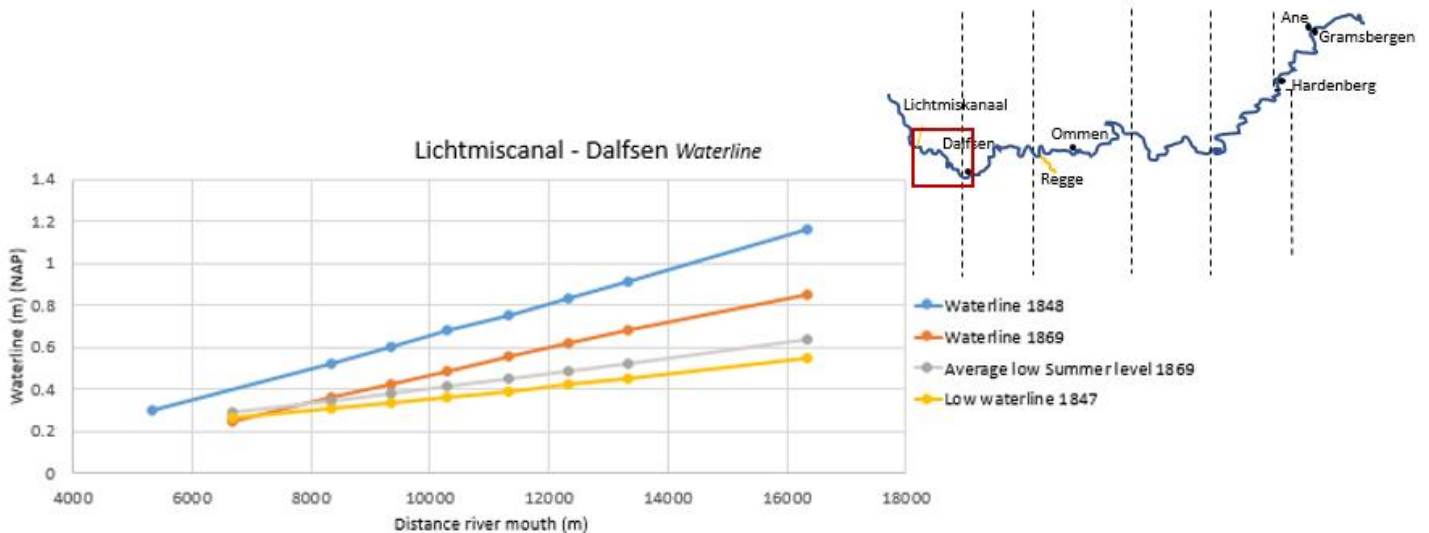
Figure 4.14 Normal and extreme summer low waterline before canal construction (1847), normal (1869) and extreme summer low (average 1854 – 1886) waterline after canal construction.

to be the main cause for the low quality of the river. The municipality states that due to the weirs water levels dropped and ships endured navigation problems over the river. In figure 4.14 the average normal waterline before and after the construction of the canals are presented together with extreme low summer levels.

Literature and reported water levels (figure 4.14) show the impact of constructed canals. Normal water levels dropped and caused multiple problems for cities situated at the river border. Dalfsen complained that transport was of vital importance, but that due to the canal system transport was almost impossible [62] [44]. Multiple times the municipality of Dalfsen expressed their concerns and complaints to the province, but their complaints were shifted to following meetings and suggestion were rejected, because in their opinion more research was needed [62]. However, multiple investigation and possible solutions were already available. Staring and Stieltjes wrote an extensive report and also the municipality of Dalfsen tested and monitored groyne constructions. Also the willingness to pay was low. The government withdrew their cooperation, because the province was not willing to pay either [62]. The reserved attitude towards river improvements shows that the river the Overijsselse Vecht had little important meaning for the province. This drove the municipality of Dalfsen desperate by eventually writing a letter to the king about this matter.

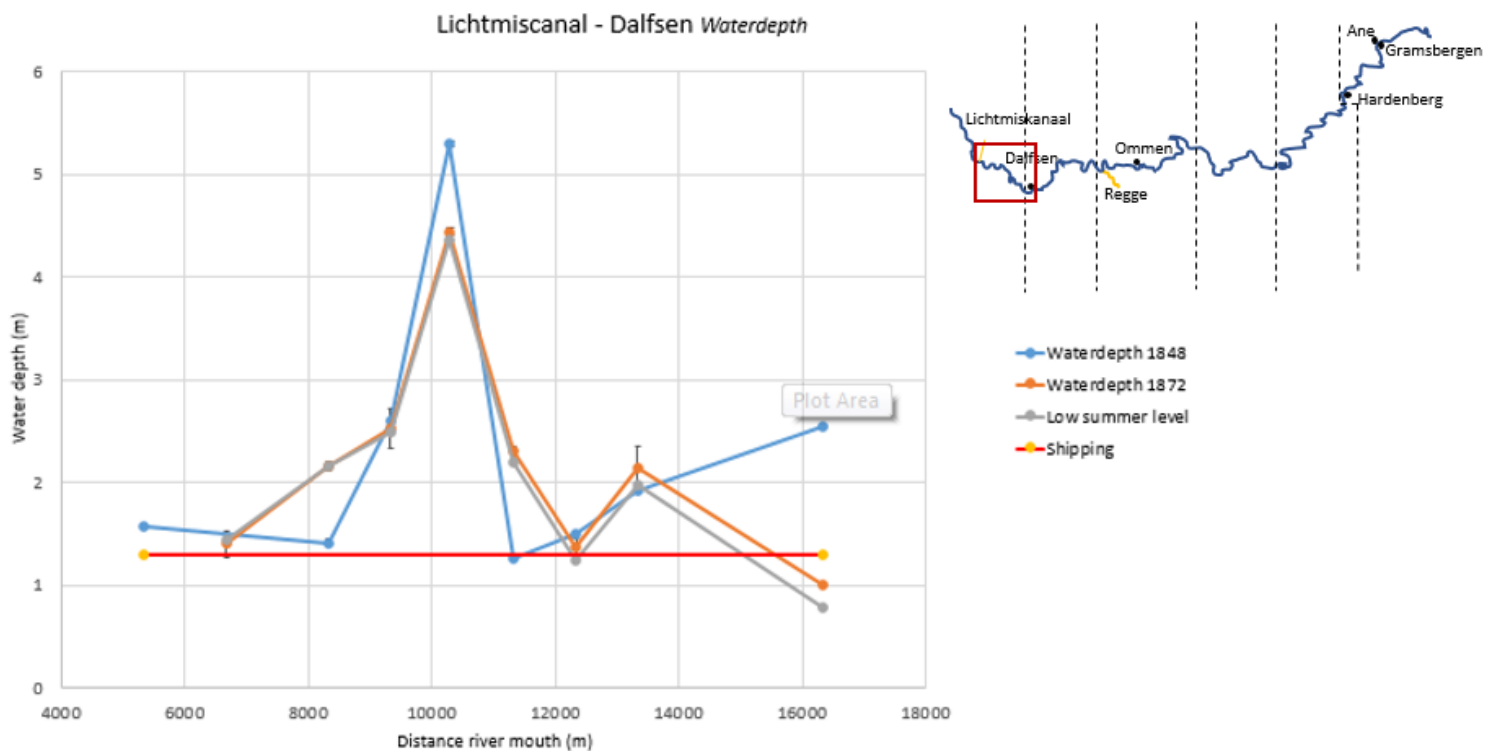
Figure 4.15 Water depth before and after the canal construction including the extreme summer lows after canal construction. Red line indicates shipping threshold of 1.30 m.

The changed water levels with changes in in river bed elevation can show the effect on shipping possibilities. 1.30 meter is the desired depth for shipping and can be used as a threshold for shipping possibilities [44]. Figure 4.15 shows the water depth resulting from the subtraction of river bed elevation from the water line height.

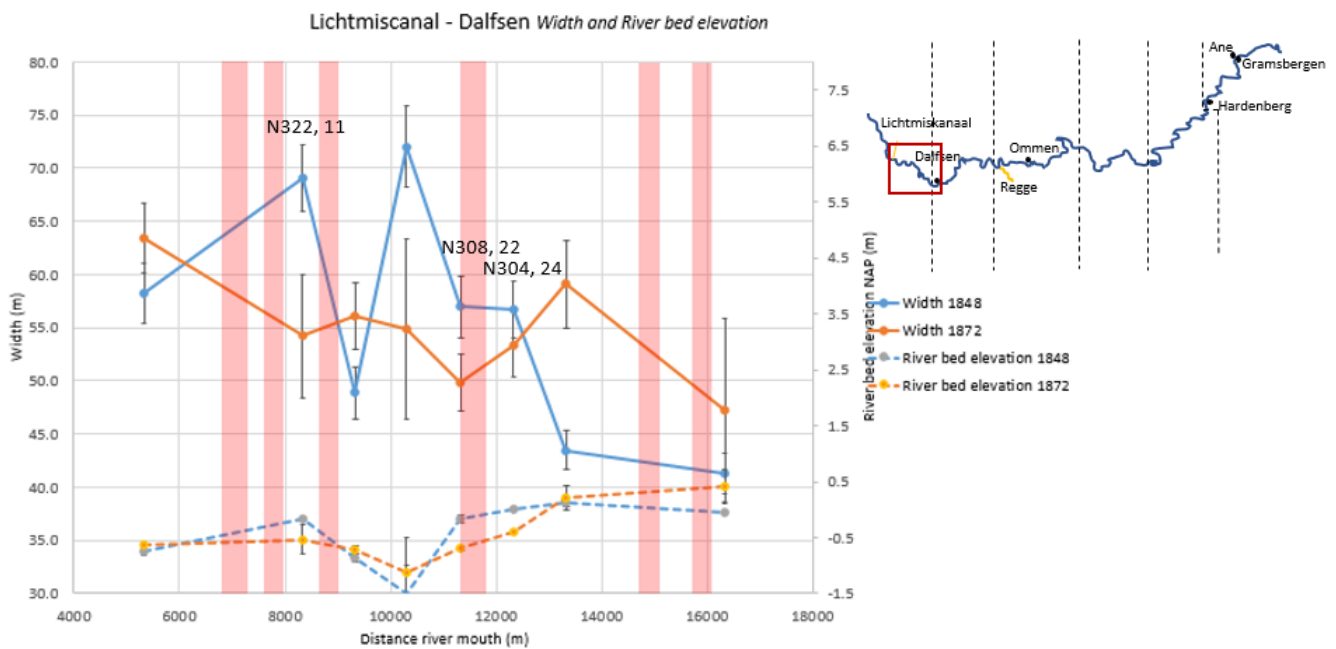
Figure 4.15 Water depth before and after the canal construction including the extreme summer lows after canal construction. Red line indicates shipping threshold of 1.30 m.

Due to complaints and problems of the municipality of Dalfsen, eventually 73 groynes were implemented in the section between Dalfsen and the Lichtmiskanaal. Dalfsen stated that groynes would solve the problems by increasing river depth. Also engineer A. Deking Dura concluded that larger depth near the constructed groynes were found. From archive material [44] the exact locations of the groynes are known and are presented in figure 4.16 with the changing width and river bed elevation.

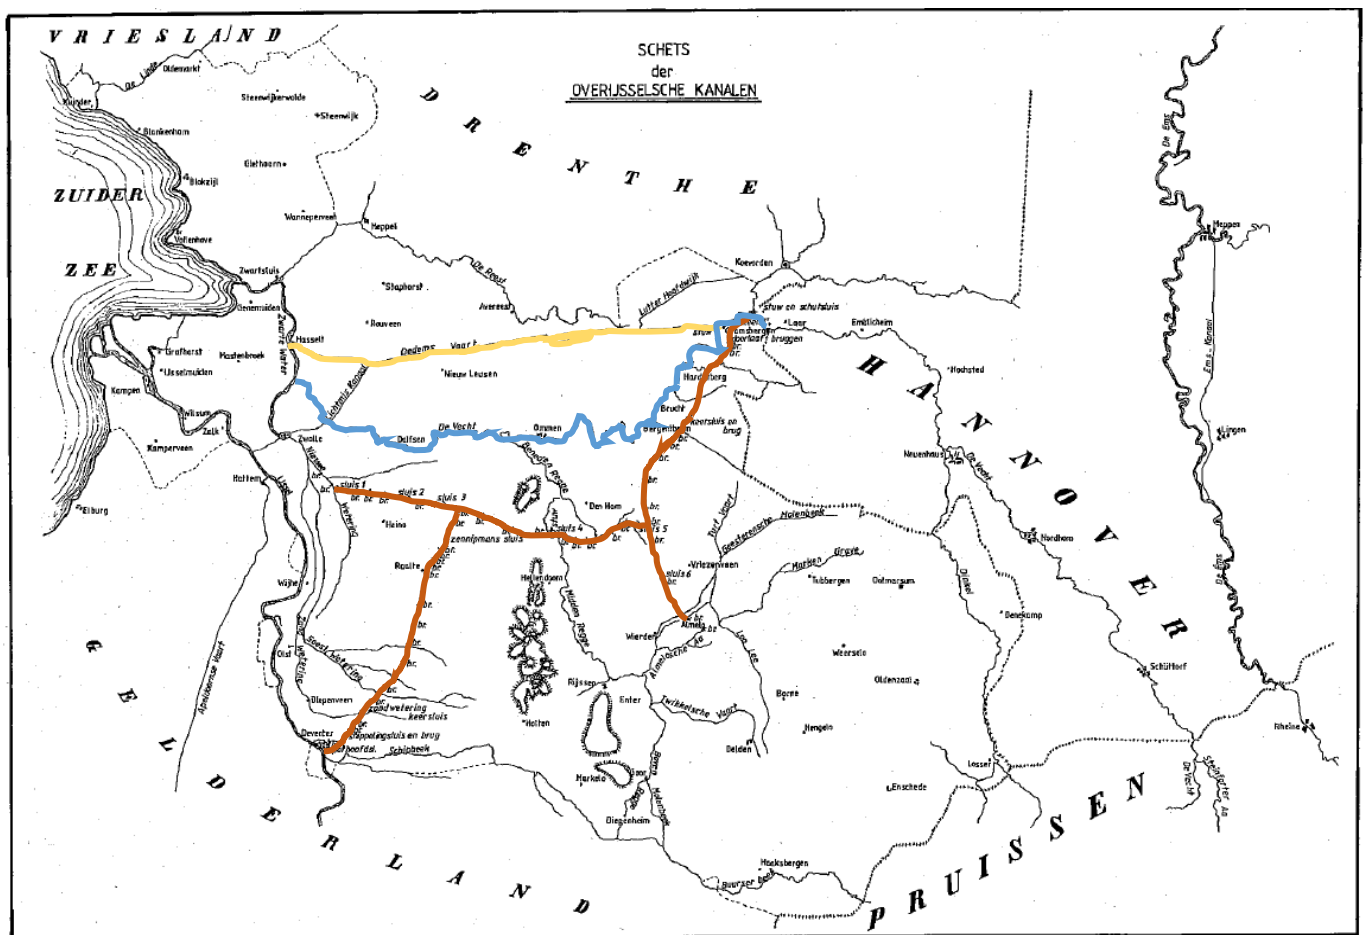
Figure 5.3 figure Overview of the Overijsselse canal system. In blue the Overijsselse Vecht (Dutch part), in yellow the Dedemsvaart and in orange the Overijsselse canals [42].

The deteriorated state of the Overijsselse Vecht caused problems for transport. Together with growing interest in peat more and more individuals started to dig small canals to transport peat. The best example is the Dedemsvaart which is located northerly of the Overijsselse Vecht and is a canal which connects Hasselt and Ane. Because of the increased industry near the Dedemsvaart (figure 5.2) and because in Twente the textile industry grew, the province started to think in 1826 of the construction of canals in order to improving shipping possibilities. But due to high costs, financial risks and the fact that the canals would get insufficient supply of water from neighbouring rivers, it did not work out [42]. When eventually in 1845 the option of train connections was too expensive too they had to go back to their old plans of canals. In 1849 the plan was approved and eventually the last part of the Overijsselse canals, canal from Deventer to Dalmsholte, were completed in 1858 (figure 5.3).

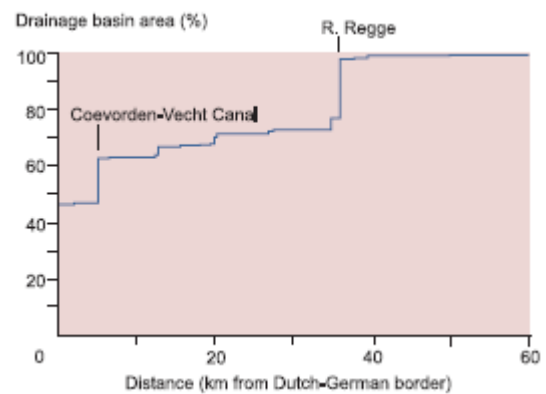
Figure 5.5 changes in discharge along the Overijsselse Vecht. Distance to river border is based on its current river length [3].
