River management and its morphological consequences

Influence of river management on river morphology of the Overijsselse Vecht
between AD 1750-1900

Master Thesis

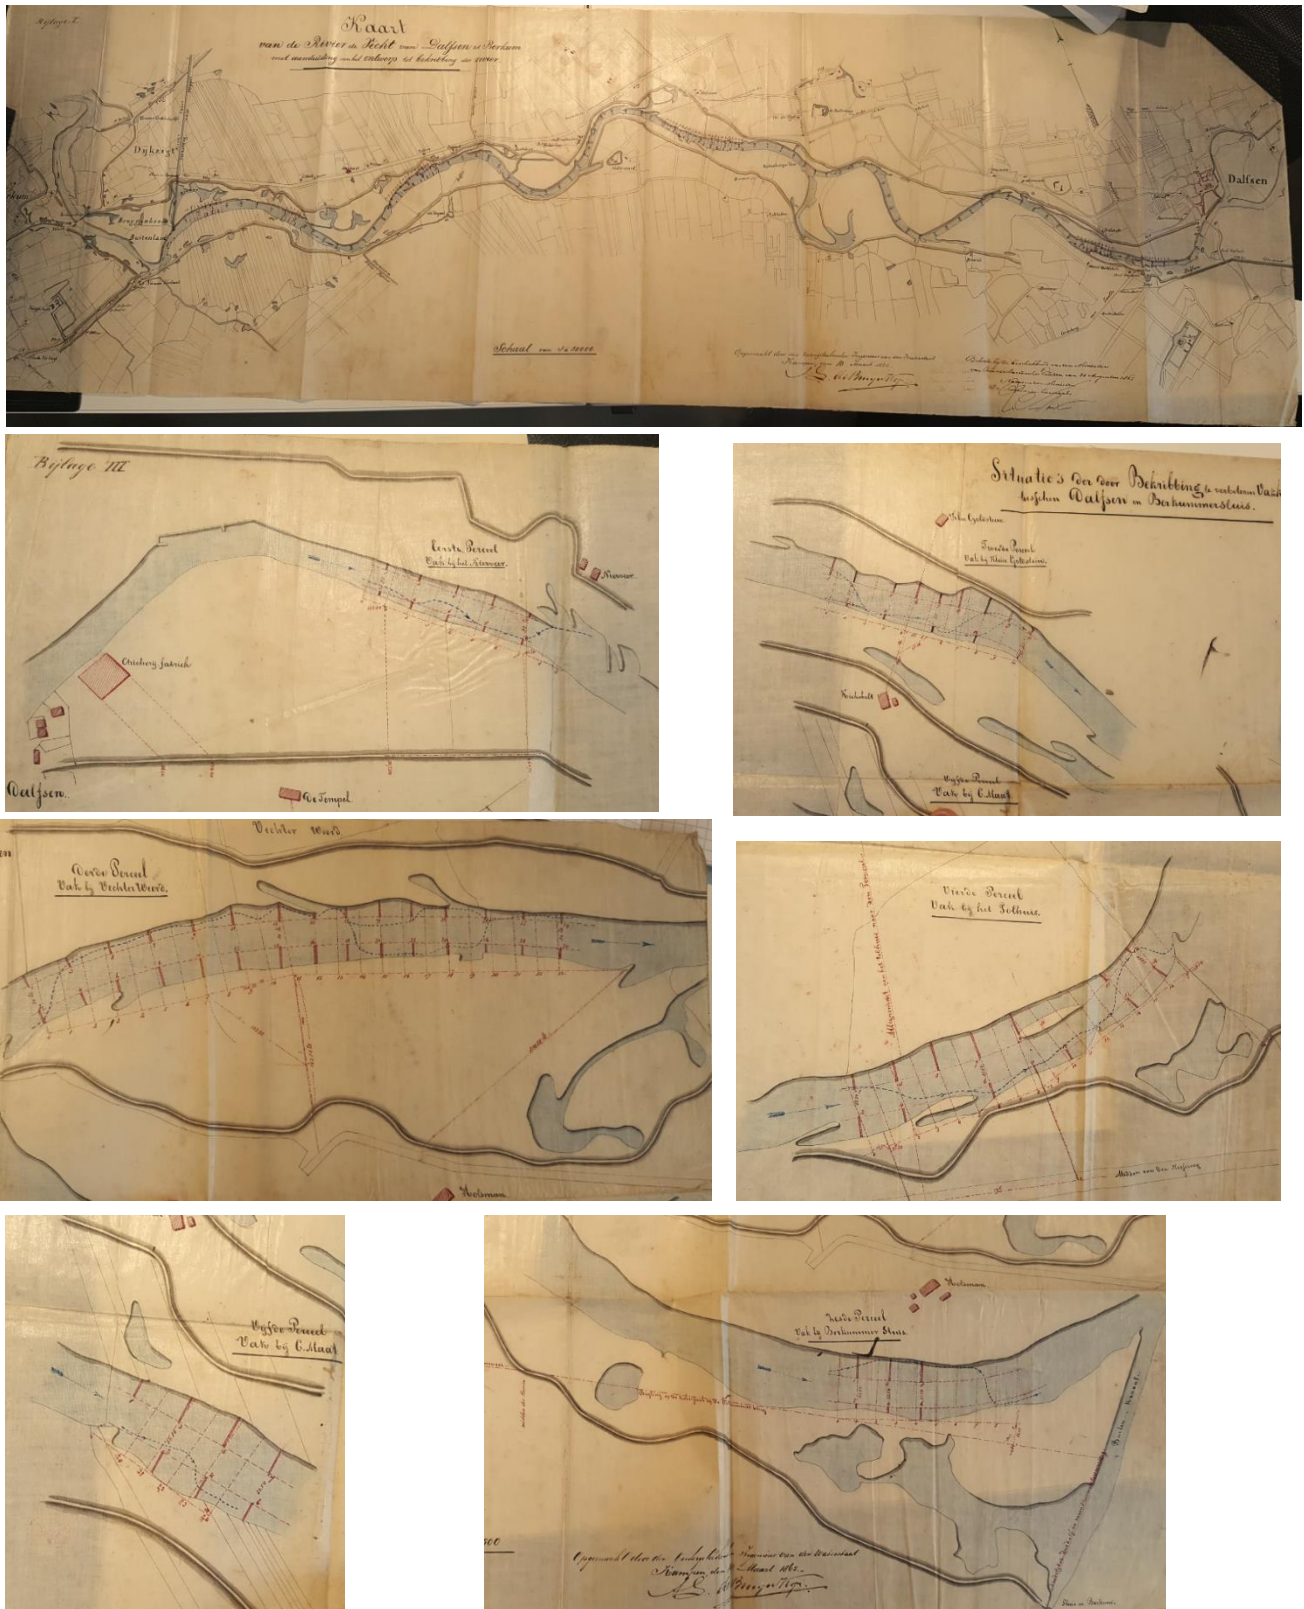
[C] Locations groynes Dalfsen - Lichtmiskanaal

Figure C Locations of groynes in the section Dalfsen – Lichtmiskanaal. Figure on the top are all the groynes through the whole section. Other figures are all groynes in particular subsections.

In addition of the letter to the province, the municipality writes a letter to the king. They felt they had no other option, because the province does not fulfil their promise to help. They write that the river is vital for Dalfsen and that no one is taking care of the maintenance of the Overijsselse Vecht (figure 4.5). The province was the first to ask, but they have little attention to their problem. When the problem was first discussed in 1857 the province postponed the problem to meetings in 1861. Furthermore, the province is responsible for construction of the weirs which obstruct shipping possibilities. In the letter the municipality of Dalfsen also elaborates on the proposed solution, which they have tested by monitoring a few constructed groynes. The chief-engineer expects large progress, but still the province asked for more investigation without telling which direction it will go [62]. A few months after the letter to the king the chief-engineer replies to the province that the municipality will get subsidy from the province when they further elaborate the plan. After the new plan is presented in 1865, subsidy is given and groynes are constructed at agreed locations between Dalfsen and the Lichtmiskanaal [44](sketches and locations in appendix C).
