Silver eel behaviour in the vicinity of pumping stations: a telemetry study in Friesland

Report number C120/13

IMARES Wageningen UR

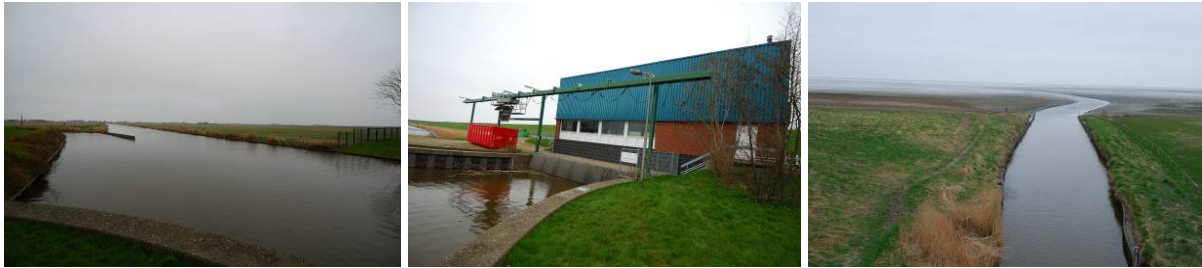
Figure 3.1.2. *H.G. Miedema; the canal in front of the pumping station (left), pumping station (middle) and the canal behind the pumping station leading to the Wadden Sea (right).*

Pumping station H.G. Miedema (Figure 3.1.2) is located along the dike between Friesland and the Wadden Sea, close to the town of Zwarte Haan. The pumping station pumps water from an area of 8110 ha through a canal (Koude Vaart) into the Wadden Sea. The area is not connected to the canal and lake system of Friesland. The pumping station has two pumps (closed propeller pump) with a capacity of 315 m³/min each (De Vries, 2012). A third pump takes water from a canal along the dike and has a capacity of 70 m³/min. The average yearly pumping volume between 2006-2010 was around 40 million m³. At the Wadden Sea site, water runs through a 300 m long canal that leads into the Wadden Sea.

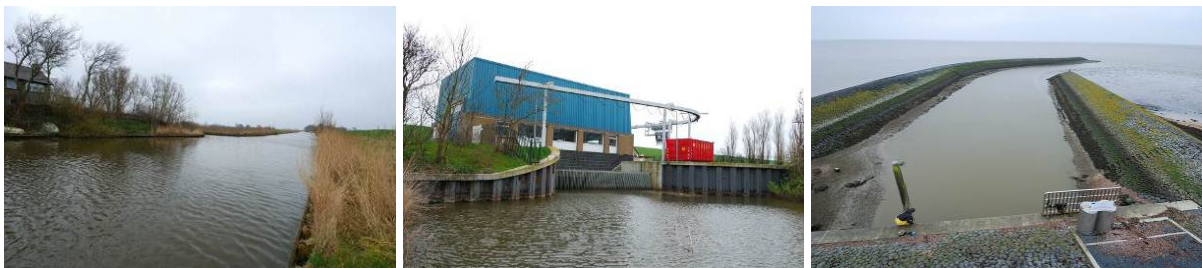
Figure 3.1.3. *Ropta; the canal leading to pumping station Ropta (left), pumping station (middle) and the canal behind the pumping station leading to the Wadden Sea (right).*

Pumping station Ropta (Figure 3.1.3) is located along the dike between Friesland and the Wadden Sea, close to the town of Roptazijl. The pumping station pumps water from an area of 5010 ha. The pumping station pumps water from a canal into the Wadden Sea, using two larger pumps (closed propeller pump) with a capacity of 180 m³/min each, and a small third pump with a capacity of 100 m³/min. A fish passage was built in 2000 to facilitate fish (glass eel, stickleback) migrating from the Wadden Sea to the polder site near this pumping station (Brenninkmeijer *et al.*, 2005). The average yearly pumping volume is estimated at about 27 million m³ (Paap, Wetterskip Fryslan, pers. Comm.).

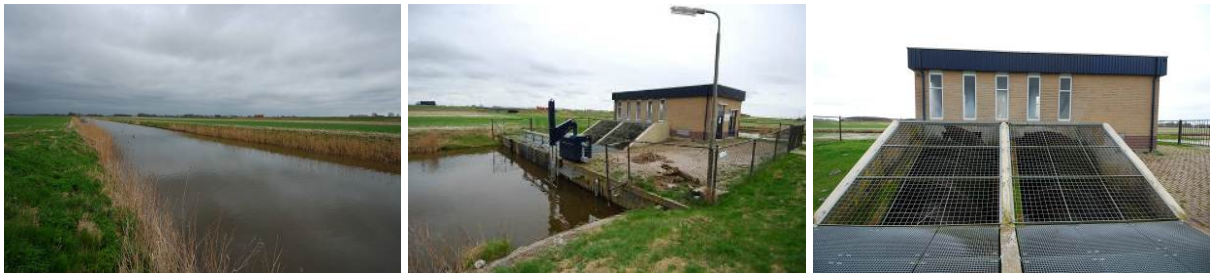
Figure 3.1.4. *Schalsum; the canal in front of the pumping station (left), pumping station (middle) and the pump blades (right).*

Pumping station Schalsum (Figure 3.1.4) is located between the towns of Franeker, Dongjum and Schalsum. The pumping station pumps water from an area of 3165 ha. The pumping station pumps water into a canal that leads to the Van Hanrinxma Canal between Leeuwarden and Harlingen, and consists of two pumps (archimedes screw) with a capacity of 150 m³/min each. The average yearly pumping volume is about 14 million m³.

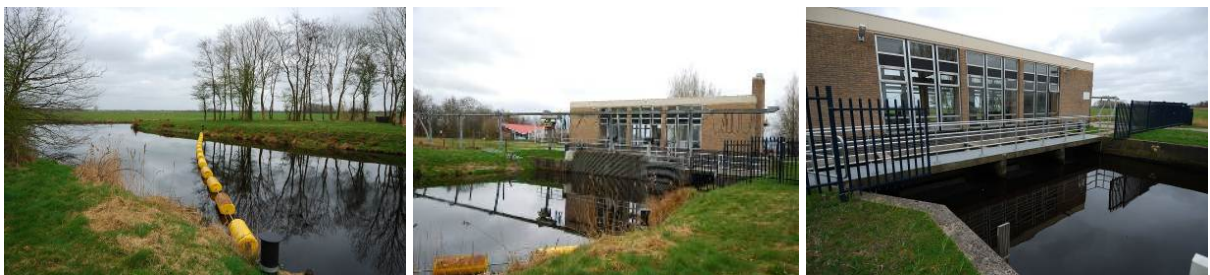
Figure 3.1.5. *Offerhaus; the canal adjacent to the pumping station (left), pumping station (middle) and the rear of the pumping station (right).*

Pumping station Offerhaus (Figure 3.1.5) is located close to the town of Earnewald. The pumping station pumps water from an 2.250 ha area into an area with shallow peat lakes and the water will eventually stream towards Lauwersmeer through Dokkumer Nieuwe Zijlen. The pumping station has three pumps with a total capacity of 228 m³/min. One pump is an open pump (open propeller pump), with a fish exclusion device (FIS: nine flashing lights) in front of the entrance to the pump, while two pumps are Fishtrack pumps. The average yearly pumping volume is unknown, but estimated at about 9 million m³ (Paap, Wetterskip Fryslan, pers. Comm.).

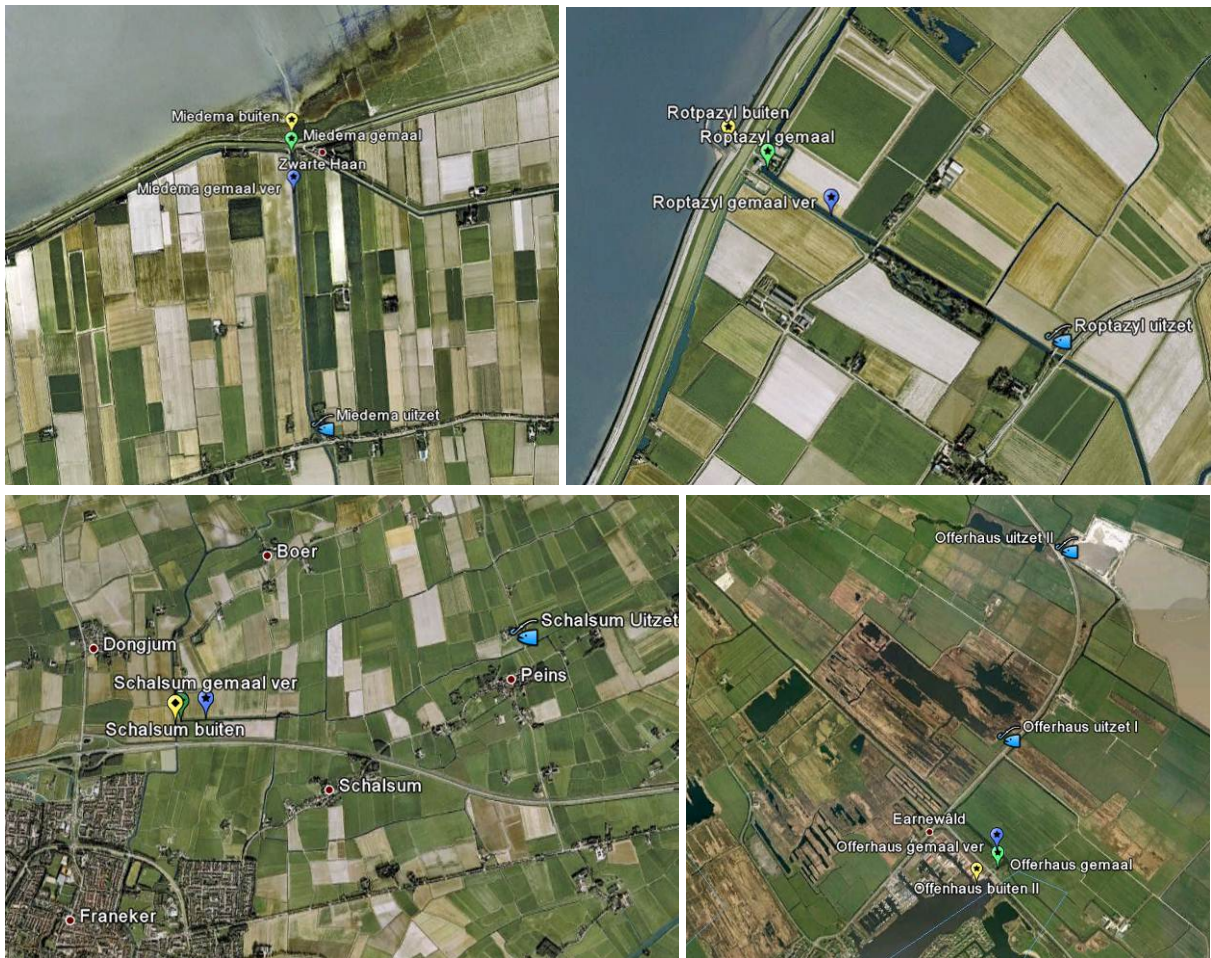
Figure 3.2.2. Receiver placement at each study site; H.C. Miedema (top left), Ropta (top right), Schalsum (bottom left) and Offerhaus (bottom right).

Blue mark (receiver A) indicates receiver at distance from the pumping station at polder side.

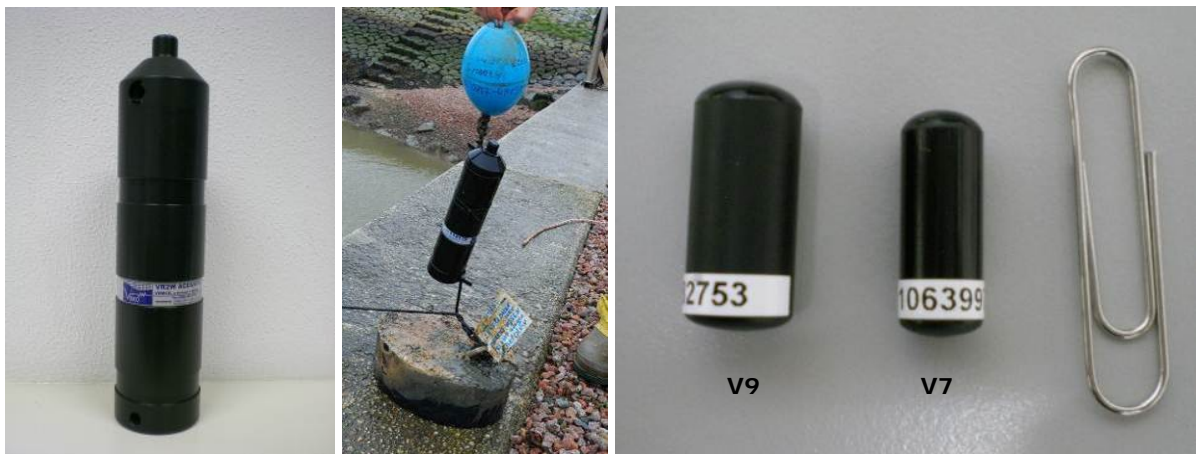
Figure 3.3.1. VEMCO VR2W receiver (left), receiver mooring with a float and a weight (middle), and VEMCO transmitters V9 and V7 (right).

A VR2W receiver (Figure 3.3.1, left) records the identification number and time stamp from acoustic transmitters as a tagged animal travels within receiver range. The VR2W consists of a hydrophone, receiver, ID detector, data logging memory and battery, all housed in a submersible case. The VR2W has a battery life of approximately 15 months and can store 1-million detections. To deploy a VR2W, the receiver was moored with tie-wraps along a line, which was connected to two weights at the bottom and a pop-up float (Figure 3.3.1, middle). Data from the receivers can be exported to a computer through a Blue Tooth connection using the VEMCO VUE software package.

VEMCO coded transmitters are available in different sizes (Figure 3.3.1, right). Each tag sends an acoustic pulse train (8 pulses in approximately 3.2 seconds) at pre-set time intervals. These acoustic pulse trains are random about an average delay time to minimise collisions between different tag pulses. Each pulse train includes a specific ID number for each tag to track the individual fish. The V9-2L transmitters used for this study were programmed to send a pulse train random between 40 to 70 seconds, with an estimated tag life of 261 days. Shorter random pulse trains would increase chance of tag collisions and misdetections. The V9-2L tags have a length of 29 mm and a width of 9 mm, weight of 4.7 gram in air and a power output of 146 dB re 1uPa @1m.

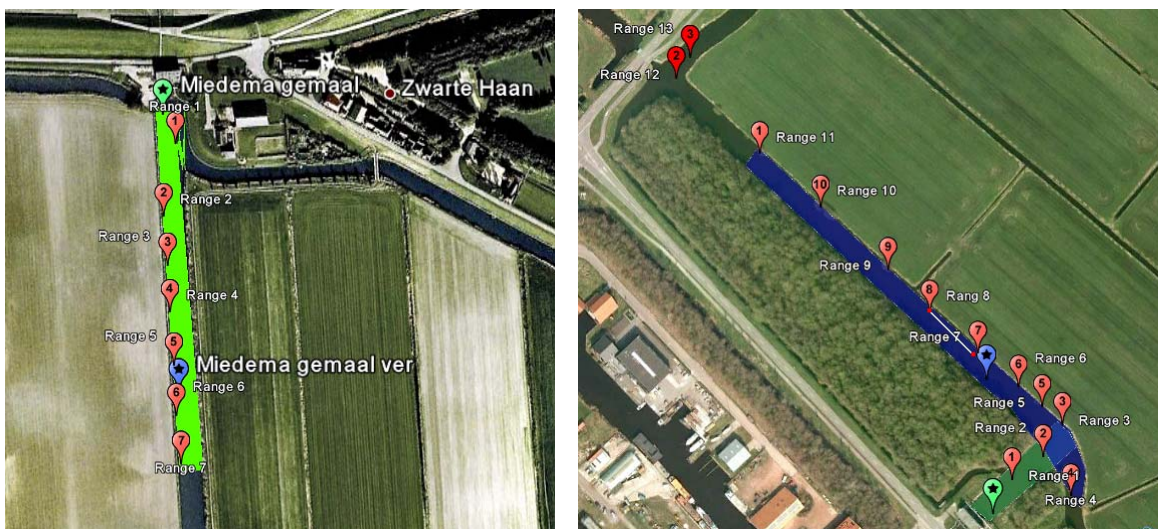
Figure 4.1.1. Detection range at Miedema (left) and Offerhaus (right) the beginning of April 2012. Red marks indicate range test point. At Miedema the range test transmitter was detected by both receivers in the study area, and the border of the detection area was not yet detected. Detections of transmitters on the receiver close to the pumping station during the study period indicated that the detection range was often less than during this range test. At Offerhaus the green area marks detection area for the receiver close to the pumping station (receiver B) and blue area (receiver A) the detection area for the transmitter in de polder.

The range tests gave a maximum detection range of approximately 200 meters during a test in the polders in front of Schalsum (27-09-2011) and Offerhaus (02-04-2012), while in Miedema (04-04-2012) the detection range was over 300 meters (Figure 4.1.1, left). In Offerhaus, where the pumping station is situated at a side arm of the polder, the detection range of receiver B, close to the pumping station, was around 80 meters (Figure 4.1.1, right). Detection ranges can possibly be shorter with e.g. high turbulence during water pumping. The detection data from the receivers at Schalsum, Ropta and Miedema showed that during the autumn of 2011, there was an area where receivers A and B overlapped. Also there were areas where receivers A and B did not overlap in detection range, suggesting the detection range was less than 300 meter as found at Miedema in April 2012.

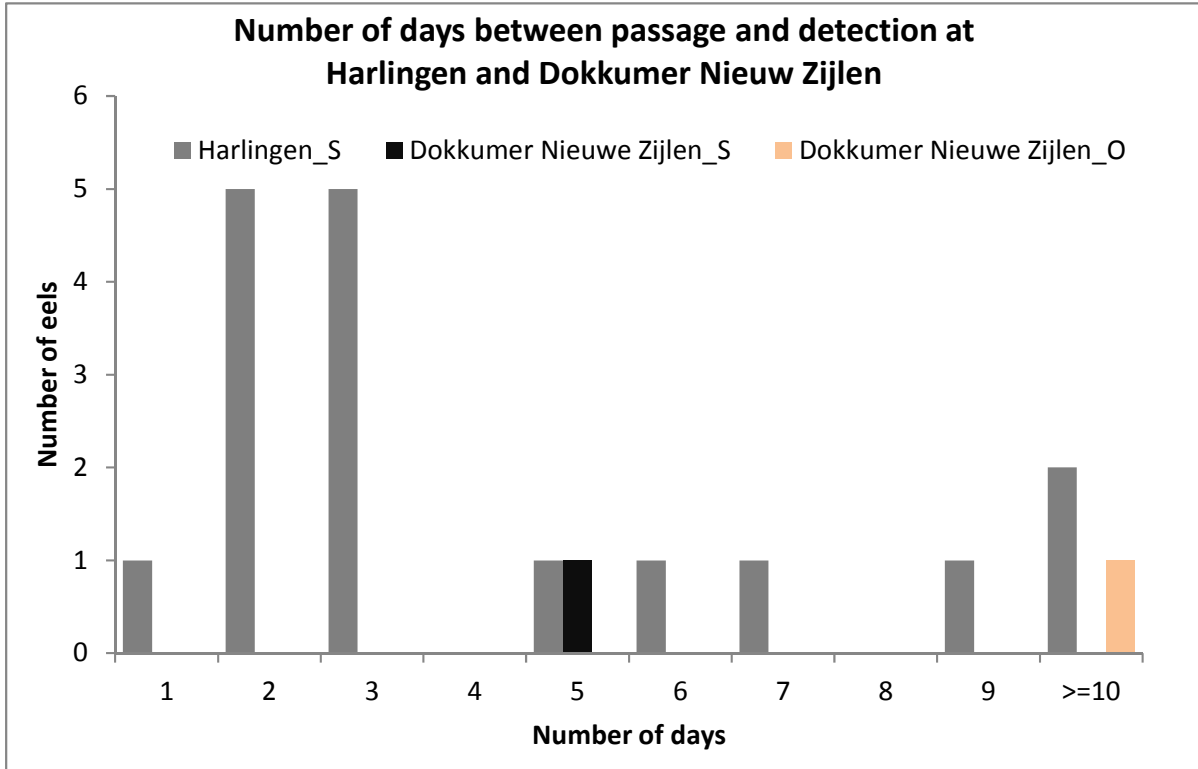
Figure 4.3.5. Number of days between first detection at receiver C (for four eels not detected at receiver C, the last detection at receiver B was taken) and detection at Harlingen or Dokkumer Nieuwe Zijlen for Schalsum (_S) and Offerhaus (_O).

From the 19 eels detected at either Harlingen and Dokkumer Nieuwe Zijlen, for 11 eels it took 1-3 days to get from the pumping stations to the exit points, while for three eels it took over 10 days (Figure 4.3.5).

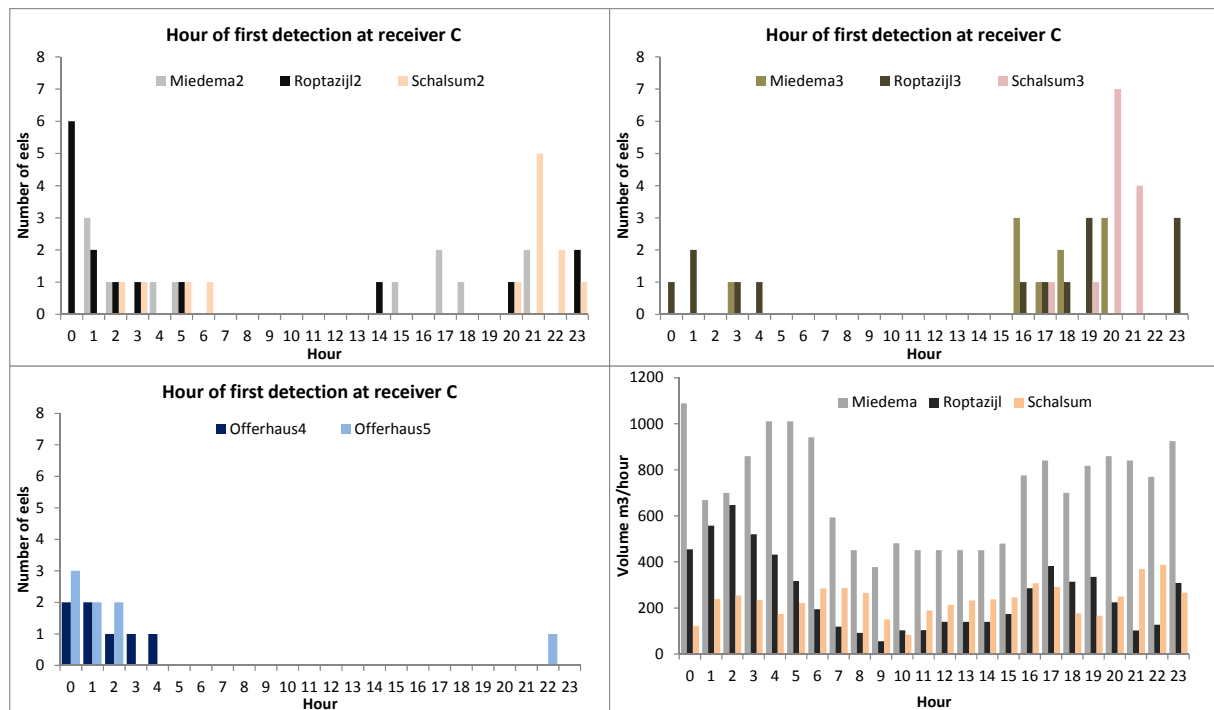
Figure 4.4.3. Hour of first detection at receivers C.

Top left: release at 5 October at Miedema, Ropta and Schalsum,

The hour of first detection at the receiver behind the pumping station was mainly during 8 pm and 6 am for the batch released at 5 October at Miedema, Ropta and Schalsum with 35 out of 40 eels detected between these hours (Figure 4.4.3, top left). For the batch release at 19 October most eels were detected during 4-11 pm, with 31 out of 37 eels detected during these hours (Figure 4.4.3, top right). At Offerhaus almost all eels were detected during 0-4 am, with only one eel detected at 10 pm (Figure 4.4.3, bottom left).

Pumping stations were active during night and day, suggesting that activity of the pumping station did not limit migration opportunities for eels (Figure 4.4.3, bottom right). For Miedema and Ropta, the volume of water pumped during nightly hours is more than during daily hours, but for Schalsum this pattern is not clear.

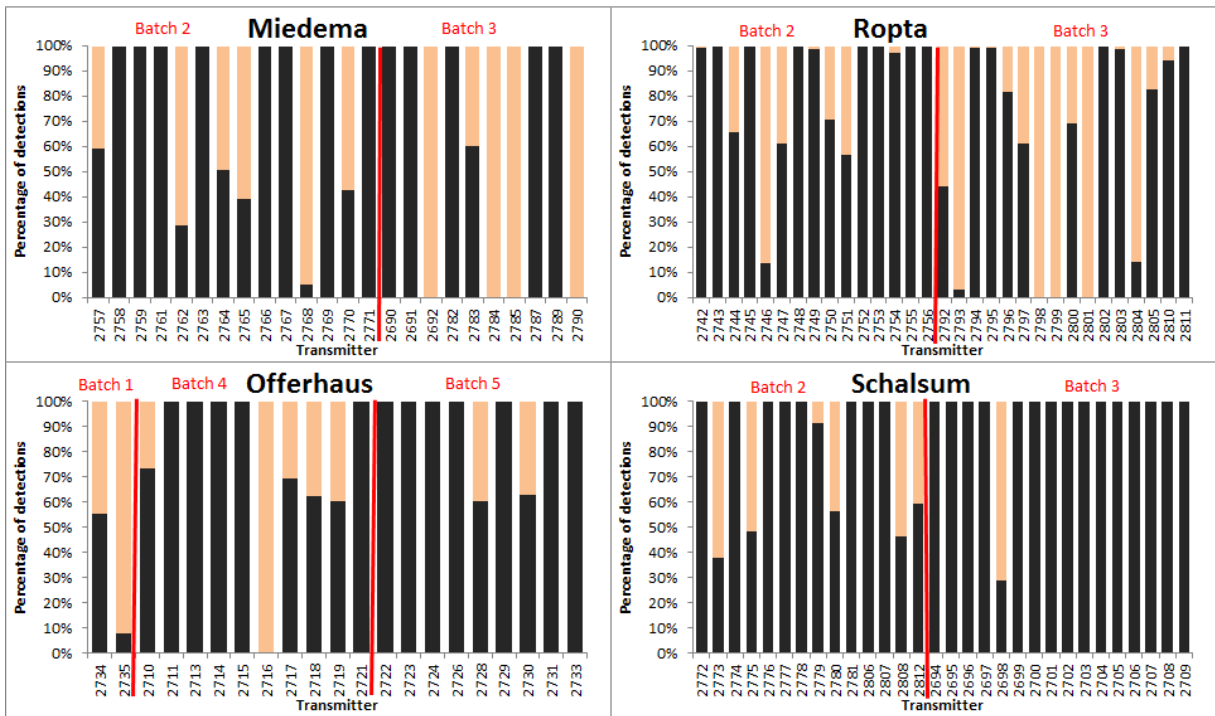
Figure 4.4.5. Percentage of number of detections at receiver B during night (dark bars: between sunset and sunrise) and day (light bars: between sunrise and sunset) for each transmitter.

The average number of detections during day and night time per batch (Figure 4.4.4, left) showed that for all batches, except Offerhaus at 28 September (n=2), more fish were detected during nightly hours between sunset and sunrise than during daylight hours between sunset and sunrise. For Miedema and Ropta, eels were more active during daylight for the third batch compared to the second batch, but for Schalsum the opposite seems to be the case. Patterns in percentage of detections for individual eels during day and night time differed between eels only detected during day and eels only detected during night (Figure 4.4.5).
