Monitoring ground settlement to guide sewer asset management

Proefschrift

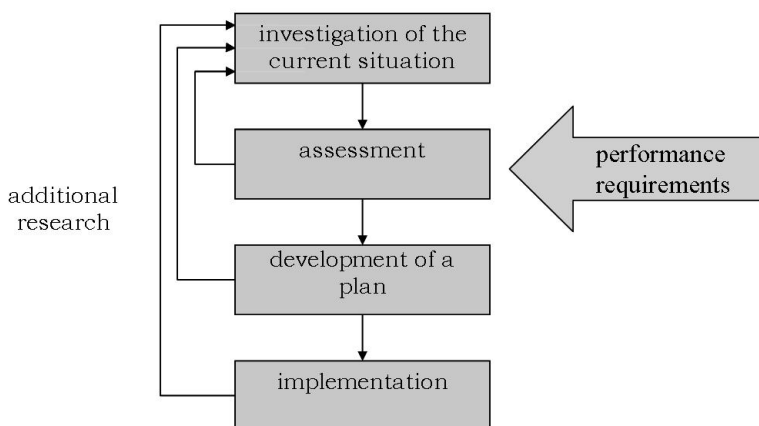
Figure 1.1: Sewer system management process [EN 752:2008, 2008].

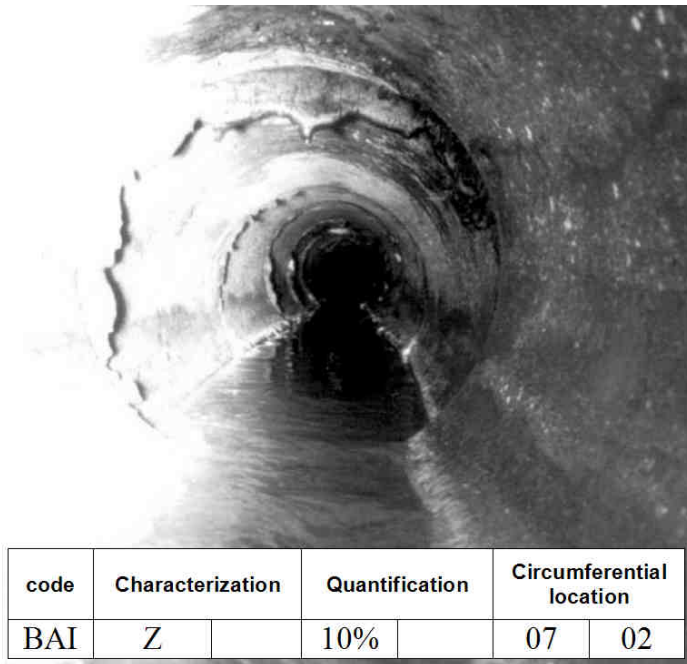
Figure 2.3: Example of a photograph used for examination. Among others, the defect ‘intruding sealing material’ can be observed; the correct description of this defect according the EN 13508-2 is shown.

During the examinations, the candidates were given photographs of sewers and asked to describe the condition of the sewer according to the coding system. Figure 2.3 shows an example of a photograph which was typically one of those that could have been used for the examination. For each photograph a correct answer was formulated by the examiners; most photographs showed sewers with more than one defect.

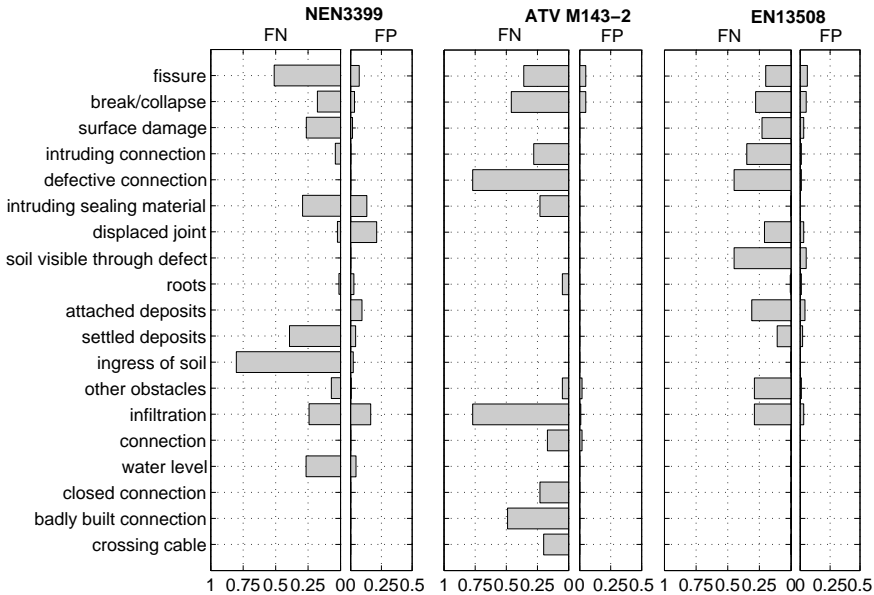
Figure 2.4: Probability of a false positive (FP) and false negative (FN) derived from the inspector examination results of the course ‘Visual inspection of sewers’ in the Netherlands using the NEN3399 and the sewer inspection course from the ÖWAV using ATV M143-2 and NEN 13508-2 in Austria.

When comparing the results of the three inspection courses for individual defects it appears that the probability of a false positive and a false negative seems to vary depending on the defect and used standard. These variations are probably caused by the use of only a small amount of different photographs for the NEN and ATV courses as can be seen in table 2.3. For the EN inspection course more photographs were used, therefore the results of the EN inspection course are believed to more closely represent the actual probability of a false positive or false negative. From the results of the EN course it can be concluded that only one defect, ‘roots’, has a significantly lower probability of a false negative in comparison to the other defects. Apparently defects with distinct features (such as roots) are easier to recognize. For the other defects the probability of a false negative is of the order of 0.25 whilst the probability of a false positive is around 0.04.

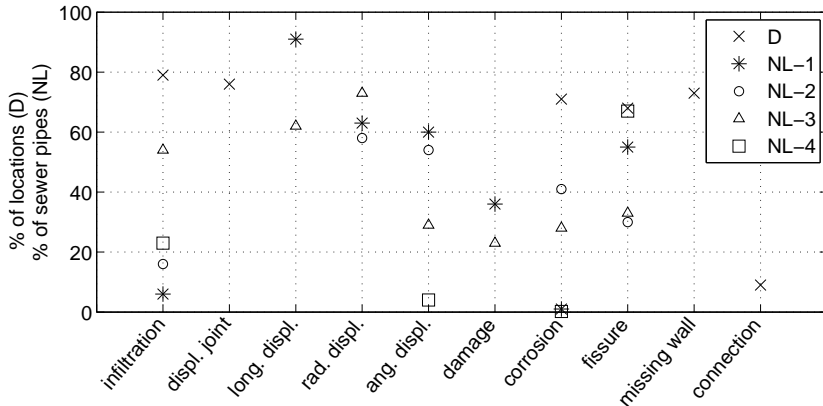
Figure 2.5: Sewers inspected more than once for four municipalities in the Netherlands (NL 1 to 4) and one municipality in Germany (D). The graphs indicate per defect type the percentage of sewers/locations for which the defect was registered at the first inspection but not at the second inspection.

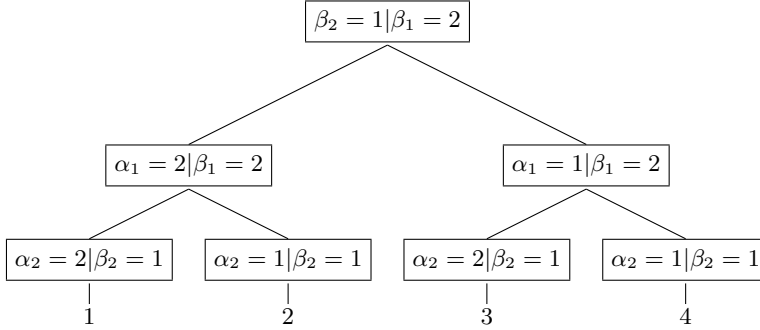
From the event tree it is concluded that four sequences of events are possible. Sequence 2 describes the situation where a defect is present during the first inspection ($\alpha_1 = 2$) but not during the second inspection ($\alpha_2 = 1$). Because only defects are examined that are very unlikely to disappear without any rehabilitation or replacement, the occurrence of this sequence is unlikely.

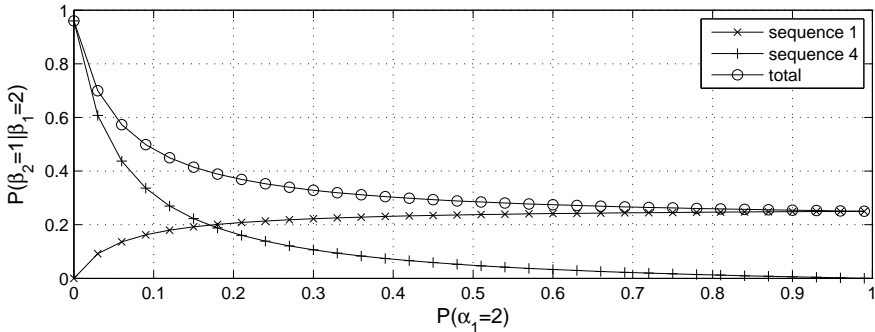
Figure 2.6: Probability of a ‘disappearing defect’ given that the first inspection indicated that the defect was present as a function of the probability that the defect was actually present during the first inspection.

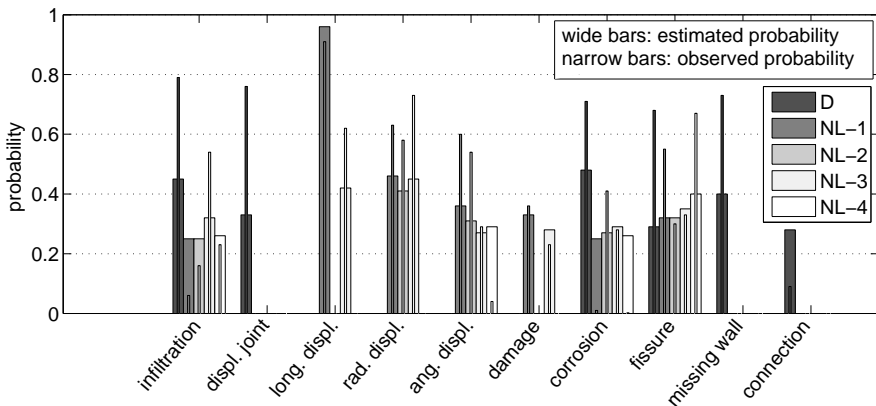
Figure 2.7: Estimated and observed probability of a ‘disappearing defect’.

As can be seen in figure 2.7, the estimated and observed probabilities are in the same order of magnitude. As no structural deviation between the observed

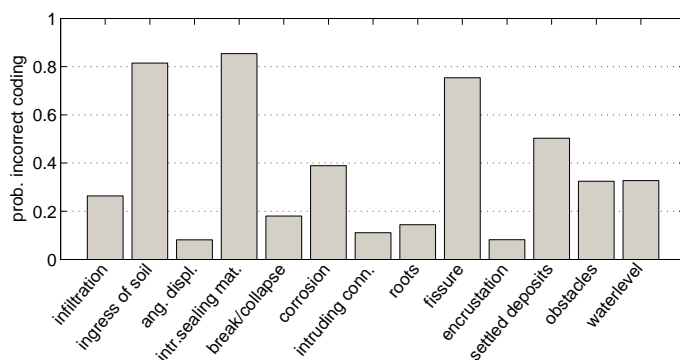
Figure 2.8: Probability of incorrect coding derived from the inspector examination results of the course ‘Visual inspection of sewers’ in the Netherlands (based on the results of Korving [2004]).

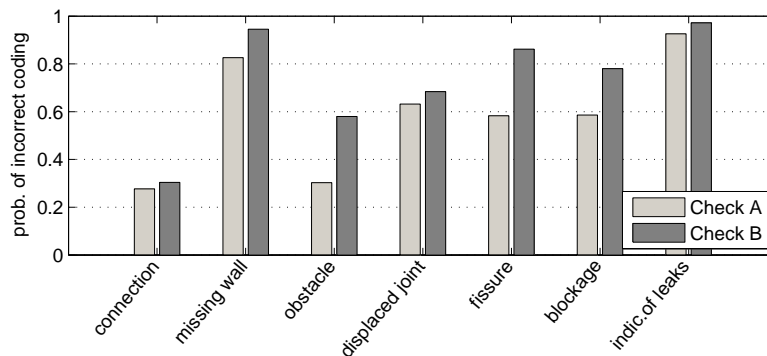
Figure 2.9: Probability of incorrect coding derived from the inspector examination results of the ÖWAV using the ATV coding system.

As can in figure 2.9 and figure 2.10, the probability of an incorrect coding (check B) is for all defects (except 'connection' in the ATV coding system) larger

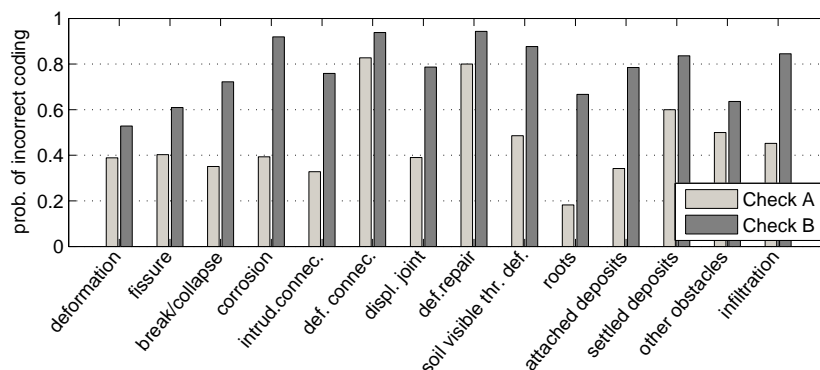
Figure 2.10: Probability of incorrect coding derived from the inspector examination results of the ÖWAV using the EN coding system.

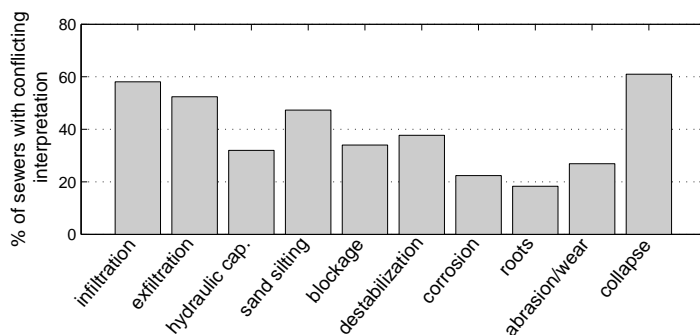
Figure 2.11: Percentage of sewers for which the interpretation of the inspection report by 4 to 6 different experts showed a difference of at least 2 points.

On average the experts did not agree on the interpretation of approximately 40% of the inspection reports. For the performance indicators ‘infiltration’ and

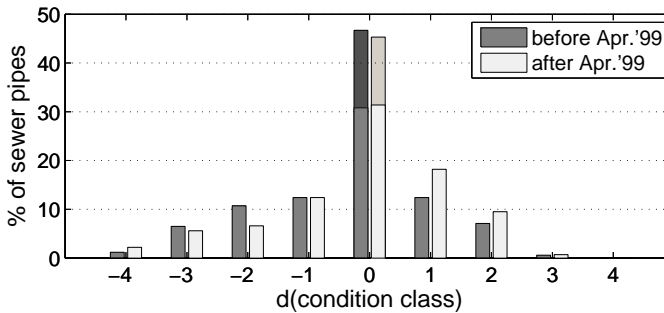
Figure 2.12: Sewer pipes inspected more than once for the municipality of Braunschweig in Germany. The graph indicates the difference in overall condition score between two inspections. For pipes in which the overall condition score did not change, the upper part of the bar indicates the percentage where the defects and their classification in the two consecutive reports were identical. [Hübner, 2002]

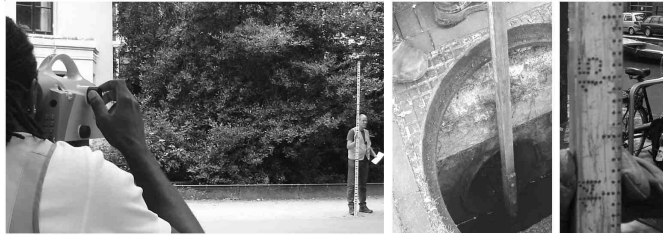
Figure 3.3: Left: measurement of a manhole cover using a levelling instrument. Middle: measurement of the distance between invert level and manhole cover using a rod. Right: graduation on the rod.

The level of each manhole cover is measured relative to NAP using a levelling instrument (figure 3.3). The measurement starts from a bench mark (NAP bolt). These bench marks are usually stainless steel pins attached to objects with a piled foundation such as buildings and bridges. In the Netherlands, bench marks are usually within reach of 1 *km*.

After the measurement of the level of the manhole cover, the distance between manhole cover and invert level is measured using a rod. An extra bar is welded perpendicular to the rod; this bar is positioned on the invert of the sewer and a foot is placed on the manhole close to the rod (figure 3.3). The distance to be measured is indicated by the underside of the shoe and can be read on the rod. As can be seen in figure 3.3, the rod is marked in 0.01 m increments.

with $s_z = 0.016\text{ m}$ and $s_{manhole} = 0.007\text{ m}$ this results in $s_{distance} = 0.013\text{ m}$. Since the measurement equipment is marked with a centimetre graduation (figure 3.3) an error of 1-2 centimetres was to be expected.

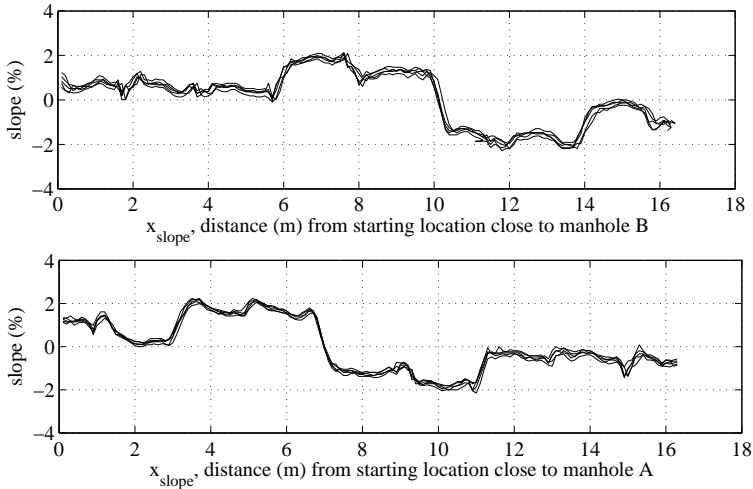
Figure 3.10: The result of 10 slope measurements: 5 for each direction (raw data).

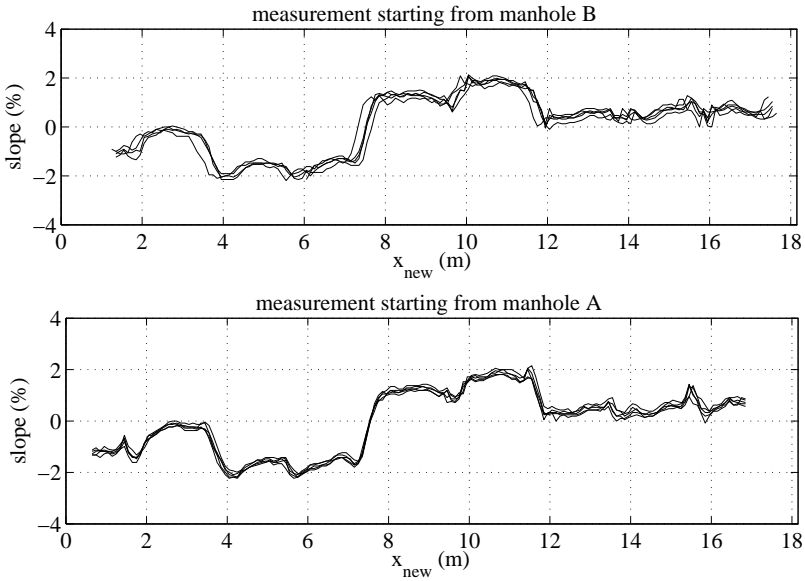
Figure 3.12: Measurement results after transformation of the distance vector.

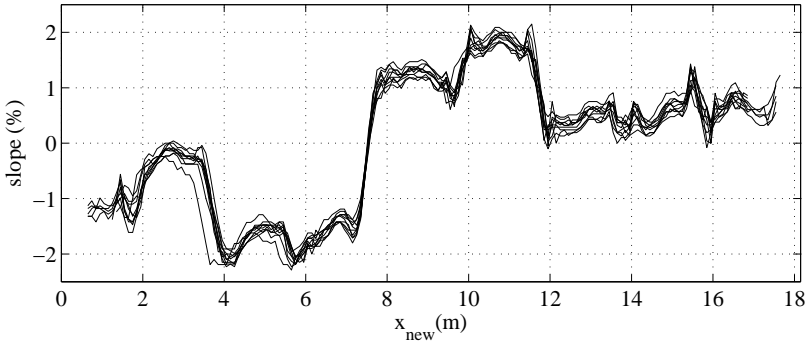
Figure 3.13: Measurement results after horizontal translation.

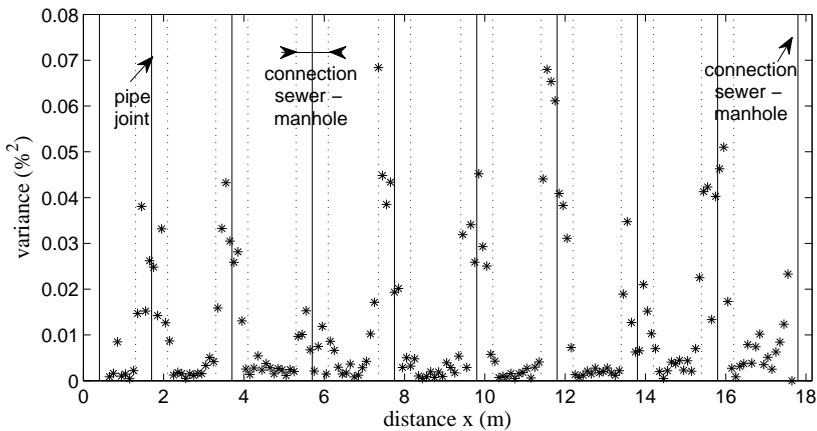
Figure 3.14: Variance in slope measurements along the sewer length.

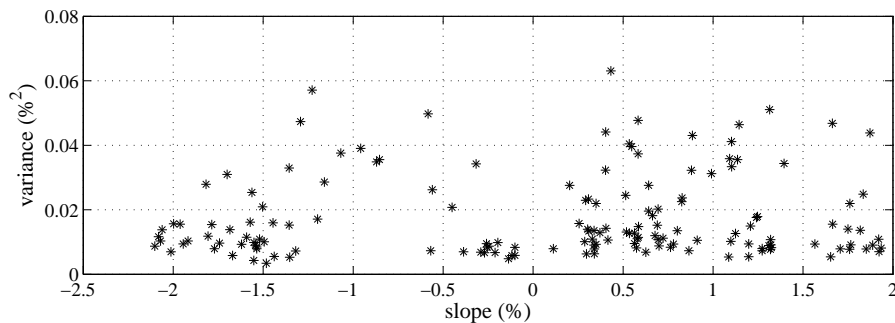
Figure 3.15: The variance in slope measurements as a function of the average measured slope. Data around pipe joints and individual pipes are combined.

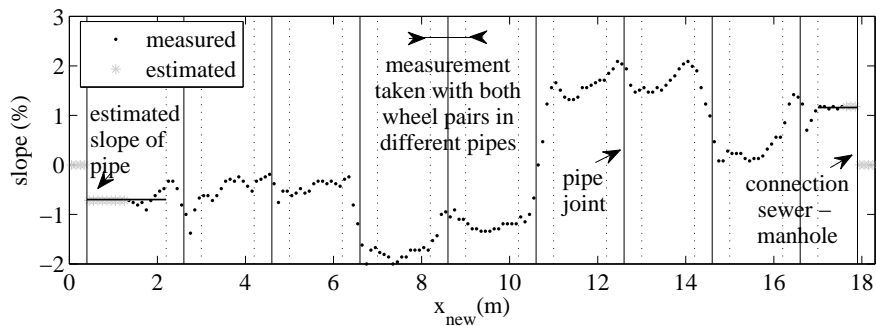
Figure 3.16: Measured and estimated values of slope measurement 9.

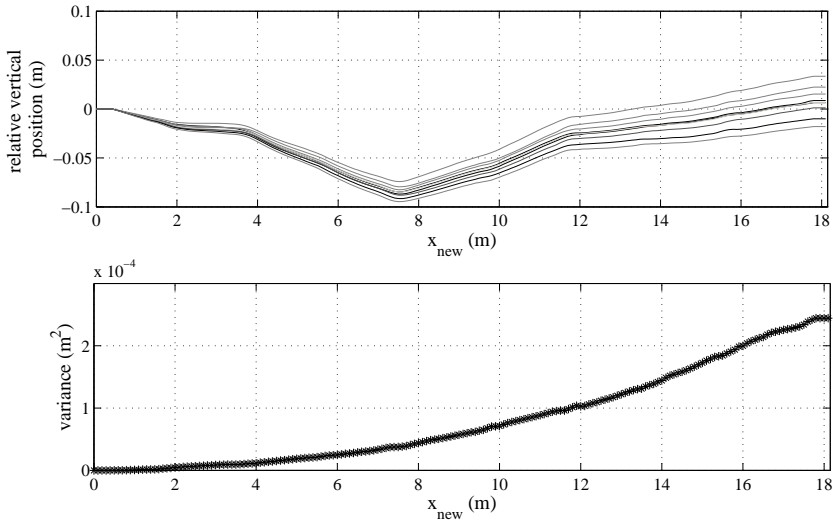
Figure 3.17: Upper graph: the resulting sewer invert profile for the 9 measurements. Lower graph: the variance in the vertical position along the sewer length.

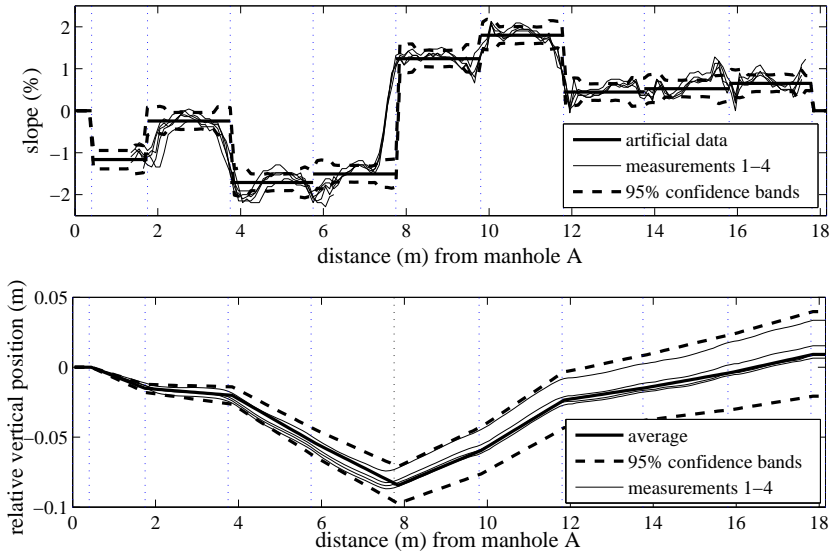
Figure 3.20: Confidence bands for the expected results of the measurement of a sewer with a profile similar to the measured sewer.

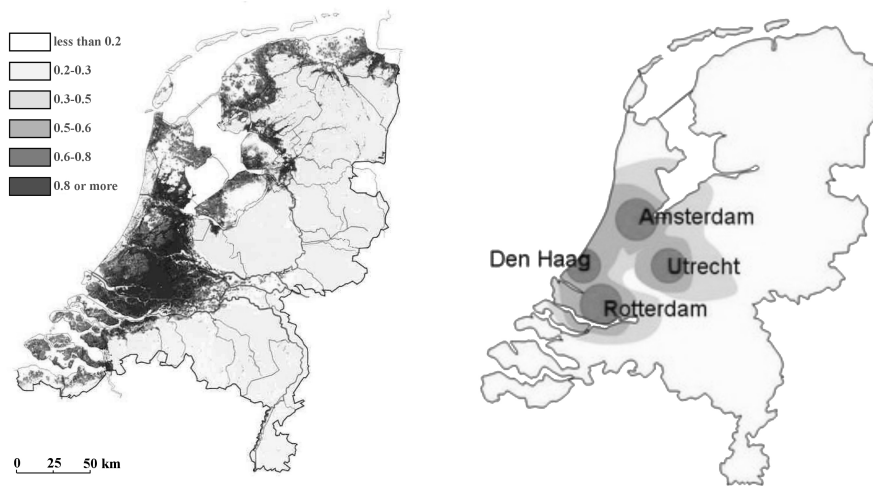
Figure 4.1: Left: expected settlement in meters when applying 1 meter of sand. Right: map of the Netherlands, the shaded area indicate the Randstad.

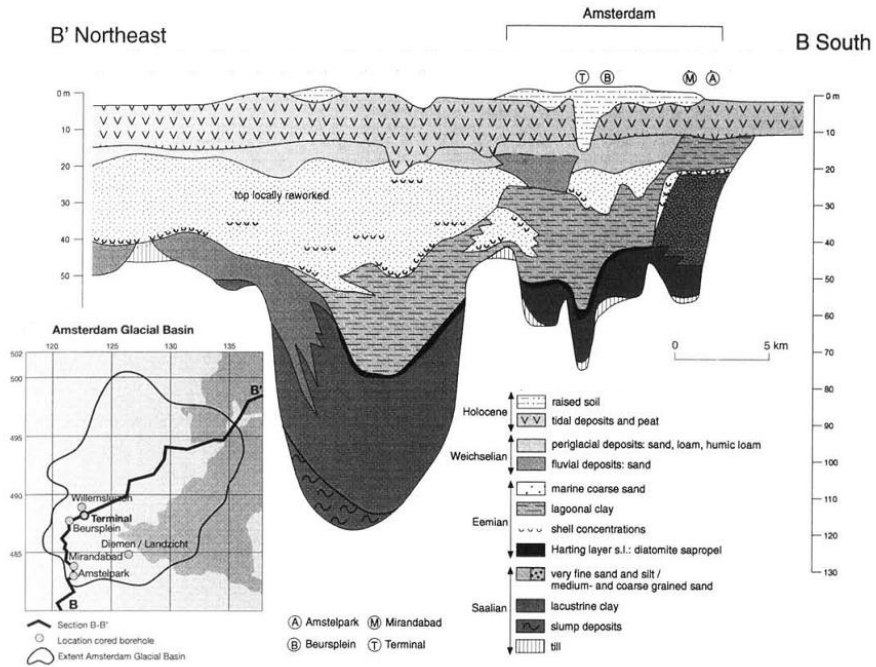
Figure 4.3: Cross-section of the Amsterdam glacial basin [De Gans and Wassing, 2000]. The axis on the left and the right are equal and indicate the depth of the layers in meters relative to NAP. The small figure on the bottom-left shows a map of the Amsterdam glacial basin with an indication of the location of the depicted cross-section. Dark areas on the map indicate water, the lighter areas are land (in the current situation).

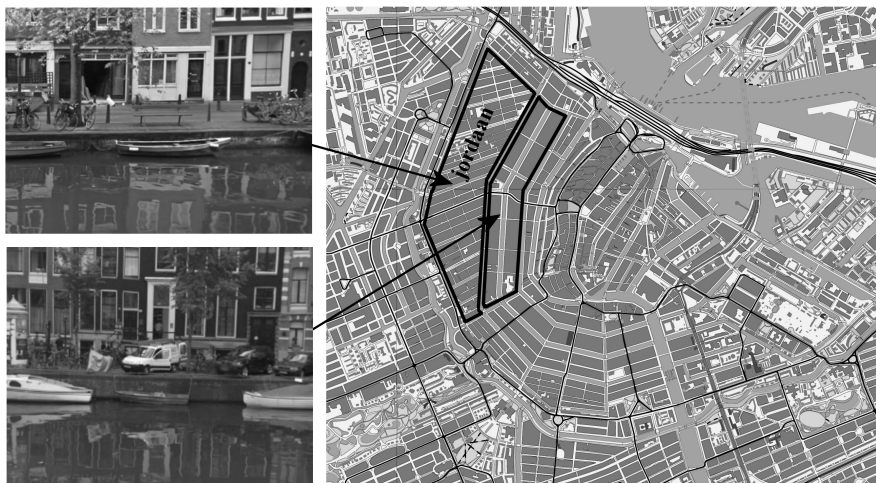
Figure 4.4: The Amsterdam city centre. On the map the neighbourhoods developed around 1615 are indicated.

Figure 4.4 shows a map of the centre of Amsterdam. To allow for city growth, two neighbourhoods were developed around 1615. On the map it can be seen the channels in the town centre follow a circular pattern with the dam square as the centre. Most small channels connecting the larger ones are laid-out perpendicular to the channels, like the spokes of a wheel. A clear exception is the Jordaan neighbourhood. As the Jordaan neighbourhood was meant to residence the less-fortuned, little money was spent on the development of the area. Where for the other, more upscale, neighbourhood the material that came free with the digging of the channels was used to elevate the ground level, ground conditions in the Jordaan area were hardly improved. The difference in ground level is still apparent today. As can be seen on the photographs of figure 4.4, the difference between the water level and the ground level is much smaller for the Jordaan area (same water level in both areas).

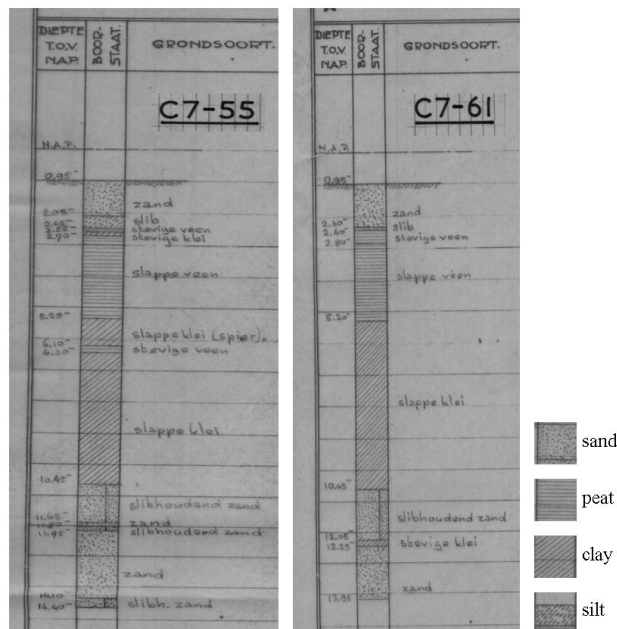
Figure 4.5: Sedimentary log, cored borehole, October 1929.

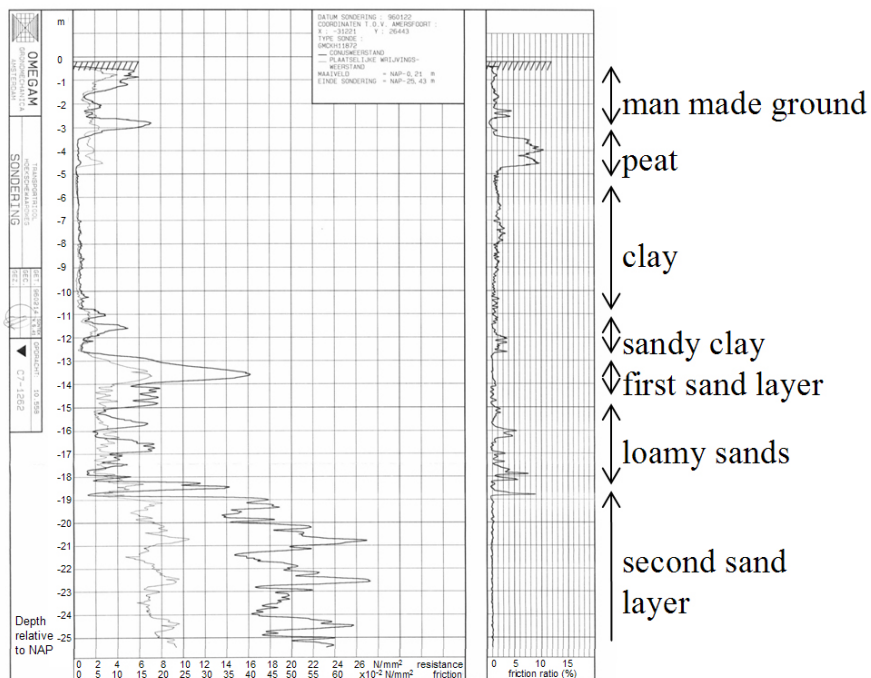
Figure 4.6: CPT result. Left hand graph: resistance (thick line) and friction (thin line), right hand graph: friction ratio. May 1996.

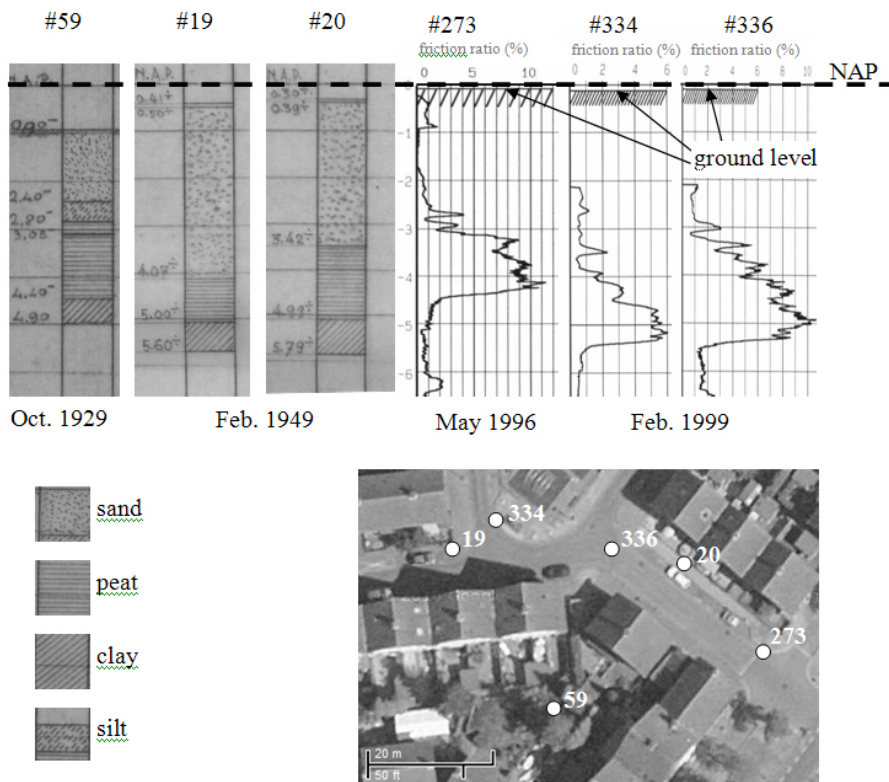
Figure 4.7: Top, from left to right: a graph indicating the soil composition before ground elevation, 2 graphs indicating the soil composition after elevation with dredged sediments and one graphs indicating the results of a cone penetration test in 1996 and two in 1999. The numbers above the graph refer to the drilling location shown on the map at the bottom of the figure.

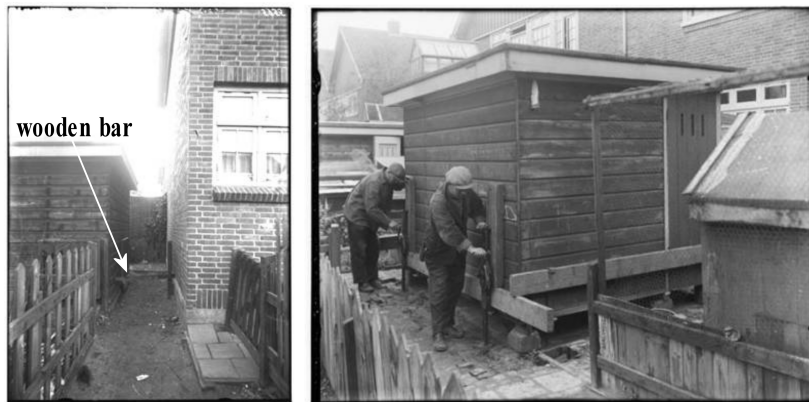
Figure 4.8: Left: difference in ground settlement between a structure with (brick house) and without (wooden shed) a piled foundation. The wooden bar indicates the level of the base of the shed after construction. Right: people jacking up a shed. Photographs taken in 1935.

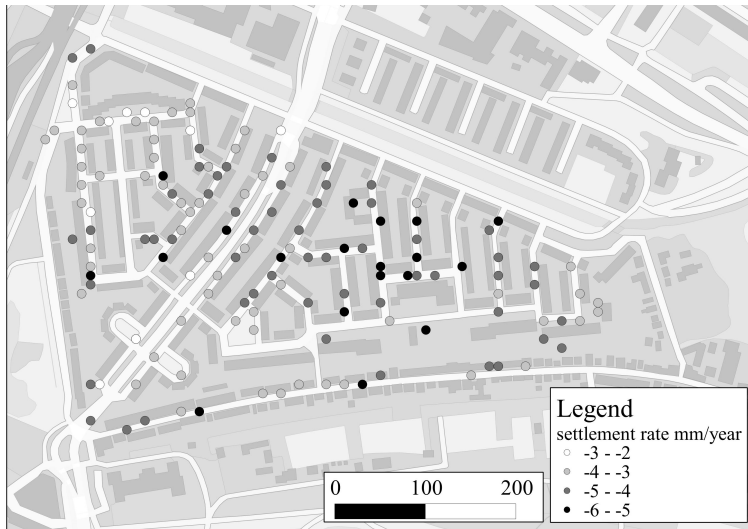
Figure 4.9: Estimated settlement rates in mm year^{-1} (distance in meters).

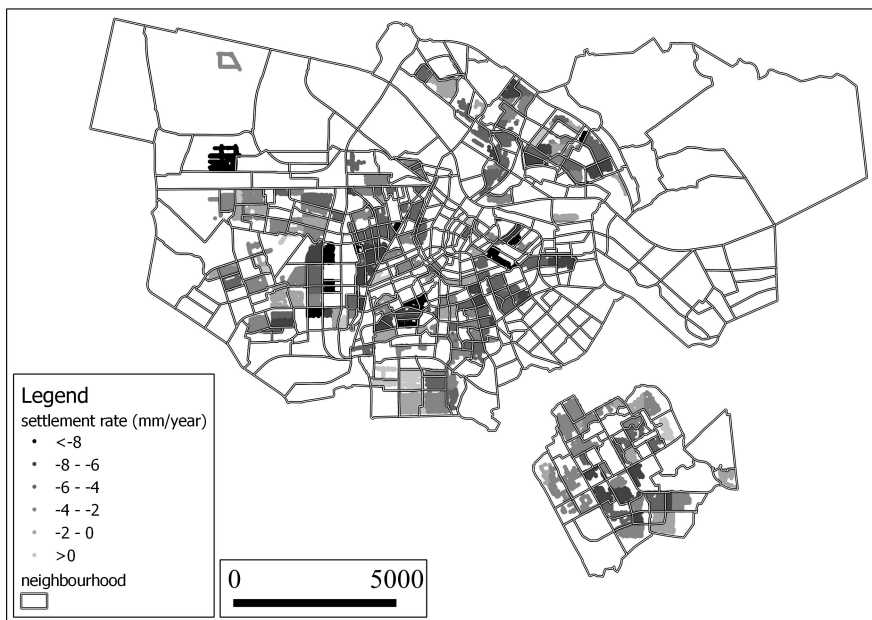
Figure 4.13: Settlement rate for the (sub-) neighbourhoods of Amsterdam (distance in meters).

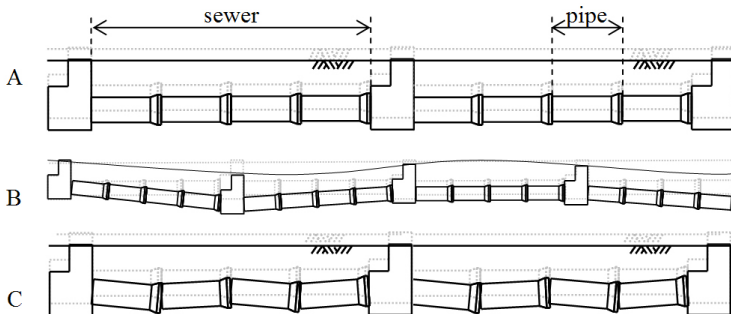
Figure 5.1: Differential settlement: A) no settlement difference, B) network level: settlement differences between manholes, C) pipe level: differential settlement of pipes.

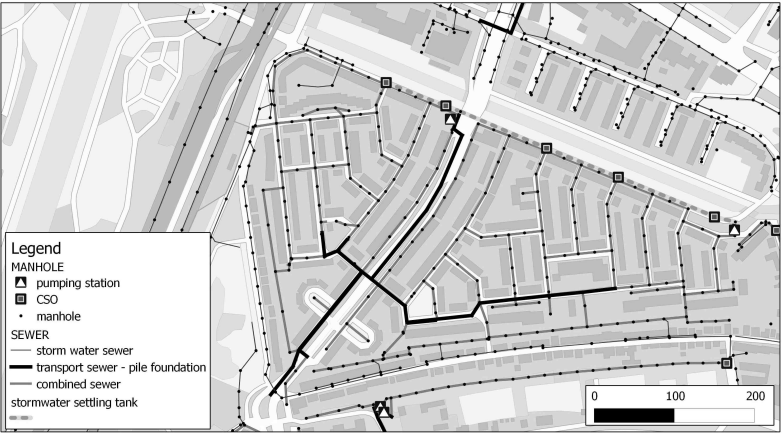
Figure 5.2: Typical layout of a combined sewer system in Amsterdam (distance in meters).

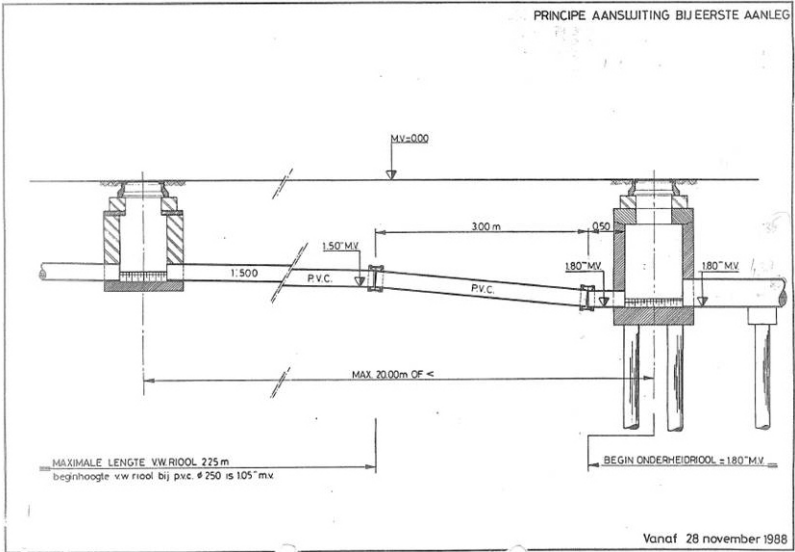
Figure 5.3: Design of the hinge sewer, a sewer with a shallow foundation connected to a manhole with a deep foundation.

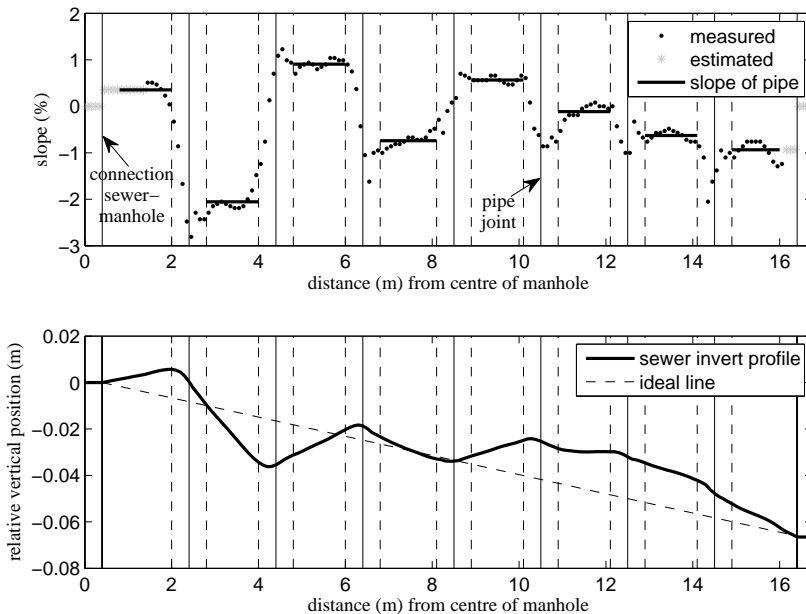
Figure 5.5: Example of a concrete sewer with a shallow foundation.

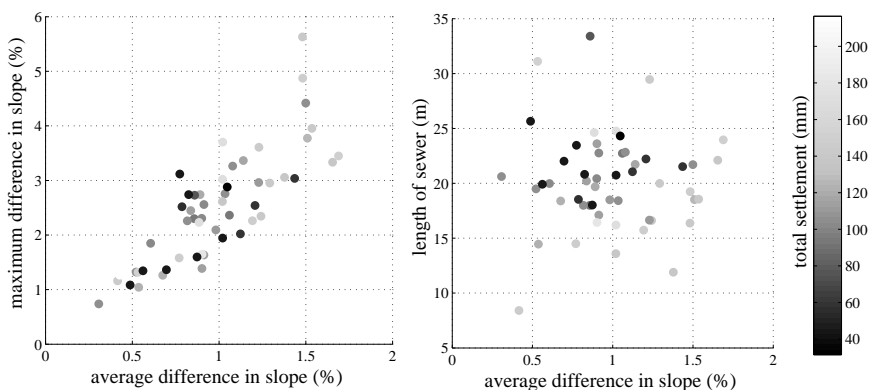
Figure 5.6: Relation between the average and maximum slope difference between neighbouring pipes and average slope difference and sewer length, the gray scale indicates the total settlement.

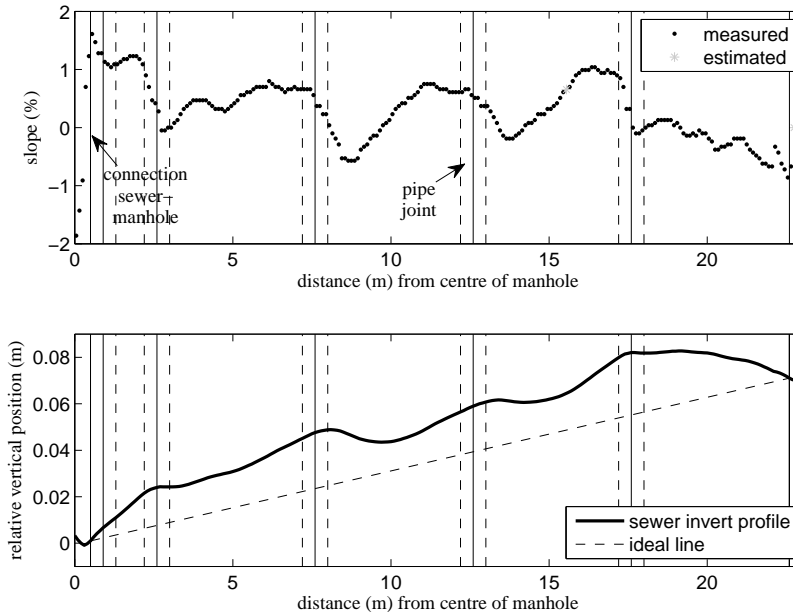
Figure 5.7: Example of a PVC sewer with a shallow foundation.

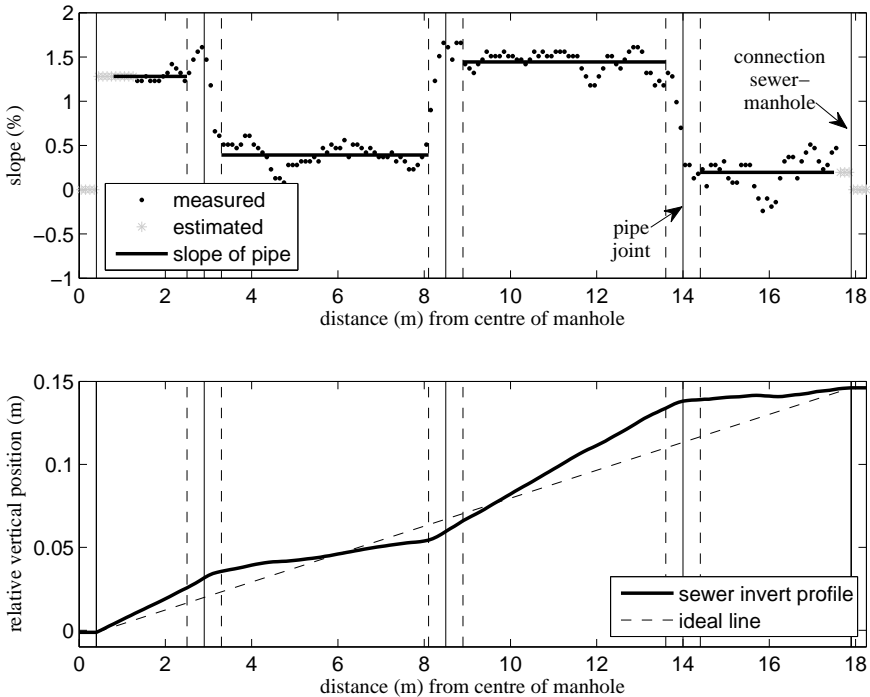
Figure 5.8: Example of a cast iron sewer with a shallow foundation.

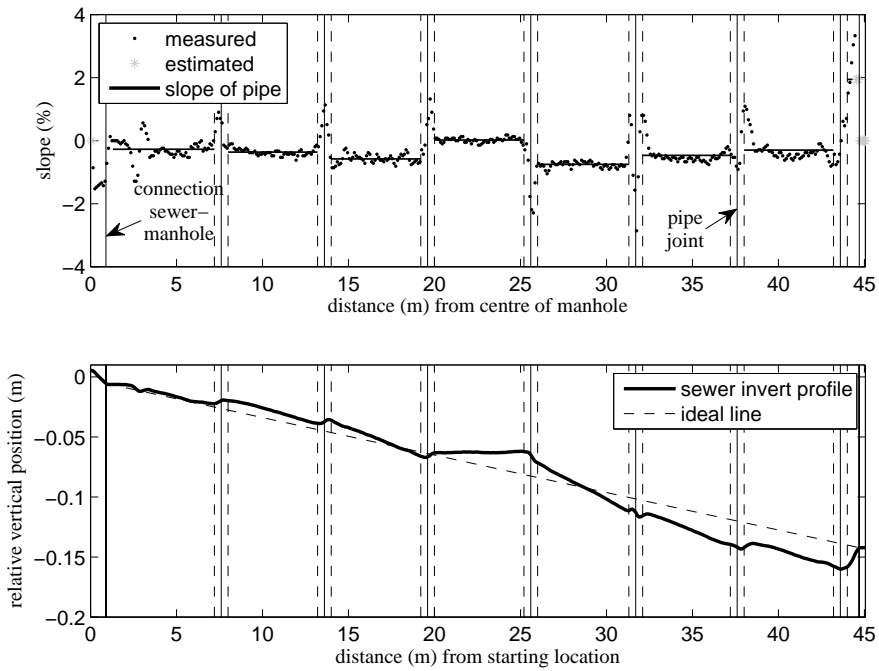
Figure 5.9: Example of a cast iron sewer with a pile foundation.

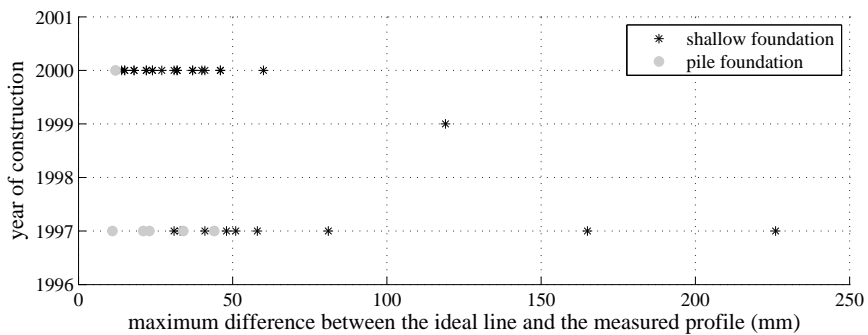
Figure 5.10: Comparison between sewers with and without a pile foundation on the maximum difference between the ideal line and the invert level.

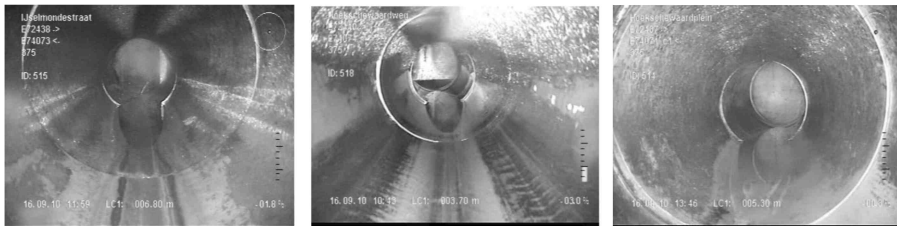
Figure 5.11: Photographs of hinge sewers made of PVC and constructed in 1997 showing small sags just in front of the manhole with a deep foundation.

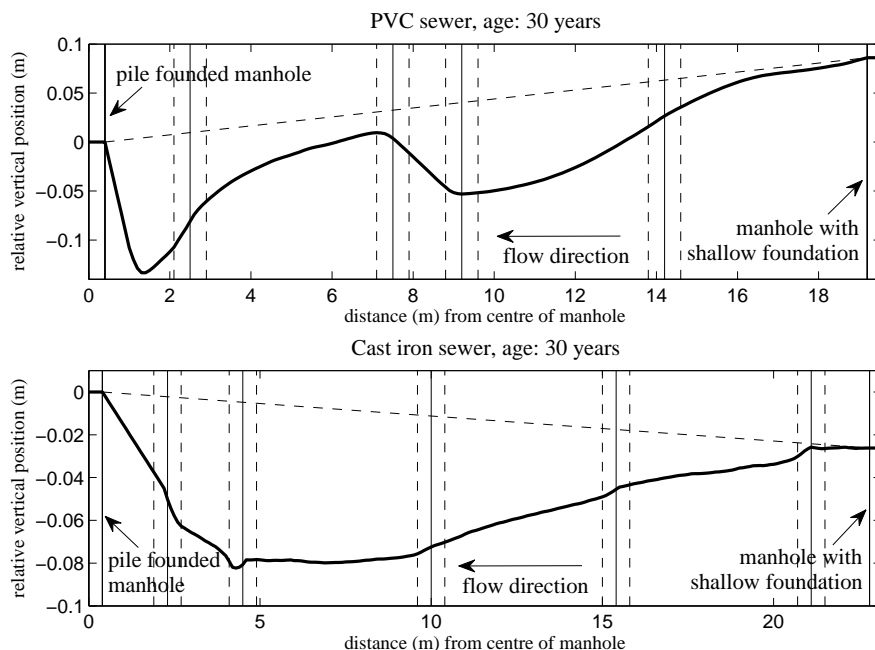
Figure 5.12: Sewer invert profile of two hinge sewers.

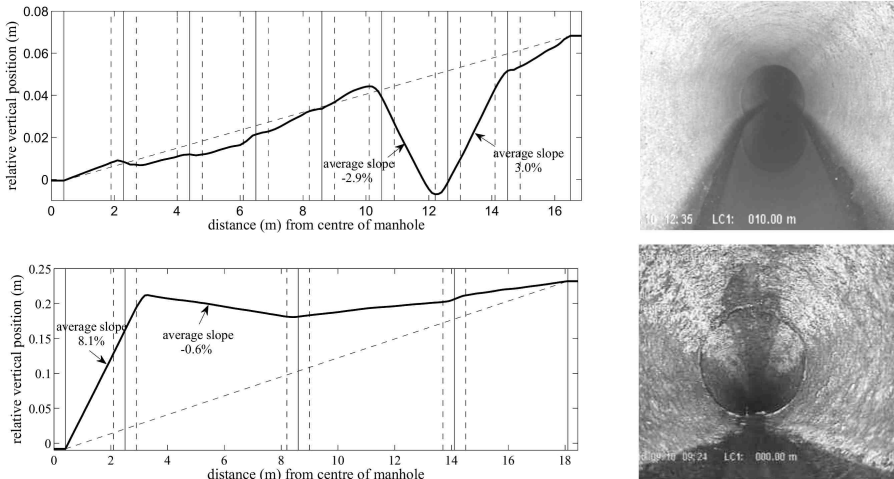
Figure 5.13: Concrete sewer (upper graph and picture) and cast iron sewer (lower graph and picture) with the largest difference in slope of between neighbouring pipes.

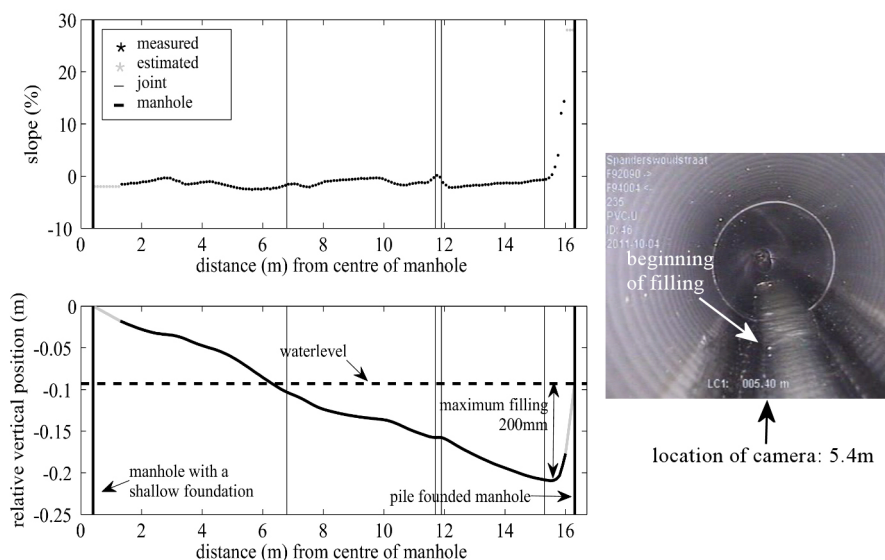
Figure 5.15: Example of the sewer invert profile of a hinge sewer. The photograph on the right shows the location of the beginning of the sag.

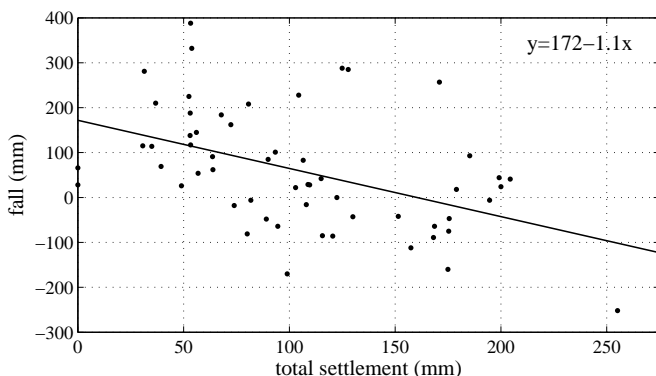
Figure 5.17: Relation between the total settlement and drop in level over the length of the hinge sewer.

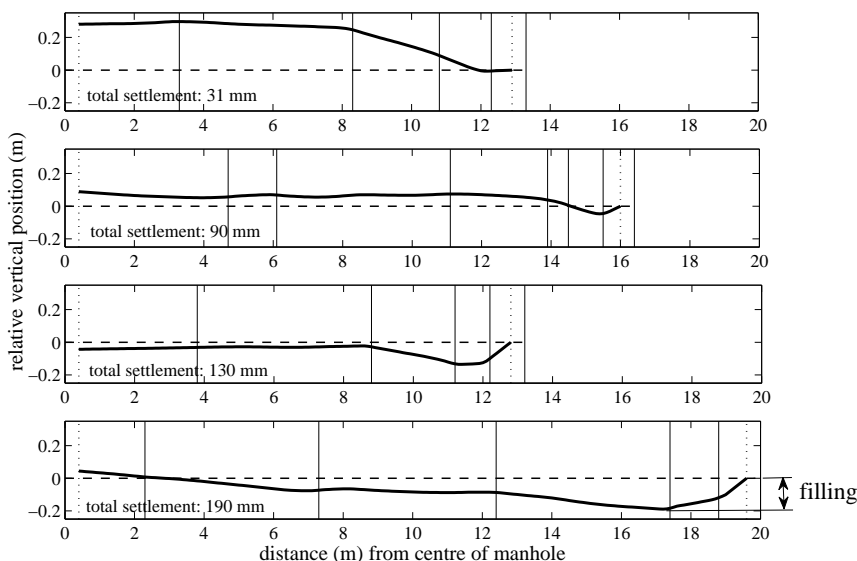
Figure 5.18: Examples of sewer invert profile at different stages of the settlement process. The flow direction is from left to right; the pile founded manhole is on the right.

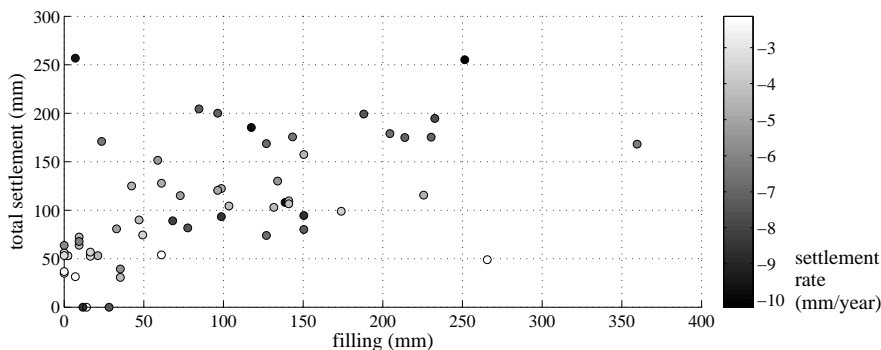
Figure 5.19: Relation between the total settlement and the filling. The gray scale gives an indication of the estimated settlement rate.

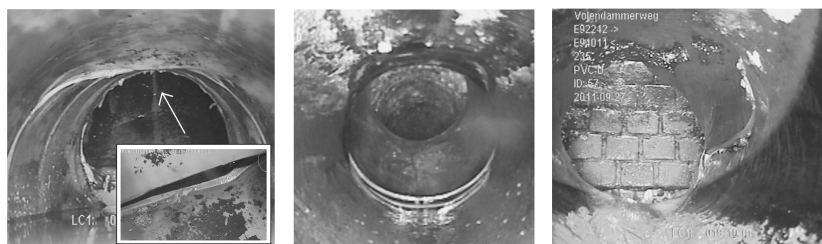
Figure 5.20: Examples of hinge sewers with severe defects.

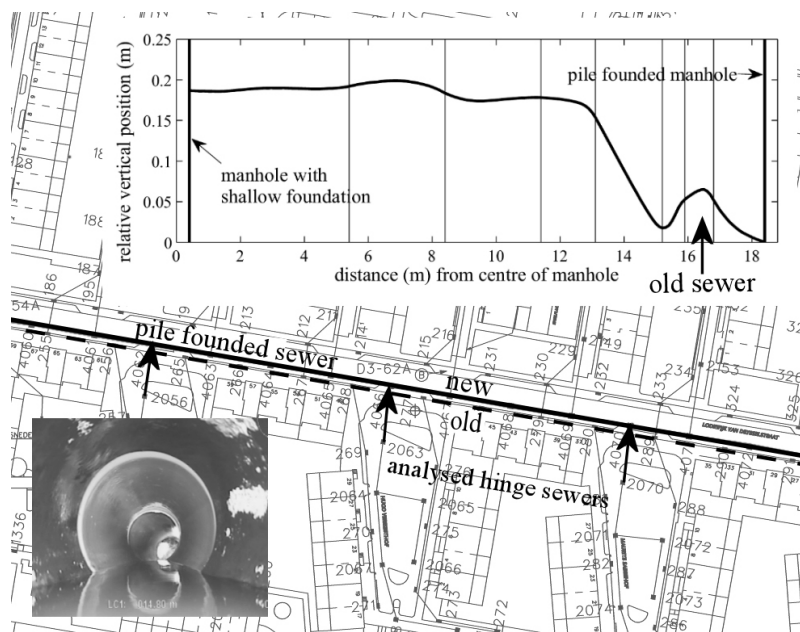
Figure 5.21: Sewers crossing an old pile founded sewer.

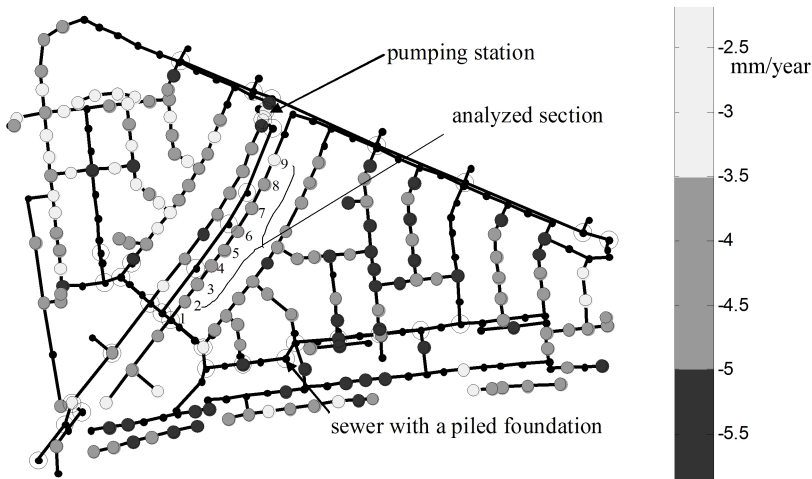
Figure 6.1: Estimated settlement rates in $mm\ year^{-1}$. Manholes are depicted by a dot; the gray scale of the large dots indicates the settlement rate. The small black dots represent manholes for which not enough data was available to give a reliable estimate. Manholes with a piled foundation can be recognized by an larger open circle.

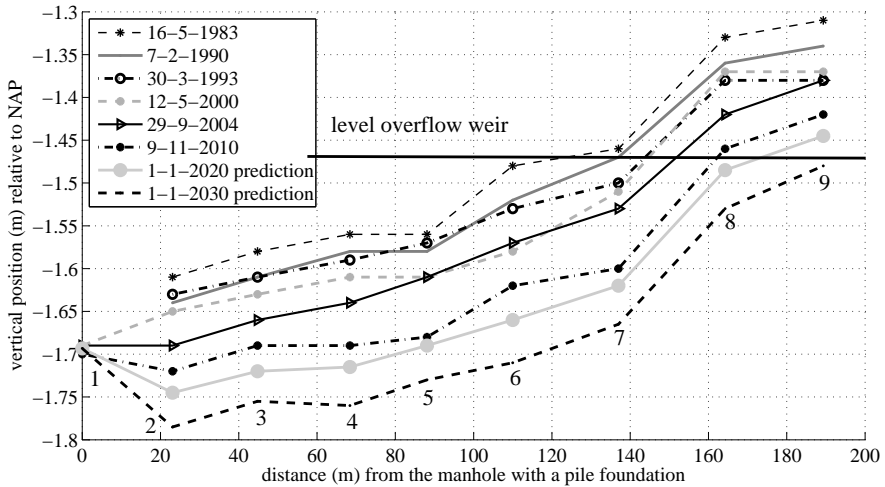
Figure 6.2: Longitudinal profile of sewer invert of the sewer section indicated in figure 6.1.

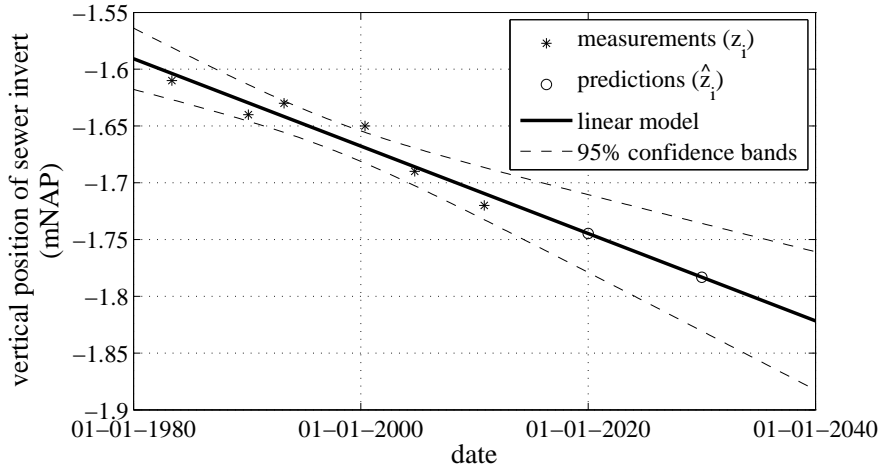
Figure 6.3: Measurement data of an individual sewer invert. The dashed lines indicate the 95% confidence bands for the estimation of y values (solid line).
