Monitoring ground settlement to guide sewer asset management

Proefschrift

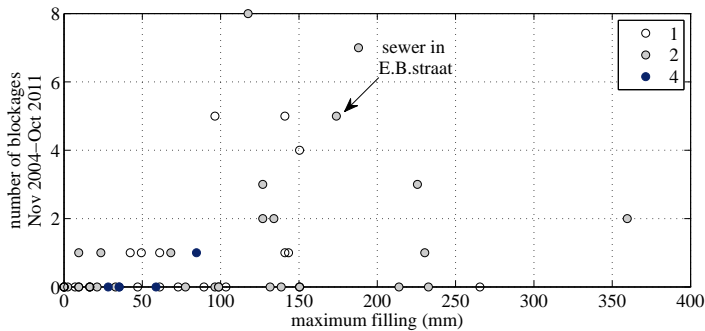
Figure 6.9: Relation between filling and blockage frequency. The gray-scale indicate the number of proactive cleaning activities.

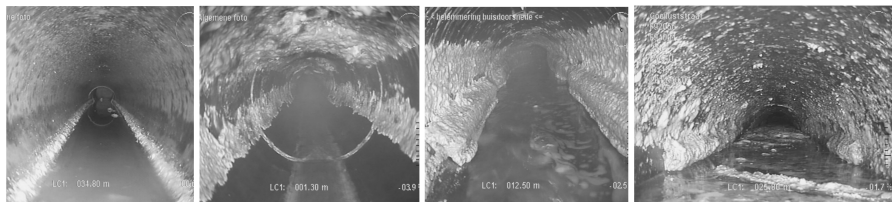
Figure 6.11: Some examples of FOG deposits.

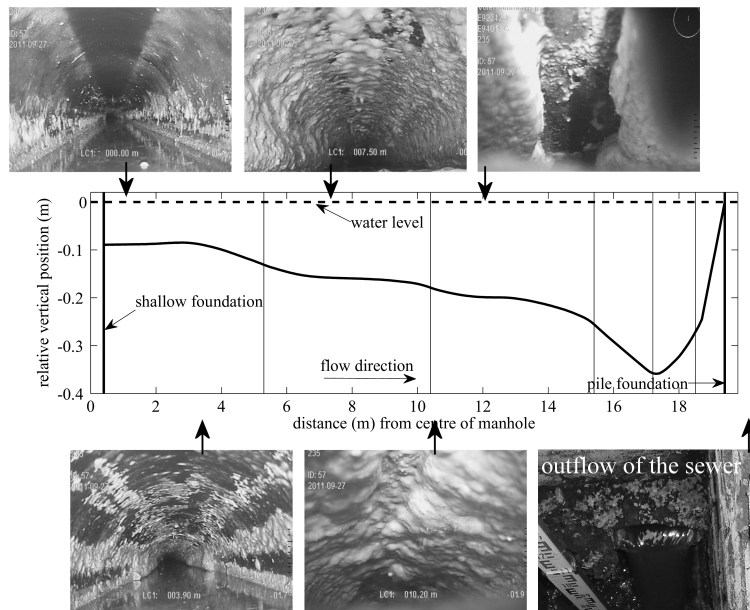
Figure 6.12: Inspection result of a sewer with a filling percentage of 100%. The graph represents the vertical cross section of the sewer.

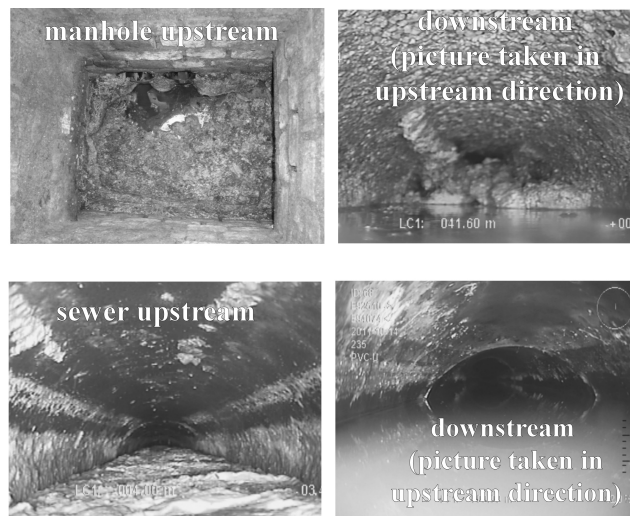
Figure 6.13: Two examples of sewers with a (partial) blockage. Of each sewer there are two photo's: one upstream and one downstream of the blockage.

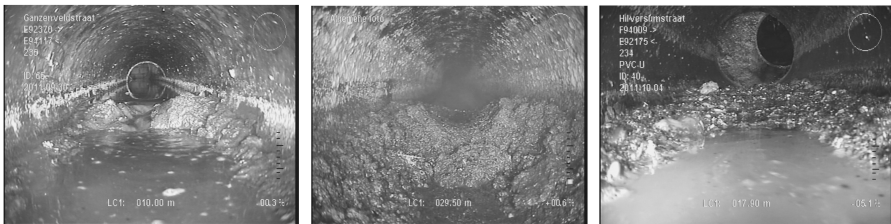
Figure 6.14: Some examples of settled deposits.

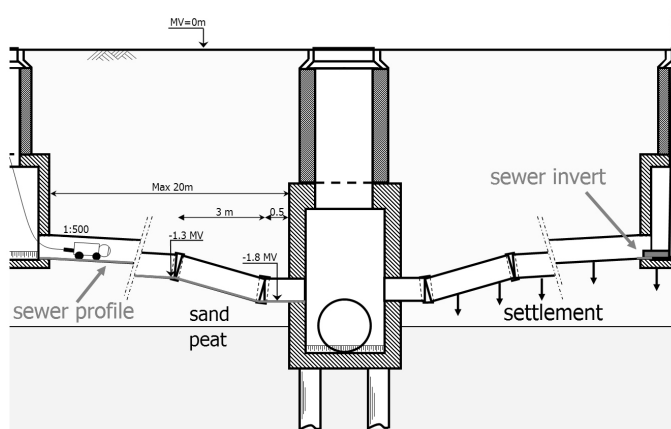
Figure 2: monitoring (differential) settlement: sewer profile and sewer invert measurements. The sewer in the middle of the figure is a pile founded manholes, the sewer connected to this manhole are hinge sewers. For the left hinge sewers some specifications of the design of a hinge sewer are indicated.

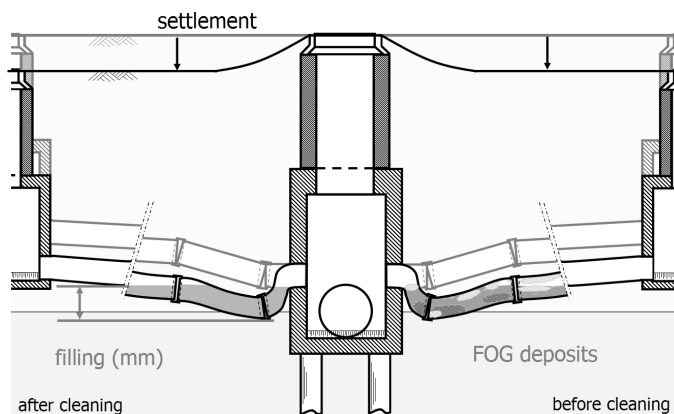
Figure 3: Differential settlement of a hinge sewer made of PVC.

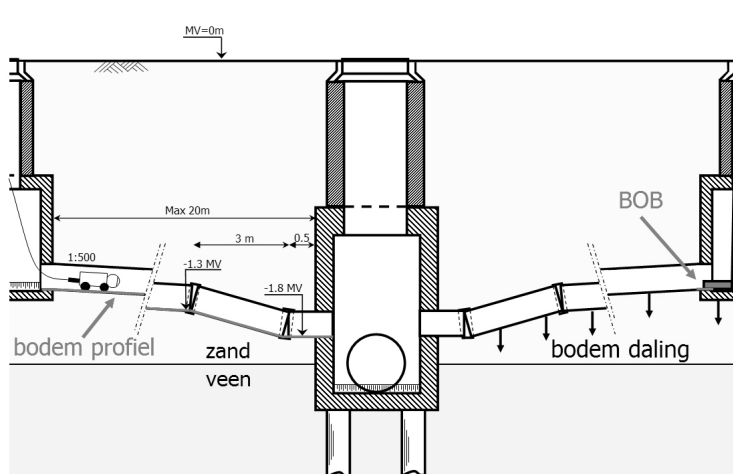
Figuur 2: Meten van het bodemprofiel van een riool en de verticale positie van een BOB. De put in het midden van het figuur is onderheid. De niet onderheide riolen die hierop aansluiten zijn pendel riolen. De ontwerp waarden voor het linker pendelriool zijn aangegeven in de figuur.

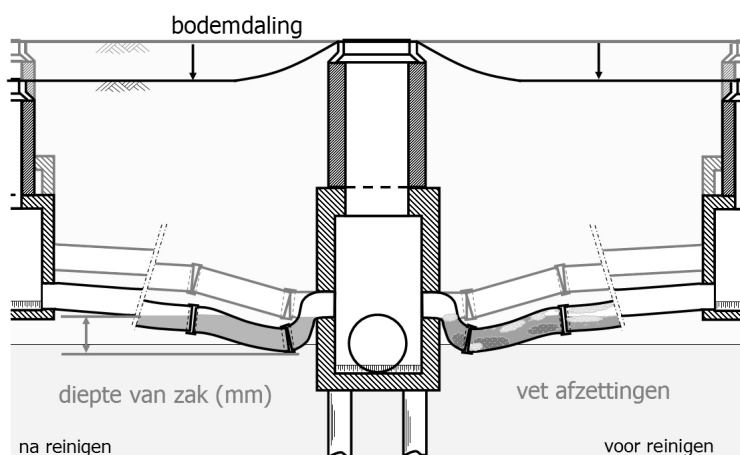
Figuur 3: Ongelijke zetting van een pendel riool gemaakt van PVC.
