Low-land Gully Formation in the Amhara Region, Ethiopia

Visualizing the role of subsurface flows in gully formation in the Minizr sub-catchment of North-West Ethiopia

Pim Rijkee
MSc Minor thesis
Wageningen UR
SLM Group

Minor MSc Thesis

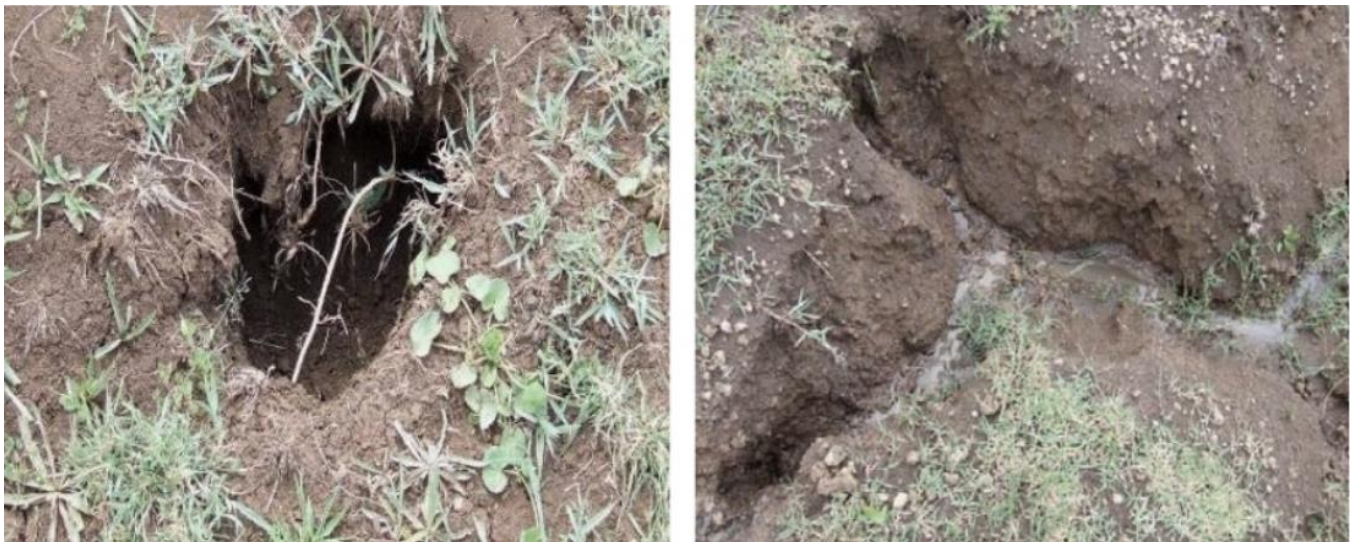
Figure 1: Evidence of piping processes in the Debre-Mawi watershed: pothole and smaller pipe (left) and a concentrated water outflow in a rill bank (right). Source: Mengisti, 2011.

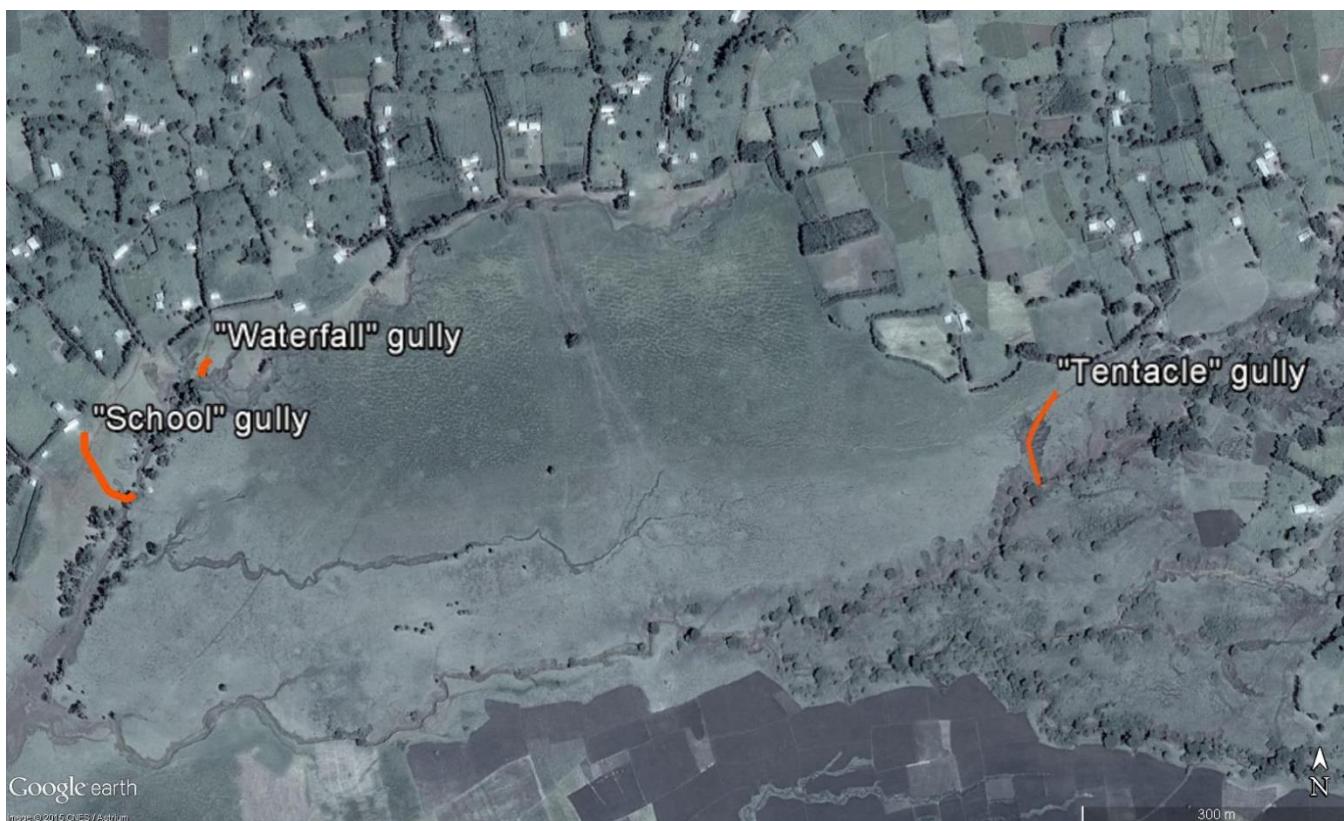
Figure 3: detail of marked area in Figure 2 (inset), location of the selected gullies in the study area. The course of the gullies as of year-end 2014 has been indicated in orange, on aerial imagery dated 2013. Image source: Google Earth, imagery copyright CNES/ASTRIUM 2015.

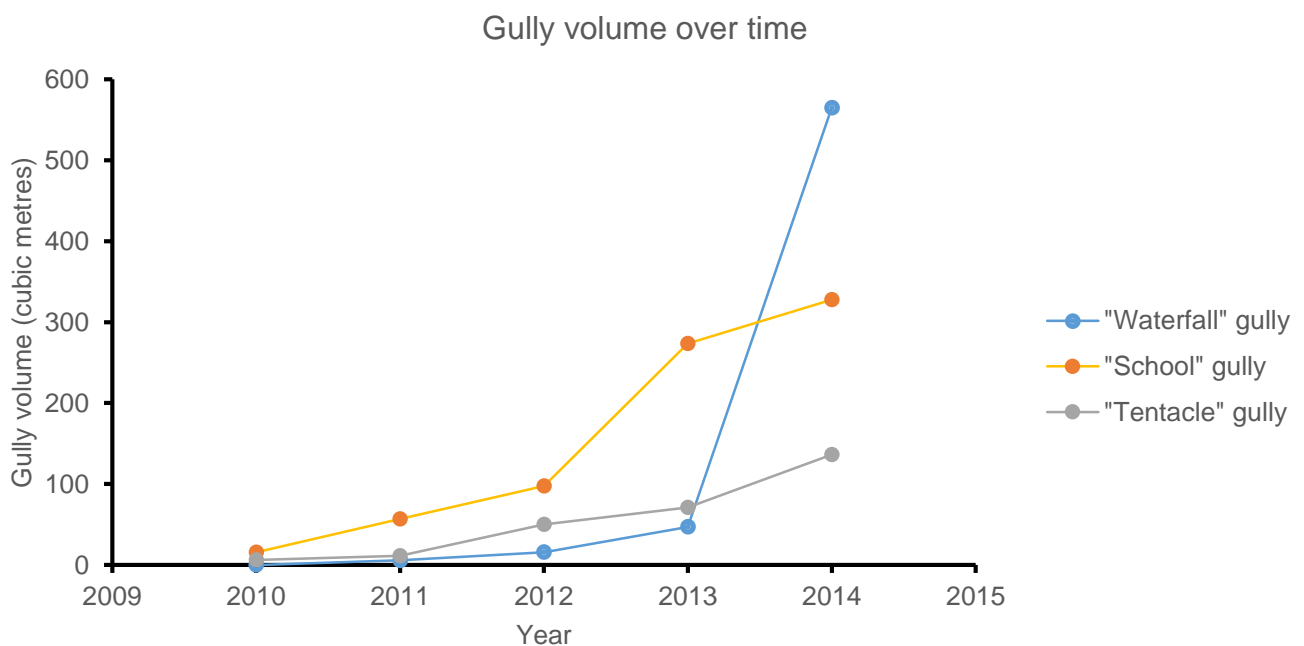
Figure 14: The Cumulative volumes for three researched gullies, from 2010 to 2014. The volumes have been derived from length measurements on aerial photographs (2010-2013) and through terrestrial photogrammetry (2014).

The volume has grown for all three gullies. The "Waterfall" gully showed the biggest jump in eroded volume, in the 2014 rainy season.

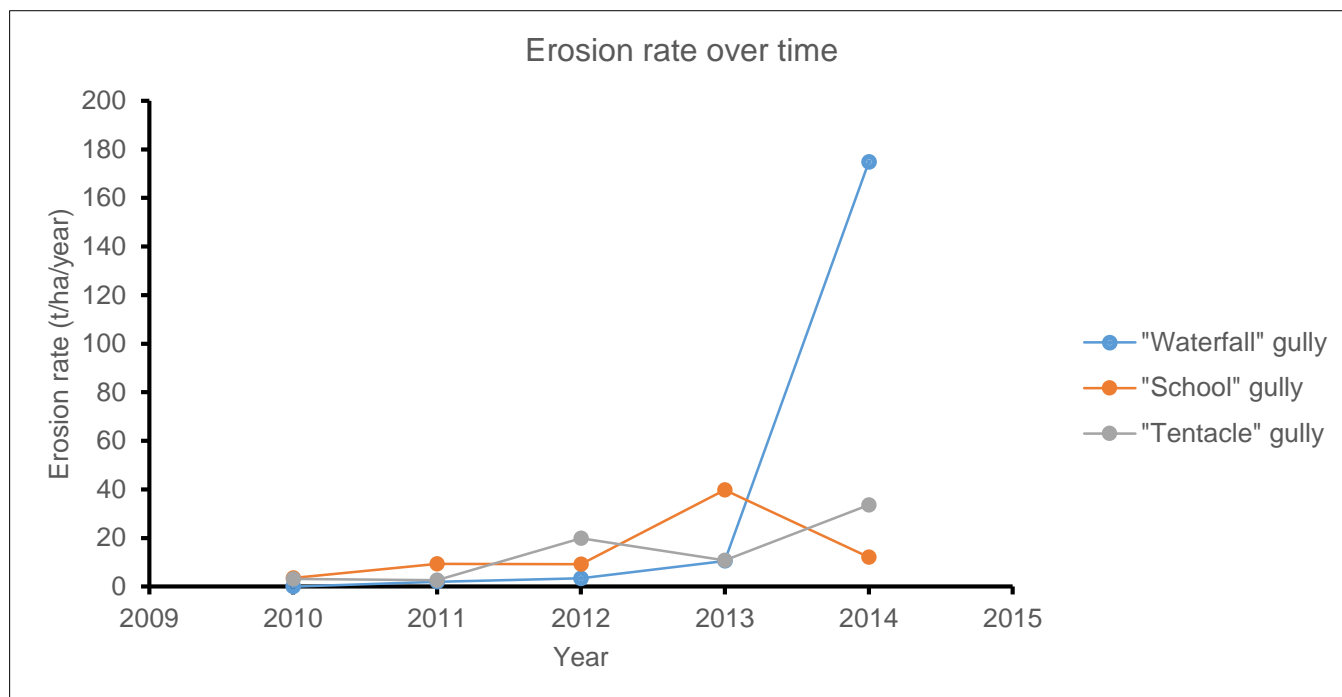
Figure 15: Erosion rates in tonnes per hectare per year for the period 2010-2014, per gully.

To see if there is a difference between the erosion *rate* before and after 2010, one must compare the erosion rate in tonnes per hectare per year. For the 2010-2014 period these rates have been calculated from the gully volumes in Figure 14. The ArcGIS procedure to delineate watersheds contributing to the researched gullies delivered satisfactory results for “Tentacle” gully (2.45 ha), but unsatisfactory results for “Waterfall” and “School” gully (both <1 ha). The resulting watersheds of the latter two were shown as a single diagonal line instead of an area. For these, the watersheds were determined manually, using the contour lines from the 3m-resolution DEM. The resulting sizes were 3.44 ha for “Waterfall” gully and 4.58 ha for “School” gully. Dividing the gully volumes by these areas and multiplying by the average bulk density for each respective gully resulted in the erosion rates for 2010-2014 (Figure 15). Figure 16 shows the average erosion rates for the three gullies.

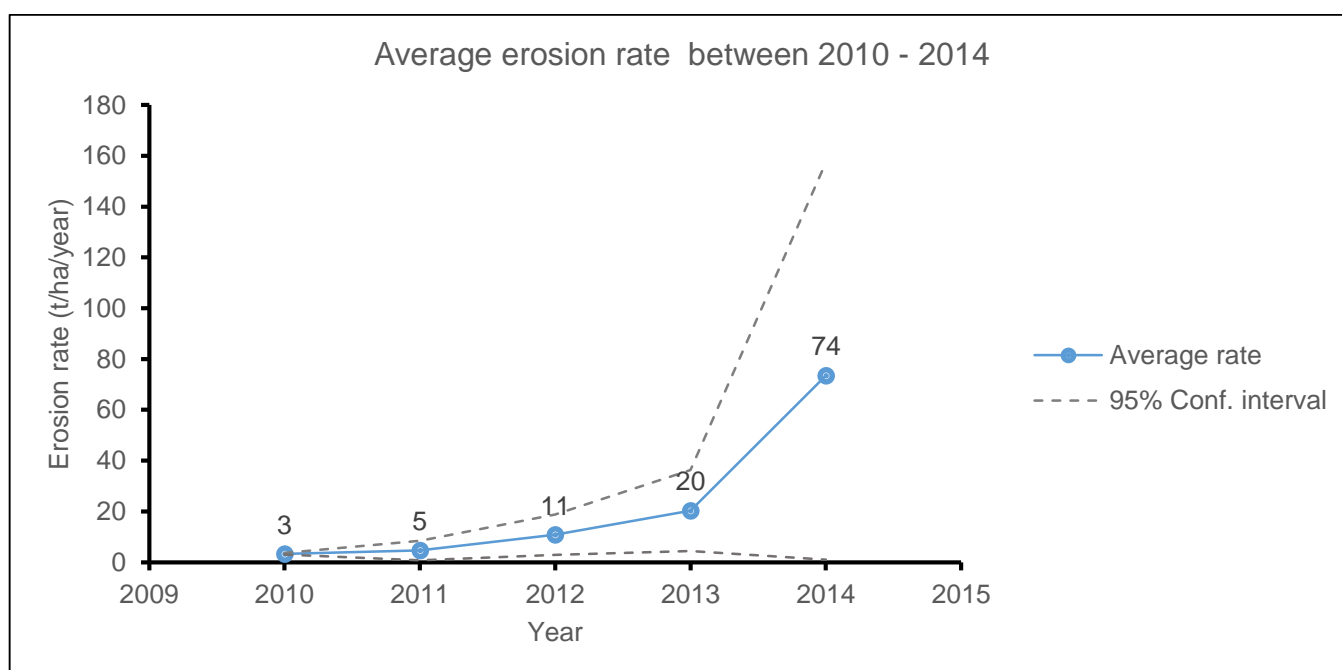
Figure 16: Average erosion rate for all three researched gullies over 2010 - 2014. The 95% confidence interval for the mean has been added.

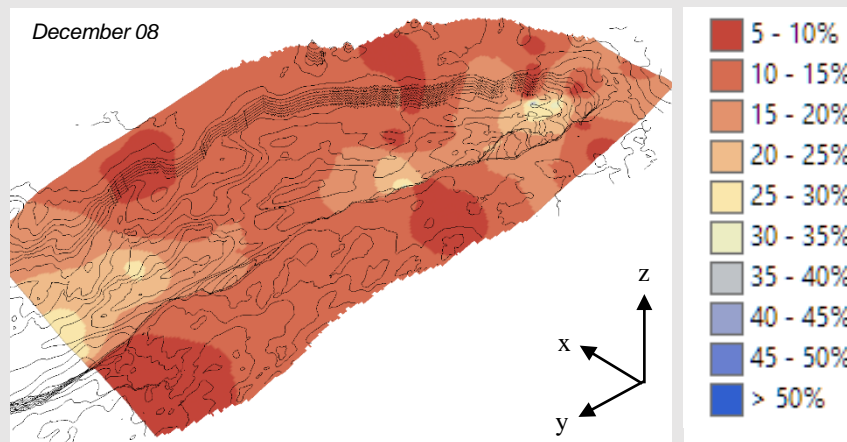
December 8 was the last measurement with yielded a value over 35% moisture, whereas the rest of the gully had dried by this time. The wet spot (barely visible on the image) was taken at the bottom of the gully head.

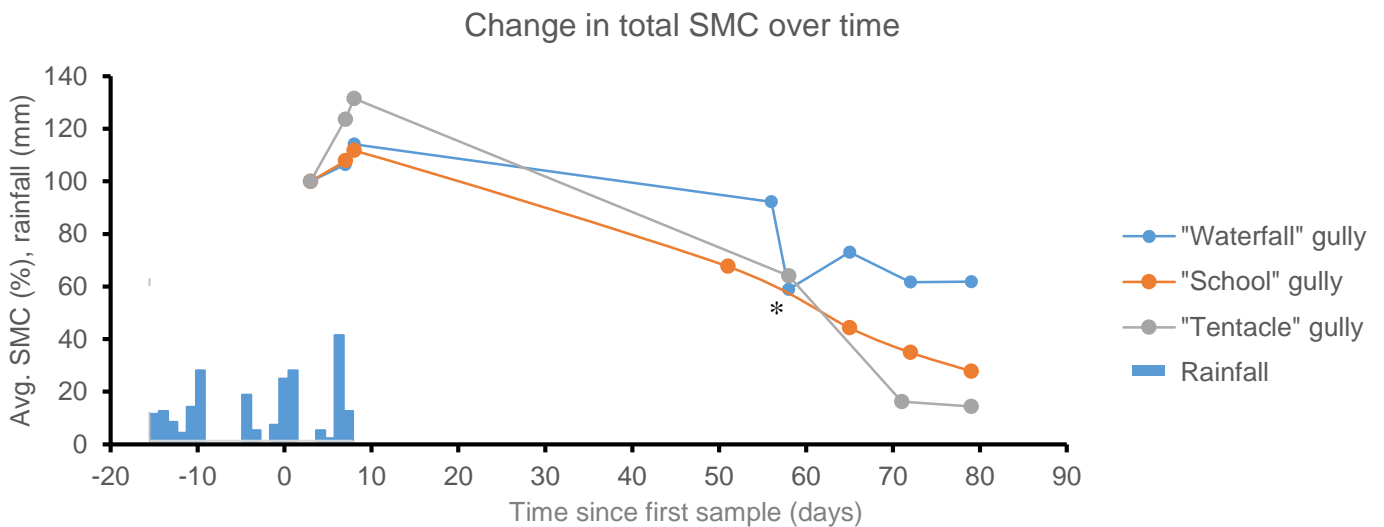
Figure 22: Change in total soil moisture content during the study period, per gully, and rainfall. The values at the first sampling date for each gully serve as reference point (100%). The asterisk indicates a sample date for “Waterfall” gully that has some missing values. Day 0 is the first sampling date, September 27, 2014.

Figure 22 presents the total amount of soil moisture and its trend throughout time, to give a better overview of the SMC distribution maps presented above. Absolute values were different for each gully due to size, so all values were compared to the values for the first sampling date for that gully, which was assigned a reference value of 100. The overall trend is similar for all gullies: first, the values increase for all gullies, before falling when the dry season progresses. The soil moisture peak trails the last rain day. Time off and lack of transport to the study area caused the 30-day data gap.

As for the trends in the individual gullies, the “Waterfall” gully has the most stable SMC totals. Together with “School” gully, its moisture peak is not as pronounced as “Tentacle” gully’s. In addition, its decline is the slowest of the three gullies. Missing data for a set of sampling points has caused the outlier at day 58: the values for the completed points at that day do fit in the overall downwards trend. The “Tentacle” gully has shown the most pronounced trend: it first shows the highest total SMC value, before its decline. The decline is the fastest out of the three gullies and drops to the lowest level. The “School” gully has a very linear downwards trend, more so than the other two gullies.

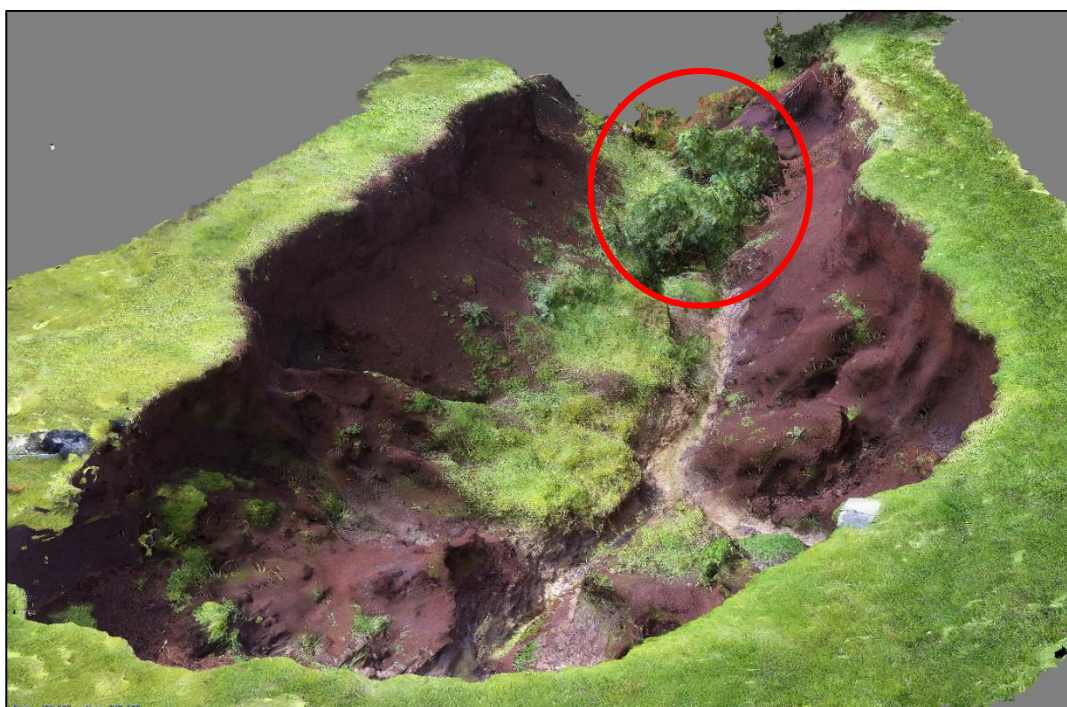
Figure 27: Looking from the gully head to gully exit, and example of the representation of vegetation in a 3d model. The bushes (circled) in "Waterfall" gully are part of the surface.
