**STUDIES OF
SOIL EROSION AND SEDIMENTATION
IN TANZANIA**

Edited by Anders Rapp, Len Berry & Paul Temple

CONTENTS

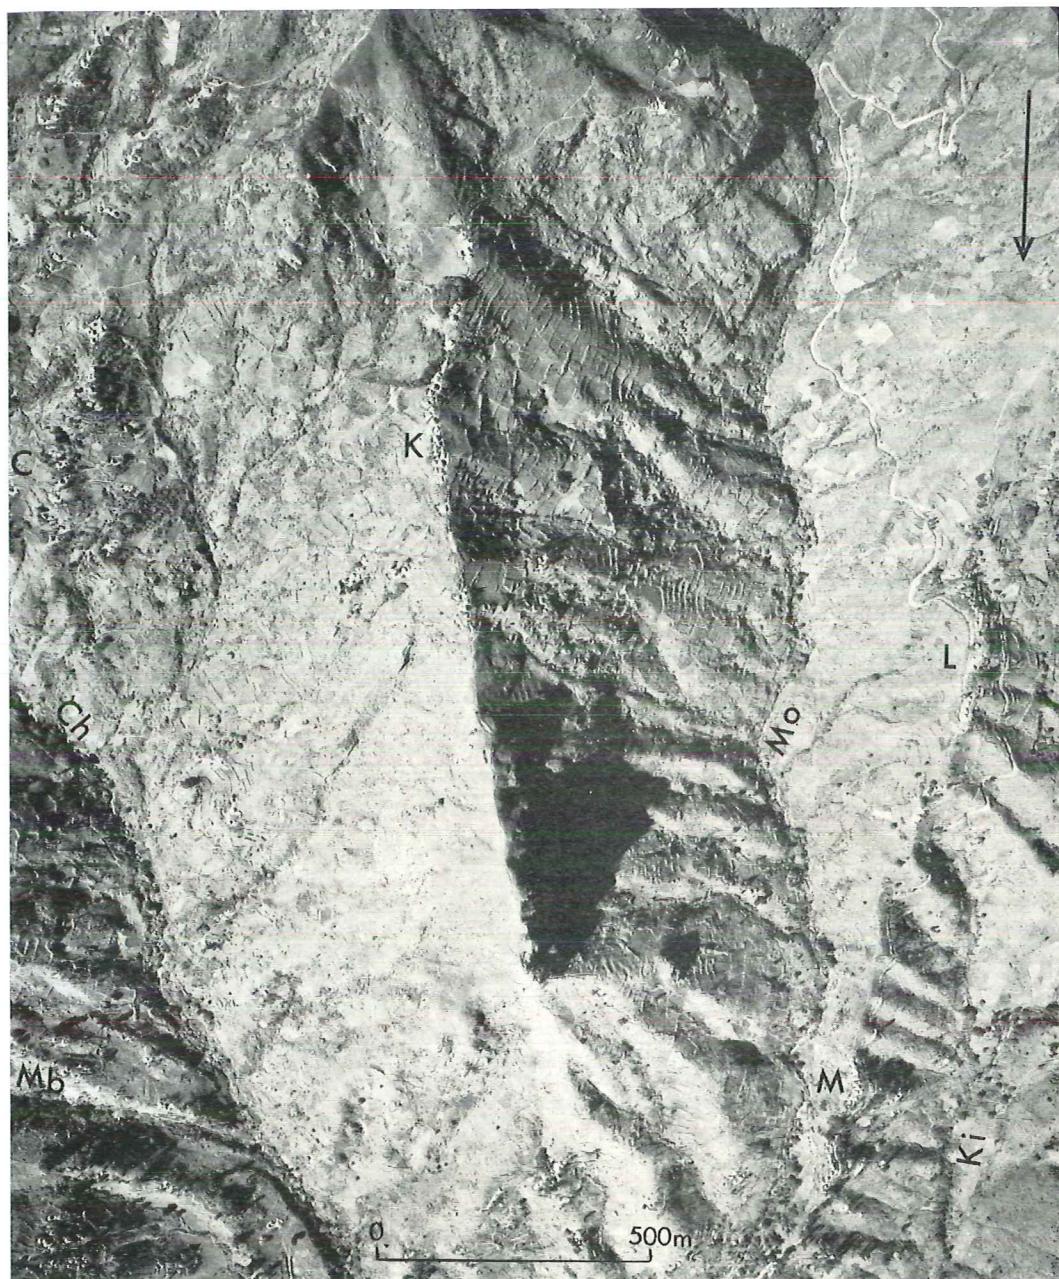
Fig. 3. Vertical air photograph of part of the Morogoro catchment. Mb, Ch, Mo and Ki = Mbete, Choma, Morningside and Kikundi streams. C, K, M and L = Choma, Kisosa, Mgongo and Luvuma villages. Photo Spartan Air, June 1970.

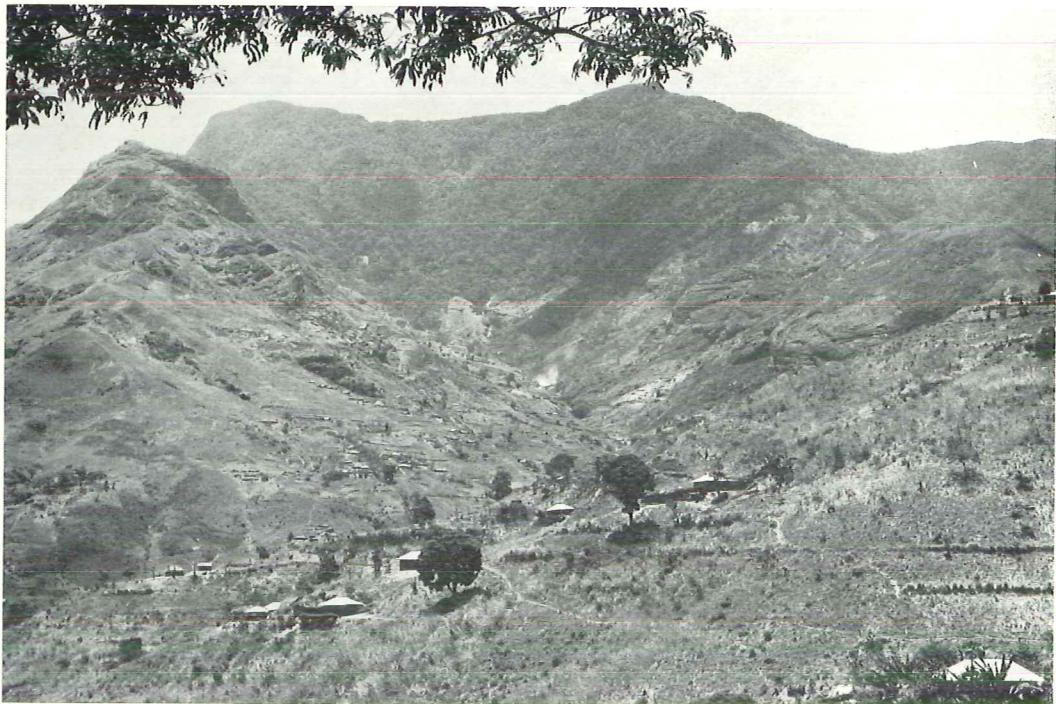
Fig. 4. Mbete valley, Morogoro river catchment. Lupanga ridge (2138 m) with montane rainforest on steep slopes in the background. The rocky, forest-free peak of Kileka (1360 m) to the left with steep cleared slopes and Mbete village in centre of picture. In foreground mainly slopes with grass fallows at 800 m altitude E of Tewero School. Note grass barriers to combat slope wash in right foreground. Photo AR 10/71.

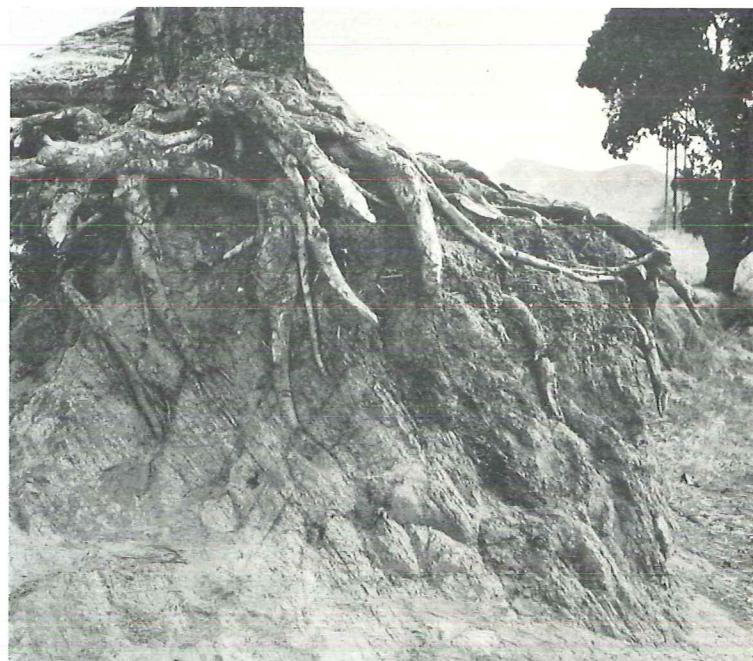
Fig. 8. Section through soil and weathered granulite rock with in situ foliation. The soil cover is only about 0.3 m thick. The bedrock is penetrated by the roots of a mango tree. The roots follow the dip of the foliation and illustrate the typical anchoring effect of trees on steep slopes with thin soil and regolith. Roadcut at Towero School above Morogoro. Photo AR 10/71.

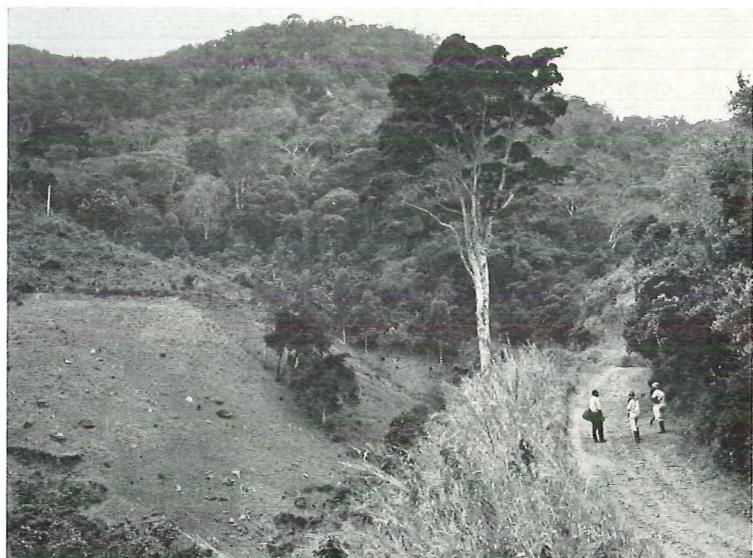
Fig. 9. Boundary of rain-forest reserve near Morning-side. To the left new cultivation on steep slope without any conservation measures. Photo AR 10/71.

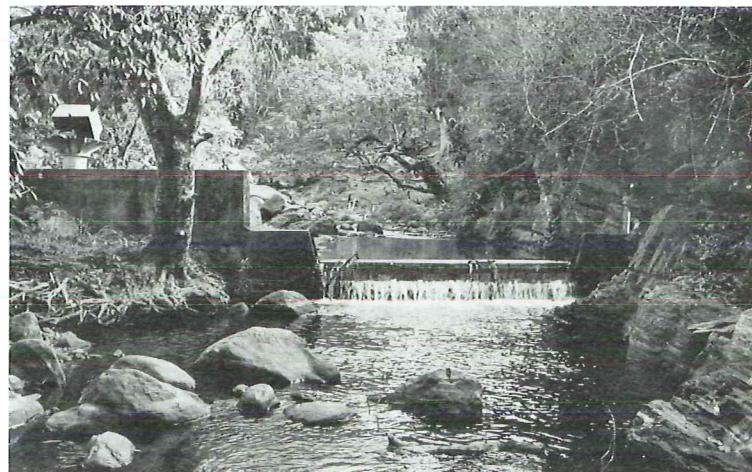
Fig. 13. Morogoro river gauging station 1 HA 8, from below. Photo AR 10/71.

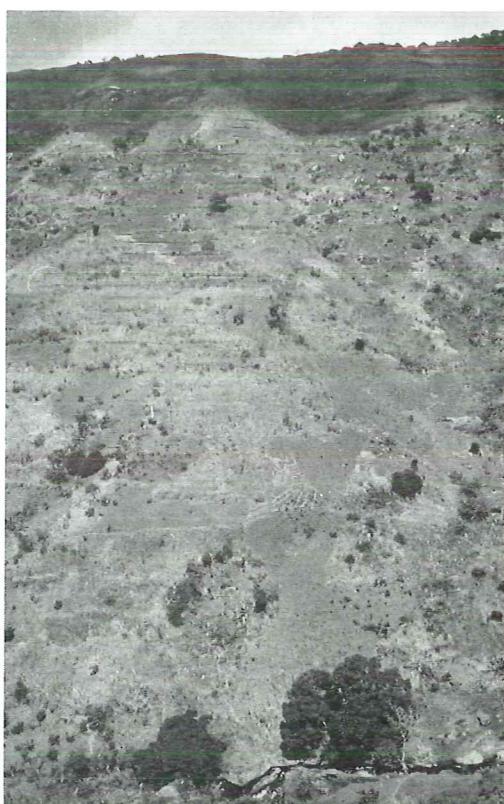
Fig. 21. Cultivated steep slope below Kisosa village (on skyline). Evergreen trees at stream channel in foreground. Many grass barriers from the 1950's are visible in the centre of the picture. Slope transect 2 runs across the stream between the two trees and up-slope to the ridge crest. Photo AR 10/71.

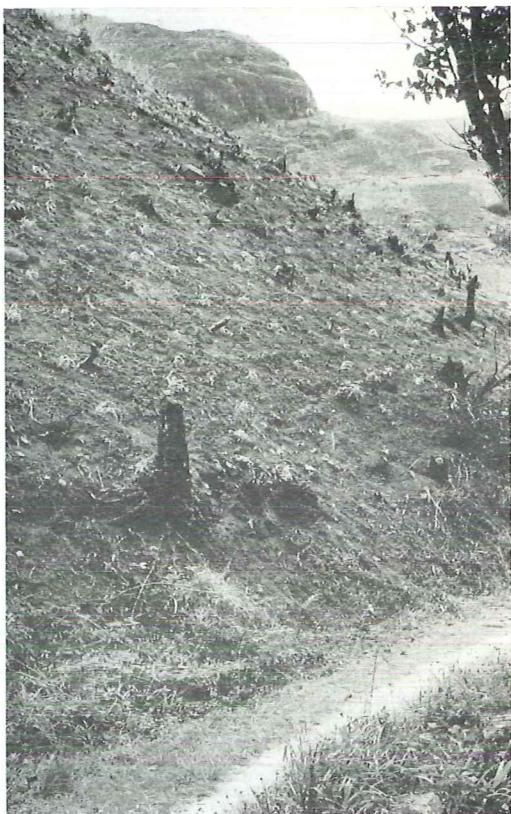
Fig. 22. Newly cleared shamba in secondary woodland near Morningside farm, Morogoro. The slope is 42°, planted with maize. Tree stumps and roots have been left (to stabilize the soil?). Stones and soil aggregates are falling down the slope occasionally and accumulate on the path. Photo AR 10/71.

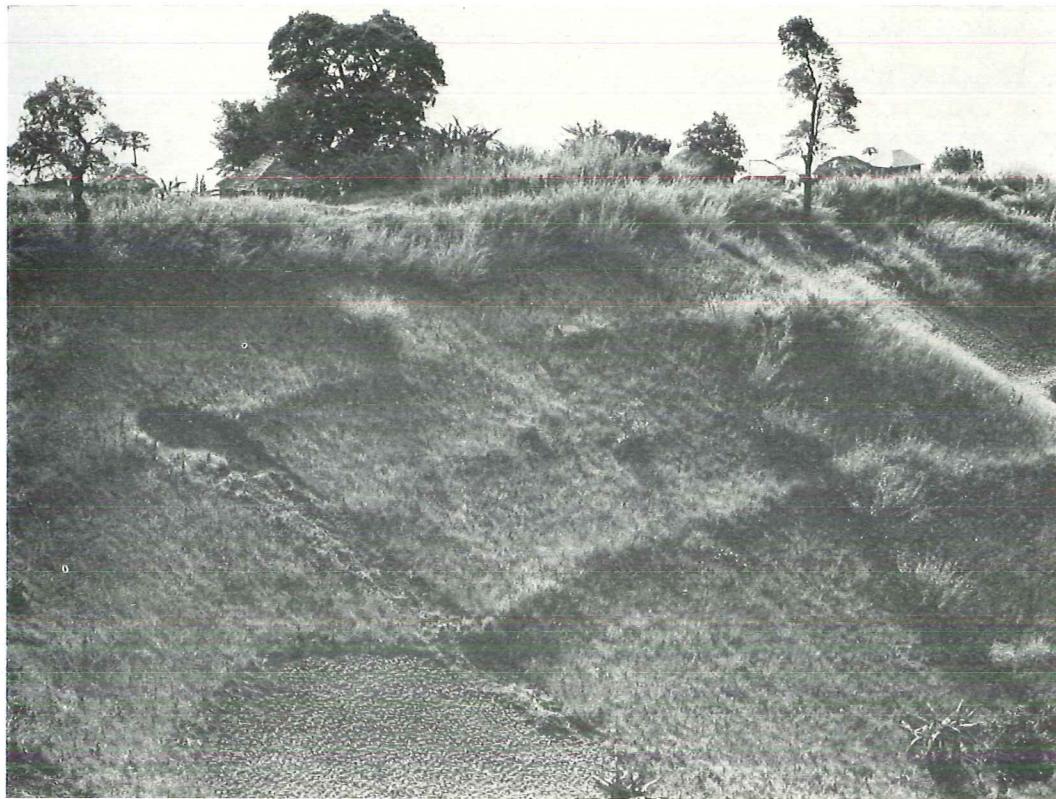
Fig. 23. Grass fallow with fresh debris slide. Luvuma village in the background. Note grass barriers for trapping slope wash. Newly cultivated fields with beans in foreground and right background. Photo AR 6/1970.

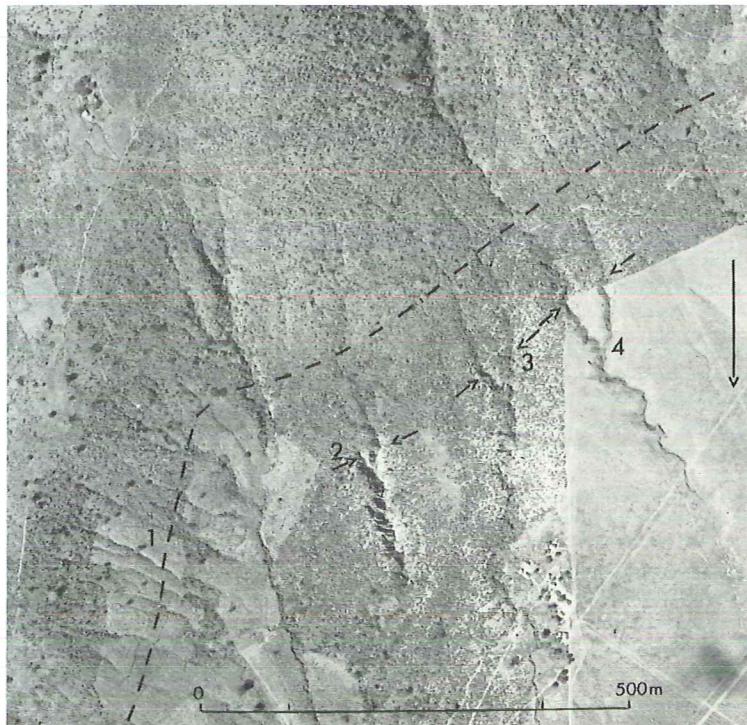
Fig. 24. Vertical air photograph of piedmont zone near the Agricultural College, Morogoro. Dashed line marks break of slope between hillslope and pediment. Figures 1—4 mark gullies. Note particularly abrupt and 6 m deep gully heads at 2, incised along fault line and into a local pocket of sandy fault-line colluvium. Fields of sisal to the right. Miombo woodland on the hillslopes. Air photo, July 1955, Survey Div. Tanzania.

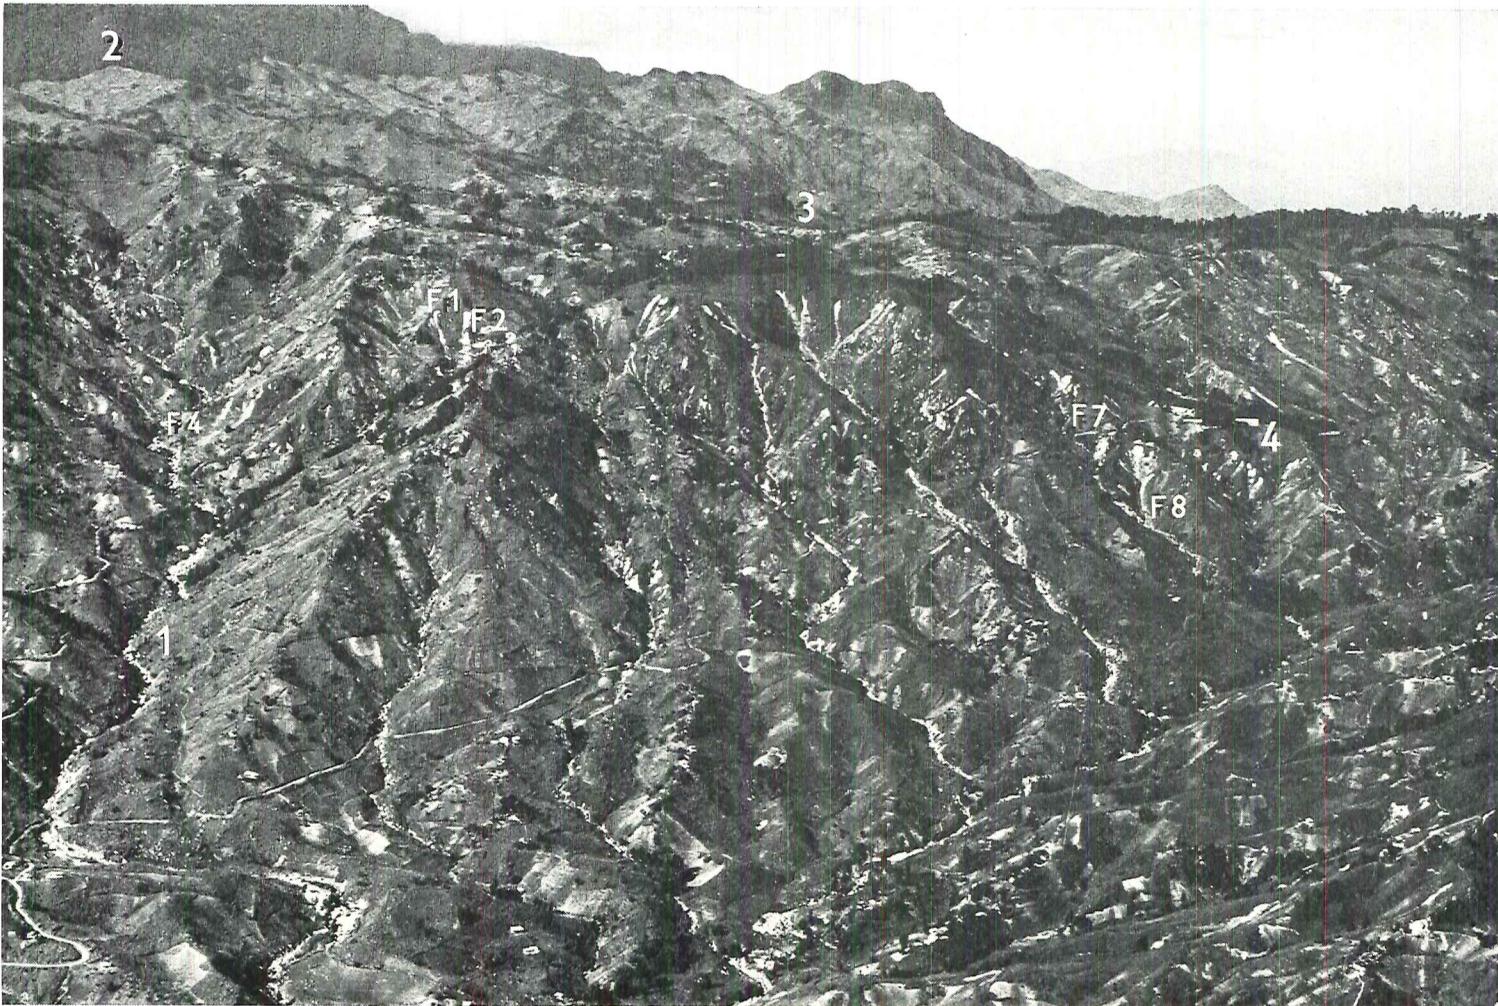
Fig. 5. Aerial oblique of landslide-scarred slopes in the Mizugu headwaters. The Mzinga valley (1), the Lukwangule plateau edge (2), Kicnzema (3) and Bumu Mission (4) are shown. Slides F1—F4 and F7 and F8 (Fig. 14) are identifiable. Photo AR: 6/70.

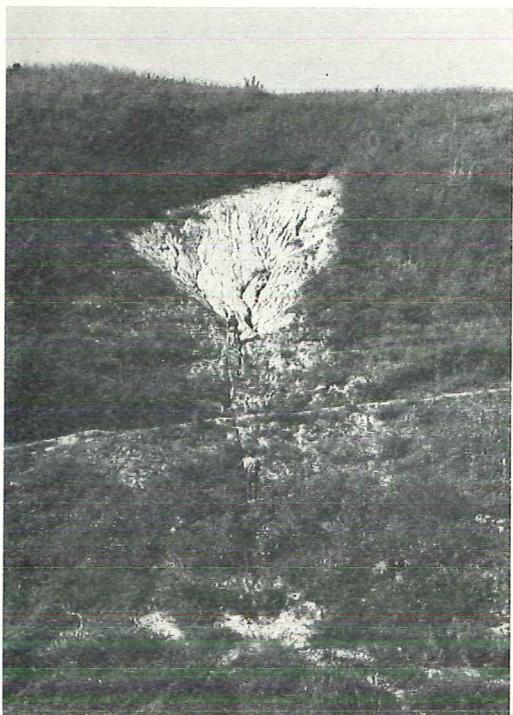
Fig. 7. Small landslide and mudflow at Mgeta (Gl: see Fig. 8). Slope under fallow with older scars above the scar on the left. The mudflow crossed the valley in the foreground and flowed 16 m up the reverse slope of 18° . Photo AR: 5/70.

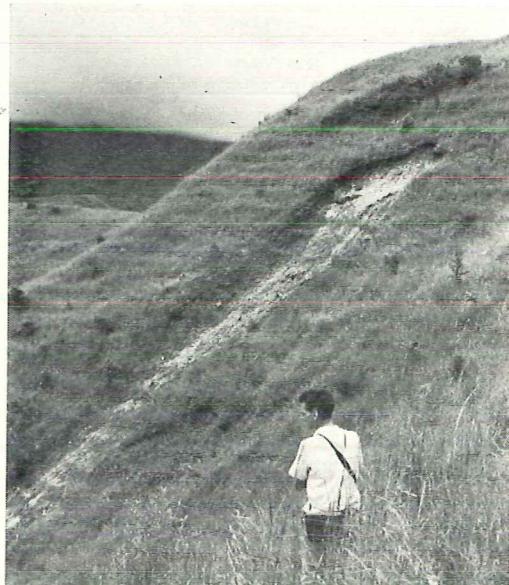
Fig. 9. Small landslide scar and mudflow track at Kidiva (C2: see Fig. 8). Slope under fallow with ladder terrace system prominent. Note also old slide scar to the left of the figure. Photo PHT: 4/70.

Mudflows were intimately related to sheet-slides and the majority of sheetslides developed into mudflows downslope. Of the scars surveyed (Table 8), 20 out of 34 showed evidence of mudflow development at their lower ends. The majority of the remainder were short and had discharged their material more or less directly into stream courses. For example, a *mudflow track* continued downslope from the lower end of the C2 sheetslide, running 160 m down a concave slope, 39°—42° steep in the upper part, flattening to 15° at the lower end—the confluence with the stream channel. The width of the flow track was the same as that of the slide scar in the upper part of the track. The track ran over undamaged soil terraces (Fig. 9) where some fresh regolith had been dropped on the terrace

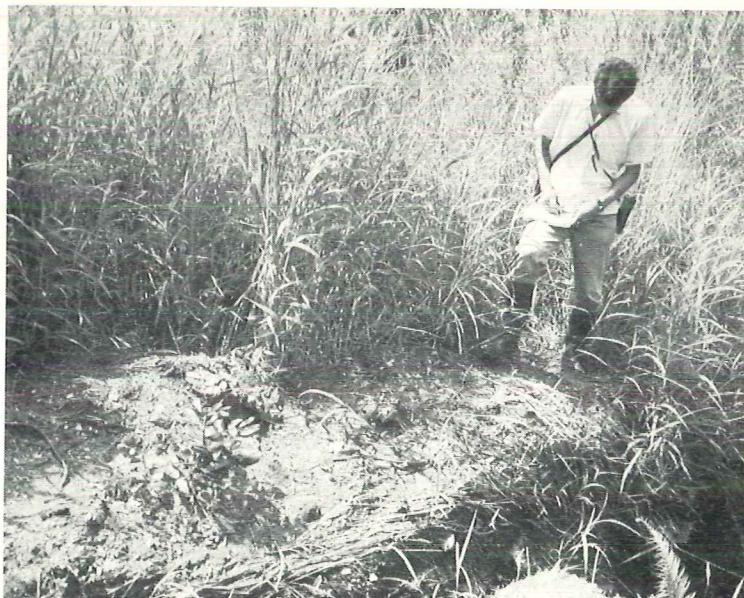
Fig. 10. Part of the mudflow lobe at the bottom of C2 (Cross section f, Fig. 8). Photo PHT: 4/70.

steps. Lower down the mudflow track narrowed to 6–8 m and ran through dense grass, which had been pressed down to the ground and "combed" in the direction of flow. The lower part of the track was on both sides of a gully, 2–2.5 m wide and 0.5–3 m deep. Thin mudflow lobes, 12–15 cm thick, had been left in patches on plastered grass on both

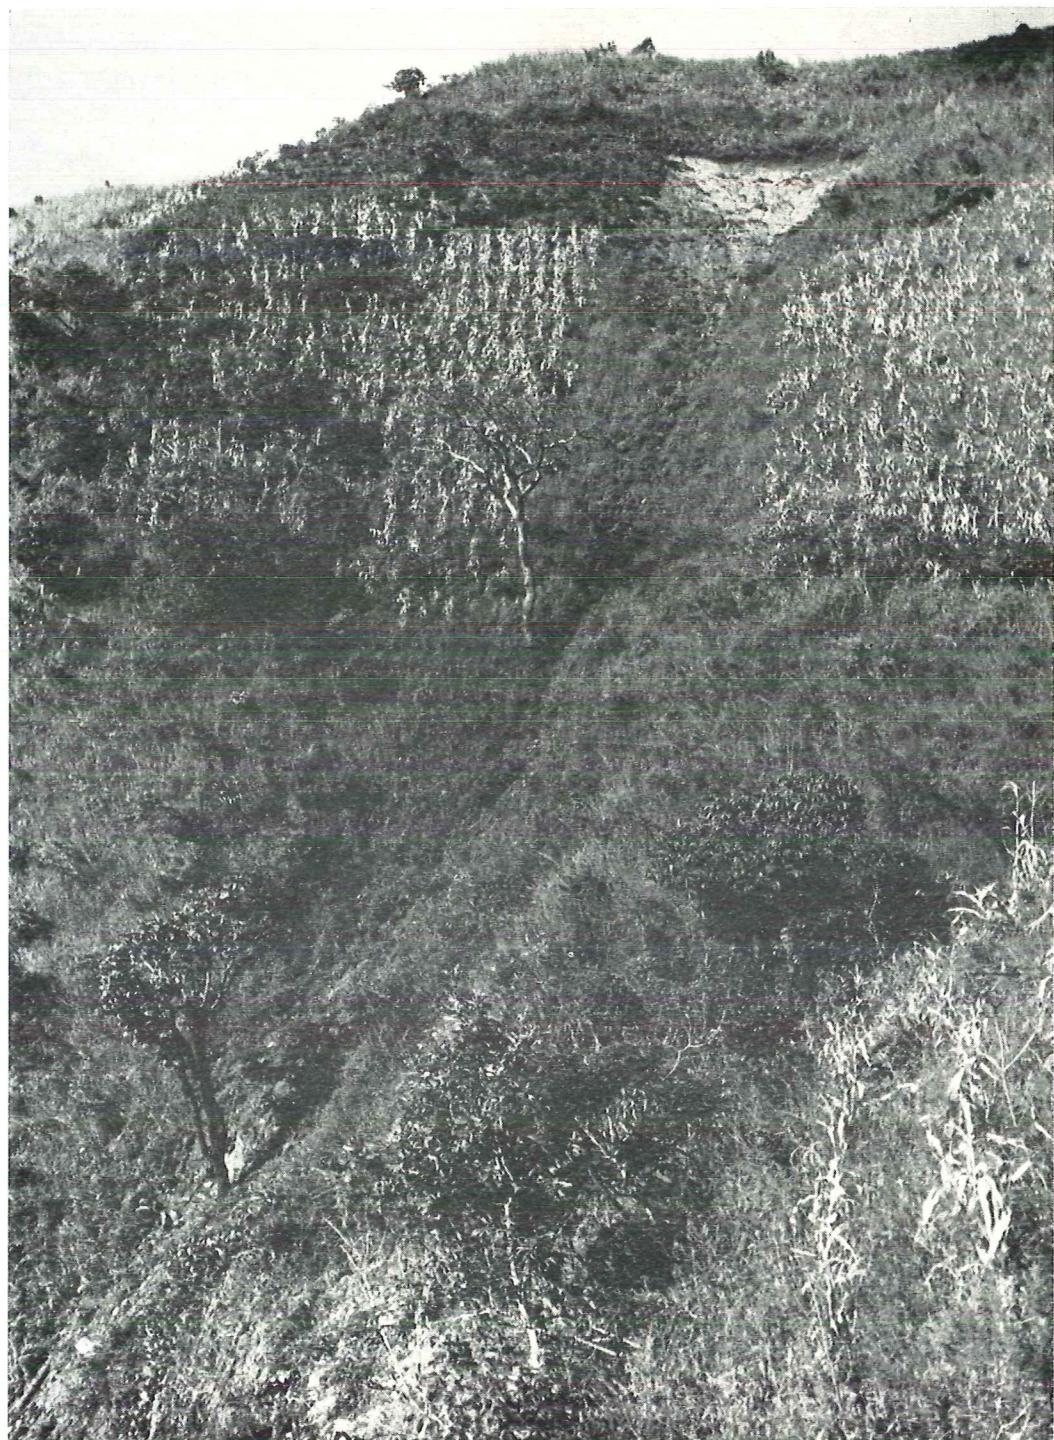
Fig. 11. Landslide and mudflow at Peko (D2: see Fig. 8). Slide started immediately below fallow grass in a *shamba* of cow peas. The mudflow carried away part of a maize crop below (clear track) and left debris and marks on the trees in its path, indicating that the flow there was 1.5 m thick. Photo PHT: 5/70.

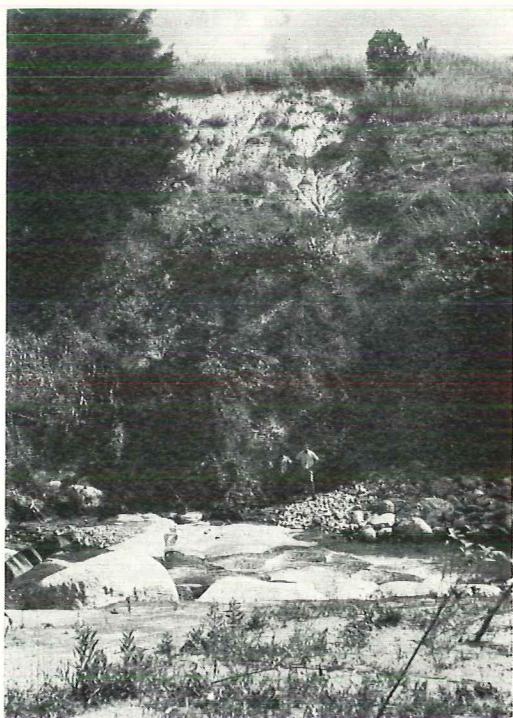
Fig. 12. Stream side slide and mudflow at Mgeta (G10; see Fig. 8). Note how trees have controlled the form of the slope failure on both sides. Scoured bedrock and coarse boulders in the Mzinga river channel and sandy flood deposits on the flood plain in the foreground are evident. Photo PHT: 9/70.

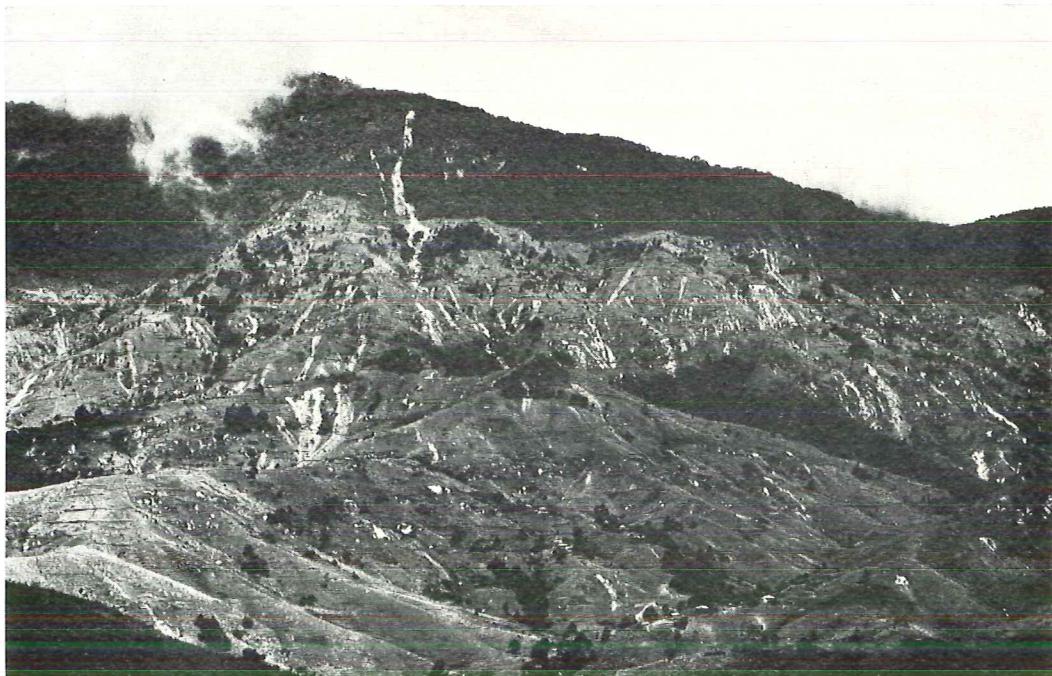
Fig. 13. Large landslide from natural woodland in the upper left center of the photograph. This slide was one of the largest observed, but was not surveyed in detail. Note the contrast between the two lone slides in woodland and the numerous smaller slides affecting cultivated land. Compare colour Plate no. 2A. Photo AR: 5/70.

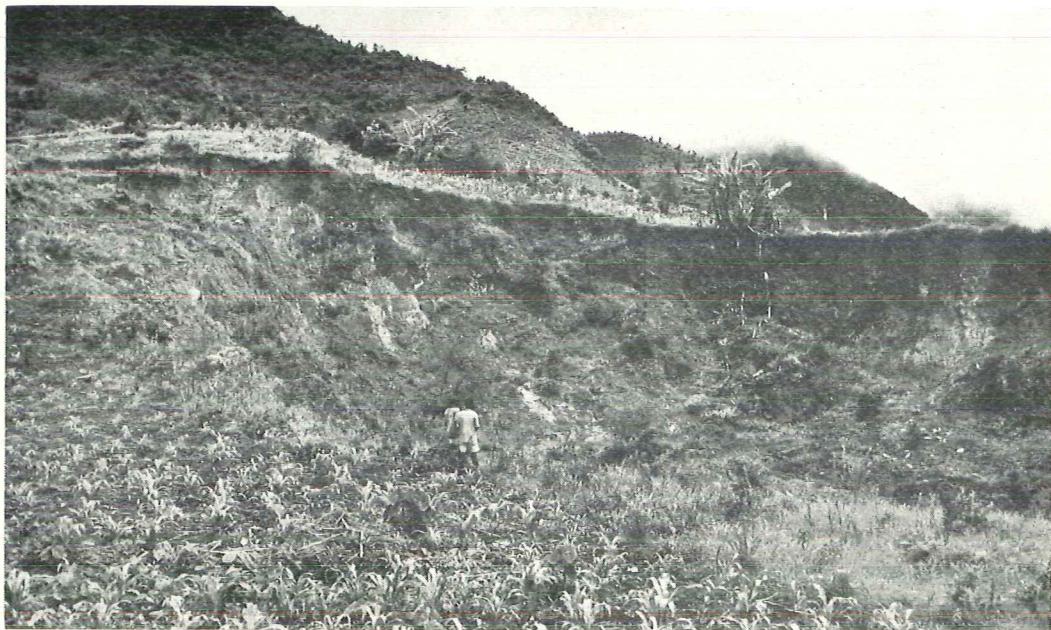
Fig. 16. Large bottleslide at Hululu (A1: see Fig. 15). Photo: PHT: 12/69.

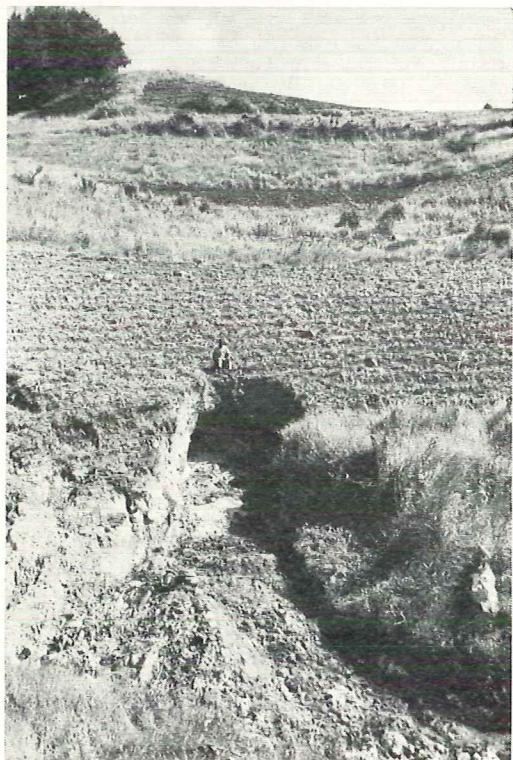
Fig. 17. Pipe flow near Vizona (E5: see Fig. 15). Photo: PHT: 5/70.

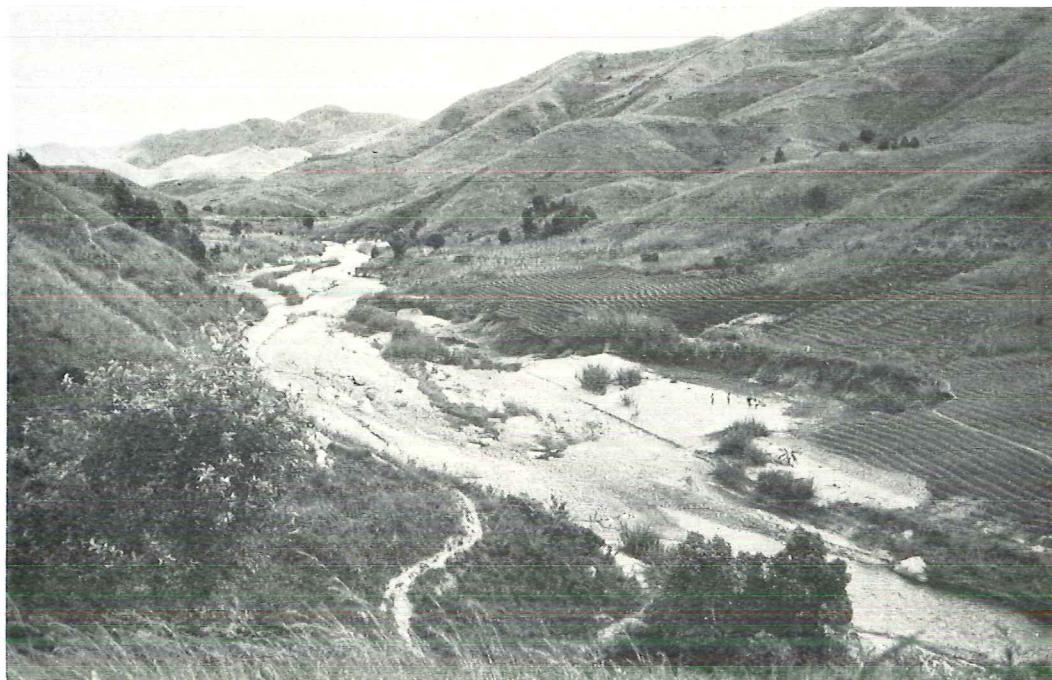
Fig. 18. Flood deposition of February 23, 1970 in the Mgeta valley, looking downstream below the Mission. Photo: PHT: 5/70.

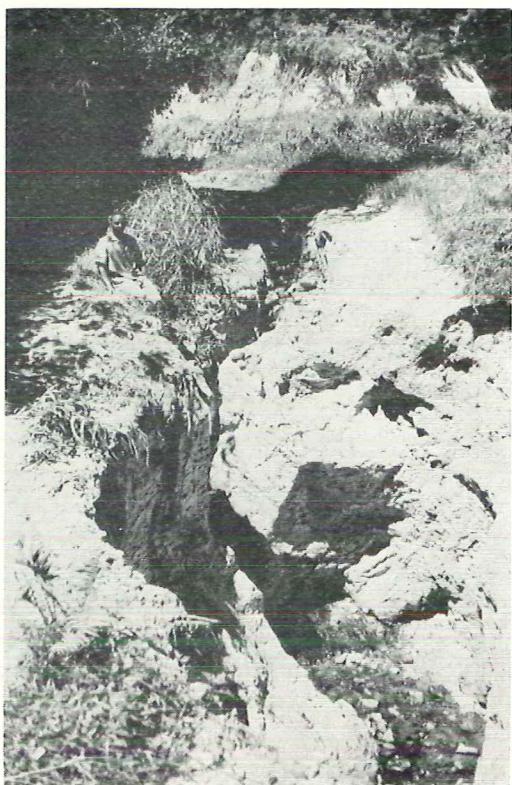
Fig. 19. Gully development on Mgeta-Kienzema road at Nyandira. Gully cut in one afternoon and over 5 m deep. Photo: PHT: 6/70.

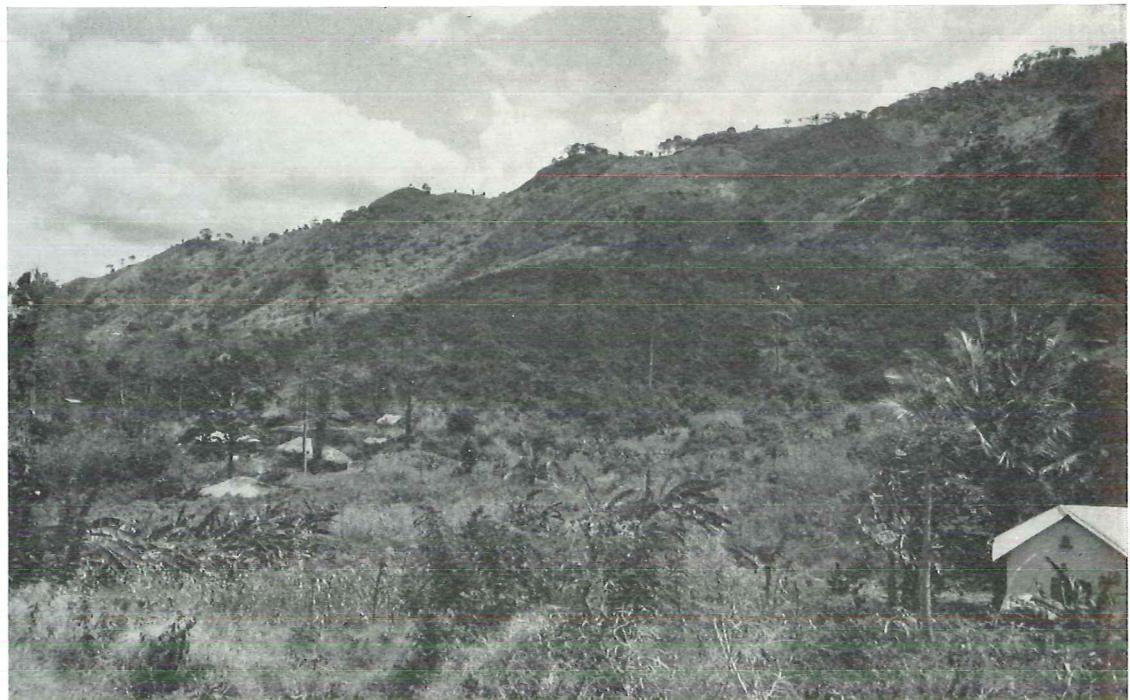
Fig. 1. The Mfumbwe experimental site. Erosion plots and rods were located in the spur slope in the middle distance. House in the right foreground is the former German estate farm, now occupied by Mr. O. Gonza. Photo PHT: 6/70.

The experimental plots are located at Mfumbwe ($6^{\circ} 53' S$, $37^{\circ} 49' E$), a small scattered settlement some 7 km N of Mkuyuni and lying W of the Morogoro—Matombo road at an elevation of 700 m. They occupy part of a former German estate made available to the Department of Agriculture under the Uluguru Land Usage Scheme (ULUS) for experimental work. The land now belongs to Mr. O. Gonza, formerly an ULUS agricultural instructor.

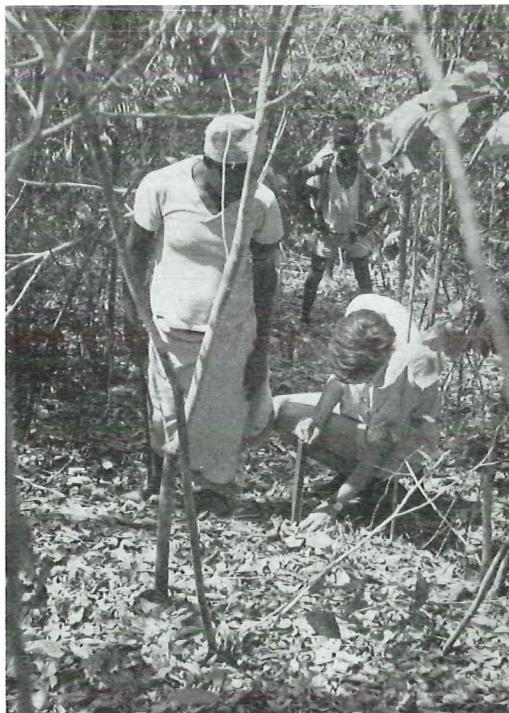
Fig. 2. Measuring surface level changes against fixed rods in June 1970. Rods installed in December 1956. Note dense secondary bush and the litter cover. Photo PHT: 6/70.

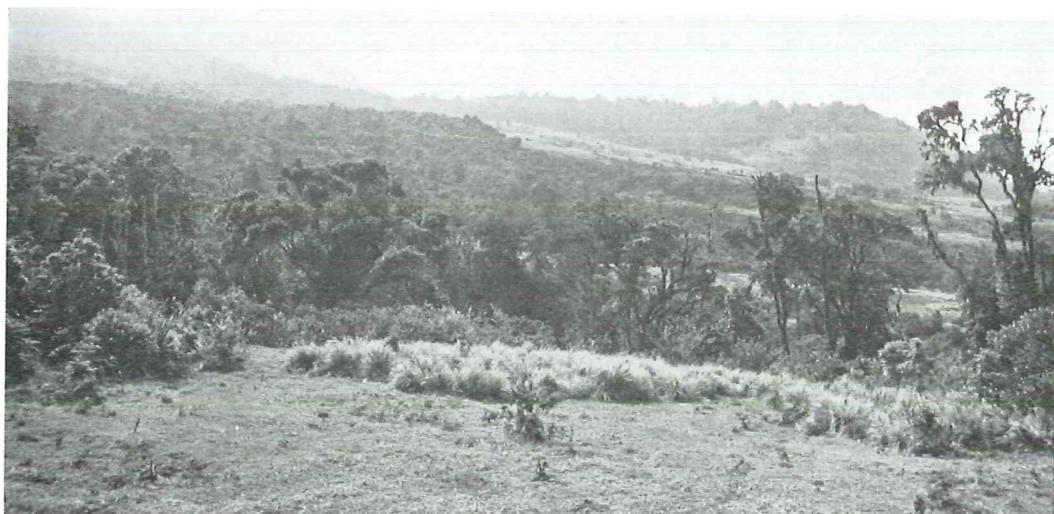
Fig. 7. A representative picture of the forest-grassland mosaic, showing the three investigated ecosystems. On the forest edges, young shrubs and trees indicate the expansion of the forest onto the glades, a result of absence of fires for the last ten years. The short, much-branched growth of the trees (see text) is also visible.

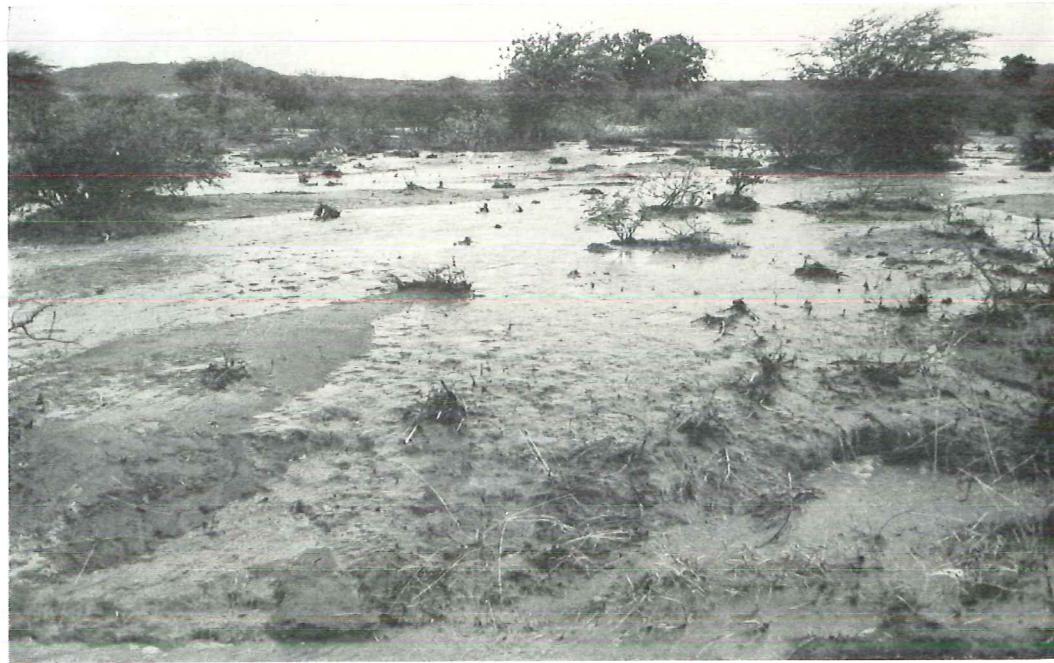
Figs. 7A and B. Two photographs of sheet flood on pediment plain about 4 km E of Dodoma. The flood was caused by a local thunder-storm on 19/12/1970. Both photos by P. H. Temple.

Fig. 7A (above). Note the wide sheets of water flowing between low islands of mounds under bushes. Flow direction is towards the camera. Chimwaga hill in background at left side.

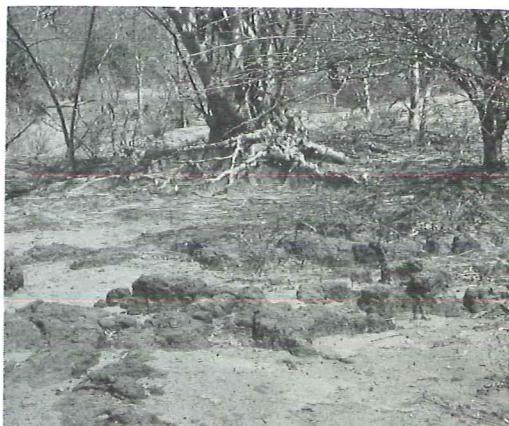
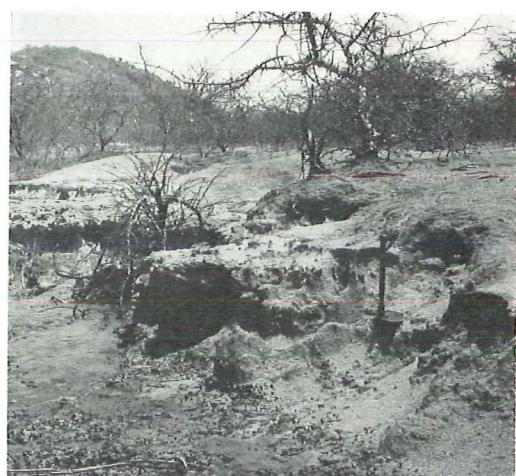
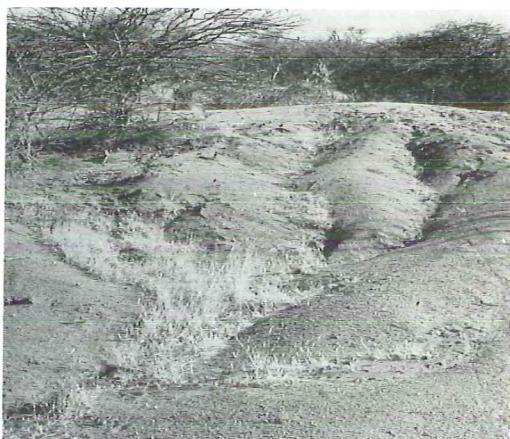
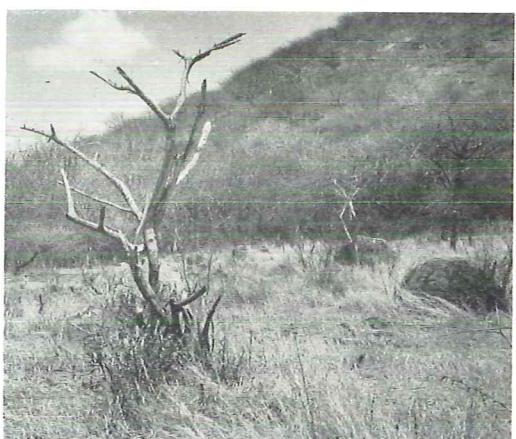
Fig. 16A. Erosion from splash, leaving pedestals under tree roots. Slope transect no 3, Ikowa. Photo AR 10/71.

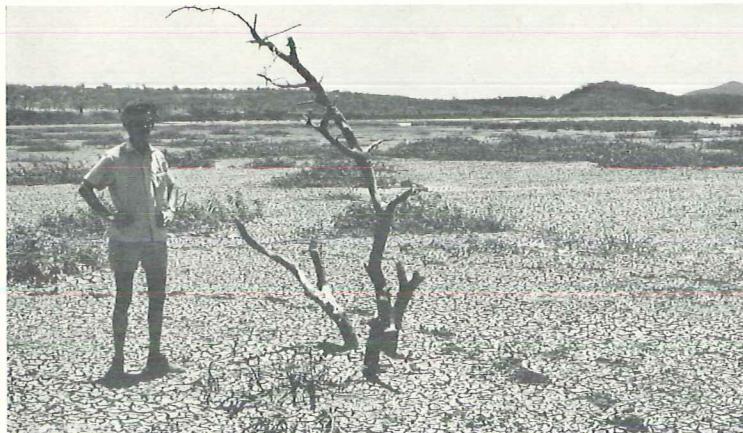
Fig. 22. Dry bottom of Ikowa reservoir with half-buried tree in clayey sediments with cracking surface. Tussocks of *Polygonum senegalense* grow on the mudflat. Location: Cross section K, SE part. Photo AR 9/1971.

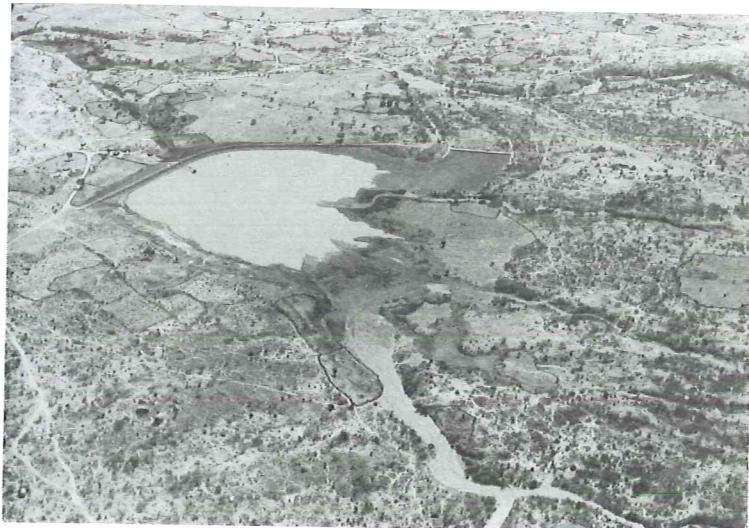
Fig. 24. Oblique aerial photograph of Msalatu reservoir and part of catchment. Sand bed of channel A in foreground. Channel B to the right. Cultivated plots within dark lines of thorn-bush fences. Cattle tracks mark areas of overgrazing and lack of grass cover. Cf. Figs 28, 29. Photo AR 25/9/1971.

delta (A) has cut off a right-side tributary channel, which now forms a shallow pond or delta lagoon (Figs. 24, 30). The same process is seen on the second tributary to the right, showing the predominance of bedload sediment supply from channel A as compared to its two neighbours. Fig. 31 A shows that 6 m of sediments have been deposited in 27 years in the middle of the delta. Fig. 31 B gives the average depth of sediments along a number of cross sections.

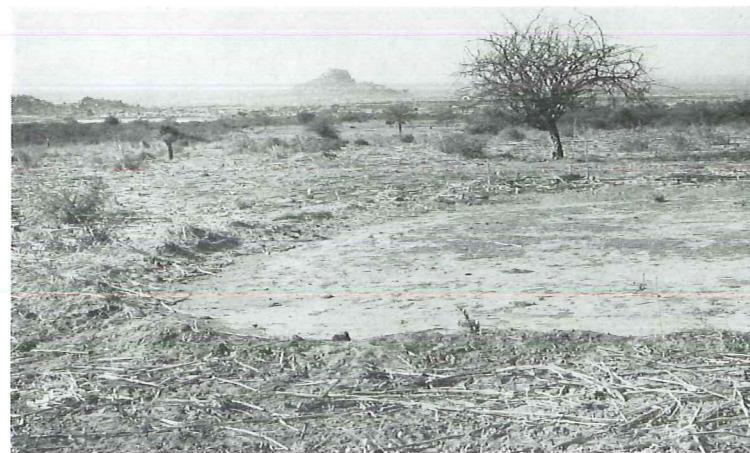
Fig. 25. Harvested field of bulrush millet, Msalatu reservoir near channel B. (Fig. 29B at B-C). Treshing-patch on old termite claycrete pan in the foreground. Msalatu reservoir in the left background, Lion's Rock (Mlimwa) inselberg at Dodoma in the center. Photo AR 10/71.

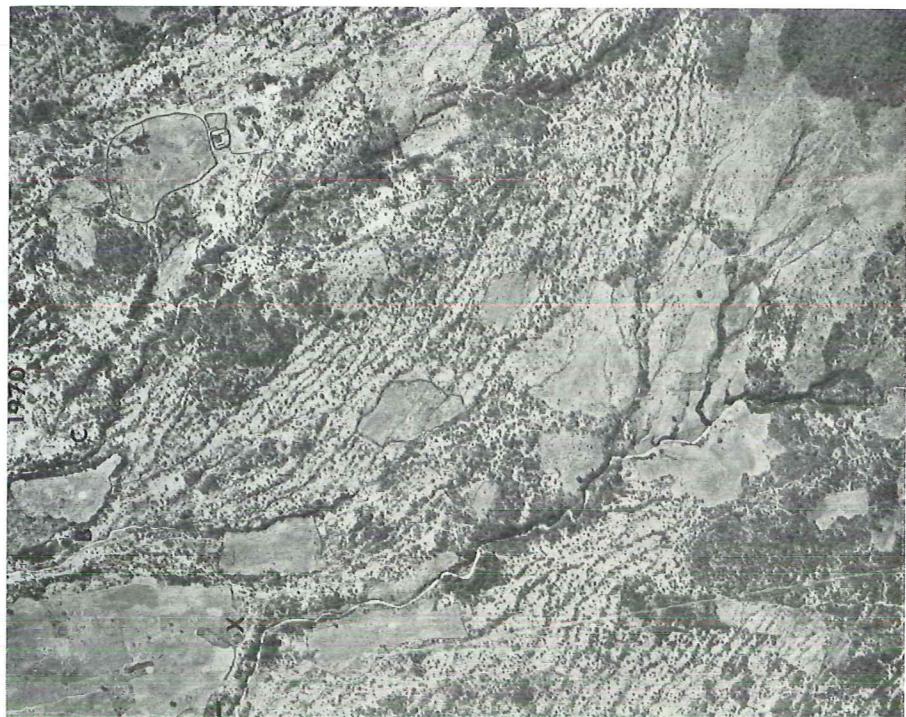
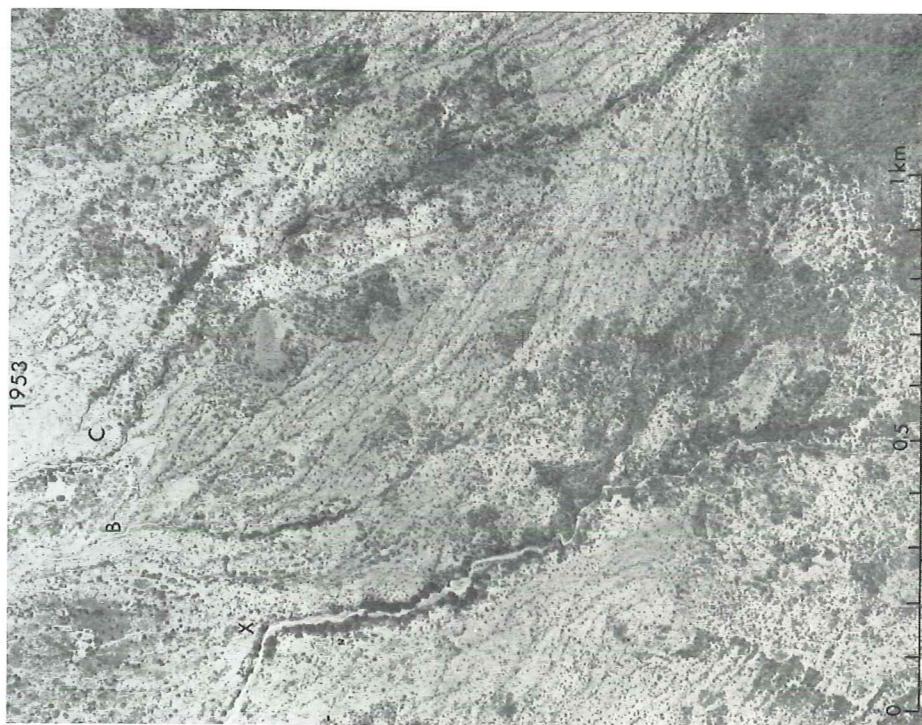
Figs. 29A and B. Vertical air photographs of gullied area in Msalatu catchment. A in June 1953, B in June 1970. Note extensive new cultivation in 1970. Cf. Fig. 28. Points X, B and C are identical in both photographs. The gully pattern (dark, parallel lines) is similar in 1953 and 1970. Fig. 25 is a photo taken of cultivation near letter B (= channel B) of 1970 aerial photo. Photos A. S. D. Tang 1080/71/1953 and Can:8/Roll No 106, 1970.

Cutting of wood and charcoal burning is common in the catchment. New areas were cleared and cultivated in 1970, e.g. in the catchments of channel B and channel A (Fig. 29B).

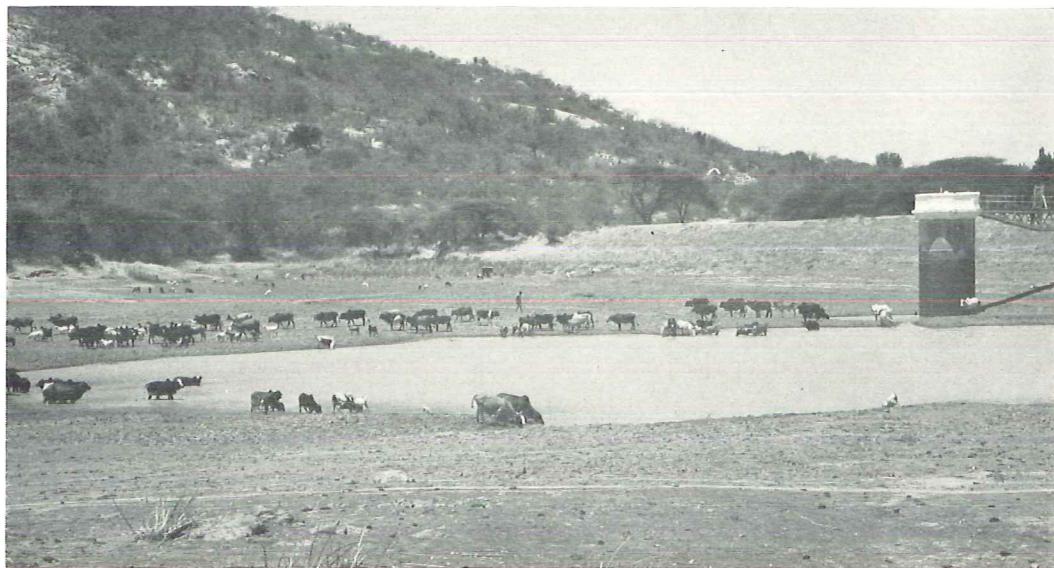
Fig. 35. Imagi reservoir at low water stage. Photo AR 10/1971.

The dam crest has a length of 275 m. The maximum height of the embankment at the time of construction in 1929-30 was 12.75 m. There are no adequate maps or construction drawings available. All information about the construction has been taken from a map of unknown age (possibly 1926) showing a preliminary outline of the dam site. There are a few levelled points on this map. Of interest is also that the spillway was finally built in another angle than is shown on the map. Drawings of some details are available in Comwork's office in Dodoma.

According to computations made from the 1926 (?) map the maximum capacity was 174,000 m³. In 1953 Fawley made an estimation and found that the capacity had decreased

considerably. According to Fawley's data the dam could hold not more than 154,360 m³ in 1953. The capacity in December 1971 was 136,000 m³.

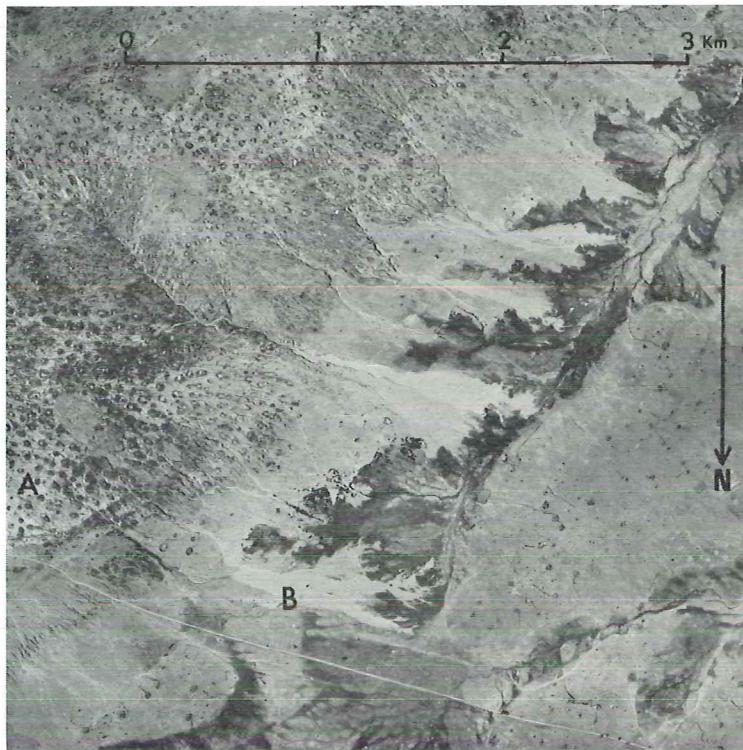
Fig. 3. Detail of vertical air photograph, Magipandwa catchment, 6 km SE of Singida town. Cf. Fig. 4, which shows the profile A—B, parallel to the road. Dark patches are termite mounds on the pediment and on the plateau. Recent sand fans in valley bottom contrast with dark zones of vegetation due to groundwater seepage. Air photograph 49TN15, 169, Aug. 1960.
