**STUDIES OF
SOIL EROSION AND SEDIMENTATION
IN TANZANIA**

Edited by Anders Rapp, Len Berry & Paul Temple

CONTENTS

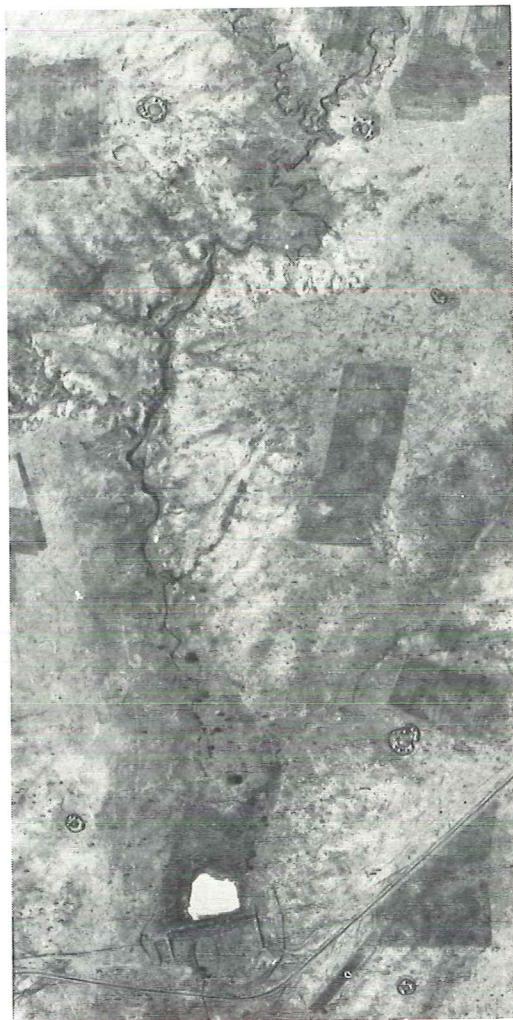
Fig. 6. Aerial photograph showing Kisongo reservoir. Note low water level of reservoir due to drought. North at top of photograph; scale approximately 1:30,000. (Enlarged from aerial photograph ASD, TANG. 467, 160/3, August 1961)

The first silt survey was carried out in October 1969. The spillway level was assumed to be 30.00 ft, as indicated on the plan, as no permanent bench mark could be found. Subsequently a bench mark, reduced level 37.10 ft, was set up at the top of the steps leading from the spillway to the embankment. A baseline perpendicular to the embankment was set up, with sections surveyed parallel to the embankment at 50 foot intervals.

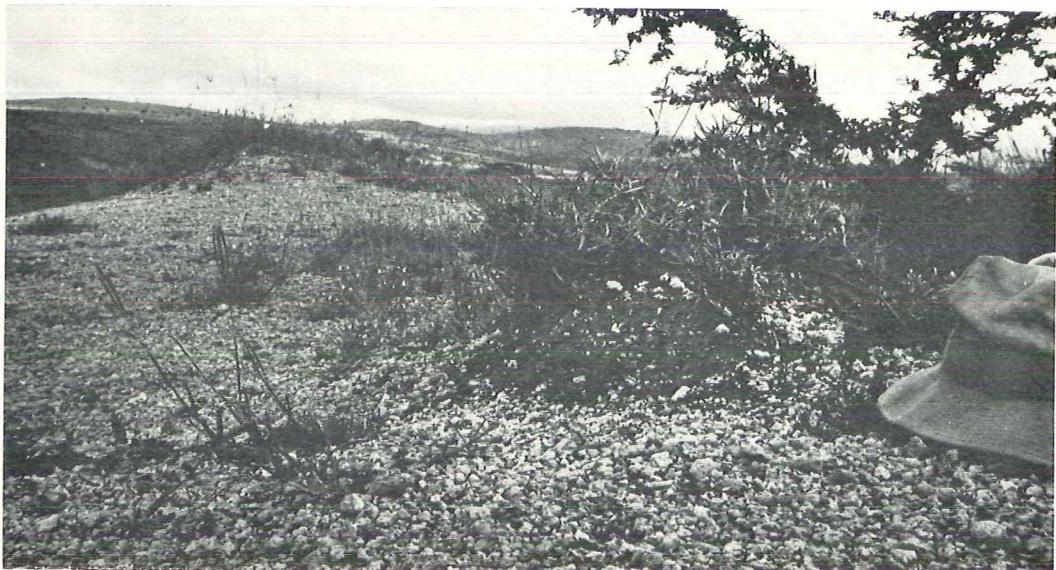
Fig. 7. Calcium carbonate concretions forming a surface layer after removal of fine material by sheetwash and rainsplash. Concretions are being exposed in a residual soil mound protected by grass. Height of soil face about 15 cm. (Photo: HMR 4/70)

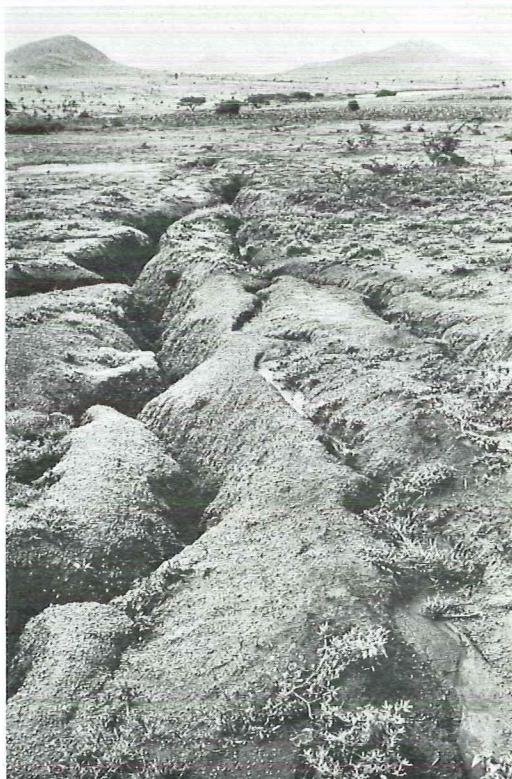
Fig. 9. Gully development on a stock route. The channels are essentially linear, forming along former stock paths. Vegetation cover is only partially removed. Ash cones on horizon beyond Kisongo reservoir. (Photo: HMR 4/70)

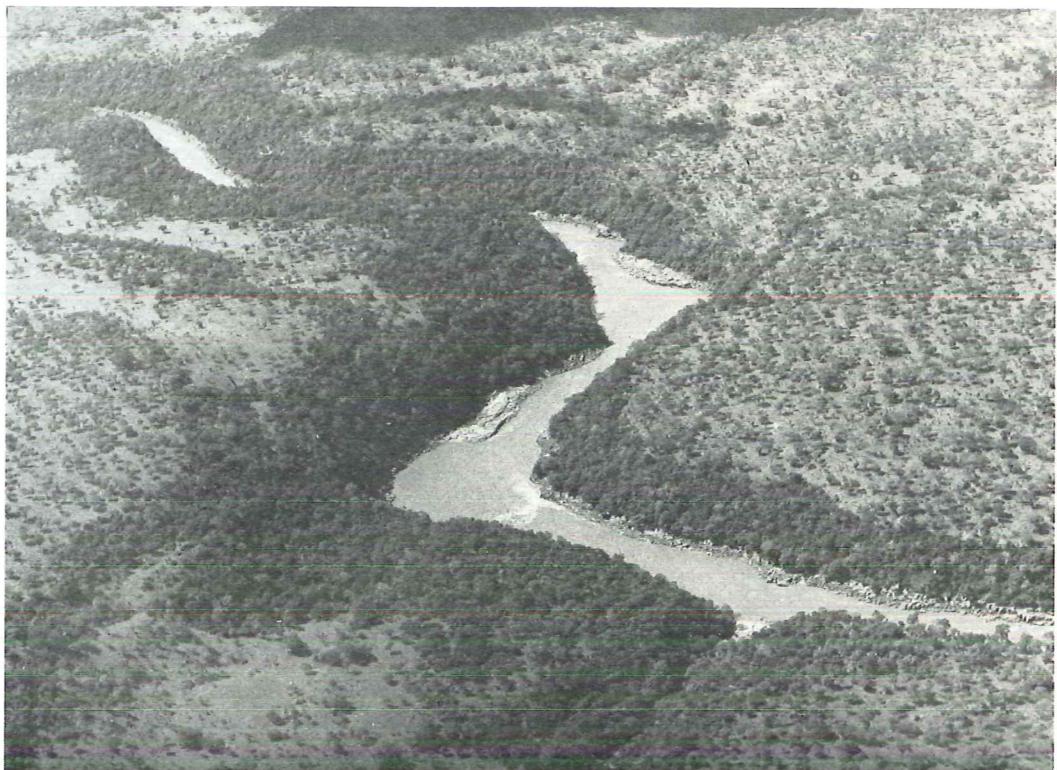
Fig. 7 Aerial view of Stiegler's gorge between Pangani rapids (1 K3 A) and station 1 K3: river flow right to left. Photo P. H. Temple, April 1972.

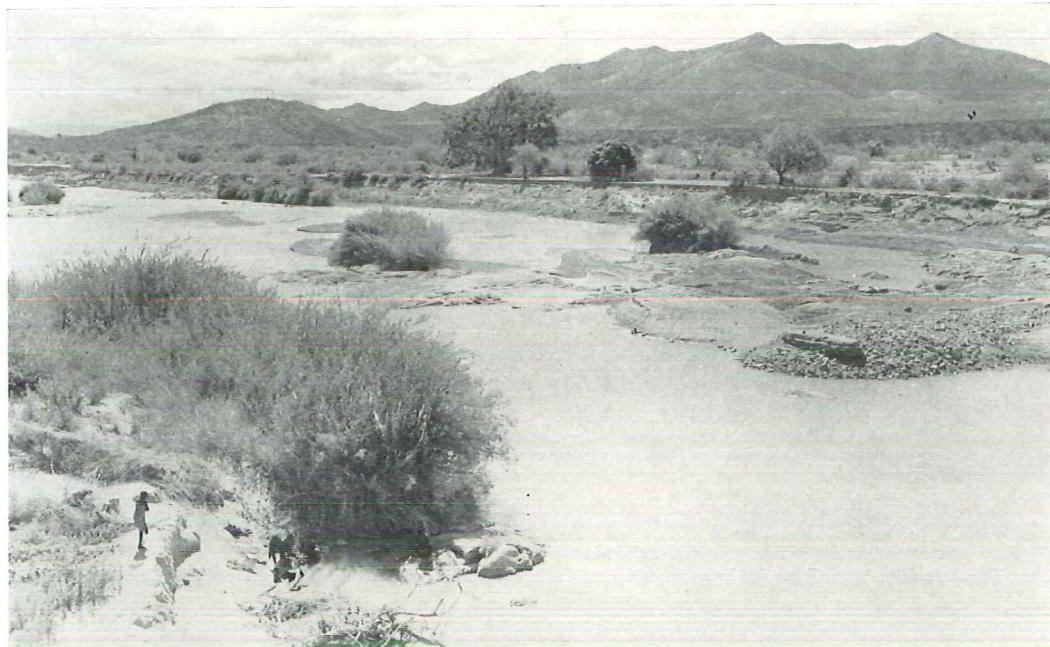
Fig. 10 The Great Ruaha river at Mtera: view downstream from gauging station 1 KA 5: low flow stage. Photo P. H. Temple, Sept. 1968.

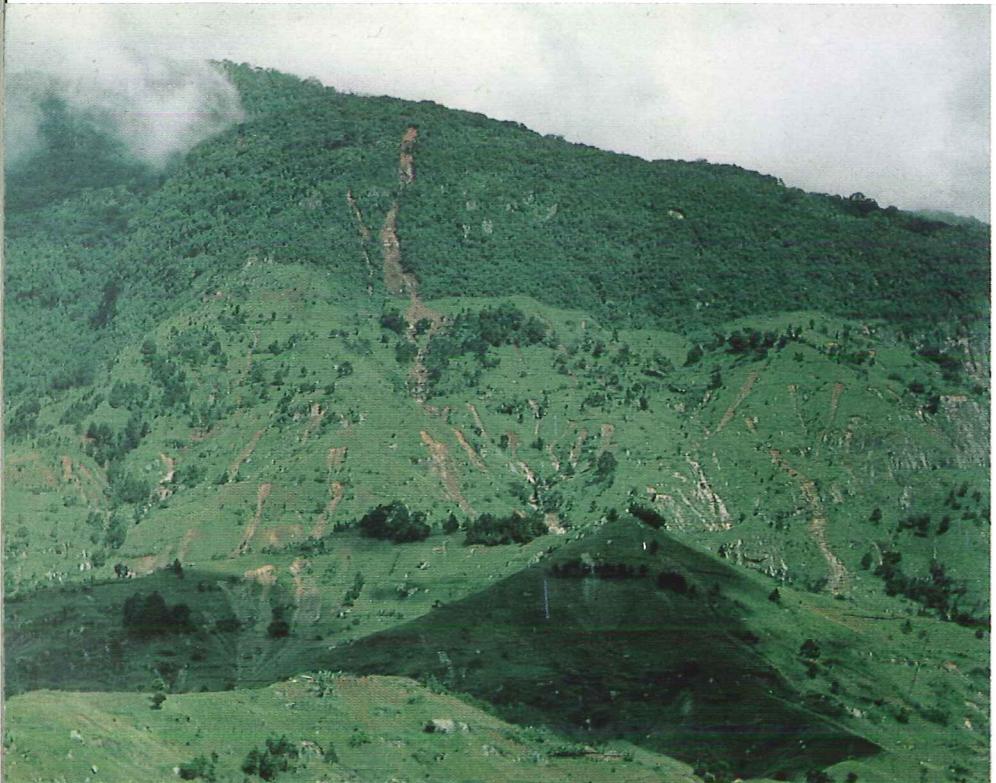
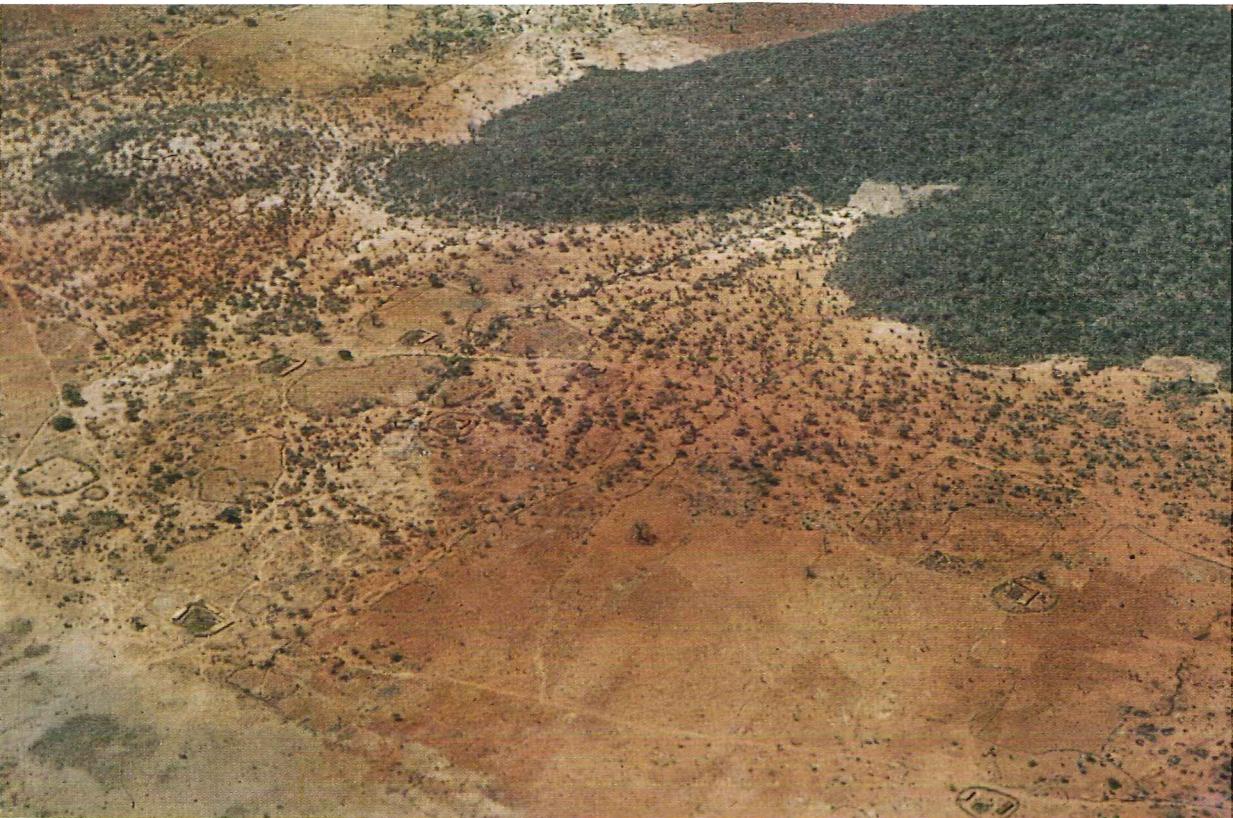
Plate 2A (above left). Debris slides and mudflows at Mgeta. Contrast the two slides originating in woodland reserve with the numerous small slides affecting cultivated land. Compare with Figure 13. The colour plate makes slide identification easier. Photo AR: 3/70.
