GEOFOOD – RAS and heating installation in The Netherlands

Half-yearly update report no. 2 – November 2019

Report WPR-946

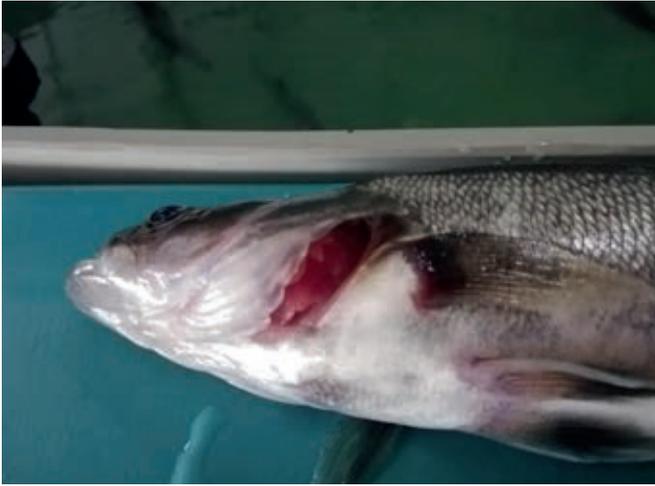
Gross examination showed clean bodies, some with small skin and fin damage from transport, some with eye damage from transport/netting. This prompted us to perform necropsies on fish to find any signs of disease.

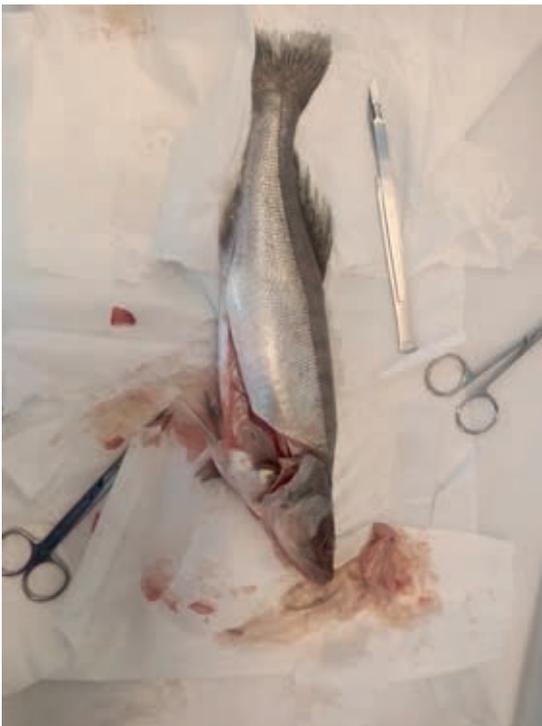
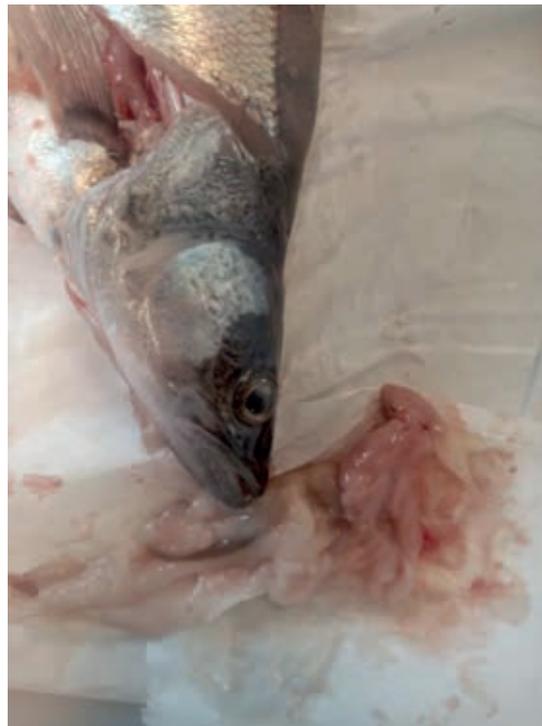
Three near-death fish were euthanized to have their gills examined on the microscope. Gill lamellae were placed in glass slides with a drop of water and covered. Two glass slides were placed under an optical microscope and examined at 10, 20, 40 and 100X magnification.
