# Tulip bulb trial shipment

fresh air exchange 100, 125 and 150 m<sup>3</sup>/h

Report 991

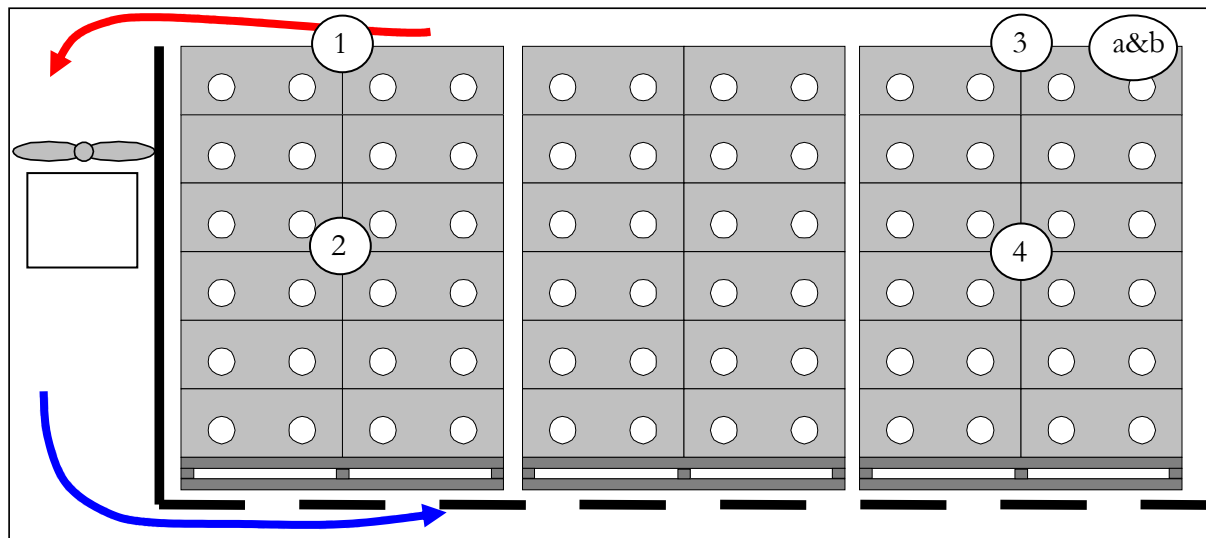
**Figure 1** visualisation of cargo sensor locations 1 till 4 and bottles a and b.

During the shipment the four sensors between the bulbs in each container log temperature and relative humidity at intervals of 10 minutes. Table 3 describes the sensors used and their positions. These positions are also graphically depicted in Figure 1. The identification numbers in column 1 of Table 3 will be used in the remainder of this report. CTR I 1 means sensor no. 1 in

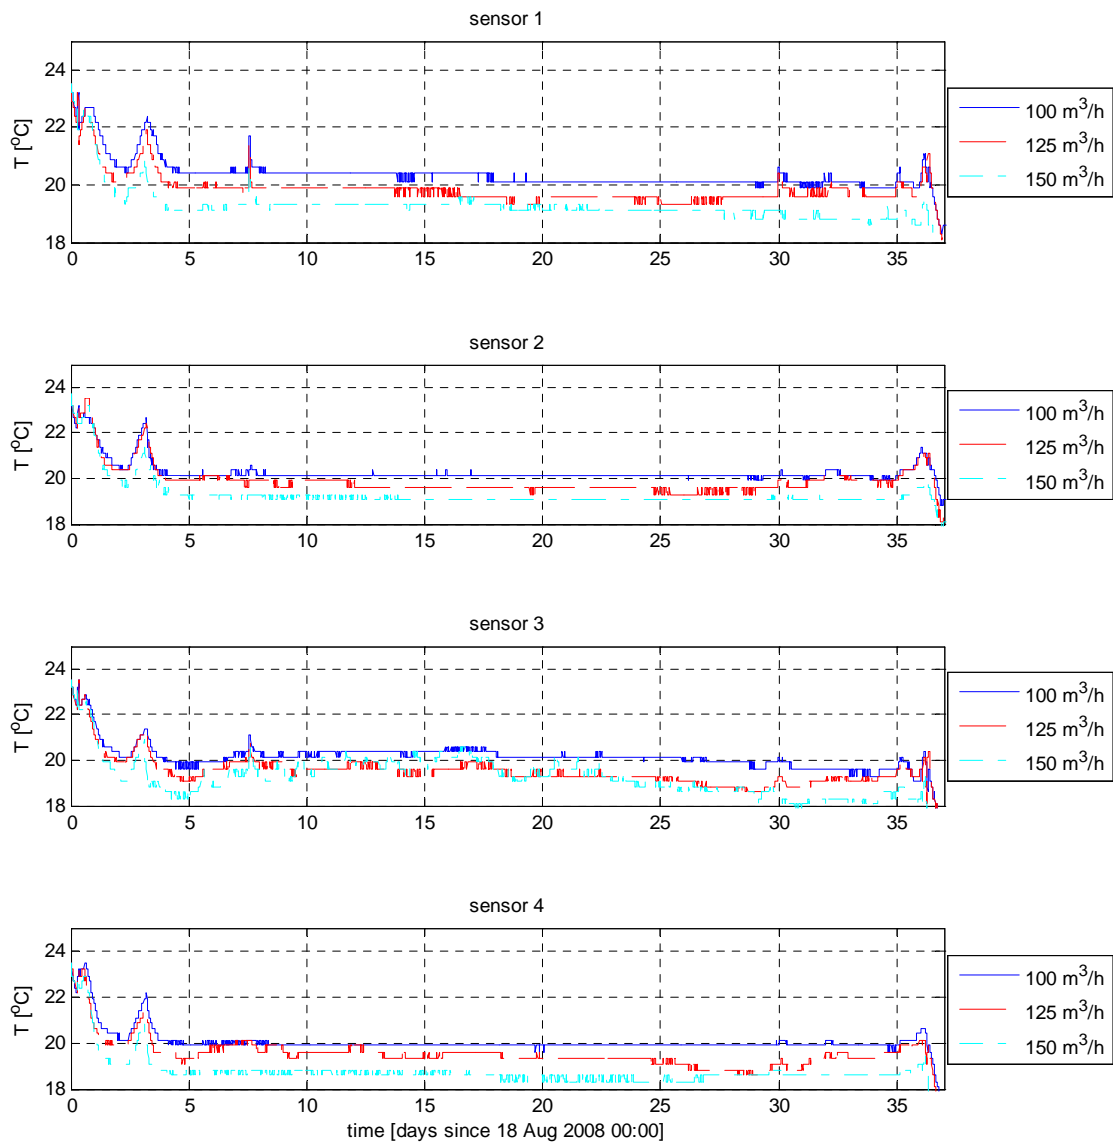
**Figure 2** temperatures registered at the 4 locations indicated in Figure 1 throughout voyage.

All cargo sensors show more or less the same pattern. In the containers with a fresh air exchange of 150 m<sup>3</sup>/h temperature is slightly lower (Figure 2), because its setpoint is 1 °C lower. Due to physics RH is strongly correlated to temperature: RH increases when temperature drops. So to allow a more profound comparison also absolute humidity X is calculated from temperature and RH, and depicted in Figure 4. Observations from Figure 2 - Figure 4:

1. Differences between pallet centre and pallet top are negligible.
2. Mean temperature in container CTR I (100 m<sup>3</sup>/h) is ~ 20.2 °C.
3. Mean temperature in container CTR II (125 m<sup>3</sup>/h) is ~ 19.7 °C.
4. Mean temperature in container CTR III (150 m<sup>3</sup>/h) is ~ 19.2 °C.
5. Mean RH in CTR II (80.1%) and CTR III (79.0%) is marginally higher then in CTR I (76.8%).
6. Mean abs. hum. is lowest in CTR III: mean absolute humidity is 11.2 g/kg in CTR I, 11.4 g/kg in CTR II and 10.9 g/kg in CTR III.
7. RH at the door-end in CTR II and CTR III slightly increases in time.
8. Absolute humidity at the unit-end is lower than at the door-end for CTR II and CTR III

What explains the observations 7- 8? Absolute humidity at door-end remains constant (Figure 4). Yet RH increases (Figure 3) because temperature at door-end decreases slightly (Figure 2). It remains to be explained why temp. at door-end decreases when sailing warm climates and rises again when sailing more moderate climates after day 25.

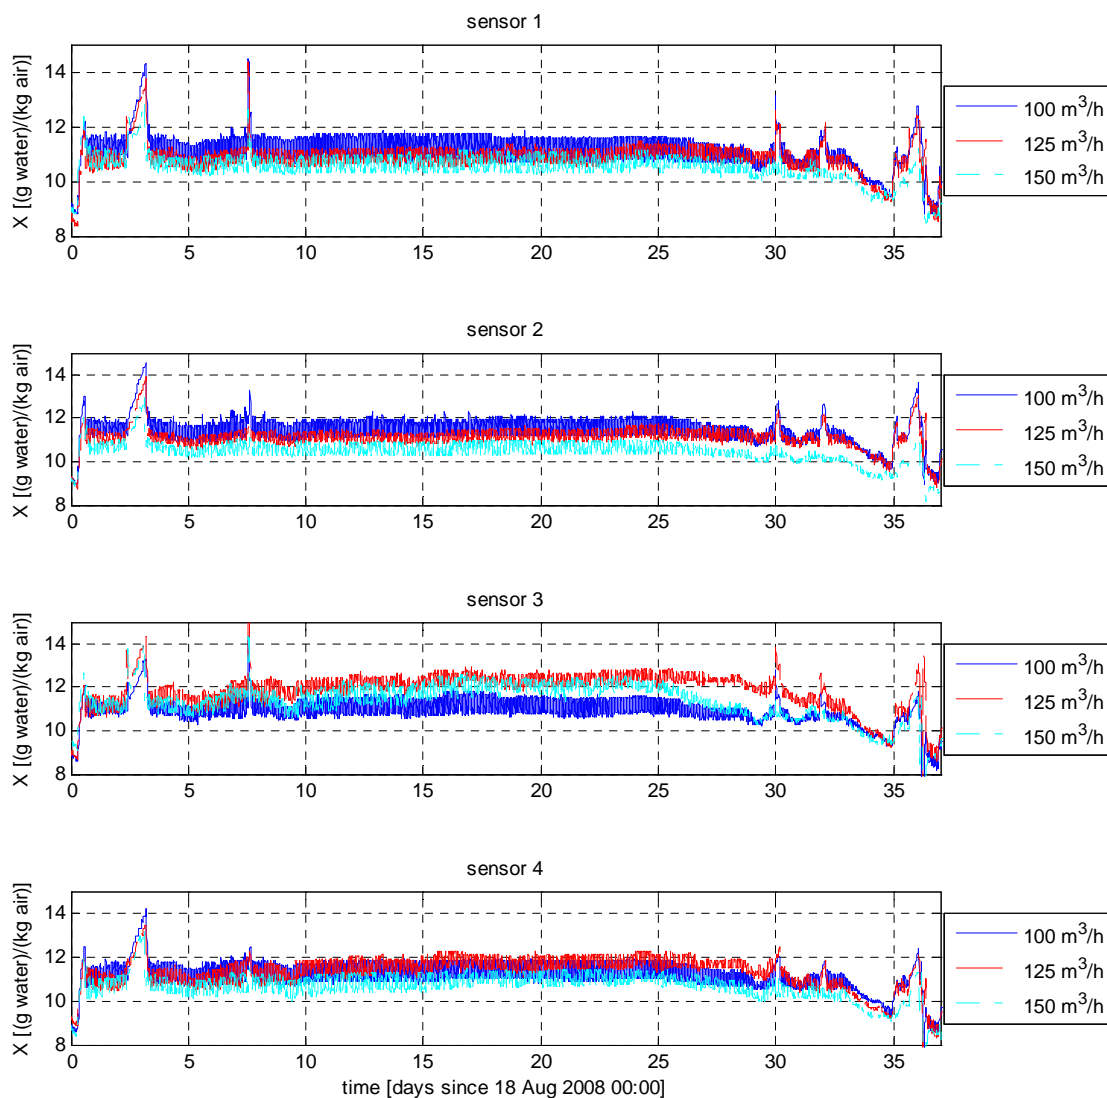
**Figure 4** absolute humidity during voyage, calculated from measured T and RH.

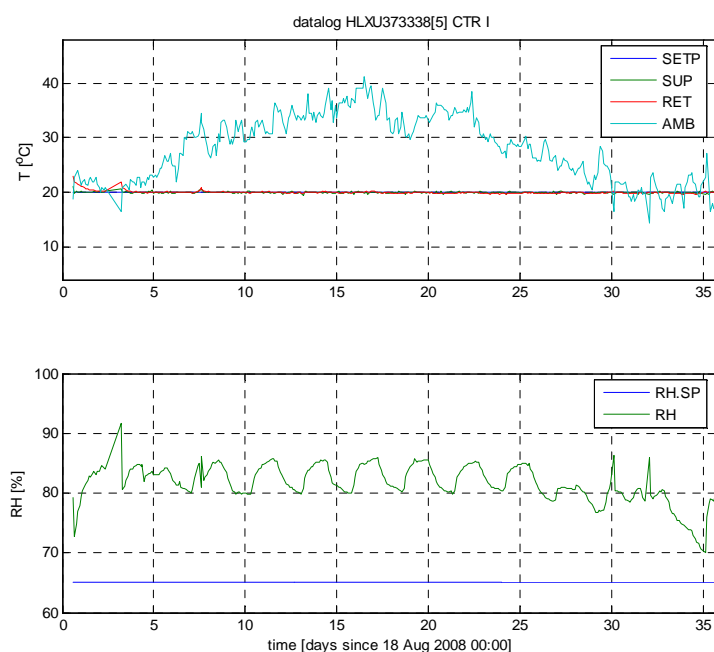
In the figures below temperature and RH logged by the reefer units are graphically visualized. Setpoint temperature (SETP), supply air temperature (SUP), return air temperature (RET) and ambient temperature (AMB) during the trip are shown in the top of the figures. In the lower half of the graph relative humidity (RH) and relative humidity setpoint (RH.SP) are shown.

**Figure 5** data registered by reefer unit in HLXU3733385 (100 m<sup>3</sup>/h).

The difference between the three unit datalogs is minimal (Figure 5 - Figure 7). Observations:

1. Setpoint of CTR I and CTR II was 20 °C instead of 19 °C.
2. Supply temperature SUP is perfectly controlled at SETP ± 0.2 °C.
3. No defrosts occur, which is right.
4. RH registered by the unit is in range with RH measured in the cargo (Figure 3).

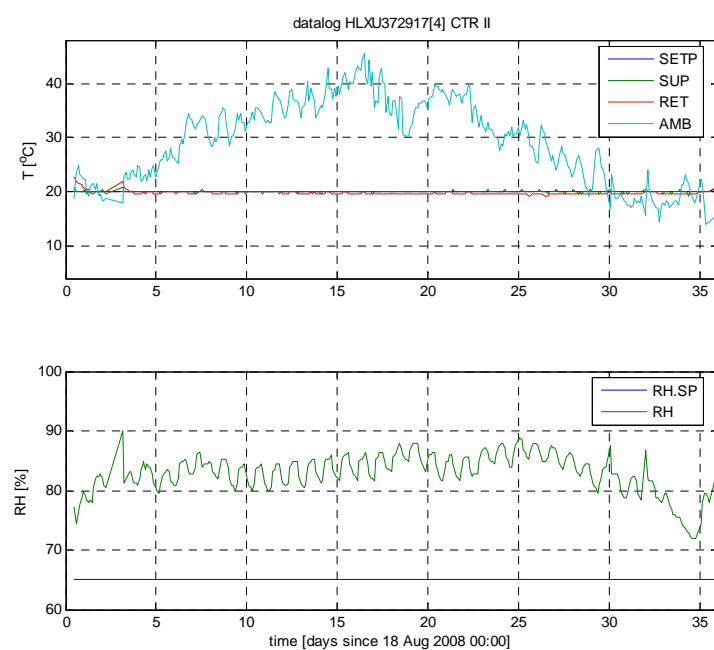
**Figure 6** data registered by reefer unit in HLXU3729174 (125 m<sup>3</sup>/h).

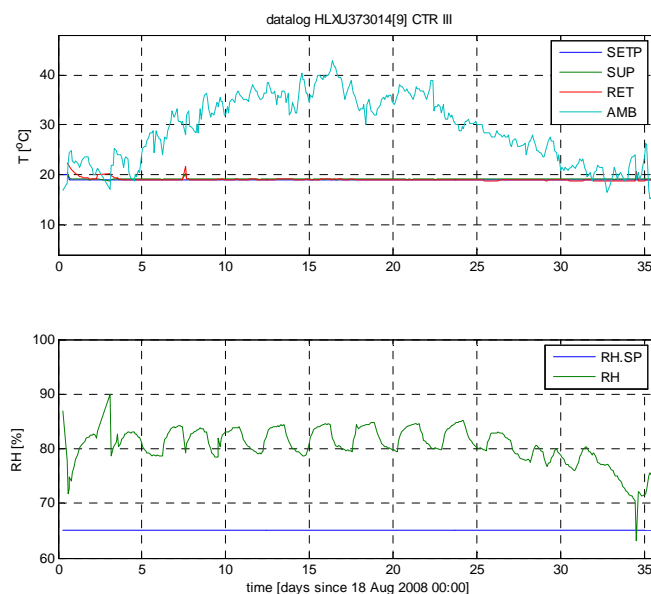
**Figure 7** data registered by reefer unit in HLXU3730149 (150 m<sup>3</sup>/h).

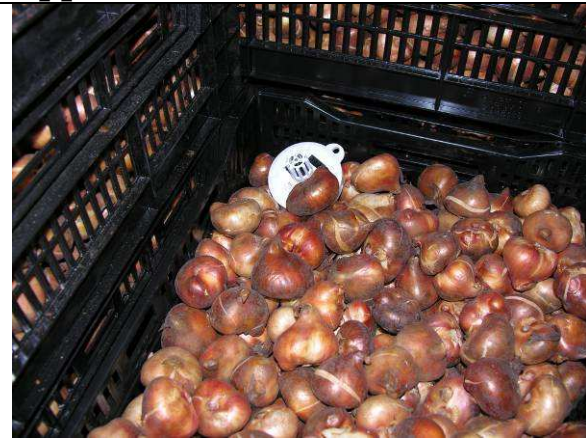
Figure 8 Escort T, RH logger.

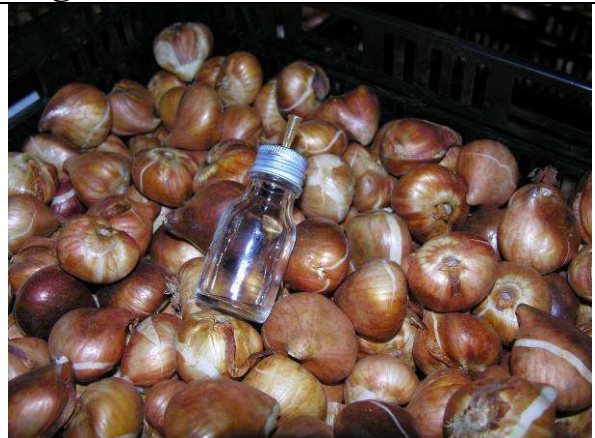
Figure 9 Ethylene sample bottle

In each container two bottles were placed to sample ethylene concentration inside the reefer container. When the container was opened for the first time at place of destination the bottle was immediately sealed from the environment in order to preserve the atmosphere in the bottle as good as possible. Afterward the bottles were sent to our laboratory where the samples were measured for ethylene concentration. The concentrations found in the samples are presented in Table 1.
