The functioning of extended defrost in Starcool's new design

The (extended) defrosting of Starcool's new designs of return air grid and evap. fans.

Report 1678

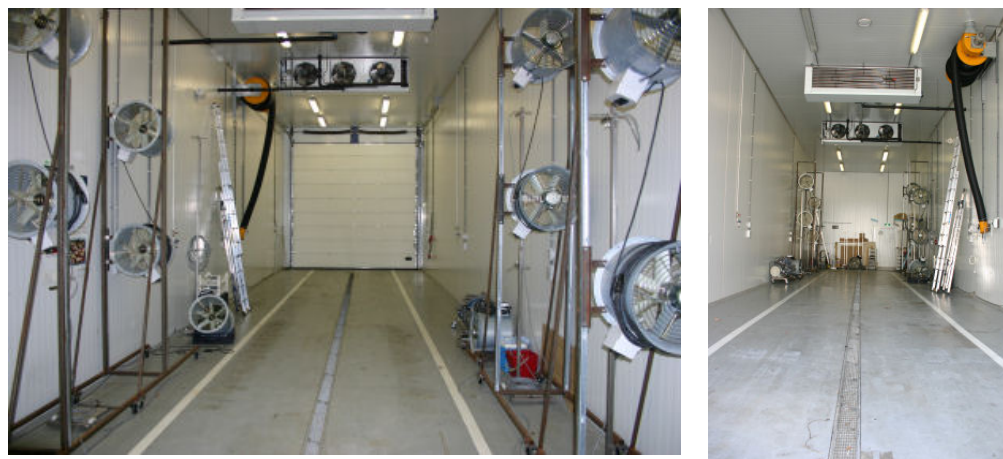
Fig. 1, climate chamber used.

All tests are performed in our test chamber for refrigerated transport equipment (Fig. 1).
Power supply during all tests: 50 Hz / 400 V.

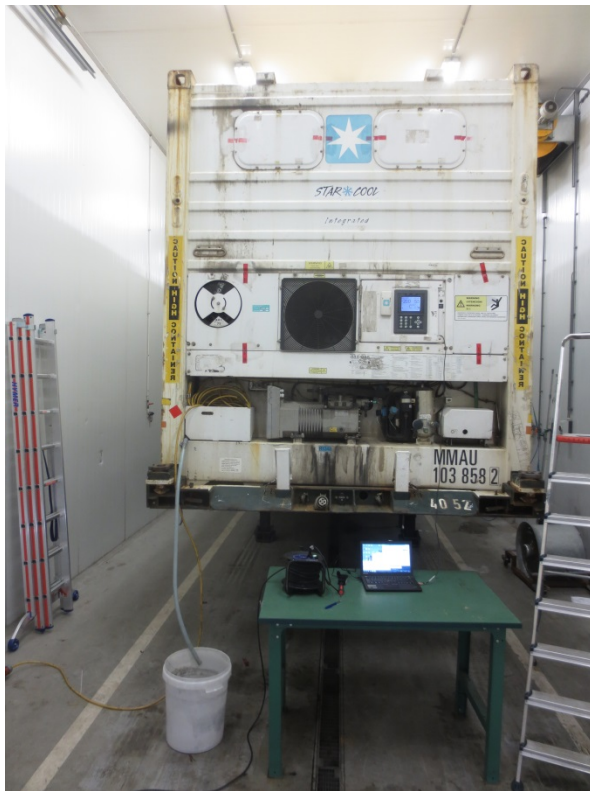
Fig. 2, test container in climate chamber.

A series of tests has been performed on container MMAU103858[2] (Fig. 2) after applying three modifications:

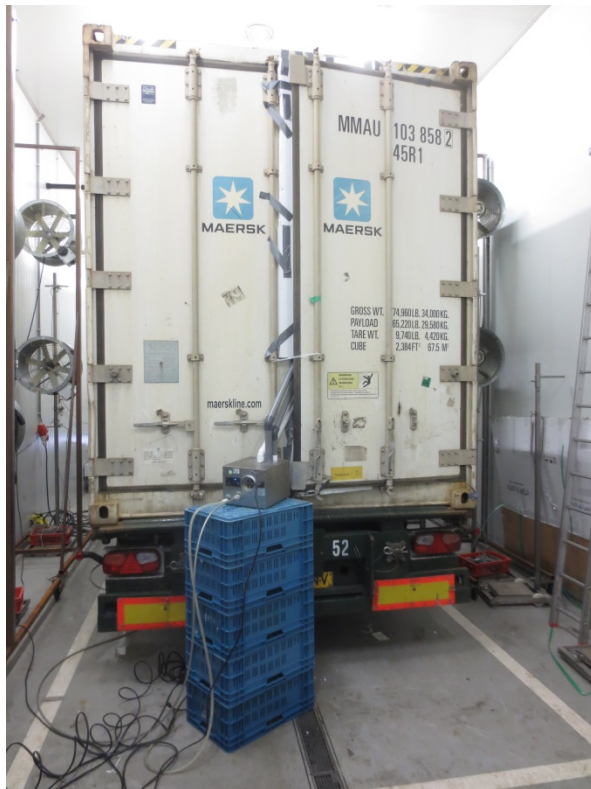
Fig. 10, humidification through door chink.

<http://www.contronics.nl/product/detail/21/31/Humidifier-HU-45>. To avoid freezing of the humidifier the humidifier is placed outside the container. The fog is blown into the container through a chink between the container door's. The remainder of the chink is closed as well as possible with EPS foam blocks (see Fig. 10).

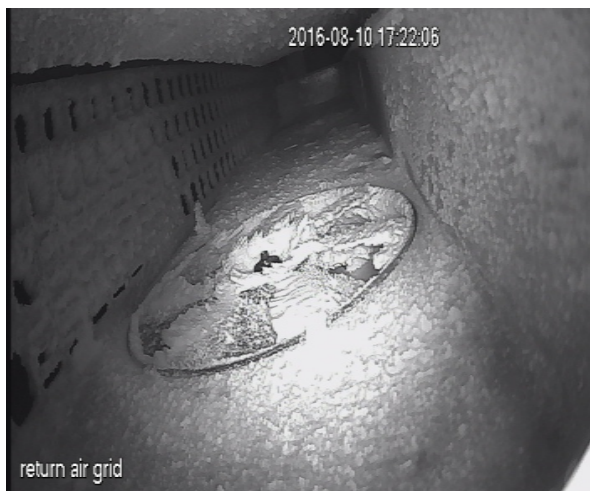
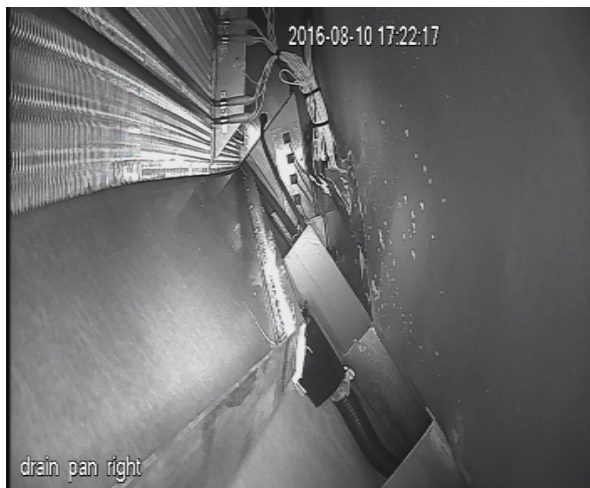
Fig. 13 - Fig. 20 are the images taken by the four IR cameras at start and end of the defrost starting 10-8-2016 17:14 and ending 10-8-2016 18:09.

Fig. 13, cam 1 at start of defrost 7 (10-8-'16 17:14).

Fig. 15, cam 2 at start of defrost 7 (10-8-'16 17:14).

Fig. 17, cam 3 at start of defrost 7 (10-8-'16 17:14).

Fig. 19, cam 4 at start of defrost 7 (10-8-'16 17:14).

The return air grid integrated in the new rear panel has smaller openings near the evaporator fans, and larger ones elsewhere (Fig. 8, Fig. 14, Fig. 21). It is interesting to observe that during the tests primarily the smaller openings clogged up with frost (Fig. 13, Fig. 21).

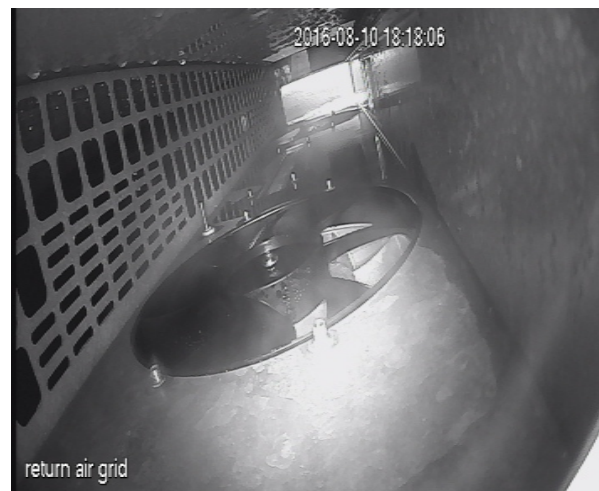
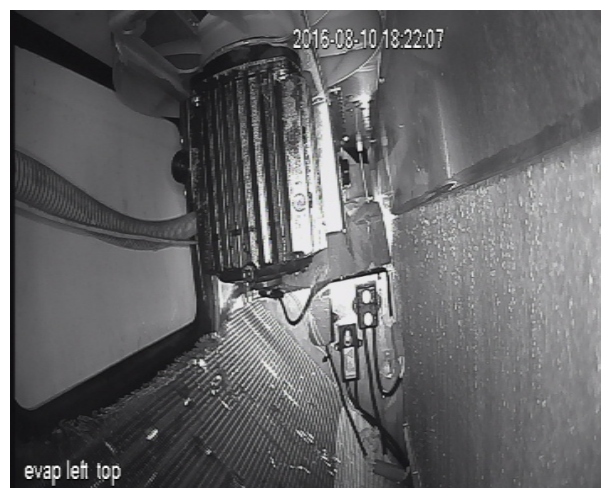
Fig. 14, cam 1 at end of defrost 7 (10-8-'16 18:09).

Fig. 16, cam 2 at end of defrost 7 (10-8-'16 18:09).

Fig. 18, cam 3 at end of defrost 7 (10-8-'16 18:09).

Fig. 20, cam 4 at end of defrost 7 (10-8-'16 18:09).

The extended defrost function suffices to completely defrost the unit in case of the new rear panel design and a new evaporator fan motor assembly. This is proven by the persistently repetitive temperature cycle during two days of testing (Fig. 12): would frost or ice accumulate over time somewhere in the unit, then the pattern of the temperature cycle would change. Extra evidence is provided by the images not revealing any frost at the end of defrost no. 7 (Fig. 14, Fig. 16, Fig. 18, Fig. 20).

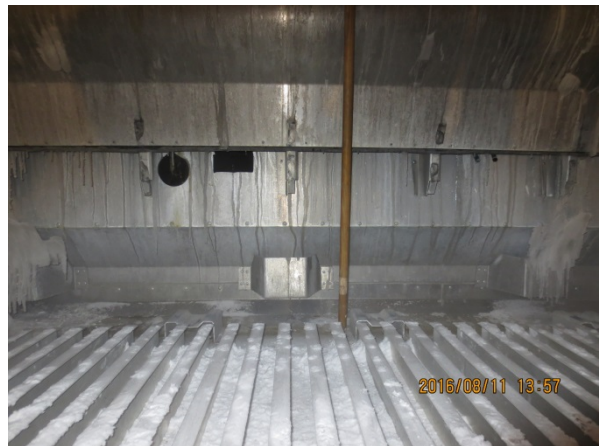
Fig. 24, some icicles behind the baffle plate at the end of test 1, esp. at the unit's front panel.

At the end of test 1 quite some ice had accumulated on the container floor underneath the unit, esp. at the far-left and far-right (Fig. 24 - Fig. 26).

Apart from the far-left and far-right not much ice accumulates underneath the unit's rear panel (Fig. 24). Apparently all melt water reaching the drain gutters also reaches the drain pan: apparently the sealant between drain gutter and rear panel is effective.

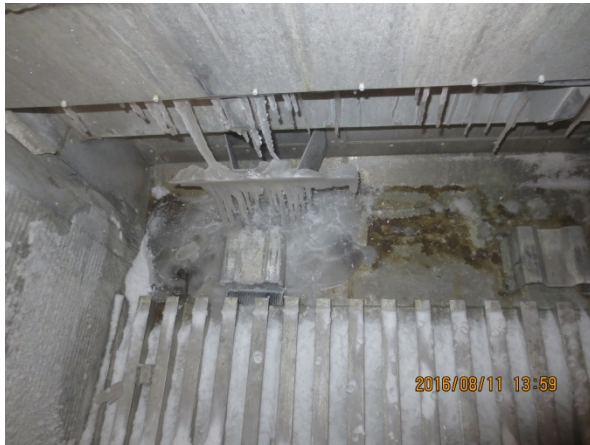
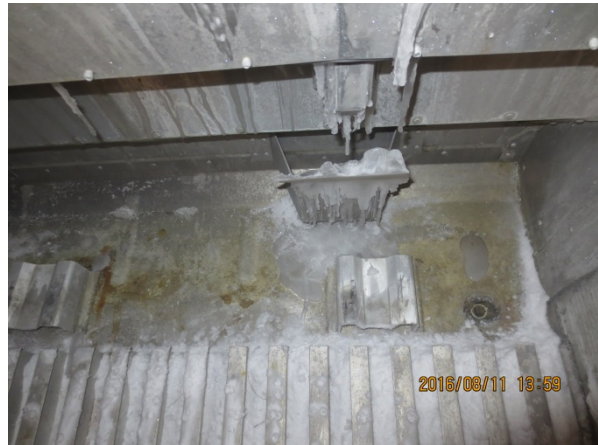
Fig. 25, ice on left-side of floor at end of test 1.

Fig. 26, ice on right-side of floor at end of test 1.

The ice accumulation on the floor at the far-left and far-right (Fig. 25, Fig. 26) is caused by melt-water trickling down further to the sides than the reach of the drain gutters.

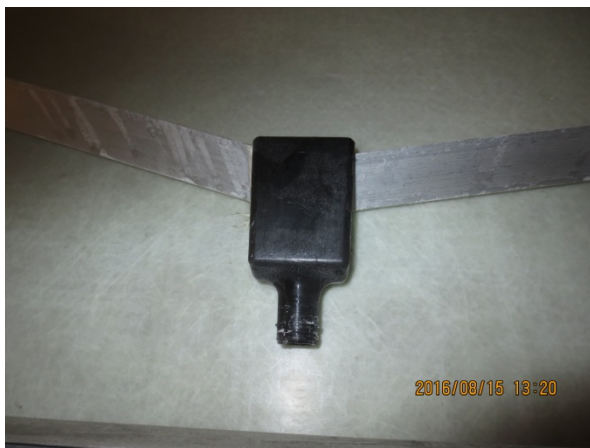
Fig. 27, at end of test 2 the drain pan is clean and no icicles have formed at the rear panel underneath the drain gutters.

Only at the end of test 2 the upper rear panel was removed, enabling some new photos. At that moment the drain pan, gutters, and upper rear panel underneath the gutters was perfectly clean (Fig. 27). It was also observed that quite some icicles were attached to the unit's front panel (Fig. 29, Fig. 30).

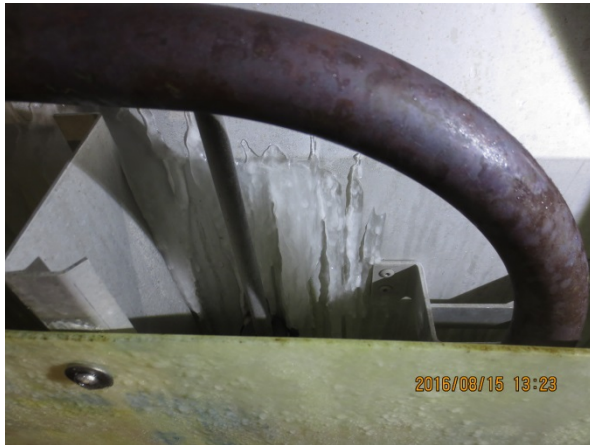
Fig. 29, icicles attached to the unit's front panel at end of test 2.

Fig. 30, icicles attached to the unit's front panel at end of test 2.

It was observed that quite some icicles were attached to the unit's front panel (Fig. 29, Fig. 30). It was also observed (not photographed) that the electric heaters were curved and hence in direct contact with the evaporator coil. These contact places are the most important points for initiation of icicle growth on the unit's front panel.

Address the curving of electric heater elements to reduce the amount of melt water not reaching the drain gutters. Note this issue is not specific for *extended* defrost, but affects every shipment.
