Nature-based Solutions for flood resilience on Bonaire

A scoping study

Wageningen Environmental Research
Wageningen, November 2023

Report 3292
ISSN 1566-7197

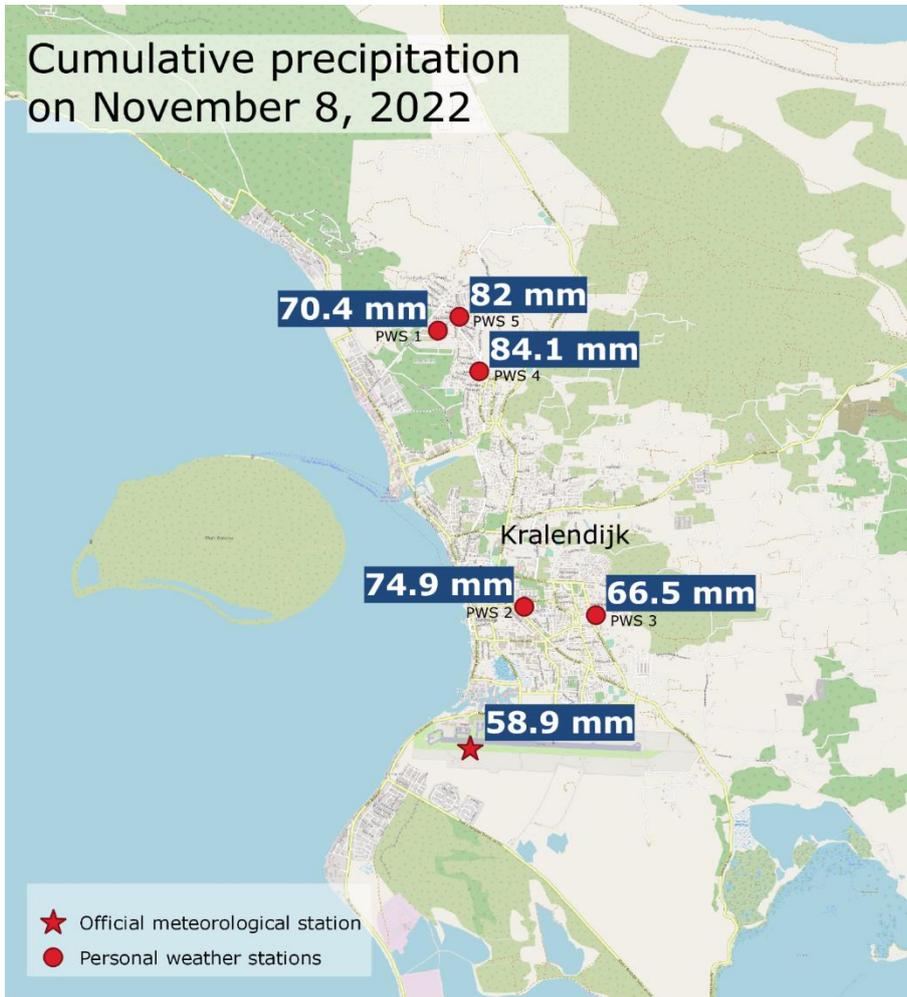
Figure 3 Measured precipitation for official and unofficial weather stations on 8 November 2022. Background: OpenStreetMap.

Figure 4 shows the recorded precipitation of the PWS in and around Kralendijk. The locations of the PWS are also indicated in Figure 3. The timeseries present the accumulated precipitation values and hourly precipitation between 30.10.2022 and 9.11.2022. The highest amounts were recorded on 8 November, when rainfall rates of more than 50 mm per hour were recorded. However, some significant precipitation amounts were also measured the days prior to the heavy rainfall event. It is likely that these antecedent wet conditions have contributed to the increased risk of flooding.

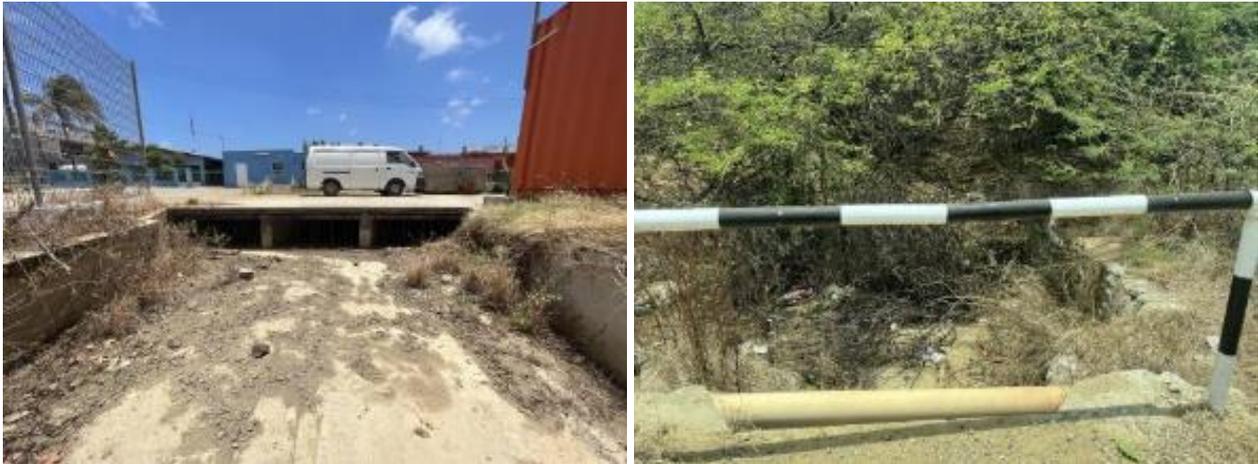
Figure 9 Examples of canalised, covered and overgrown roeien in the urban area of Kralendijk.

The urban water infrastructure in Kralendijk often lacks the capacity to drain rainwater and water from upstream to the sea during heavy rainfall (see examples in Figure 9). Three important roeien (channels) lead most of the rainwater out to sea: one between Saliña di Vlijt and Harbour Village marina, one between the southern saliñas, under Boulevard J.A. Abrahams towards the Marriot resort, and one rooi channelled underground beneath buildings and Kaya Debrot from Kaya Nicolaas to Kaya Craane on the shore (Kaya Debrot 72) (see Figure 10). Streets in between lack the facilities to lead excess water away without damage to the infrastructure, leading to damaged roads during rainfall events. Due to the geology of Kralendijk, additional water can well up from the groundwater during high tide. The lacking drainage in the urban area leads to flooding of streets and properties. Recently restored roads already show signs of water damage. In several neighbourhoods the paved roads lead water downstream when it rains, causing infrastructure damage and erosion.

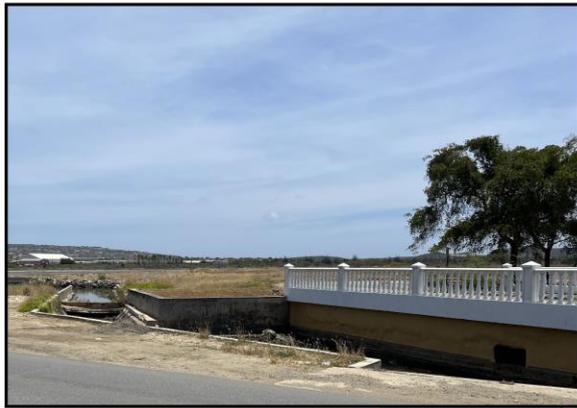
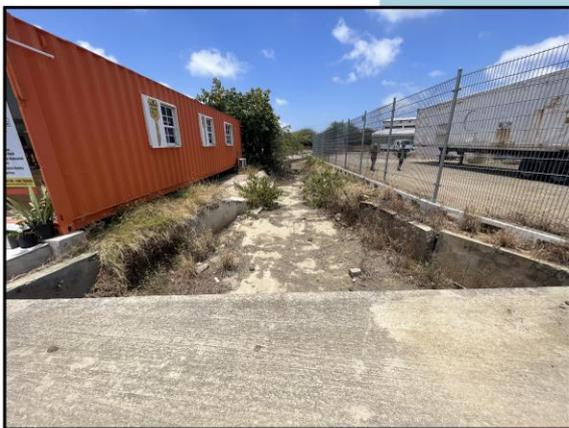
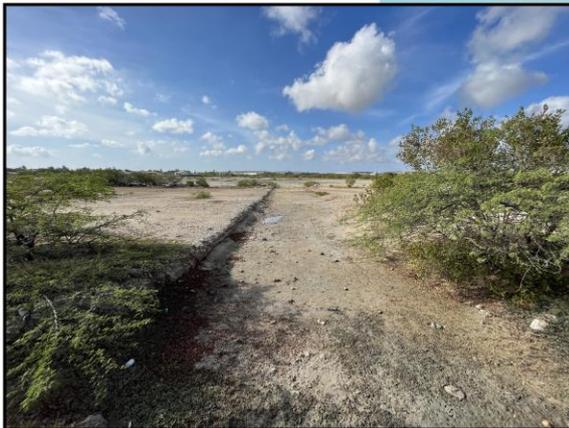
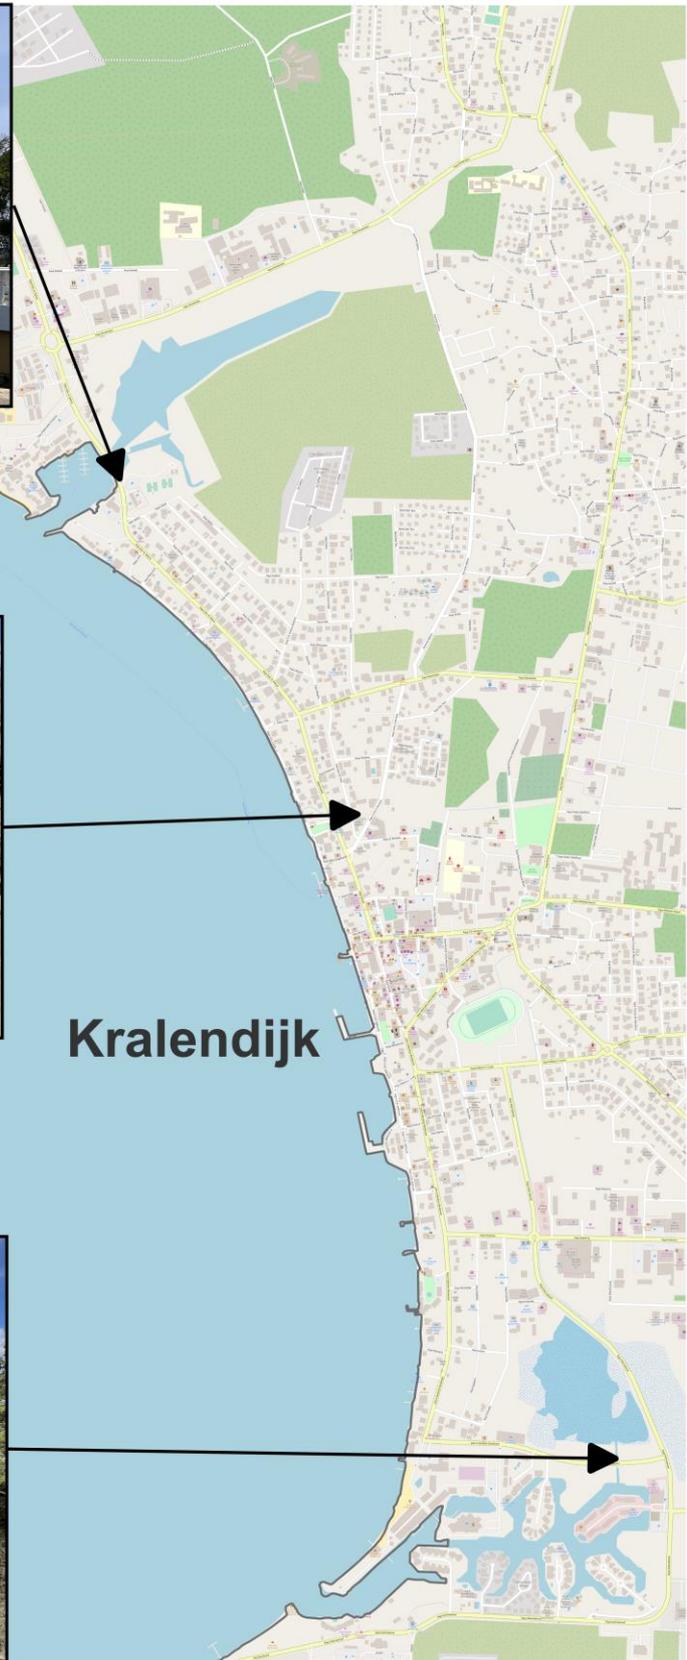
Saliña di Vlijt / Harbour Village marina

Kaya Nicolaas / Kaya Debrot

Boulevard J.A. Abrahams

Figure 10 Three main outlets for rainwater in the Kralendijk urban area. Map source: OpenStreetMaps.

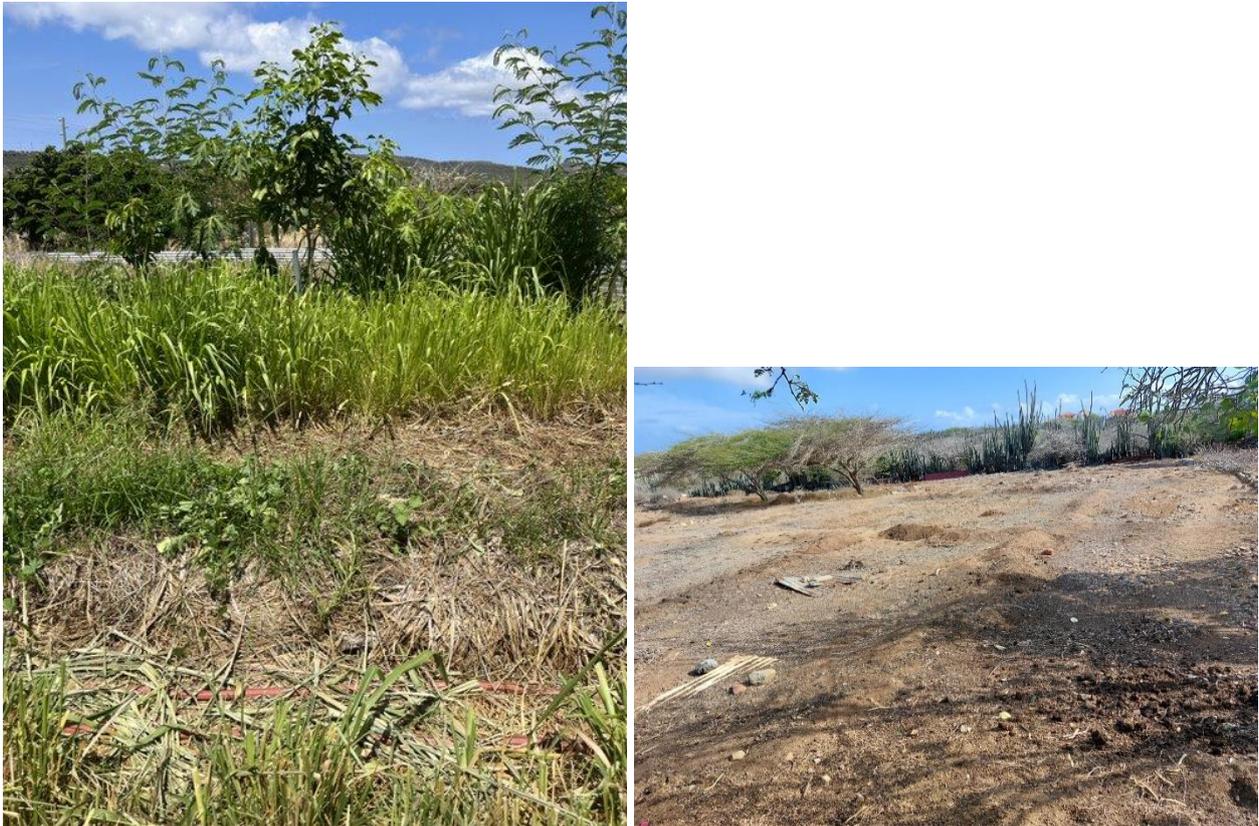
Figure 13 Left, a snapshot of syntropic farming at Mangazina di Rei. Right, levees on kunukus to retain water in the wet season. At the bottom right, goat and sheep dung fertilizer can be seen. Picture taken in the dry season.

Developing agroforestry (e.g., syntropic farming, see Figure 13) and other regenerative practices could enable sustainable small-scale food production and improved water retention. This is especially relevant for the kunukus currently in use. The few kunukus in the Kralendijk area that do have a lot of trees (see Figure 12) could potentially be used as examples, showcase farms where the practice is taught. Food production on kunukus is getting scarcer. Efficiently producing food crops is a labour-intensive job – one of the reasons kunukus are rarely used for large-scale food production. The kunqueiro needs a new perspective. Small-scale food production for the family is possible on many kunukus, but require a type of agriculture based on water and resource availability and local nutrient cycles. By showcasing the possibilities for small-scale permaculture, agroforestry and landscaping for kunukus (e.g., by building terraces surrounded by levees to retain more water), an attractive usage of kunukus can be promoted. It is possible that kunqueiros need help realizing these practices in terms of knowledge exchange, planning or executing projects, and financing of investments. It is essential that land owners are taken along in the process of development and decision making so that they feel ownership of the solution, since management will be carried out primarily by them. A viable business model should be discussed and evaluated.

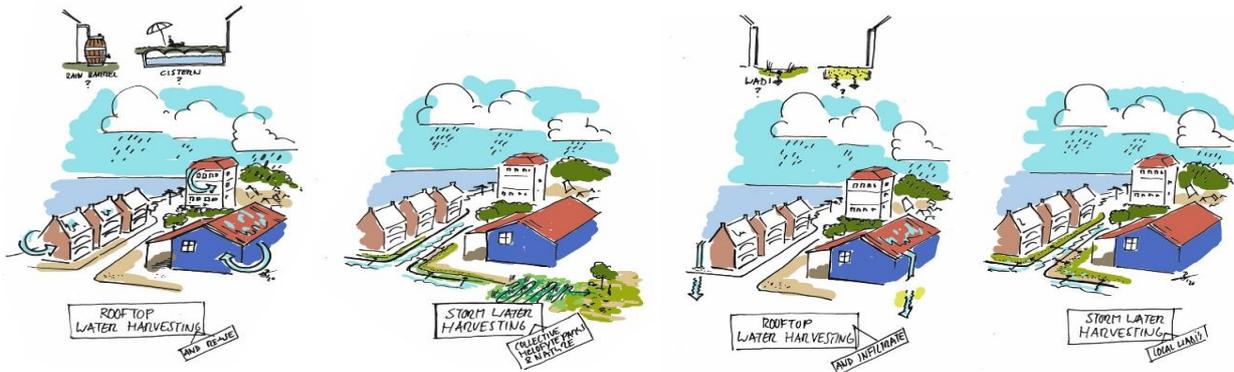
Figure 15 Rooftop water harvesting and storm water harvesting can help to reduce urban flood risks. In addition, the water that is collected can be used during dry spells.

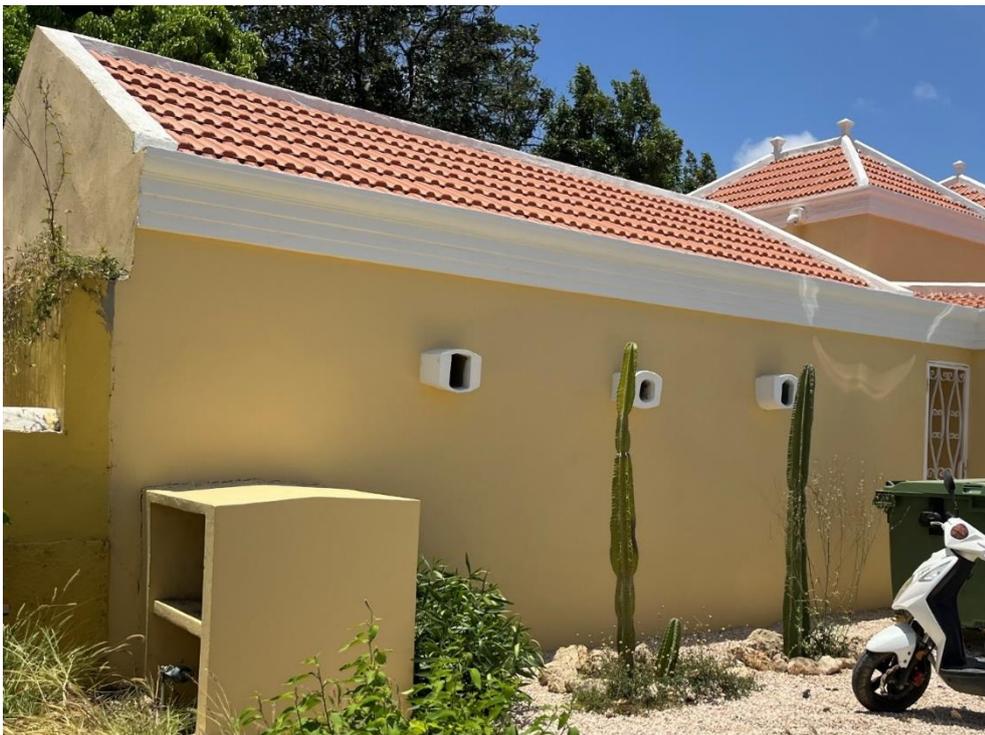
Figure 16 Example of water harvesting on roofs on Bonaire. The three white openings in the wall are overflows in case of water storage limitations.
