Flood-induced buttertub spill reveals riverine macroplastic transport dynamics

Rahel Hauk^{1*}, Martine van der Ploeg¹, Adriaan J. Teuling¹, Winnie de Winter² and Tim H. M. van Emmerik¹

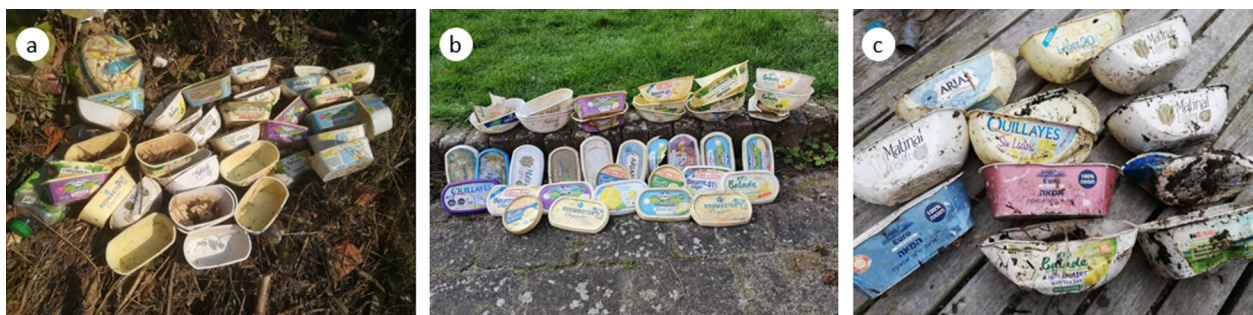
Fig. 2 Illustration of buttertubs collected by the authors of this study (a) and by volunteers from the Clean Rivers Project (b, c). Pictures taken by authors of this study (a) and volunteers from the Clean Rivers Project (b and c)

Figure 2b and c shows pictures taken by Clean Rivers citizen scientists which indicate that indeed the correct type of buttertubs was counted during the monitoring rounds. However, it cannot be ruled out that some citizen scientists did not count any of the distinct lids.

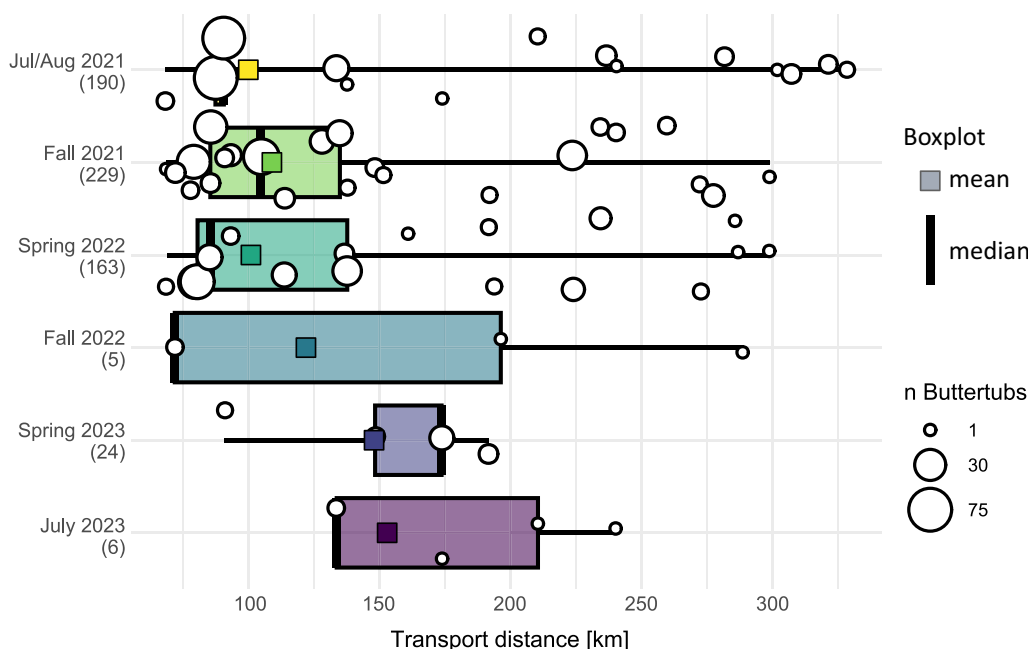
Fig. 3 Transport distance of buttertubs along the Dutch Meuse in different measurement rounds. All of these buttertubs were removed from the riverbanks, with the exception of Jul/Aug 2021, then most buttertubs were left in place and only 70 were collected from one location for further analysis. The x-axis starts at 66 km to match the extent of this study. The whiskers extent to the least and furthest transported buttertubs, with no regard for the interquartile range (no outliers were defined). Placement of circles indicates the number of buttertubs according to transport distance but random on y-axis

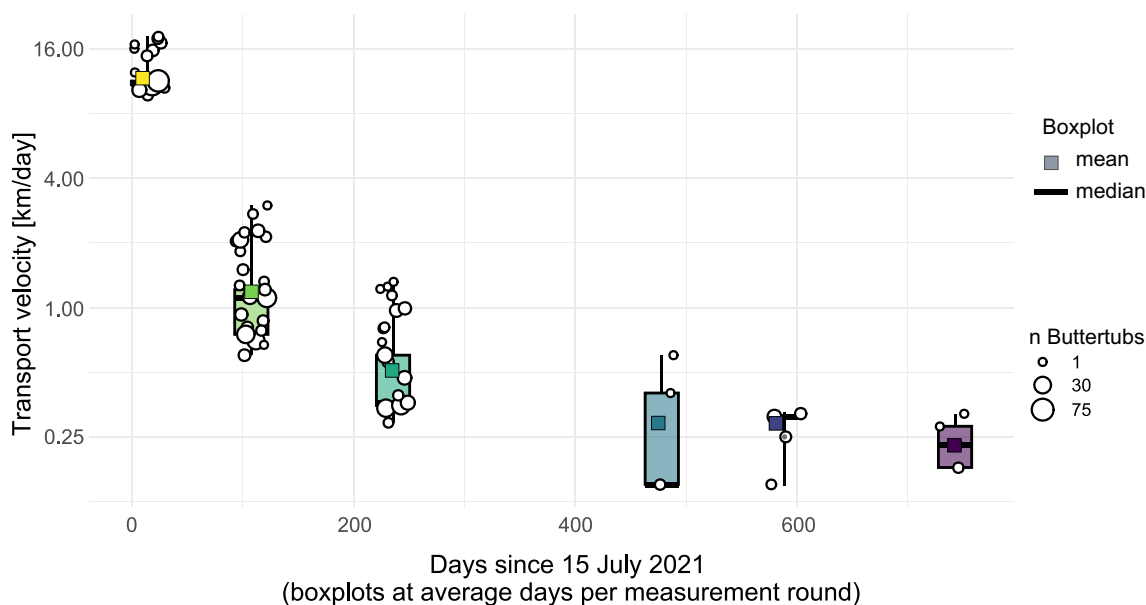
Fig. 6 Transport velocity of buttertubs in the Dutch Meuse for the different monitoring rounds. Transport velocity in logarithmic scale

The mean transport velocity shows a non-linear decay from 11.7 km/d after the flood to 0.2 km/d in July 2023 (Fig. 6). Based on the riverbanks where buttertubs were found within 3 weeks after the flood event, they were transported at a velocity between 9.8 and 18.3 km/d. The flow velocity of the Dutch Meuse is typically about 1–3 m/s (86–259 km/d) and can increase up to 4.3 m/s (372 km/d) [33] during floods. So the transport velocities we found are realistic, but likely much lower than the velocity of buttertubs in motion. Until Fall 2021, on average 108 days after the flood event, the average transport

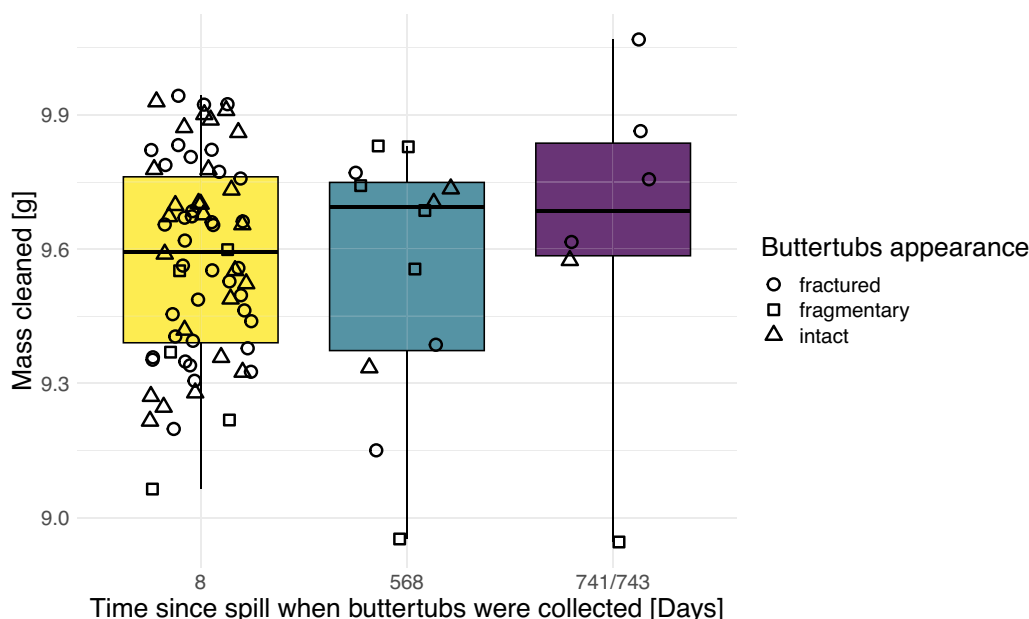
Fig. 7 Mass distribution of buttertubs after 8, 568, and 741 days of exposure in the environment. Aggregated mass available in Table 1

Mass data was grouped by intact buttertubs, i.e., that show no damage, fractured buttertubs, i.e., that appear cracked but complete, and fragmentary buttertubs, i.e., that appear cracked and with parts missing. Mass distribution of buttertubs displayed in Fig. 7

Figure 7 shows the range of mass of buttertubs for each time period. While the item with the lowest mass at each point in time is a buttertub that is fragmentary, there is no conclusive pattern that links mass, buttertubs appearance, and their respective exposure time. [24] placed buttertubs very similar to the ones of this study (both PP, similar in shape and size) on riverbanks and observed their degradation over the course of multiple years. The buttertub they had placed with high exposure to sunlight became so brittle, that it was considered lost to fragmentation after 2 years. Whereas buttertubs placed protected from solar radiation stayed mostly intact. The buttertubs we collected after 2 years were found partly buried, or covered by vegetation, which could (partly) protect them from sunlight exposure and slow down their degradation. However, it is possible that some buttertubs with high exposure to sunlight completely fragmented and were, therefore, not recognised as buttertubs anymore. PP items can be very durable and remain intact in the environment for decades [37] found PP packaging that (based on use by dates) was retained on riverbanks for up to around 40 years and did not show any signs of weathering and fragmentation. The results from the studies by [24] and [37] are in line with our results on mass loss and
