The Great Eastern Japan Earthquake and Tsunami

Field observations on the coast of Tohoku six months later

NOVEMBER 2011

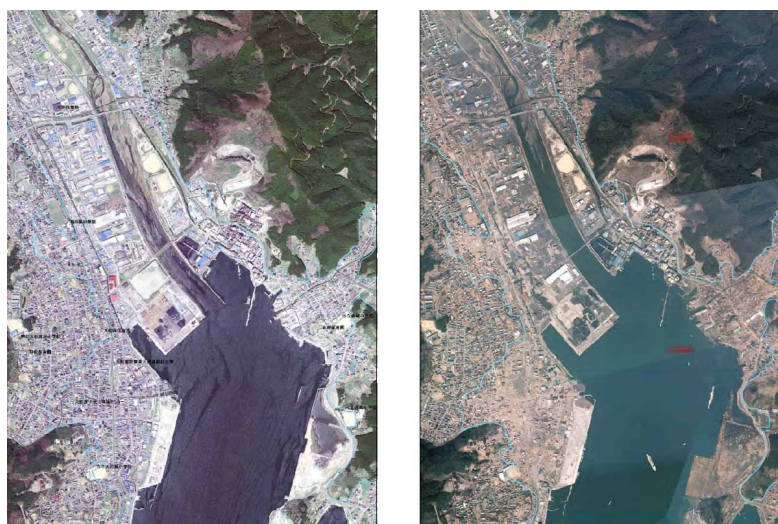
Figure 6: Ofunato before and after the tsunami (Kokusai Kogyo Group; www.kk-grp.jp)

Ofunato is a city located in the narrow bay of a ria in Sanriku region. The city has a low lying part, which was inundated, and a part lying on higher grounds, which was not affected. The maximum reported inundation height is 8.3m. Most of the concrete buildings remained in place, but were seriously damaged. Windows and doors were missing from ground till the second or third floor, which is an evidence of the tsunami depth. Wooden houses were completely destroyed. Port infrastructure seemed to have remained in place, although a uniform subsidence of more than 0.5m was evident to the entire port area. Most of the debris had been cleaned and accumulated in certain spots. The volumes of trash were impressively large, forming hills of several meters height.

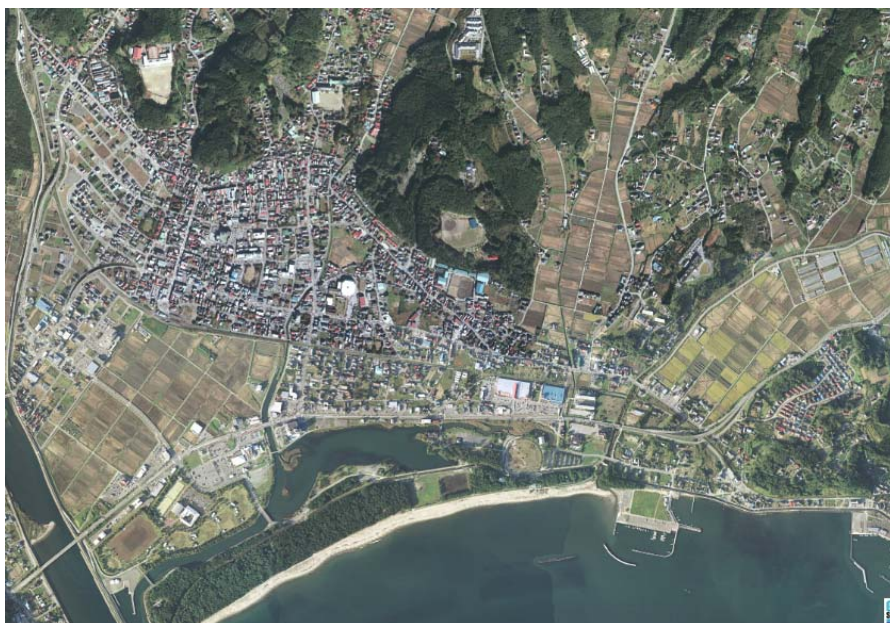
Figure 12: Satellite image of Rikuzentakata before the tsunami (Kokusai Kogyo Group; www.kk-grp.jp)

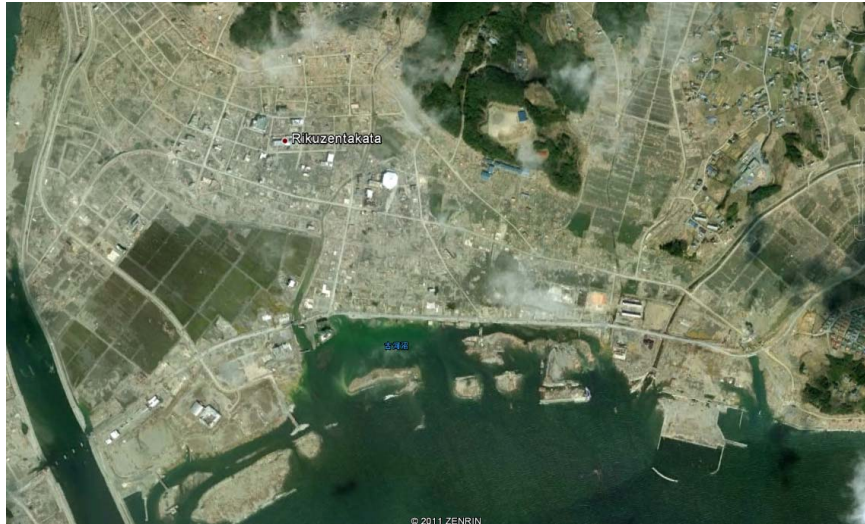
Figure 13: Satellite image of Rikuzentakata after the tsunami (Google Earth image, 2011)

Rikuzentakata is one of the most heavily damaged cities by the tsunami of March 11. It is located in a wide ria bay with a long natural sandy beach. On the top of the bay, in a zone of about 1.5km, the land slope is relatively mild. At this area, only concrete buildings of 3 floors or higher remained in place. In many of them, doors and windows of up to the fourth floor were missing, which shows that the water reached that height, and overtopped many of the buildings. The rest that was mainly wooden buildings, were washed away. As most of the debris has been cleaned and accumulated at certain spots, looking from above, the footprints of the foundations extending in several square kilometers could be seen, revealing the magnitude of the disaster.

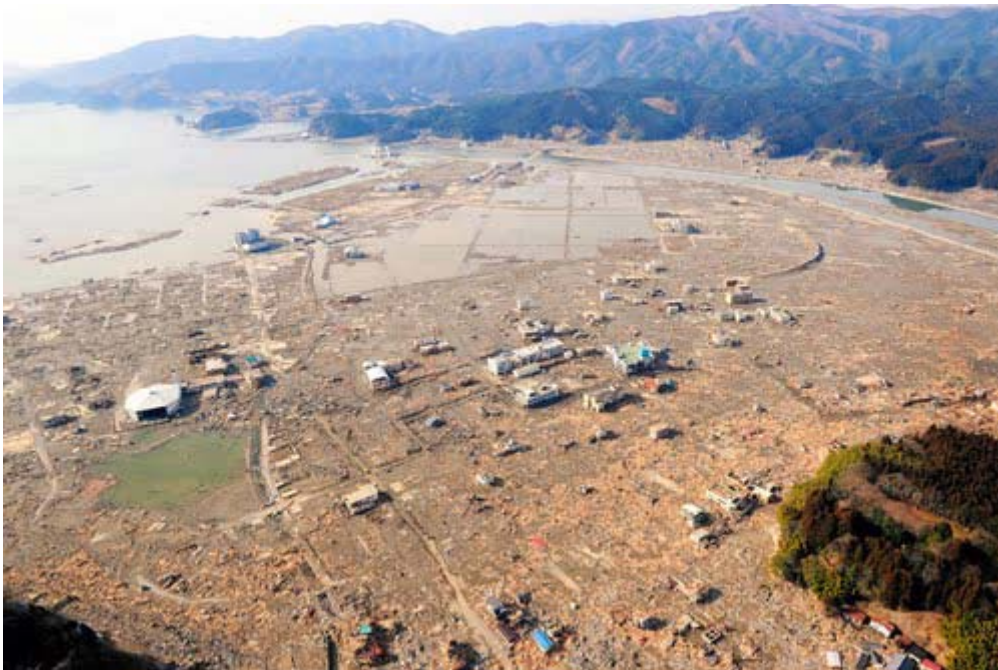
Figure 14: Rikuzentakata as seen from higher grounds (Panoramio; www.panoramio.com)

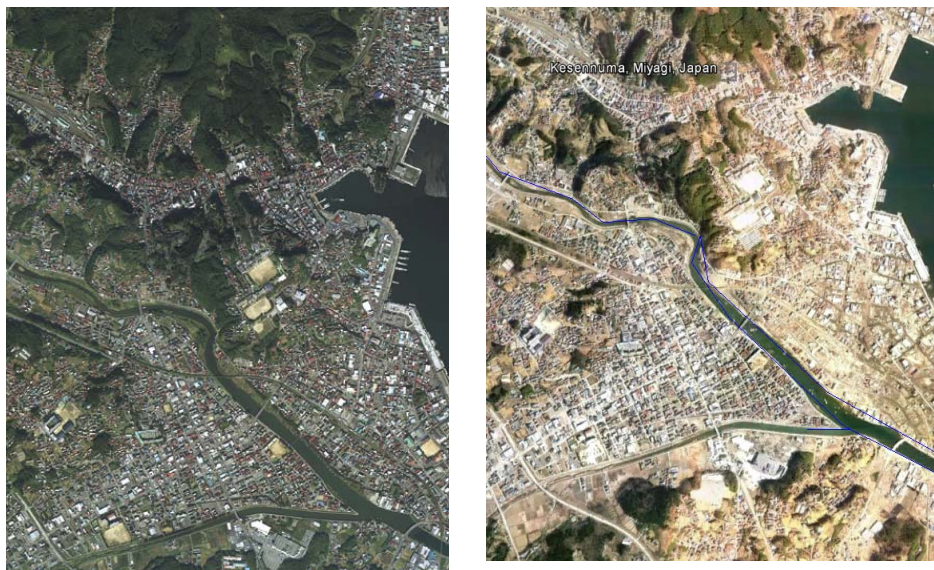
Figure 18: Kesennuma before and after the tsunami (Kokusai Kogyo Group; www.kk-grp.jp)

Kesennuma lays 12 kilometers to the south of Rikuzentakata, and was likewise severely damaged, with inundation reaching 15m in many spots on the waterfront. Apart from the tsunami, Kesennuma suffered some fire damages as well. Heavy oil was spilled and burnt during the tsunami attack. Important subsidence could be observed at the harbor infrastructure, which moved the waterline inland, towards the first roads. Some parts of the quay walls were completely inundated. Some temporary shore protection with sandbags was built to prevent expansion of the erosion further inland. Most of the rubble was already cleaned up, yet much work is still needed.

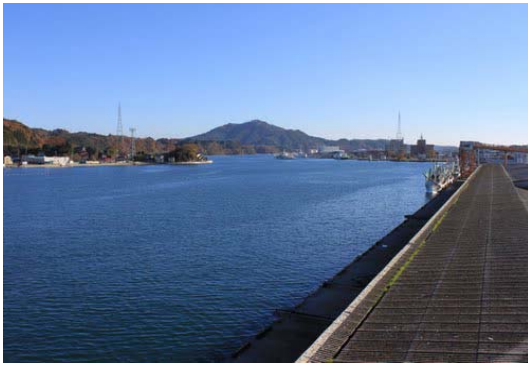
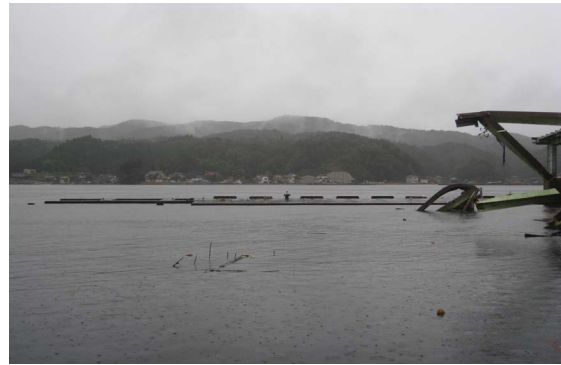
Figure 20: The waterfront of Kesennuma before and after the tsunami

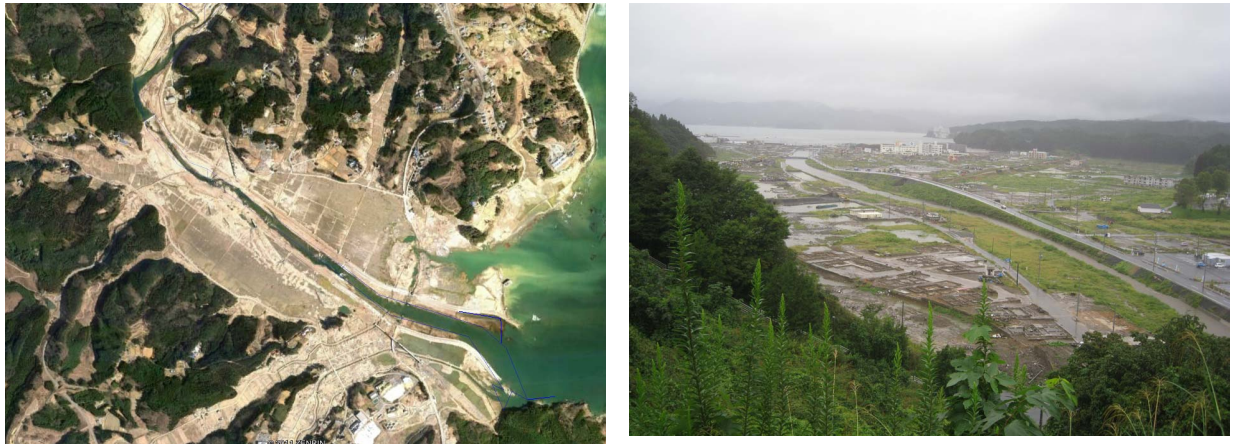
Minami-Sanriku is located in a quite narrow, fjord-like river valley. The town was almost entirely devastated. Like in Rikuzentakata, a tsunami run-up far inland along the river took place.

Figure 23: Minamisanriku after the tsunami (Left: Google Earth image)

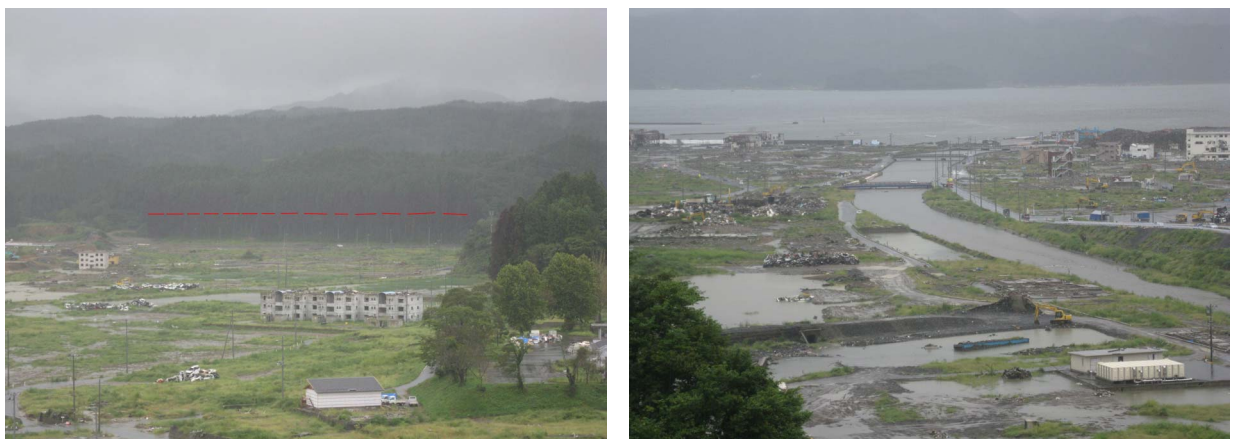
Figure 24: View of Minamisanriku from evacuation point on higher grounds. Left: Indication of inundation line demarcated on the woods.

At this area the inundation line was clearly visible on the slopes of the mountains, where the inundated part of their forest was corroded, hence brown-colored, contrasting the green of the higher grounds. The inundation heights near the frontage exceeded 15m, while the maximum run-up exceeded the 35m. Only a few high concrete buildings remained standing in the town, while the rest was washed away. Serious subsidence and erosion can be seen near the waterfront, as well as damage of coastal roads. The transportation in that area was not fully recovered. The storm surge gates at the mouth of the river were also severely damaged, as well as parts of the river dikes. Some temporary protection measures have been attempted in the form of sandbags. On the northwest side of the town some temporary houses can be found on the mountain, where the local population is sheltered.

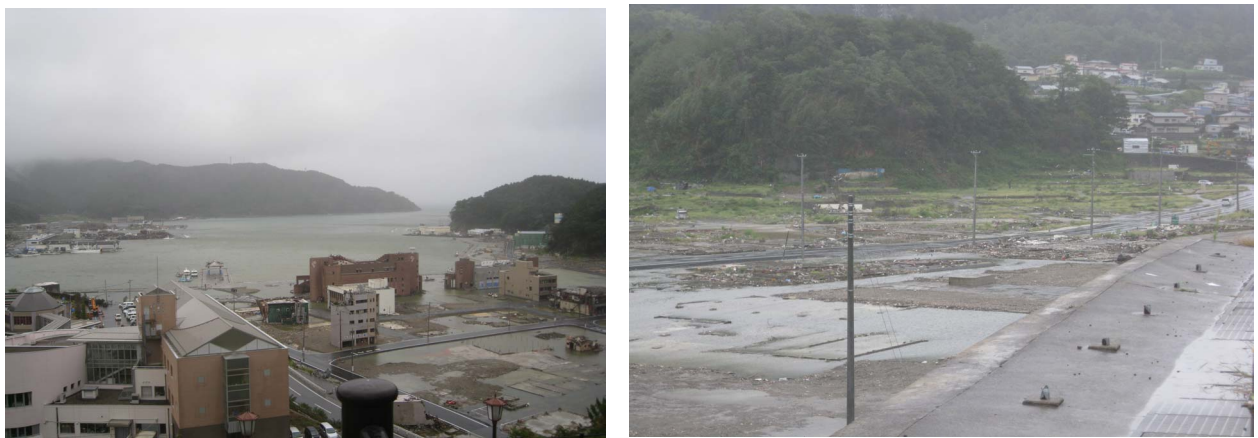
Figure 29: View of Onagawa from evacuation point in higher grounds

In the low-lying part of the city all wooden buildings were devastated, while it was interesting to see that many concrete buildings were overturned. It is believed that the cause of this special type of failure was the fact that those buildings had pile foundations that due to the earthquake were detached from the bottom of the building, and as a consequence the uplifting tsunami forces overturned the entire building. Liquefaction might have also played a role to this failure. Furthermore, some significant subsidence at the waterfront was evident, like in most areas in the rias. The inundation height near the shore was around 15m.

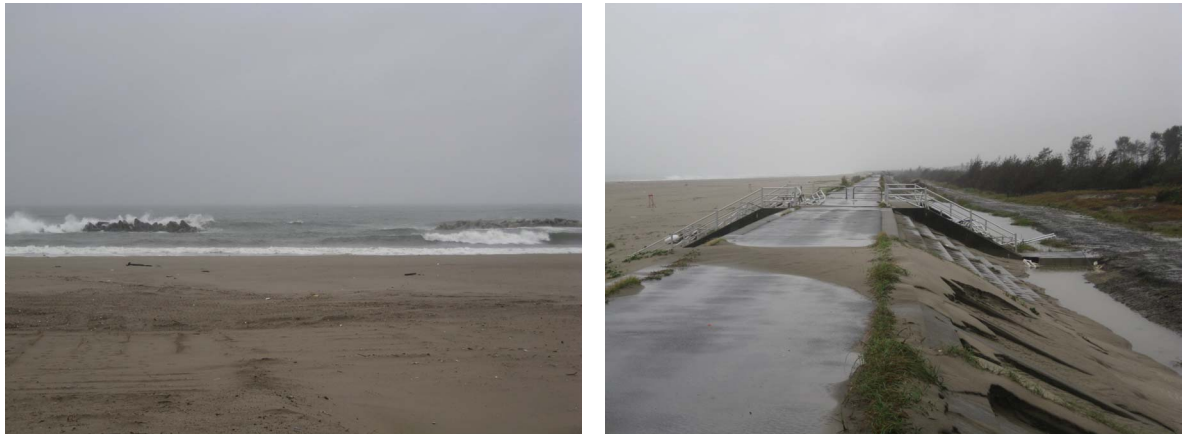
Figure 33: Sandy beach and sea dike at Arahama Wakabayashi-Ward

The levee was overtopped by the tsunami of March 11 and propagated to the flat land, inundating many square kilometers of rice paddies, and devastating a coastal pine tree forest and the settlement. A big breakage of the levee can be found on the northeast of the settlement. The inundation depths in Arahama were relatively lower than the ones recorded in the coastal cities in the rias. The watermarks and damage on concrete buildings that survived the tsunami were up to the second floor. It is notable that some concrete buildings behind the dike that were founded on sandy subsoil did remain in place, yet with significant scouring on their toe, which exceeded 2.5m. Scouring due to overtopping tsunami waves is considered to be the main cause of failure of the sea levees in that area.

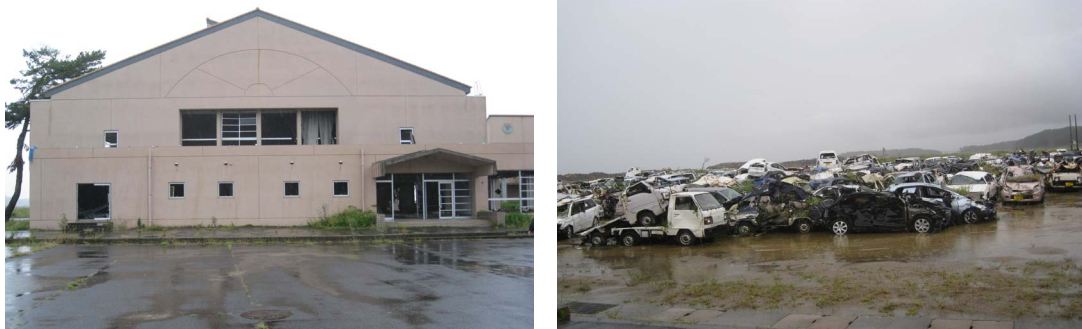
Figure 35: Left: Gymnasium building, Right: Schoolyard used for storage of destroyed cars

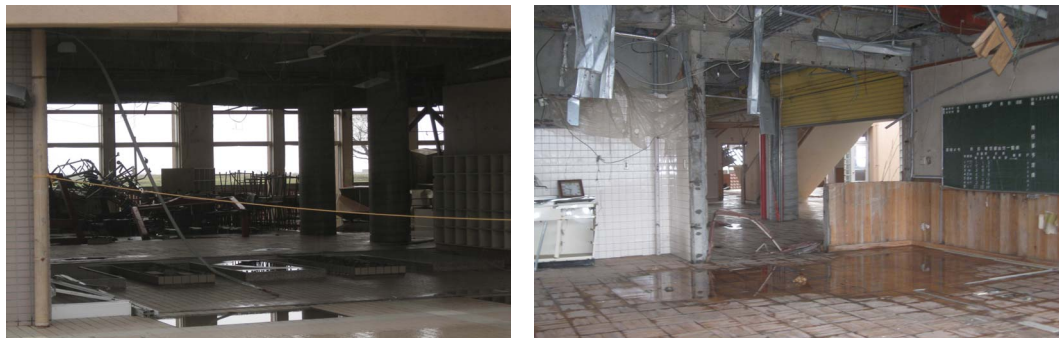
Figure 36: Inside the school

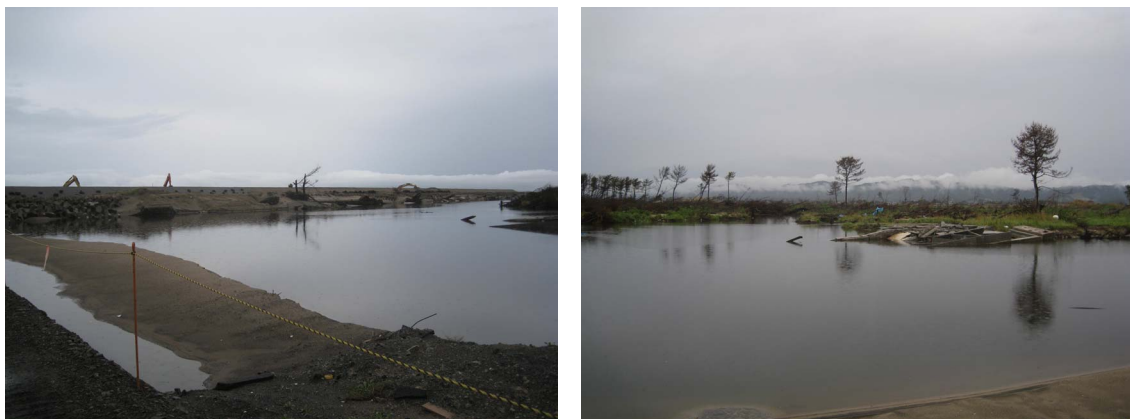
Figure 39: Inundated land on the inner side of the levee

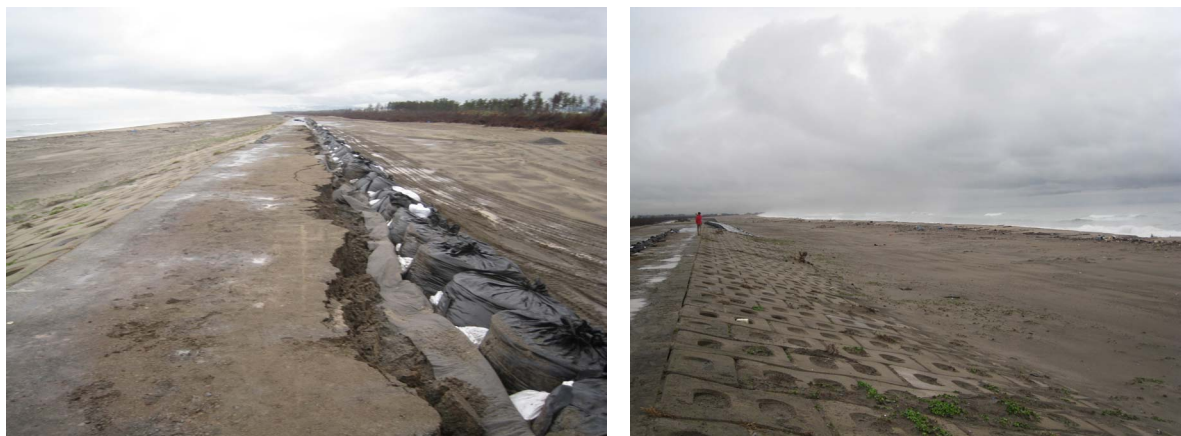
Figure 42: Left: Crest of the levee; Right: Sandy beach on the frontage

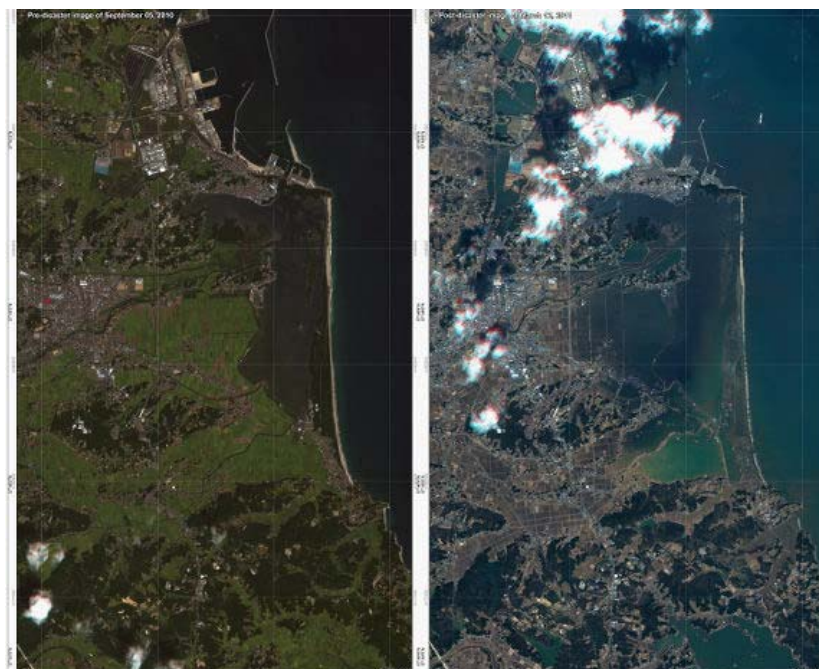
Figure 50: Soma estuary before and after the tsunami (German Aerospace Centre; www.dlr.de)

On the South of Soma port the city of Soma can be found, with a population of 38,000 inhabitants. The biggest part of the city is located on higher grounds, therefore not seriously affected by the tsunami. However an estuary with flat agricultural land fronts it, which was subsided and inundated by the tsunami. The bad weather conditions during the visit, with high water levels that intruded the subsided land, did not allow access in many parts of that site. This was in fact the case in more areas, which shows how vulnerable this land is after the tsunami.

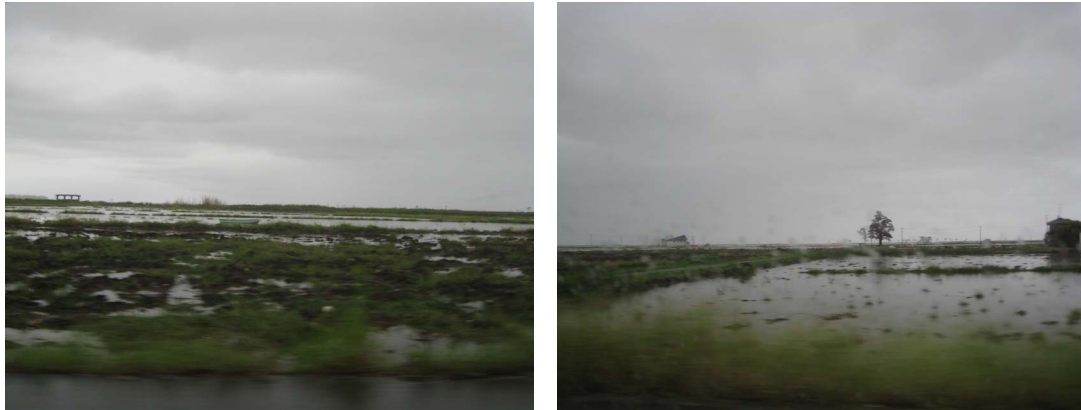
Figure 51: Inundated agricultural land on the frontage of Soma

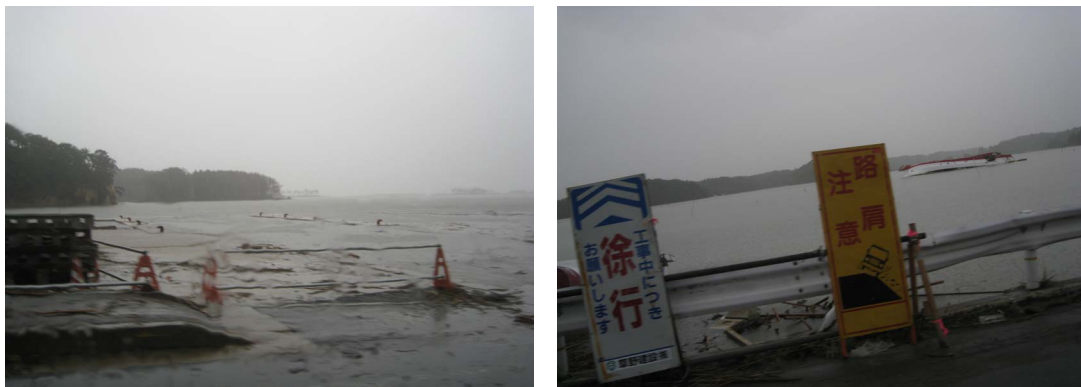
Figure 52: Left: Water intrusion during storm, Right: Ship wreck within Soma estuary
