Seepage analysis underneath the headwork of Chanda Mohana Irrigation Scheme, Sunsari, Nepal

Abstract

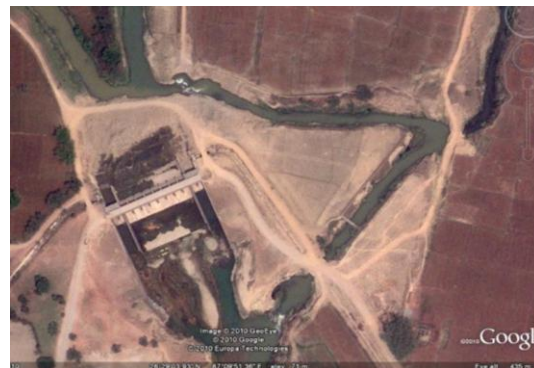
Figure 2: Layout map of CMIS after failure(Google-Earth, 2010)

The reduced level of pond level by closing the gates is 70.0 m. Furthermore, the reduced level of downstream deepest floor is 63.9 m. Thus, the head difference is 6.10 m. Floor length at the under-sluice portion and weir portion is 49.75 m and 44.75 m respectively. The sheet piles are provided only at the end of upstream and downstream of floor but not in the sides of the abutment wall. This shows that the sheet piles are not closed. Location and layout map of CMIS is shown in Figure 1 and Figure 2 respectively.

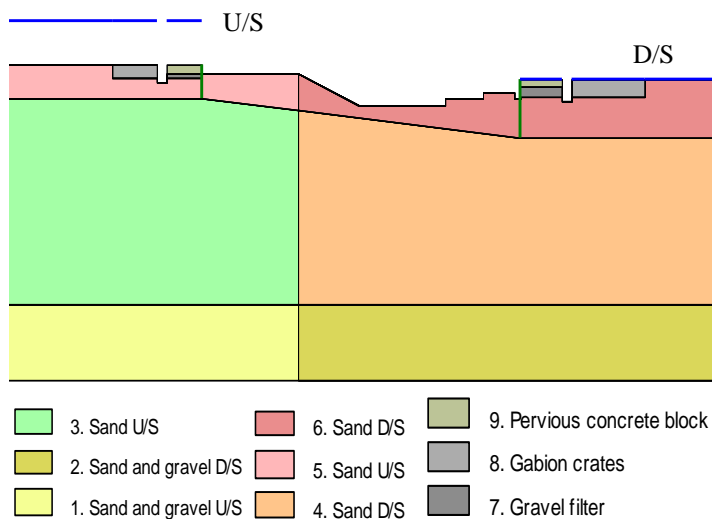
Figure 8: Schematization for under-sluice portion without lateral flow for Scenario-I

The model was run for sections of under-sluice portion and weir portion separately for the flow from upstream to downstream without considering lateral flow. Exit gradients for each section were calculated. The schematization for under-sluice portion without lateral flow is shown in Figure 8. The schematization for weir portion is shown in Figure 9. Different types of materials are shown in different layers. Each layer has its own colour as shown in legend in respective figure. The sheet piles are denoted by vertical green lines. Water levels at upstream and downstream are denoted by horizontal blue lines.

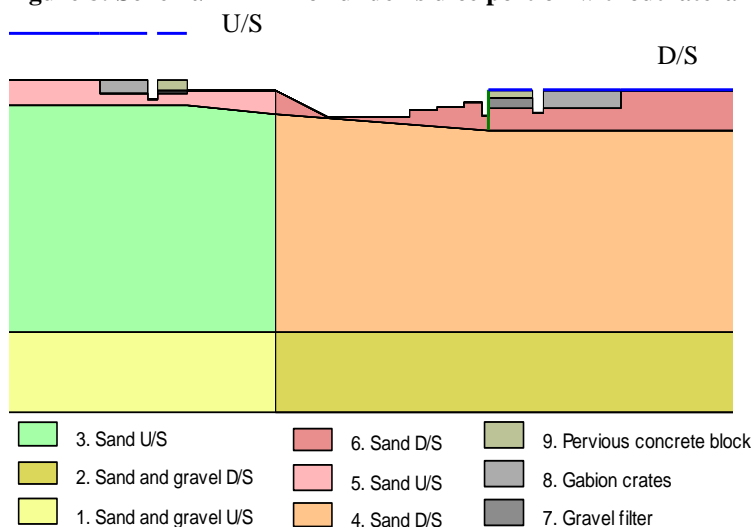
Figure 9: Schematization for weir portion for Scenario-I

The exit gradients in weir portion with and without upstream sheet piles were 0.144 and 0.146 respectively. The residual head beneath the structure without upstream sheet pile is 36.326 m at the upstream of weir crest line which was used for boundary condition to consider lateral flow.

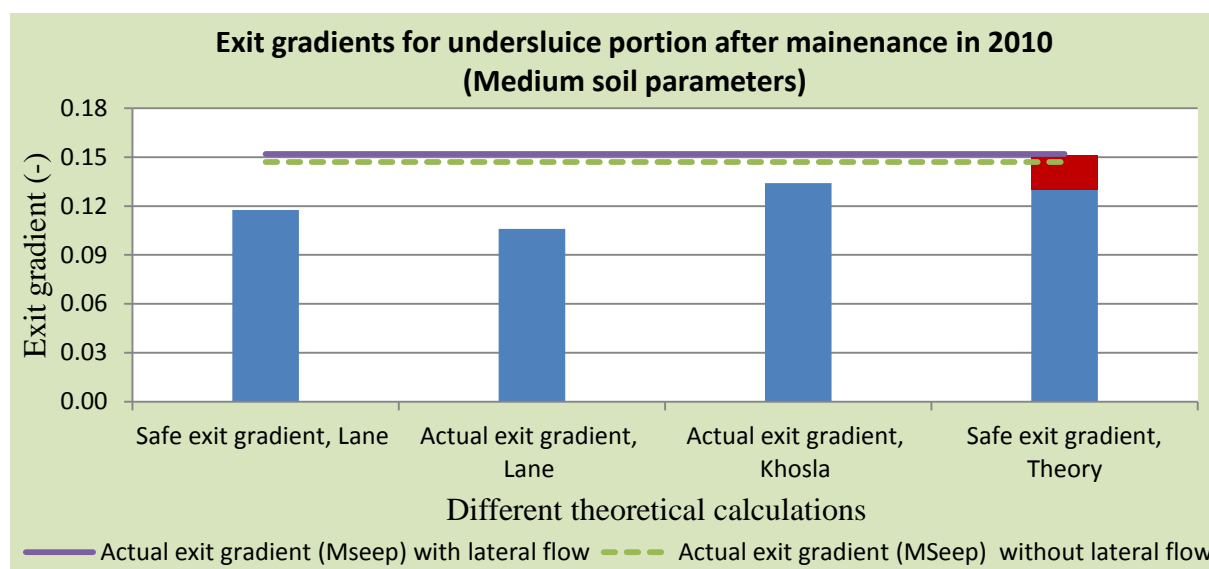
Figure 20: Comparison of exit gradients for under-sluice portion for Scenario-IV (Medium soil parameters)

The comparison of exit gradients for under-slucice portion is shown in Figure 20. As new soil parameters were considered in modelling, the exit gradient without later seepage is much higher than exit gradient by Khosla. The structure seems to be safe from Khosla exit gradient. But, it has not considered the lateral flow as well as effect of change in values of soil parameters. The vertical distance of sheet piles in inner sides is taken to calculate the lane's exit gradient though the stream line do not reach up to floor level in between the downstream sheet piles which can not be known from Lane's theory. It tells us that the exit gradient by Lane is less than the recommended which is safe for structure. The exit gradient including seepage flow is slightly above the maximum theoretical permissible limit. This shows that the structure is still at the verge of failure.

Although major maintenance works were carried out three times after the completion of the headwork, the results show that it is still not safe. If the higher safety factor than that recommended by Khosla had taken for seepage analysis during the design, the structure would not have failed.

It is difficult and quite expensive to control the quantity of seepage that occurs after construction (Uromeihy *et al.*, 2007). The repeated maintenance works due to lower safety factor cost more than one time construction cost resulting from higher safety factor. As the structure is not fully safe even after maintenance in 2010, further additional maintenance works are recommended under Scenario V.
