MINISTRY OF AGRICULTURE—NATIONAL AGRICULTURAL LABORATORIES
KENYA SOIL SURVEY

REPORT OF A VISIT TO THE EXPERIMENTAL AREA
OF THE ISHIARA IRRIGATION SCHEME.

H.M.H. Braun and N.N. Nyandat

Dec. 1972.

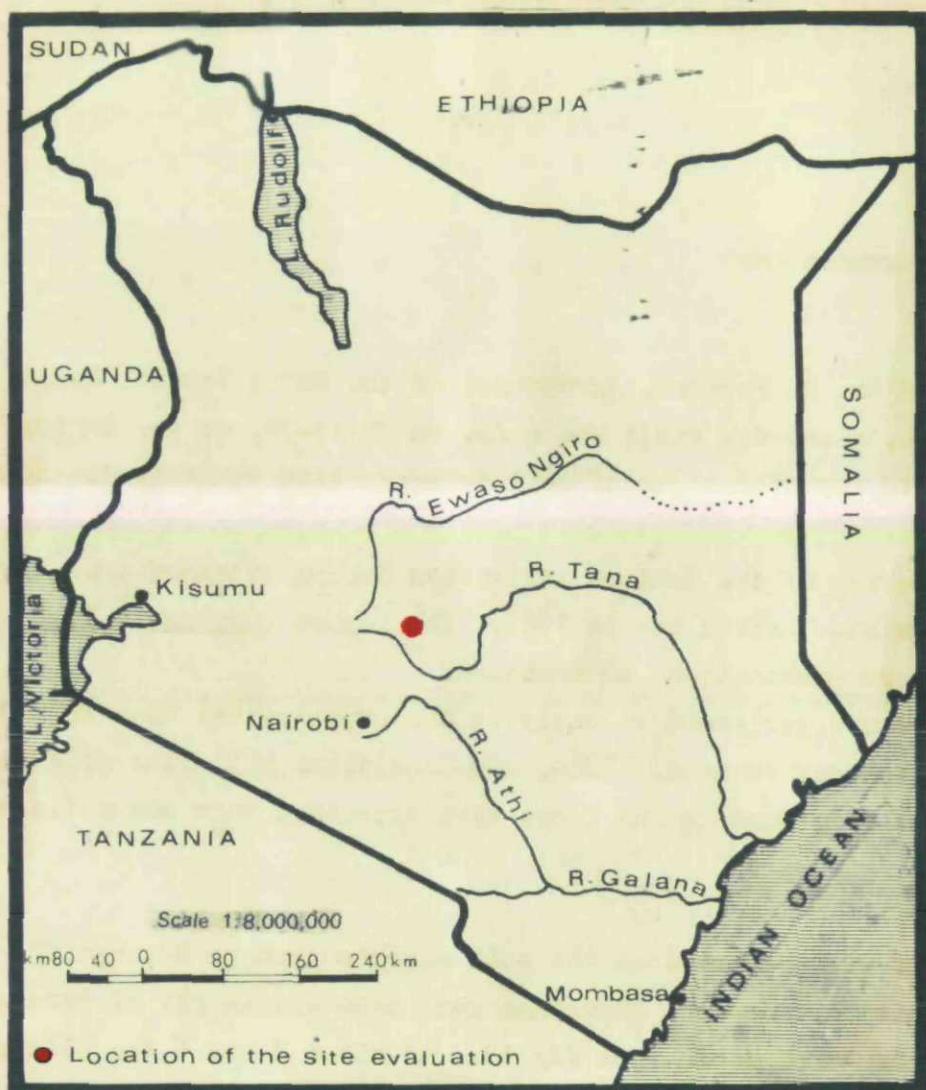
No signs of salt were observed at the soil surface perhaps because the soil was in a moist condition. Several augerings were made and in all of them groundwater was found within 150cm depth (see fig 1). At sites 3 and 6 the electrical conductivity of the groundwater was measured. The readings obtained, 150 and 200 micromho respectively, indicate that the groundwater is non-saline. Electrical conductivity was also measured in two suspensions (1:5) of soil surface samples at site 3. The readings of 130 and 150 micromho indicate that the soil surface is non-saline. A pH value of 5.3 was found in these suspensions which suggests that the soils are also non-alkaline. At site 4 soil samples were collected for salinity/alkalinity analysis in the laboratory.

In adjacent fields, belonging to private farmers, similar groundwater levels were observed. It is thought that over-irrigation and possibly also seepage from the main irrigation canal, combined with the absence of a drainage system have caused a gradual rise of the groundwater table which is believed to be deep under non-irrigation conditions. With abundant rainfall in October and November the ground water table has risen up to the soil surface.

In the augering holes made there was very little increase in the water level with time which indicates that the permeability of the soils is moderate. However it appears from the observed groundwater levels that the soils are not permeable enough enough to obtain an adequate natural drainage.

In several augerings rock or rock fragments were reached at a depth of 190 cm. or more. At site 6 mottling and iron/manganese concretions were found at 100 cm depth which indicates that variations in groundwater level also occurred under natural conditions in the recent or distant past.

For further confirmation of the non-salinity/alkalinity of the soils it would be useful to perform some measurements in the dry season.
