# Analysis of shipments of cut tulips in 12 reefer containers

Author: Leo Lukasse

Report 1626

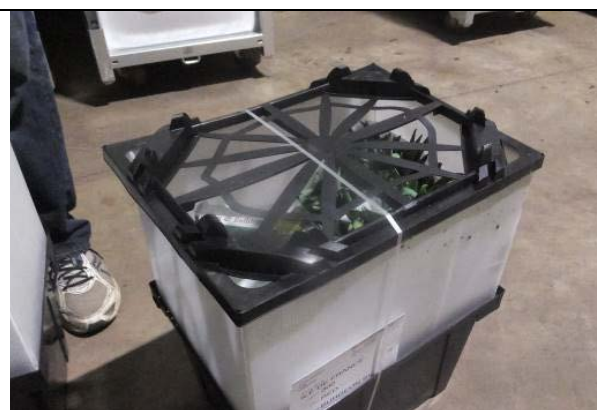
Fig. 1, box (procona) of cut tulip flowers.

Each shipment carries some 710 boxes (procona) of tulips, resulting in a payload of approx. 10,342 kg per container (Fig. 1, Fig. 2).

Evaporative cooling especially occurs where air flow rate is highest. For this type of packaging (Fig. 1, Fig. 2) that means: at the top of the stems, where the leaf tips and flower buds are.
