Field test for mortality of eel after passage through the newly developed turbine of Pentair Fairbanks Nijhuis and FishFlow Innovations

Report number C111/12

IMARES Wageningen UR

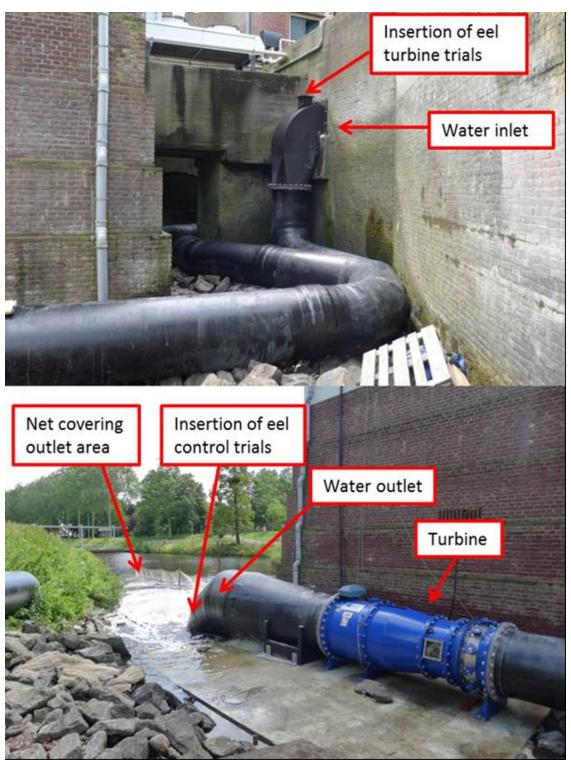
Figure 1. Overview of the pipe-construction with the turbine from the upstream water inlet (top panel) to the downstream water outlet (bottom panel). The location where the eels were inserted for the different trials, the net covering the outlet area and the position of the turbine are indicated.

To test whether the turbine causes mortality of eel, a controlled experiment was carried out in duplo with two different treatments of turbine passage and a control, i.e. 3 different groups of eel subdivided over 6 trials. The two 'treatments' that were tested were; passage through the turbine with 1) the guide vanes fully open and 2) the guide vanes open at an angle of 30 degrees. The treatments were randomly allocated to the 6 trials. The eels of the four 'treatment' trials were inserted in the upward directed opening in the inlet pipe of the turbine. The eels of the two control trials were inserted at the outlet pipe

of the turbine. The outlet of the turbine pipe exit downstream of the pumping station was enclosed by a net with 20 mm meshes that covered an 3 by 10 m area, and 2 water depth. This allowed the eel to be collected after each trial.

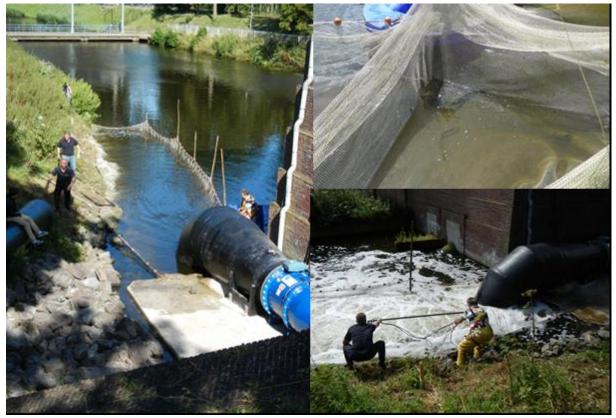
Photo: Overview of the net covering the outlet area (left), recovering the eel after a trial (top right panel), and during the turbine in operation (bottom right panel).

After each trial, the eels were collected from the net. Because the eels from aquaculture had pale greyish dorsal and white ventral sides and the wild caught eel had dark olive-brownish dorsal and yellow ventral sides, for each of the checked eels the origin could be determined. For each eel, total length was measured (cm), state (alive-death) and eventual type of visible injuries were determined. All visible injuries were noted by type and typical examples photographed. In addition, each eel was checked for swimming behaviour (normal sinuous movement and activity – abnormal swimming behaviour with indications for spinal injuries) in a tank.

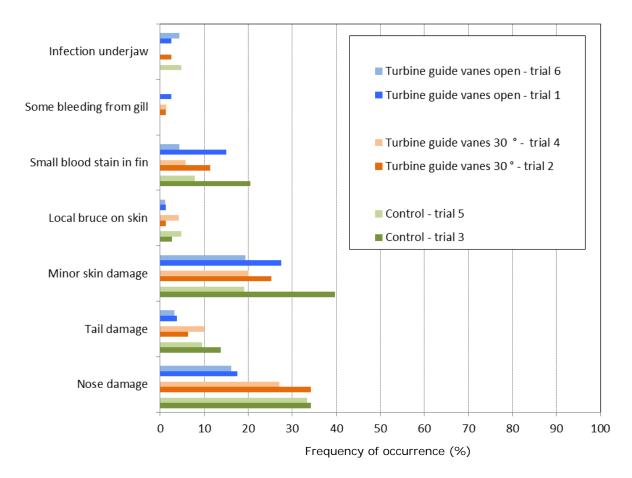
Figure 2. Overview of the frequency of occurrence of the observed minor injuries after each of the trials.

No severely injured eel were found during the experiment. Part of the eels checked after each of the trials showed minor injuries (Figure 2). The most frequent occurring minor injuries were minor skin damages (19-39 % per trial), such as scratches, and nose damage (16-34%), mostly reddish tips of the upper or lower jaw. Tail damage (4-13%) and small blood stains in fins (4-21%) were less abundant but found in each trial. More rarely found type of injuries were infection of the underjaw (0-4%), all in eel from aquaculture, local bruises on the skin (0-4%), i.e. a reddish stain on the skin, and some bleeding from a gill (0-2%). No apparent differences were found between the treatment trials and control trials, with perhaps the exception of the bleeding of a gill. The four eel in which this was observed all originated from treatment groups, but the frequency in which this occurred was very low (on average 1.3 % in the treatment trials).
