# Brisbane Watershed

# Design Charrette

JAMES DAVIDSON ARCHITECT

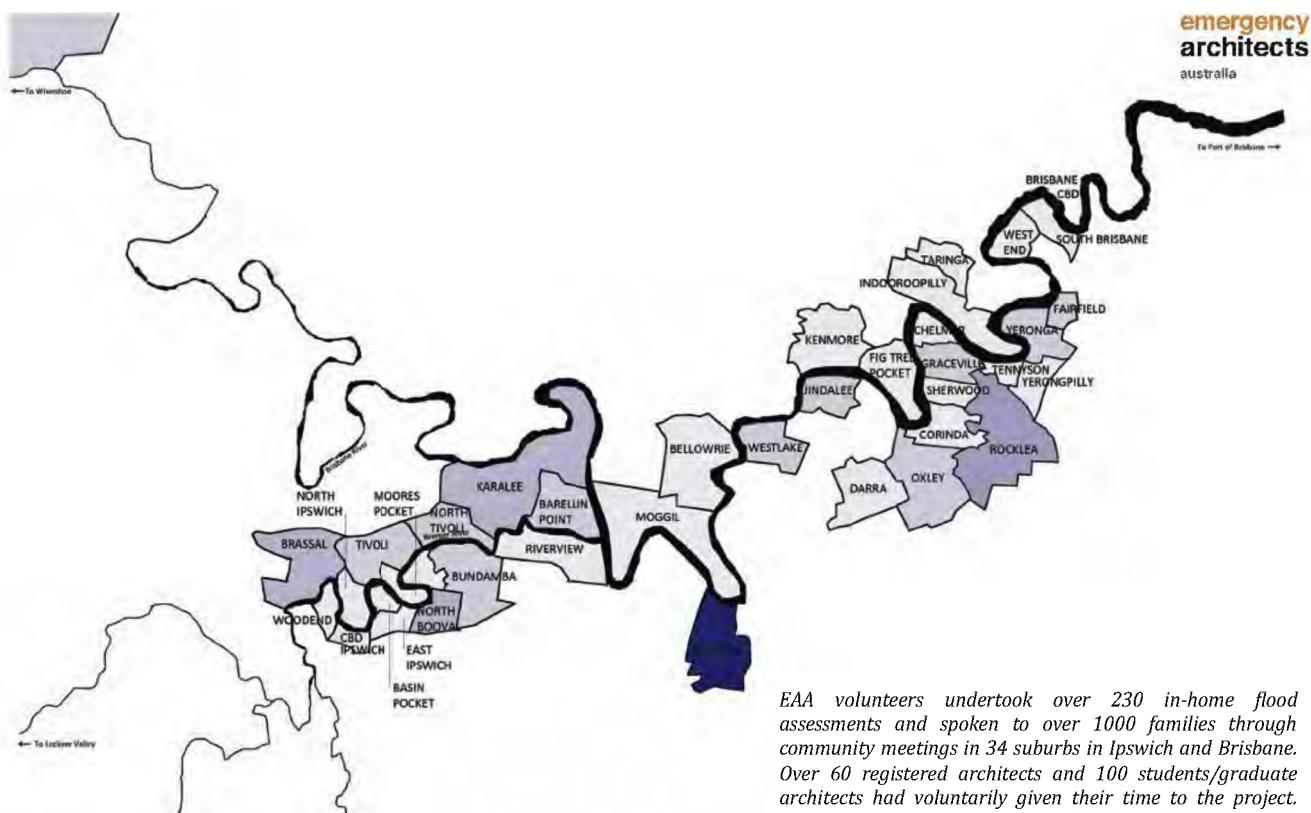
NUMBER OF EAA INSPECTIONS: 0 10 20 30 40 50

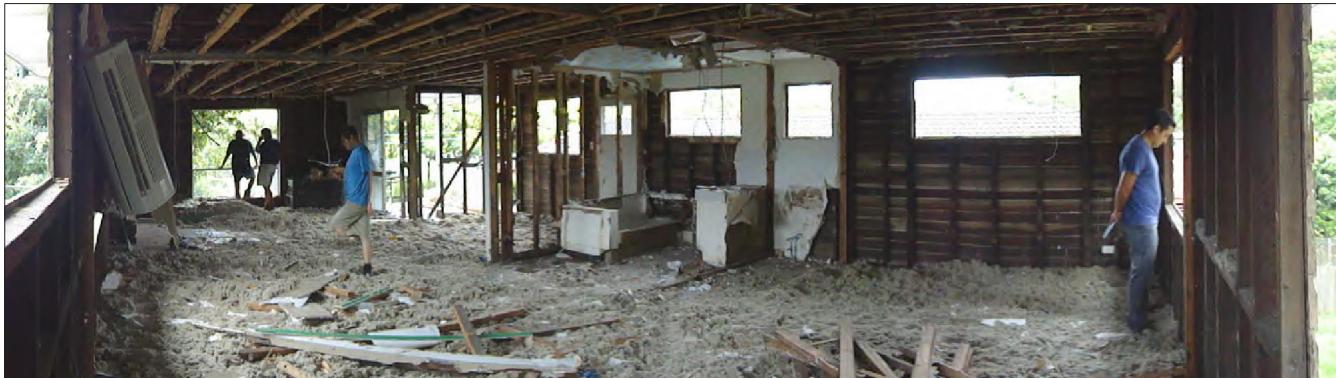
TYPE OF DAMAGE SEEN DURING EAA ASSESSMENTS

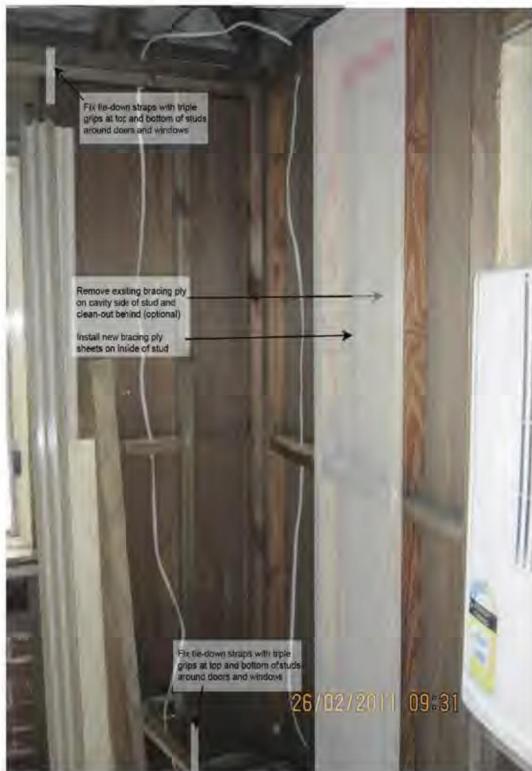
Recommendation: Bracing & Tie-down

**Potential Option for Replacement:** fix metal straps with triple grips to the top and bottom of studs around doors and windows; AND fix new bracing ply sheets to studs on the interior face of stud wall where the existing bracing ply sits (see photo on page 9). Removal of existing ply sheets before doing so optional: preferable as it allows cleaning out of any muck behind. Consult engineer also.

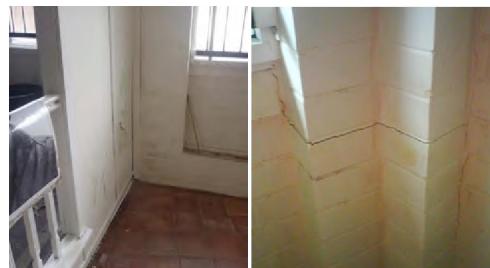
Figure 1: Subsided flooring and cracking on the south western corner of the property

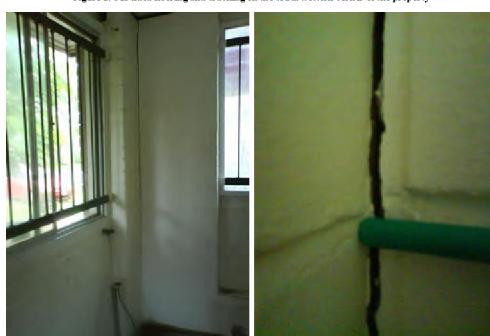
Figure 2: Cracking on the north western corner of the residence.

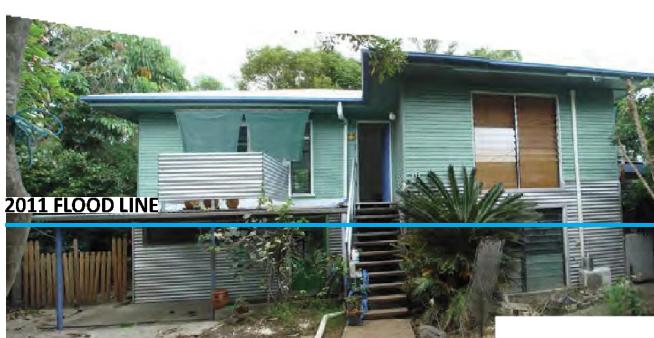
ORIGINAL HOUSE  
JDA ©2011

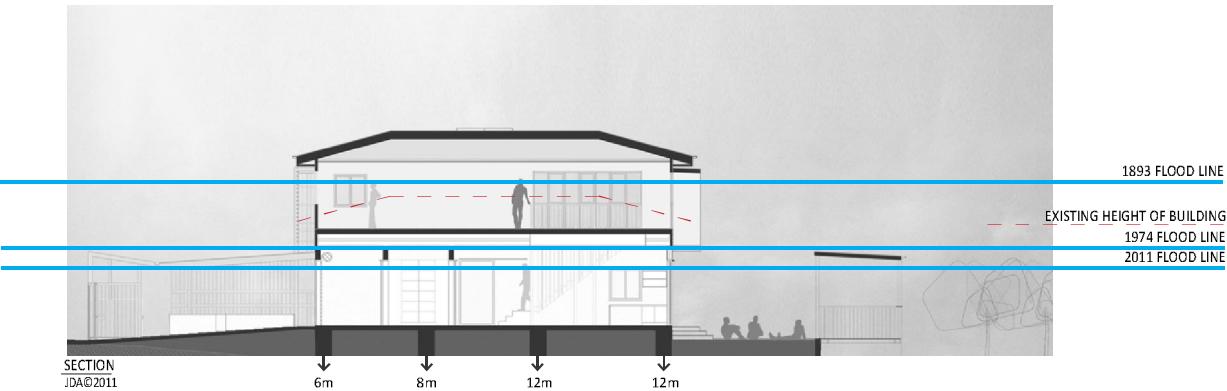
SECTION  
JDA©2011

1893 FLOOD LINE  
EXISTING HEIGHT OF BUILDING  
1974 FLOOD LINE  
2011 FLOOD LINE

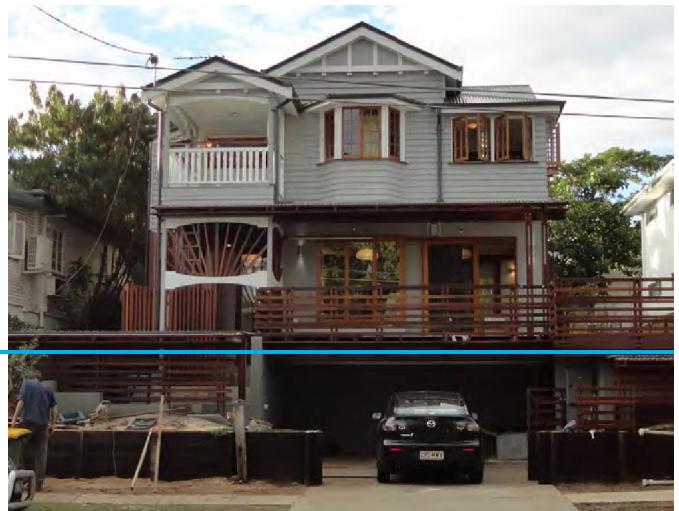
AFTER RAISE  
JDA©2012

*The scary thing is we could have legally gone 1 metre higher than we have.*

*100mm of raise = \$8,000 to \$10,000*

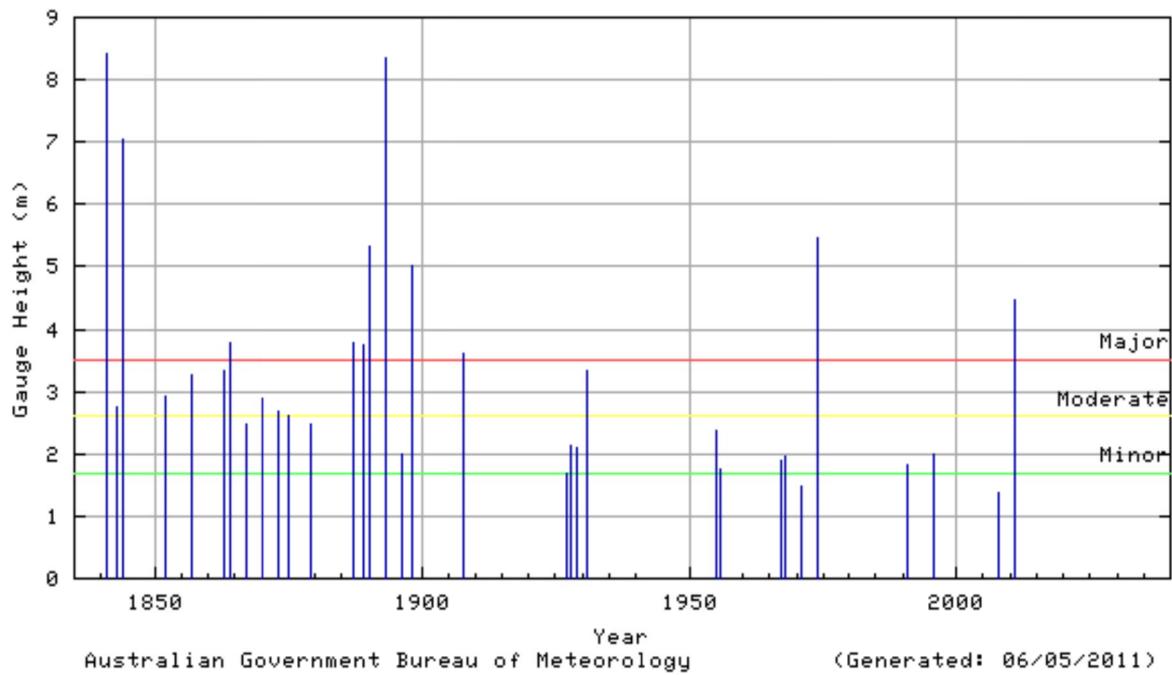
# Historical Flood Peaks, Brisbane City

Brisbane R at City Gauge \*  
Highest Annual Flood Peaks

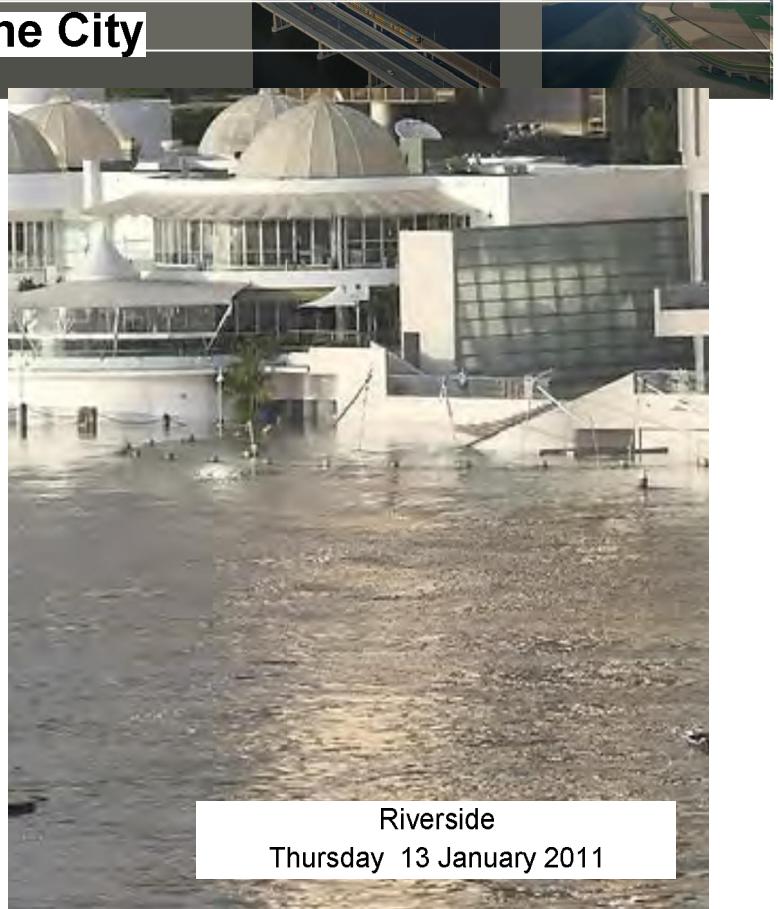
## 2011 events Brisbane City

Above major flood level (3.5m) from 12/01/2011 to 13/01/2011

Remained above minor flood level (1.7m) from 11/01/2011 to 14/01/2011.

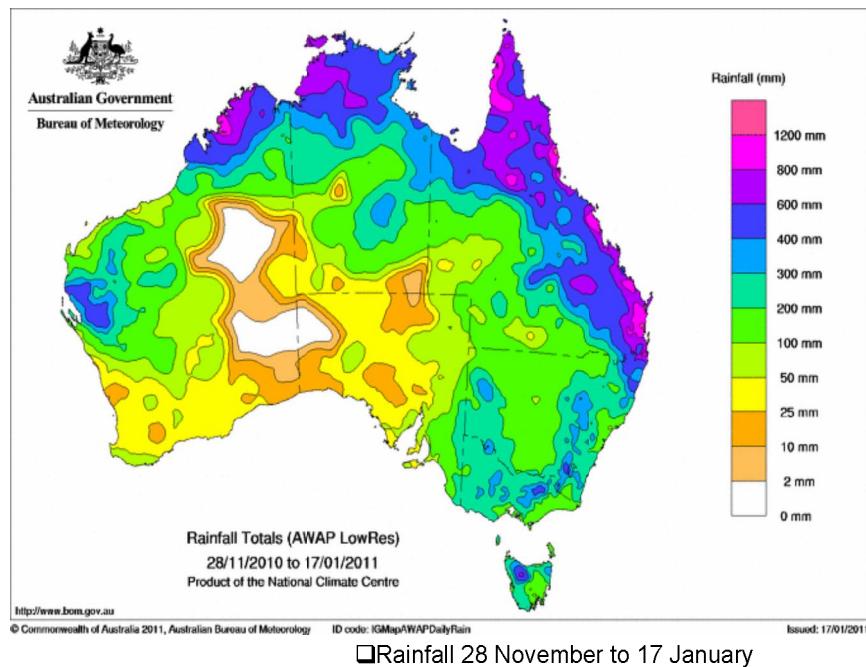
# Record Rainfall Totals

December 2010 Rainfall Deciles – Highest on Record

January 2011 Rainfall Deciles – Very Much Above Average

□Rainfall 28 November to 17 January

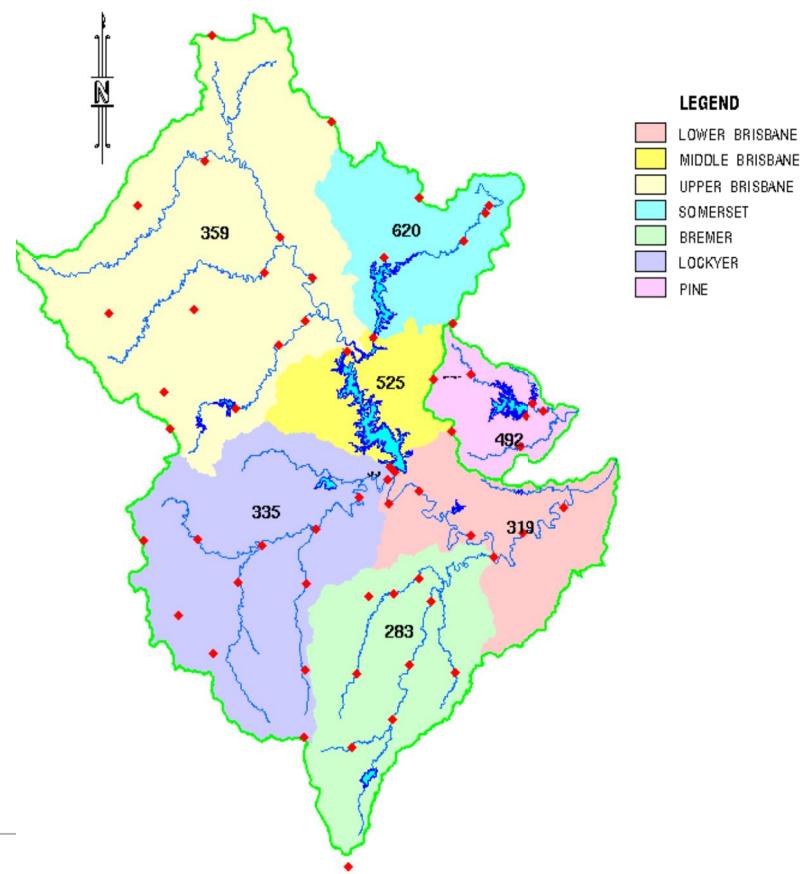
## Catchment Rainfall Totals – January 2011

6 Day Rainfall Totals  
Fri 7 Jan to Thu 13 Jan 2011

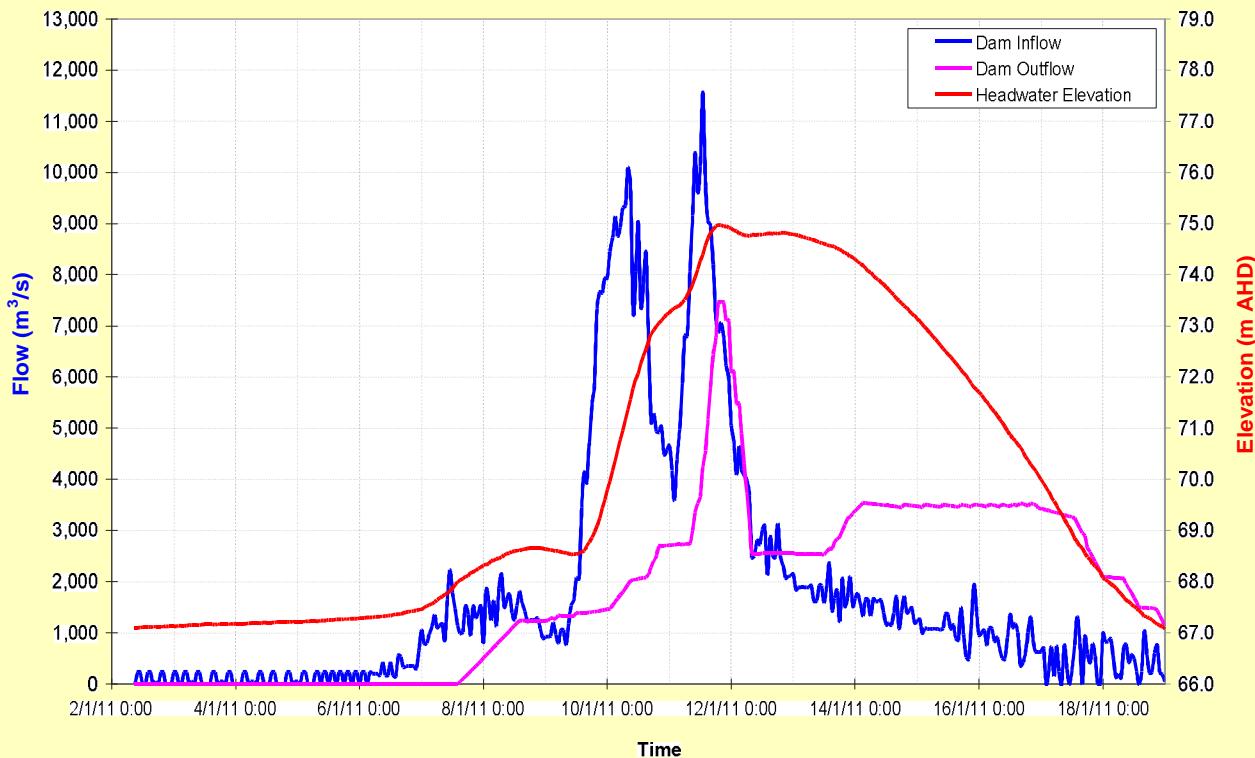
# Wivenhoe Dam Inflows and Releases

Wivenhoe Dam

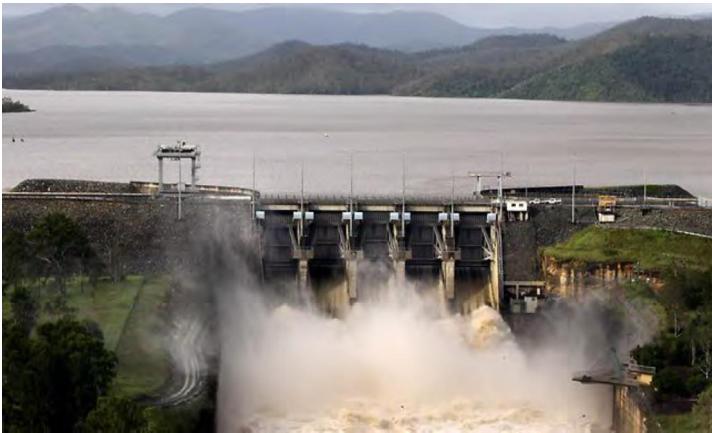
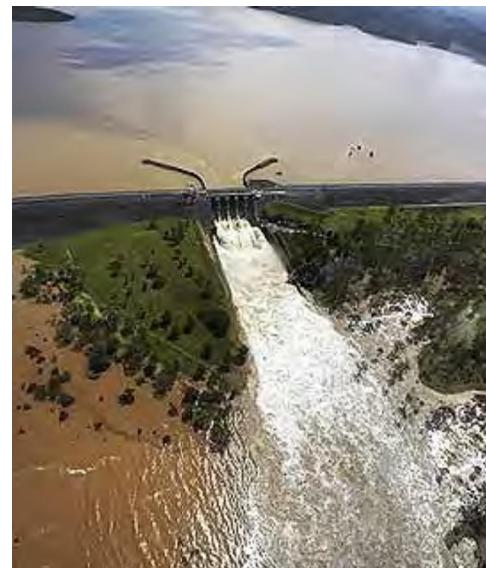
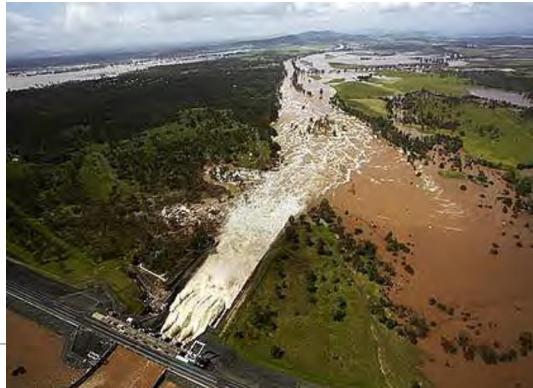
Major spilling was required for dam safety purposes

Wivenhoe Dam  
Wednesday 12 January 2011

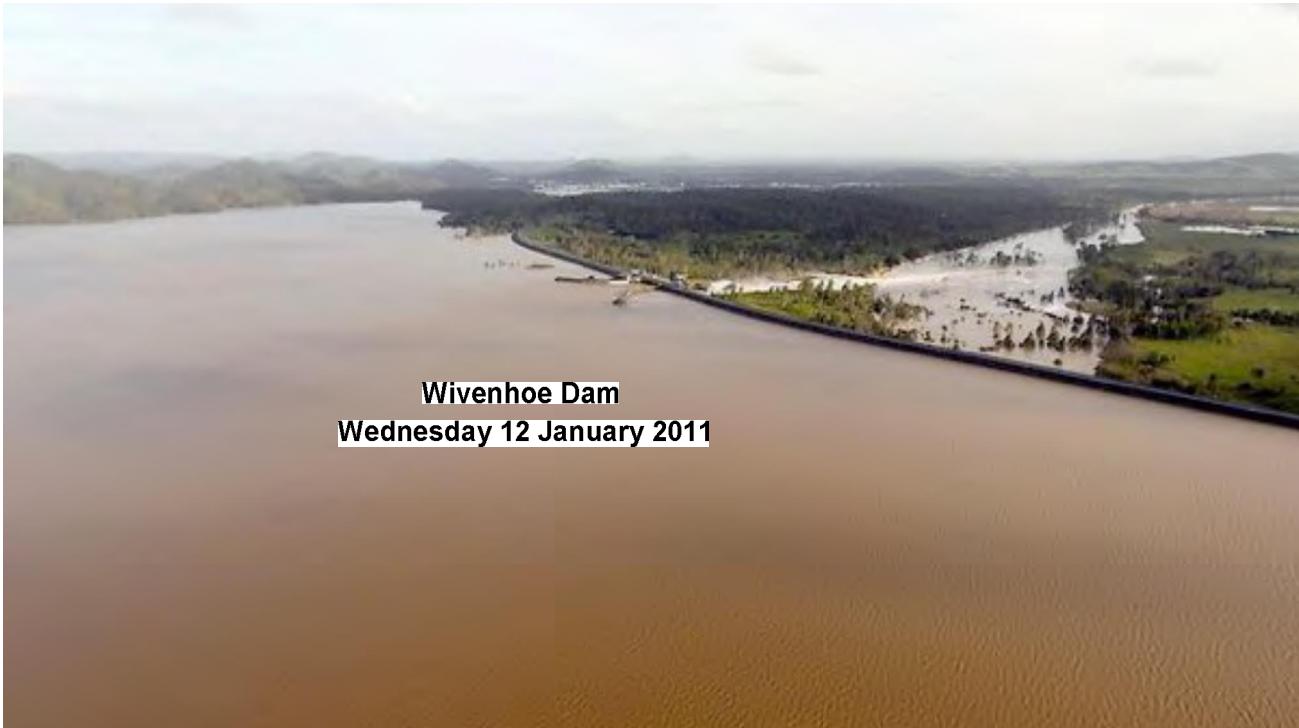
# Mitigation effect of Dams

**Wivenhoe Dam**  
Wednesday 12 January 2011

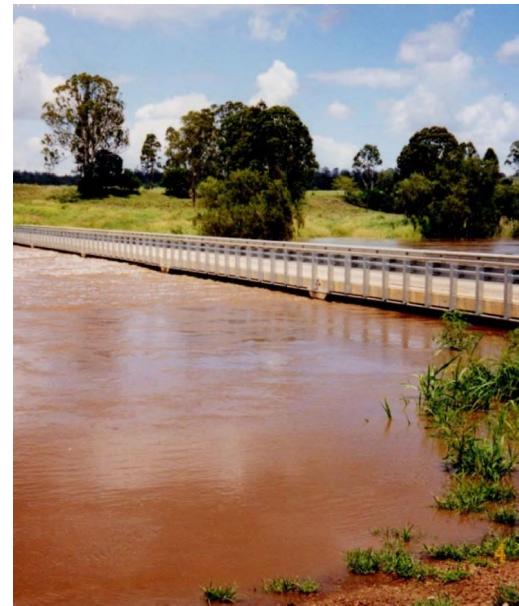
## W1 – Minor Flood

# Gate Operating Strategies – Wivenhoe Dam

Combined flows of Lockyer Ck and Wivenhoe Releases do not submerge bridges prematurely

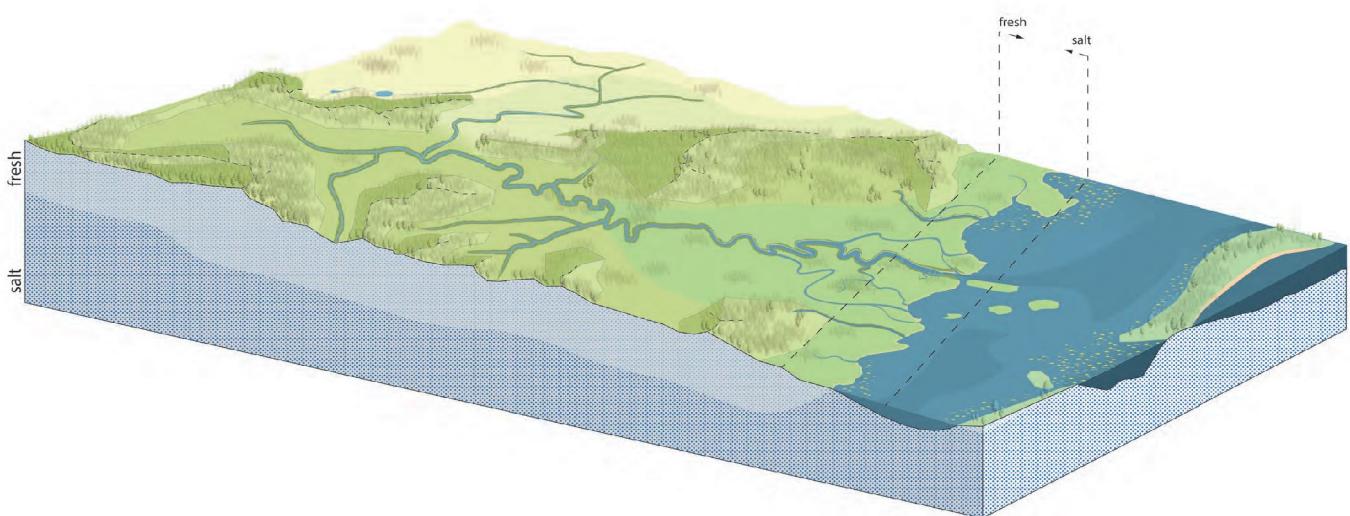
## Overview of Brisbane watershed

A natural water system with broad floodplains, **which empties into Moreton Bay**

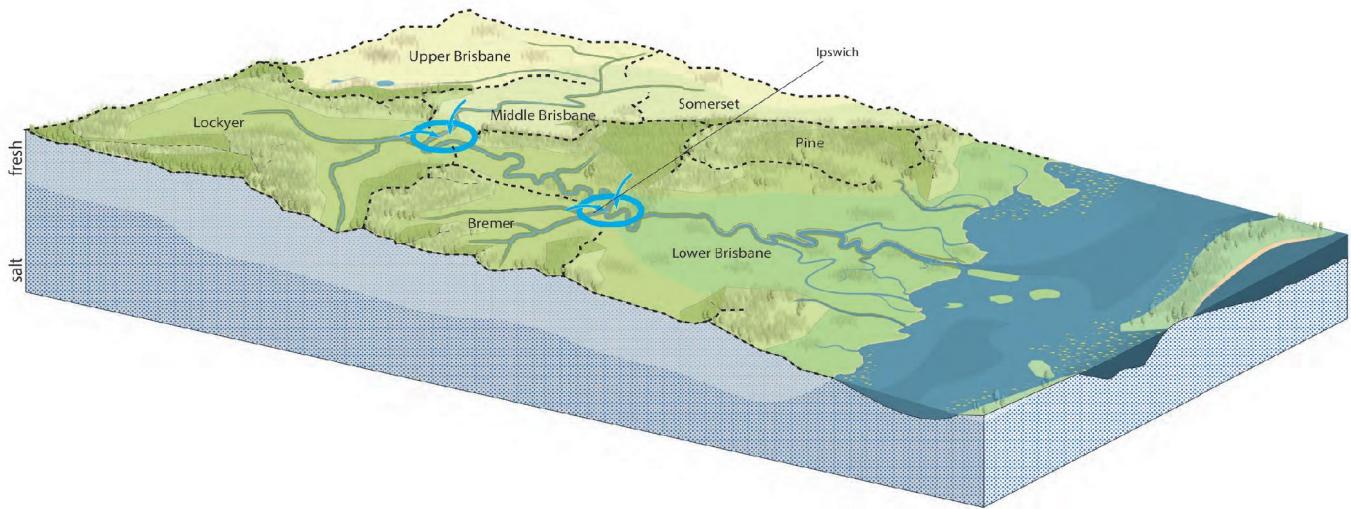
Subcatchments and confluence points

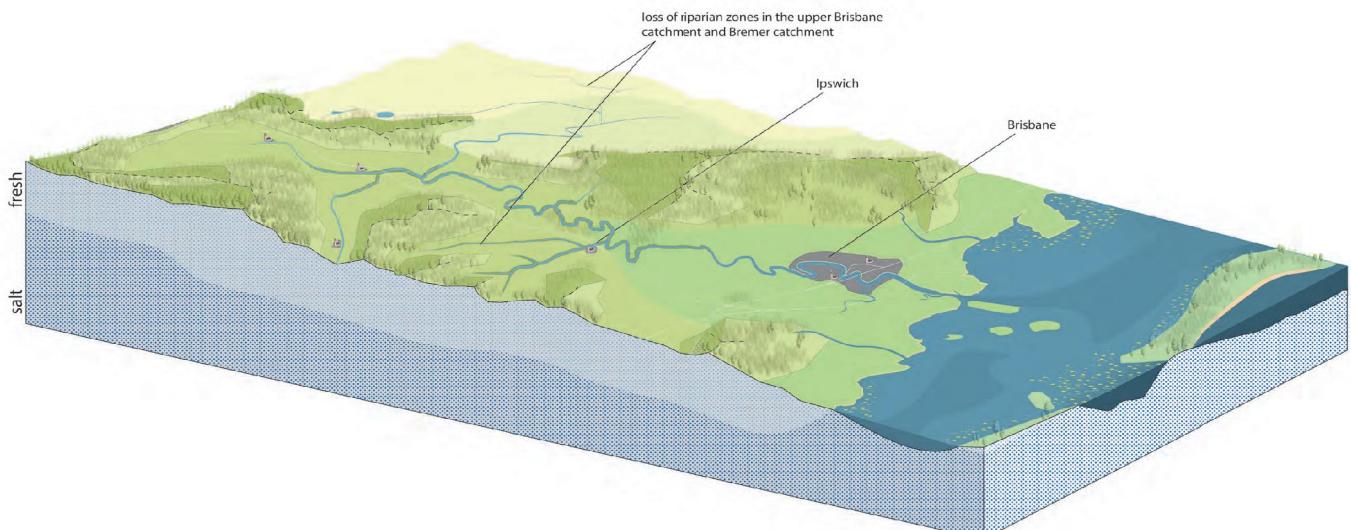
The water system is ~~flourishing~~  
Loss of riparian zones in upper catchments

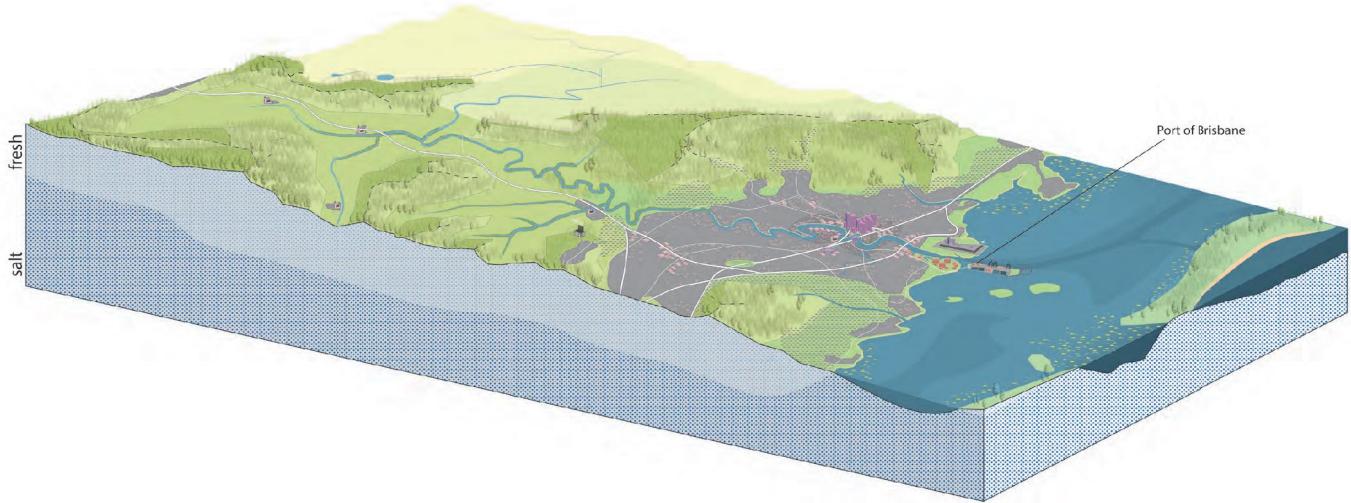
Urban development surrounds the mouth of Brisbane river

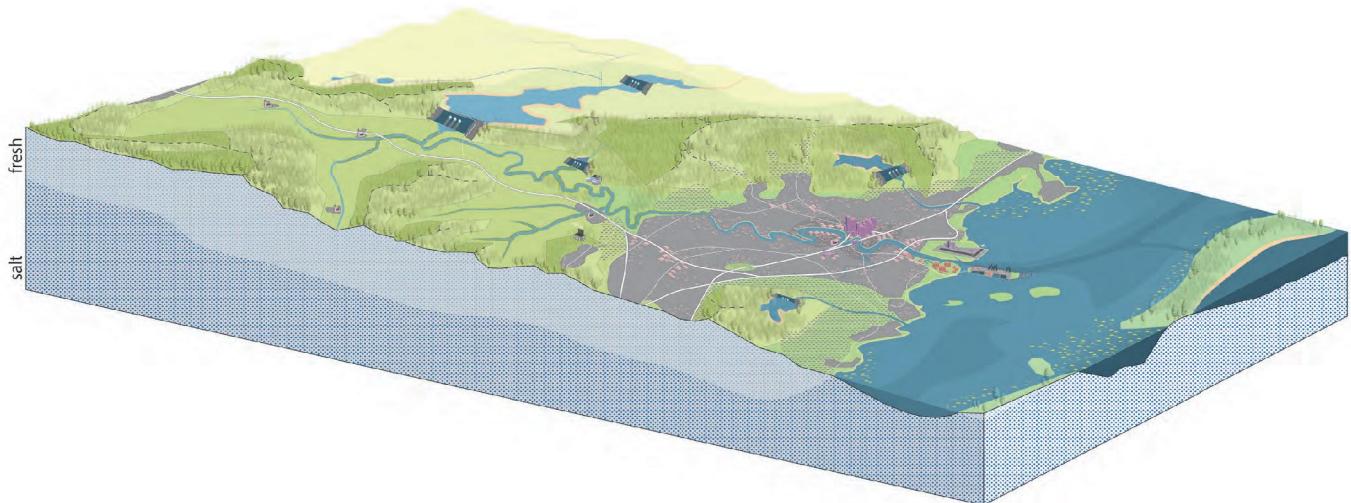
Dams create water reservoirs for the city

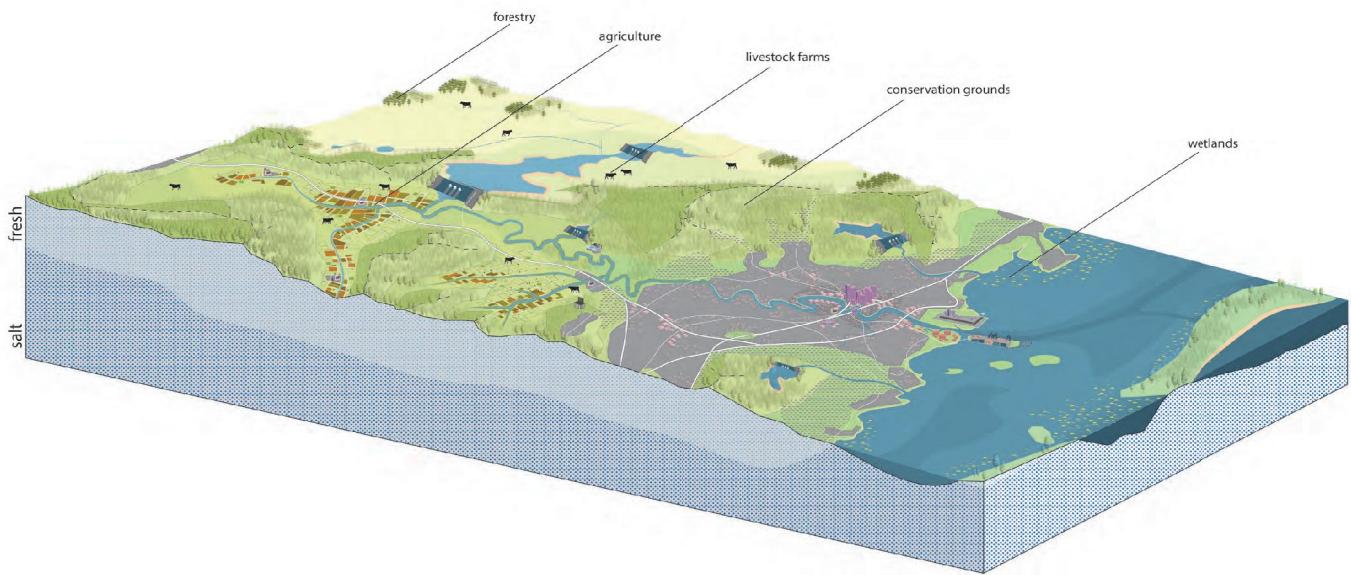
Agriculture is strongly connected to Lockyer River and Bremer River.  
Livestock and forestry on dryer grounds of the upper catchments.

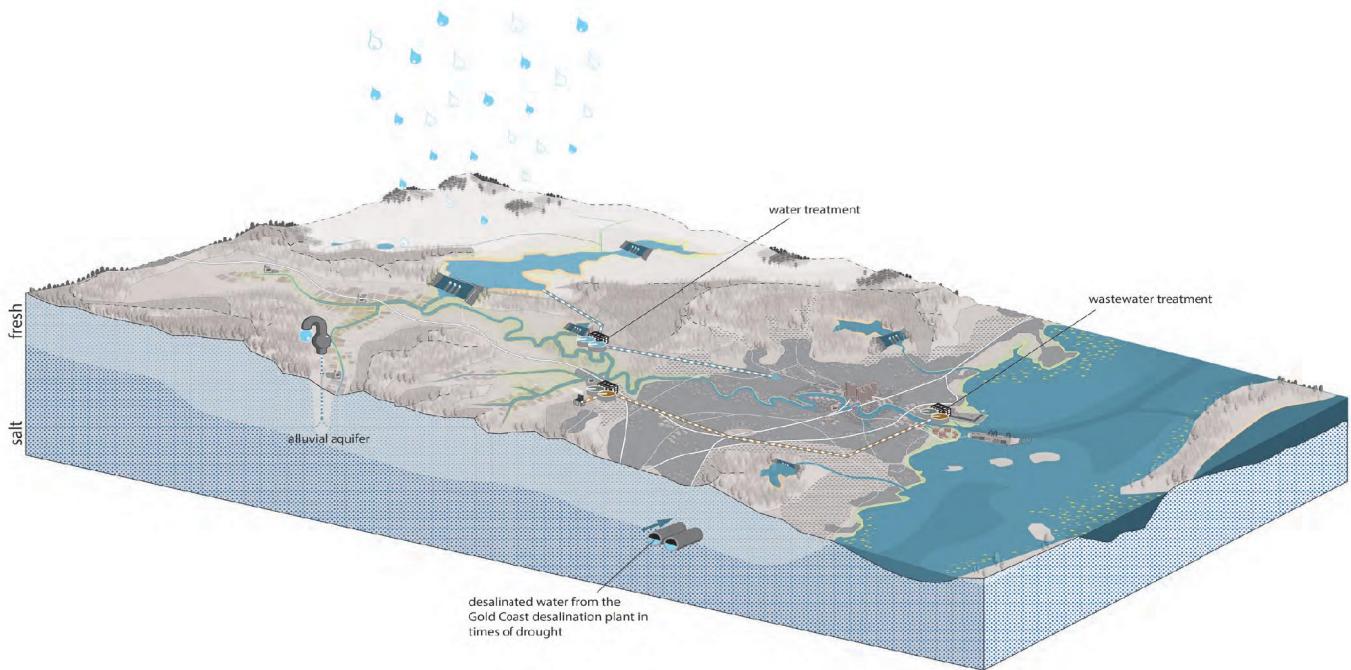
Water production by dammed reservoirs, wastewater treatment and alluvial aquifers. Desalination plant in Gold Coast is only used in times of drought.

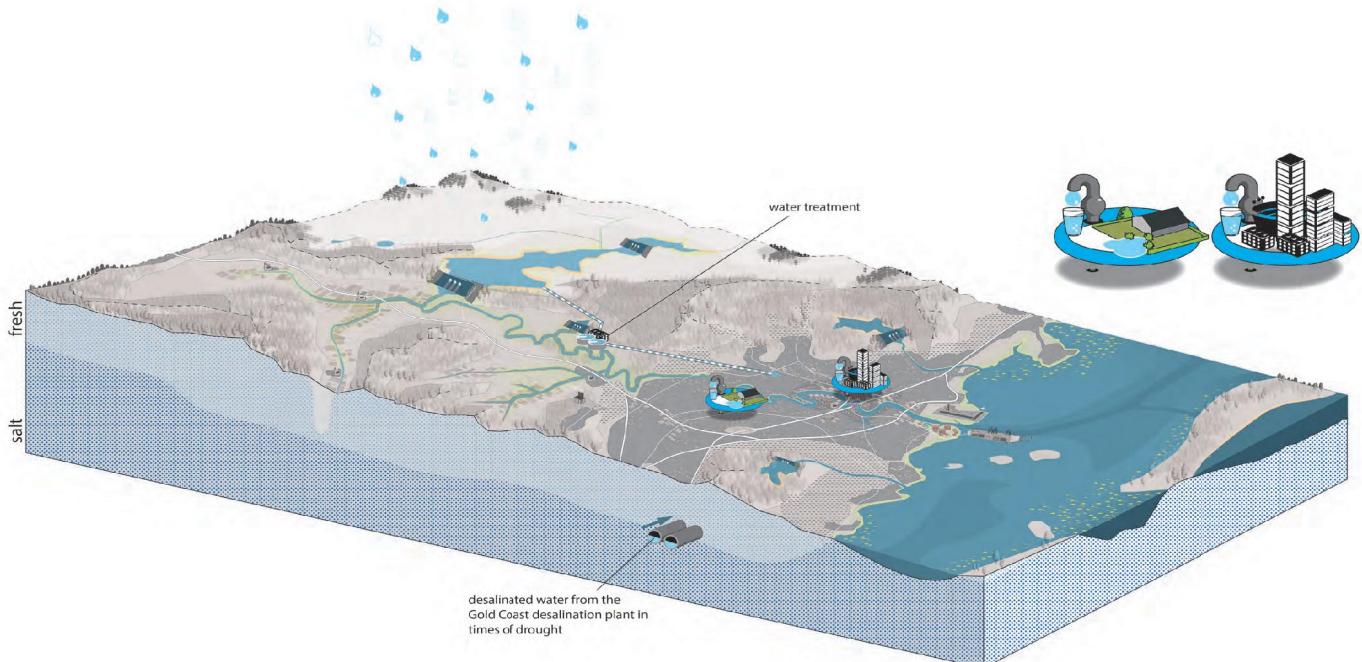
Water for the urban area originates from the water reservoir.

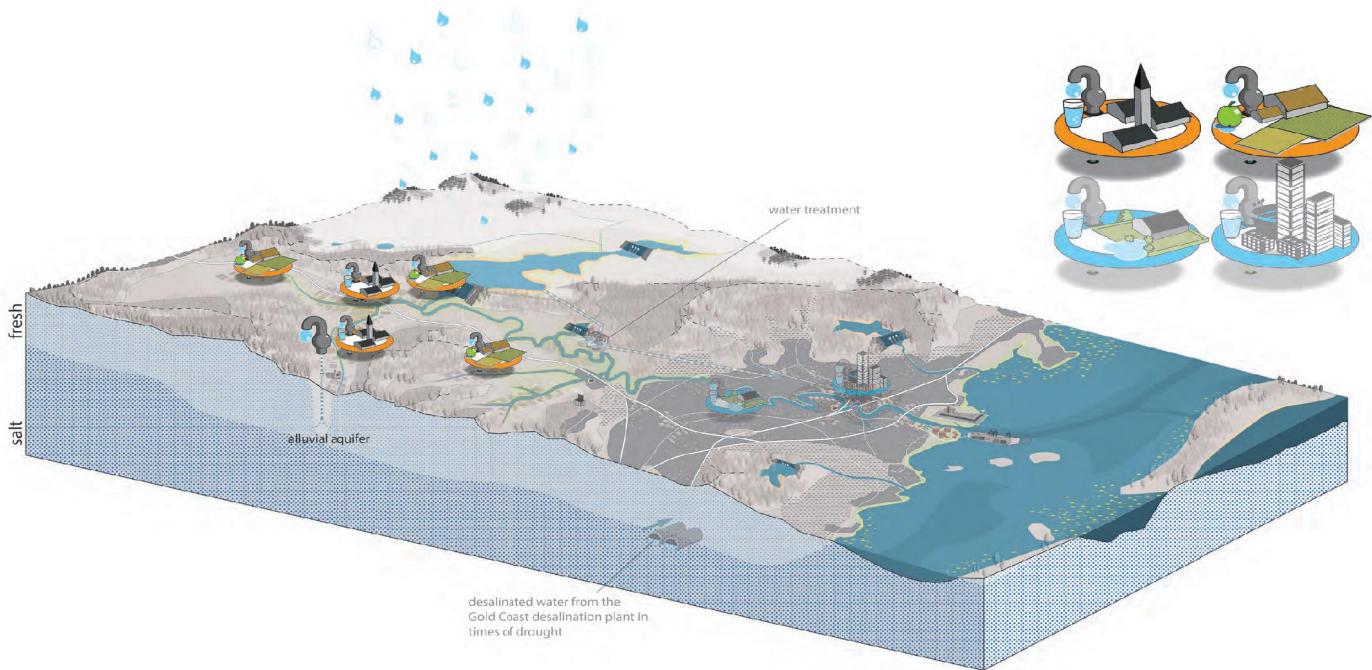
Stream in the watershed villages and farms make use of alluvial aquifers

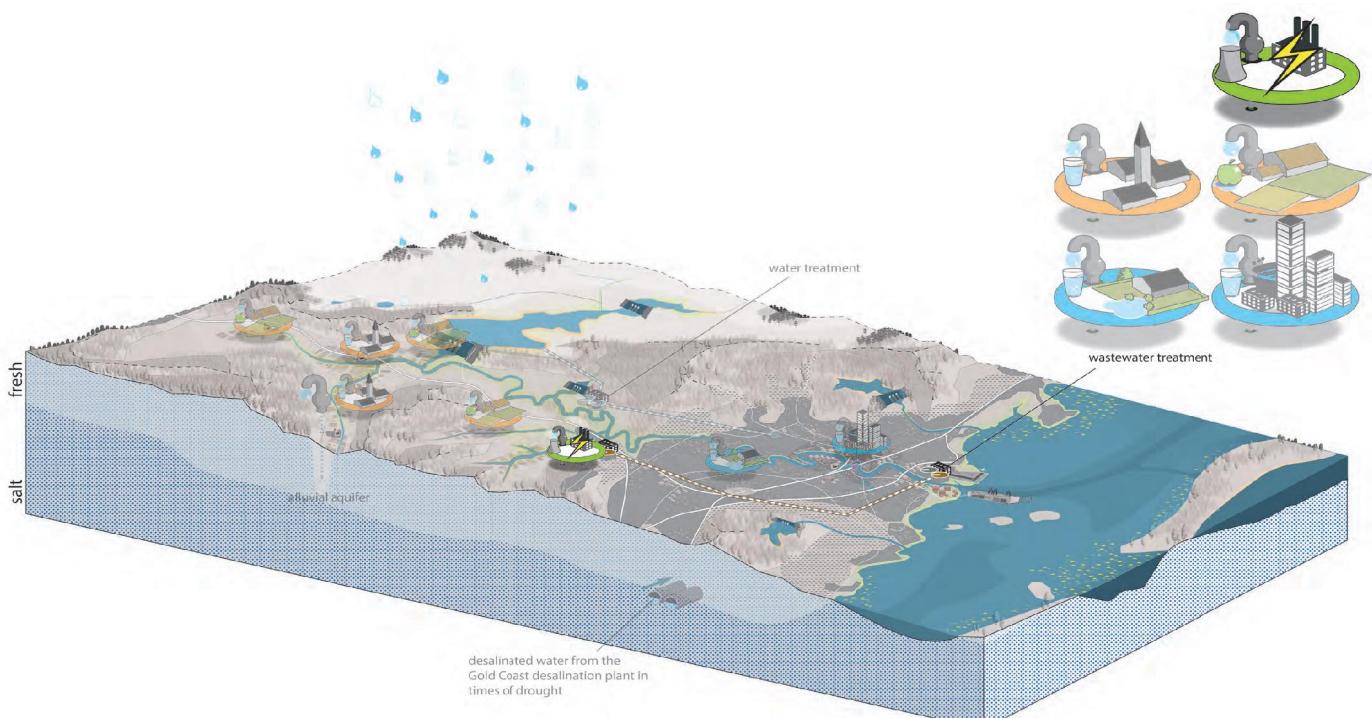
The plant makes use of recycled water from the wastewater treatment plants

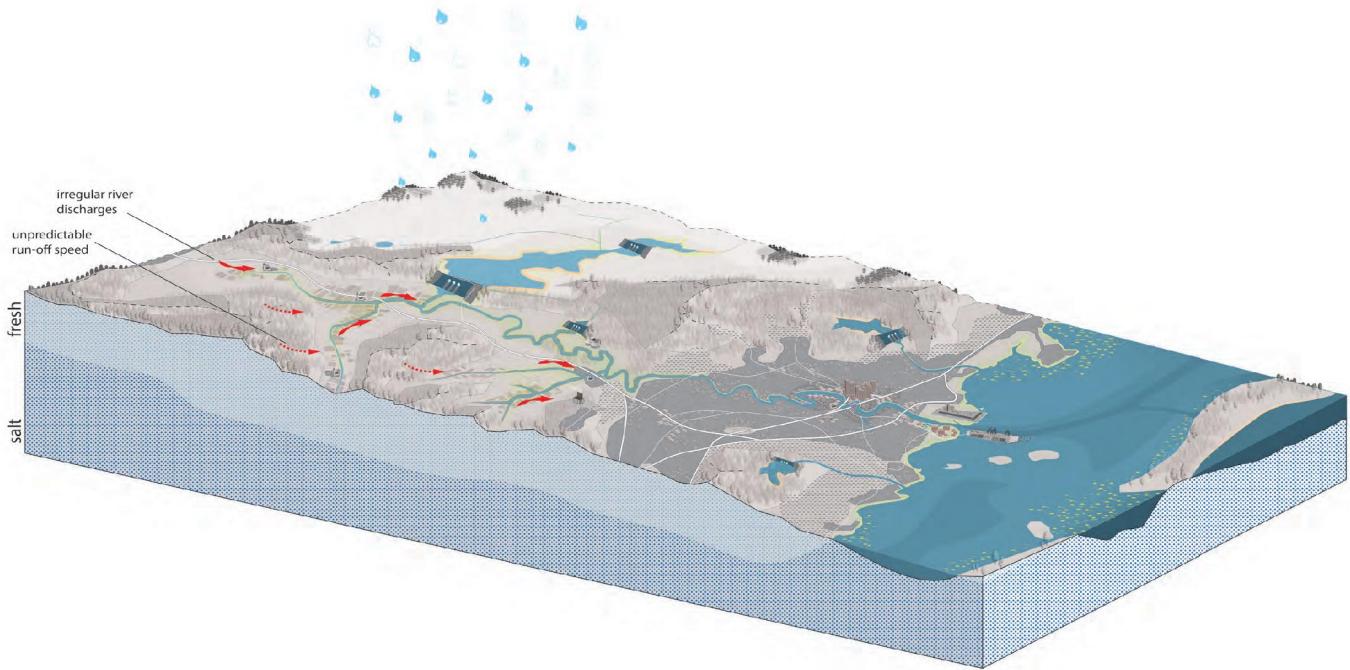
- Increased vegetation areas cause irregular river discharges

- The run-off speed and quantity of precipitation seems difficult to predict.

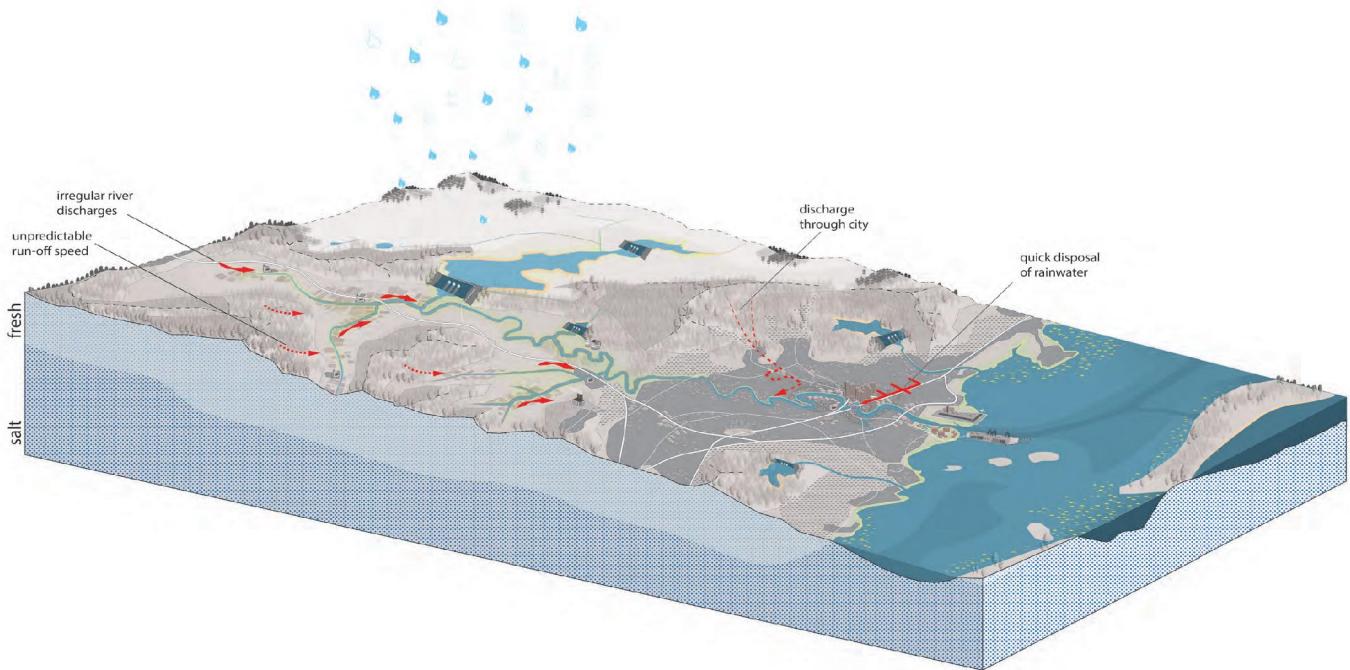
- Discharge through the city

■ Current design will discharge rainwater

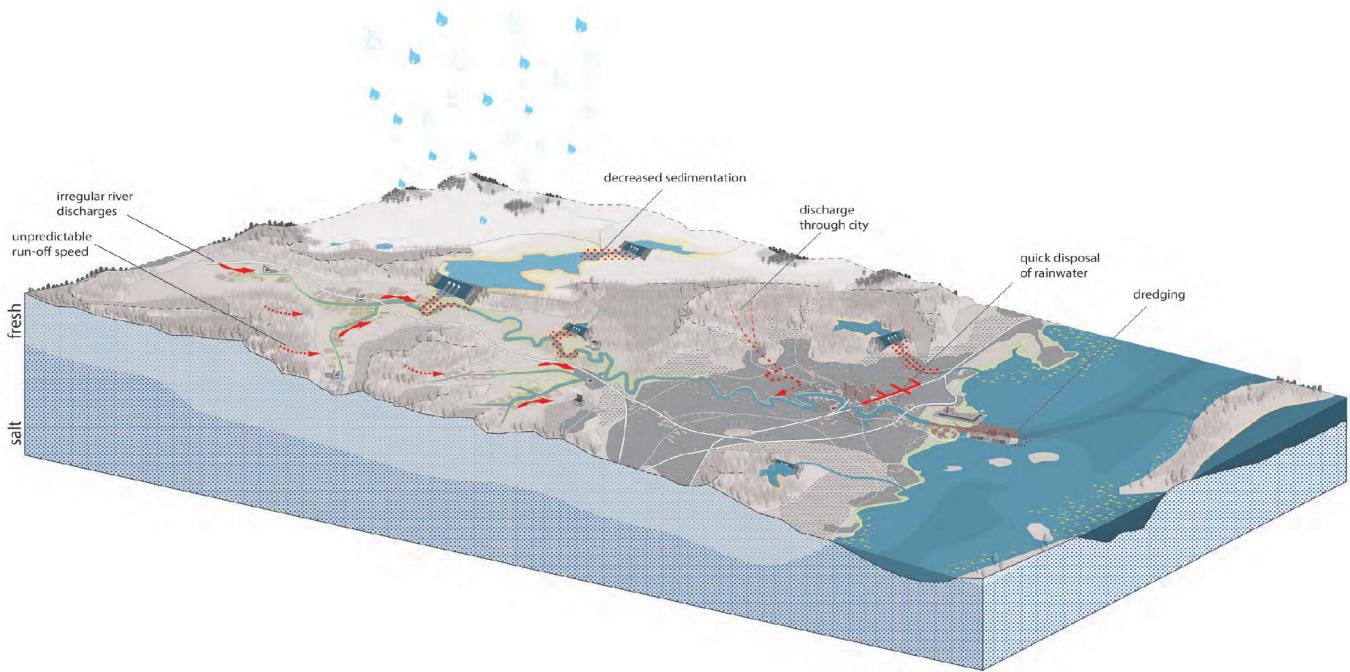
☒ Decreased sedimentation caused by measures taken upstream in the harbour area  
☒ dredging of the harbour area

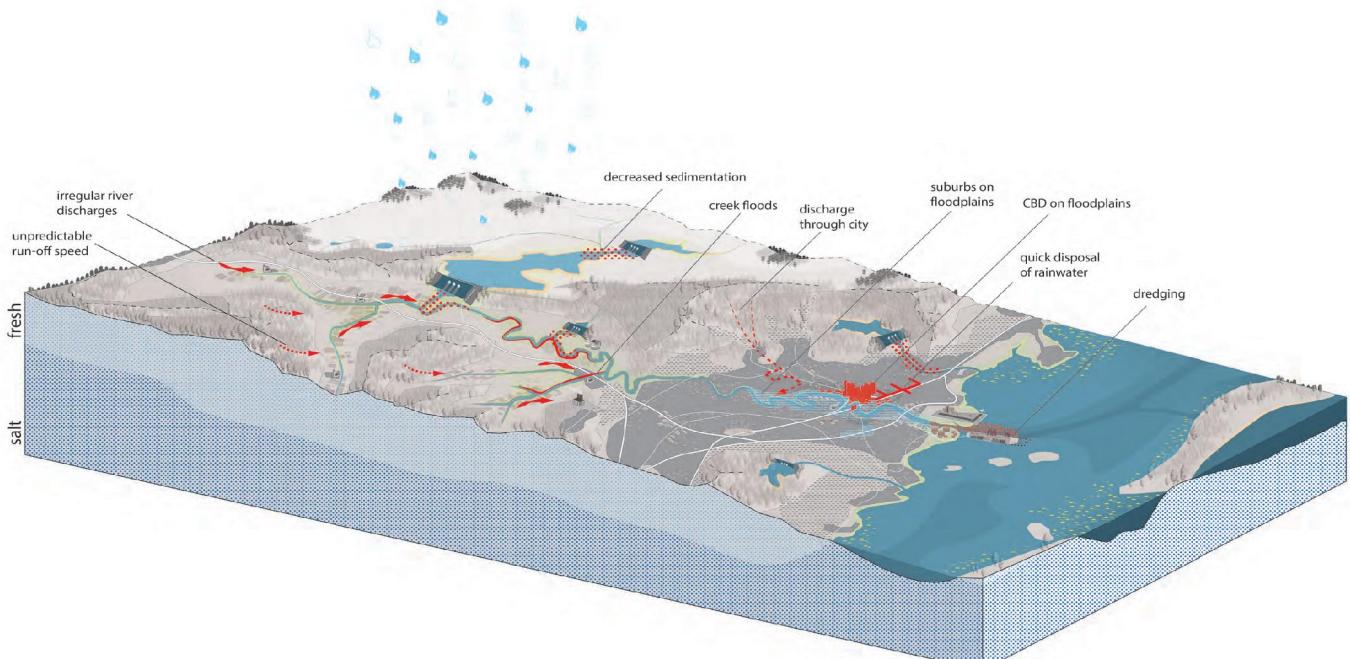
☒ Less room for the river remains as the city grows

- Decrease of infiltration capacity
- Building in floodplains
- Reducing the size of floodplains: measures to protect new developments on floodplains cause higher risk of floods in unprotected areas

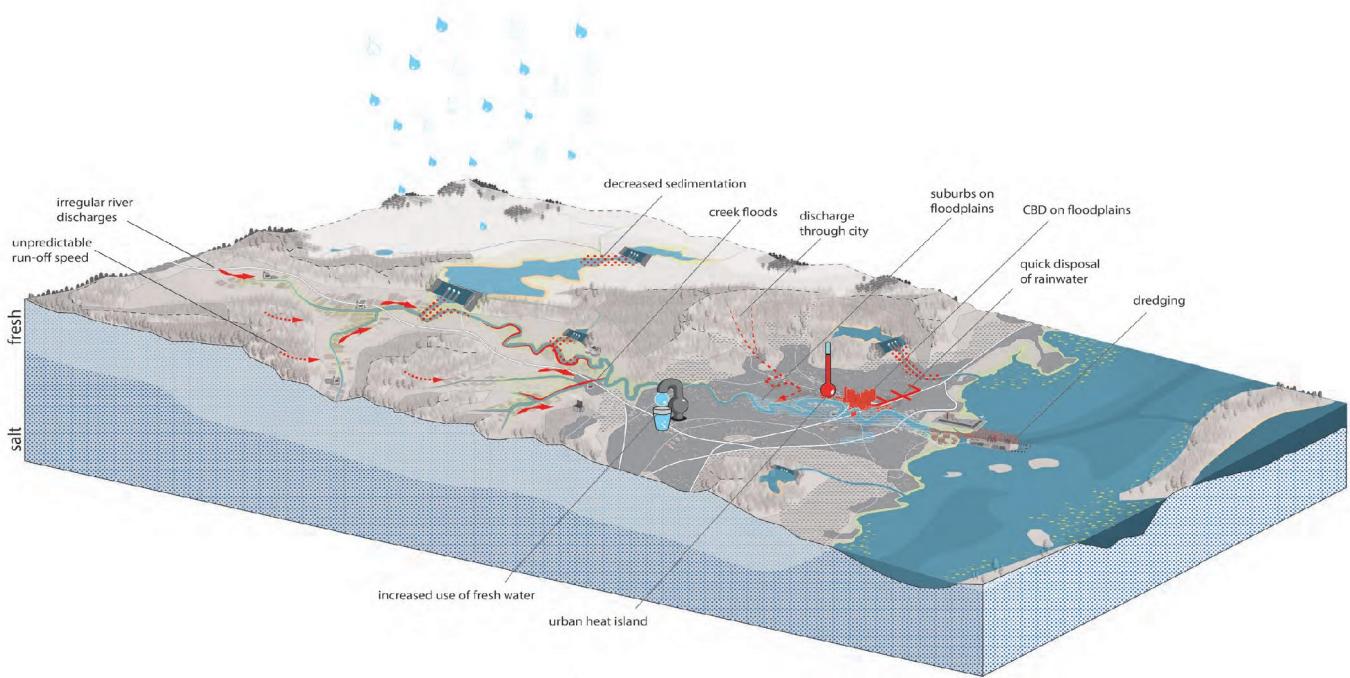
- Urban growth endangers sensitivity for heat stress
- In the new low-density suburbs a lot of water is used for the watering of gardens
- The increasing use of fresh water leads to more droughts
