# Brisbane Watershed

# Design Charrette

JAMES DAVIDSON ARCHITECT

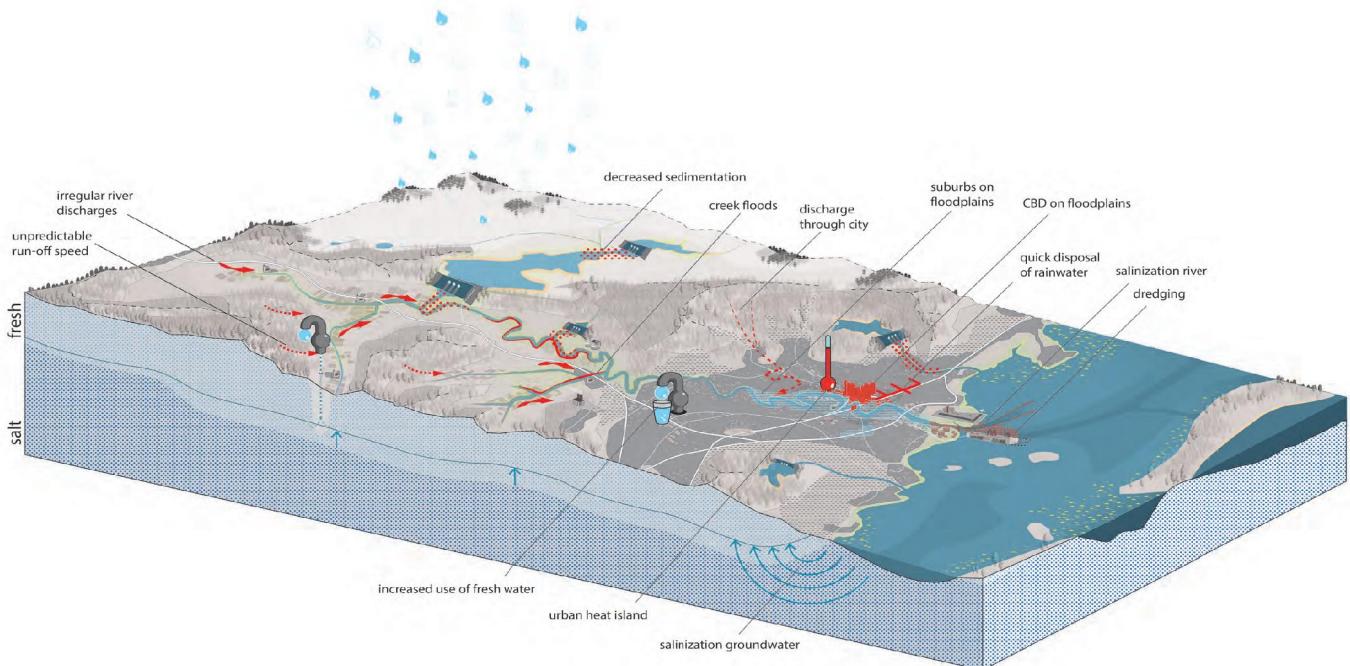
- Salt intrusion in groundwater and river water

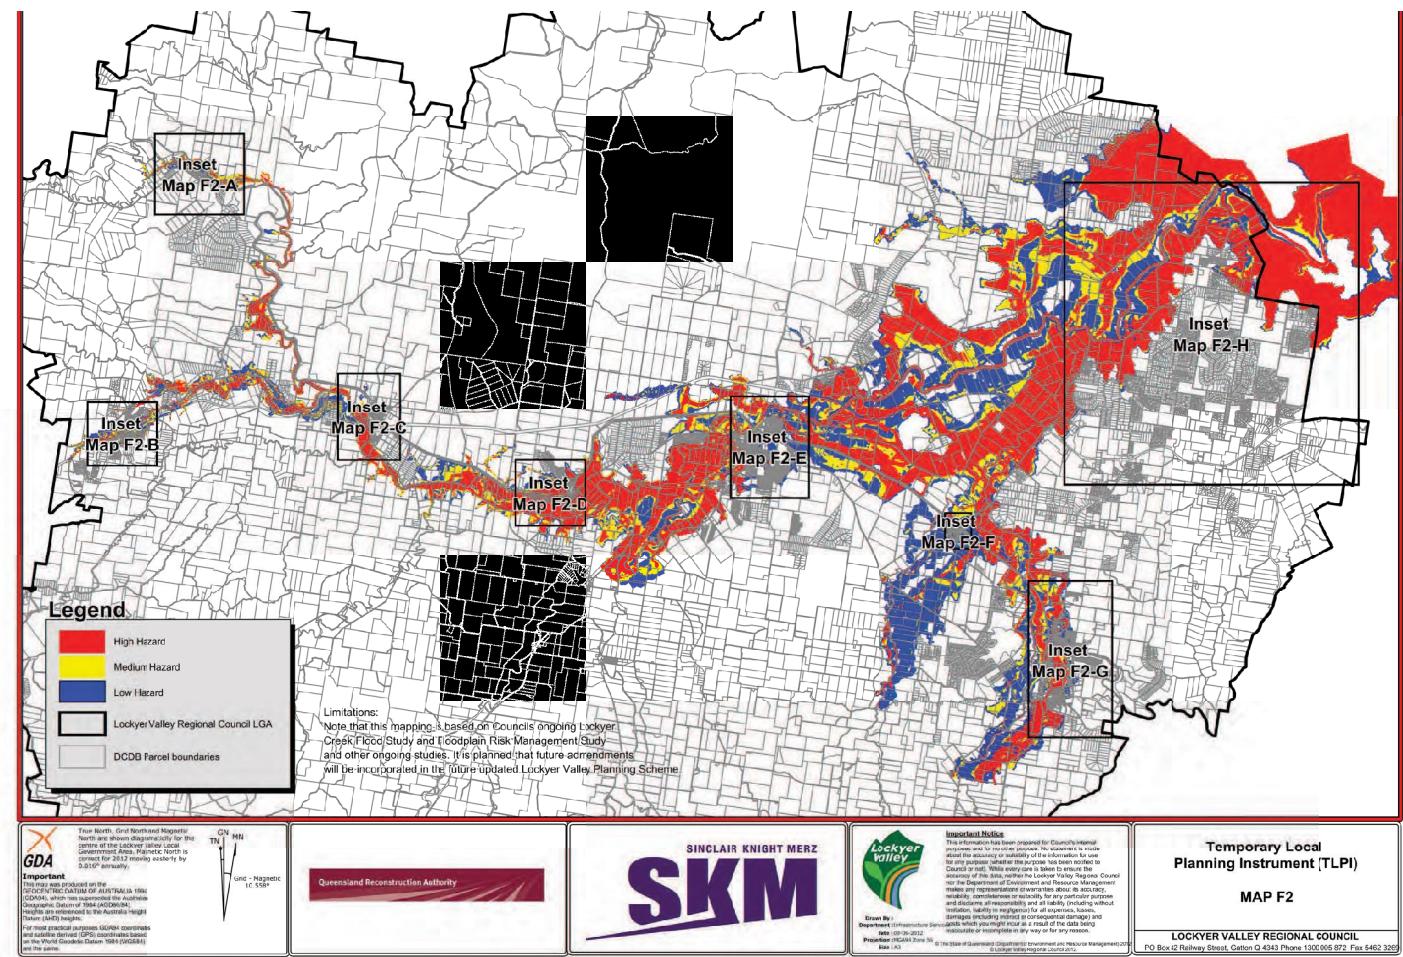
**Temporary Local Planning Instrument (TLPI)**  
**MAP F2**  
**LOCKYER VALLEY REGIONAL COUNCIL**  
PO Box 12 Railway Street, Gatton Q 4343 Phone 1300 005 872 Fax 5462 3205

True North, Grid North and Magnetic North are shown diagrammatically for the centre of the Lockyer Valley. Location is correct for 2012 moving assembly by 0.3m. Grid reference is GDA 1994. The map is based on the SINGAPORE DATUM OF AUSTRALIA 1984 Geodetic Datum 1984 (AGD84) Geodetic Height. The map is based on Mean Sea Level (MSL) Height. The map is based on GDA 1994 coordinates and satellite derived (GPD) coordinates based on the 1984 Geodetic Datum (WGS84) are the same.

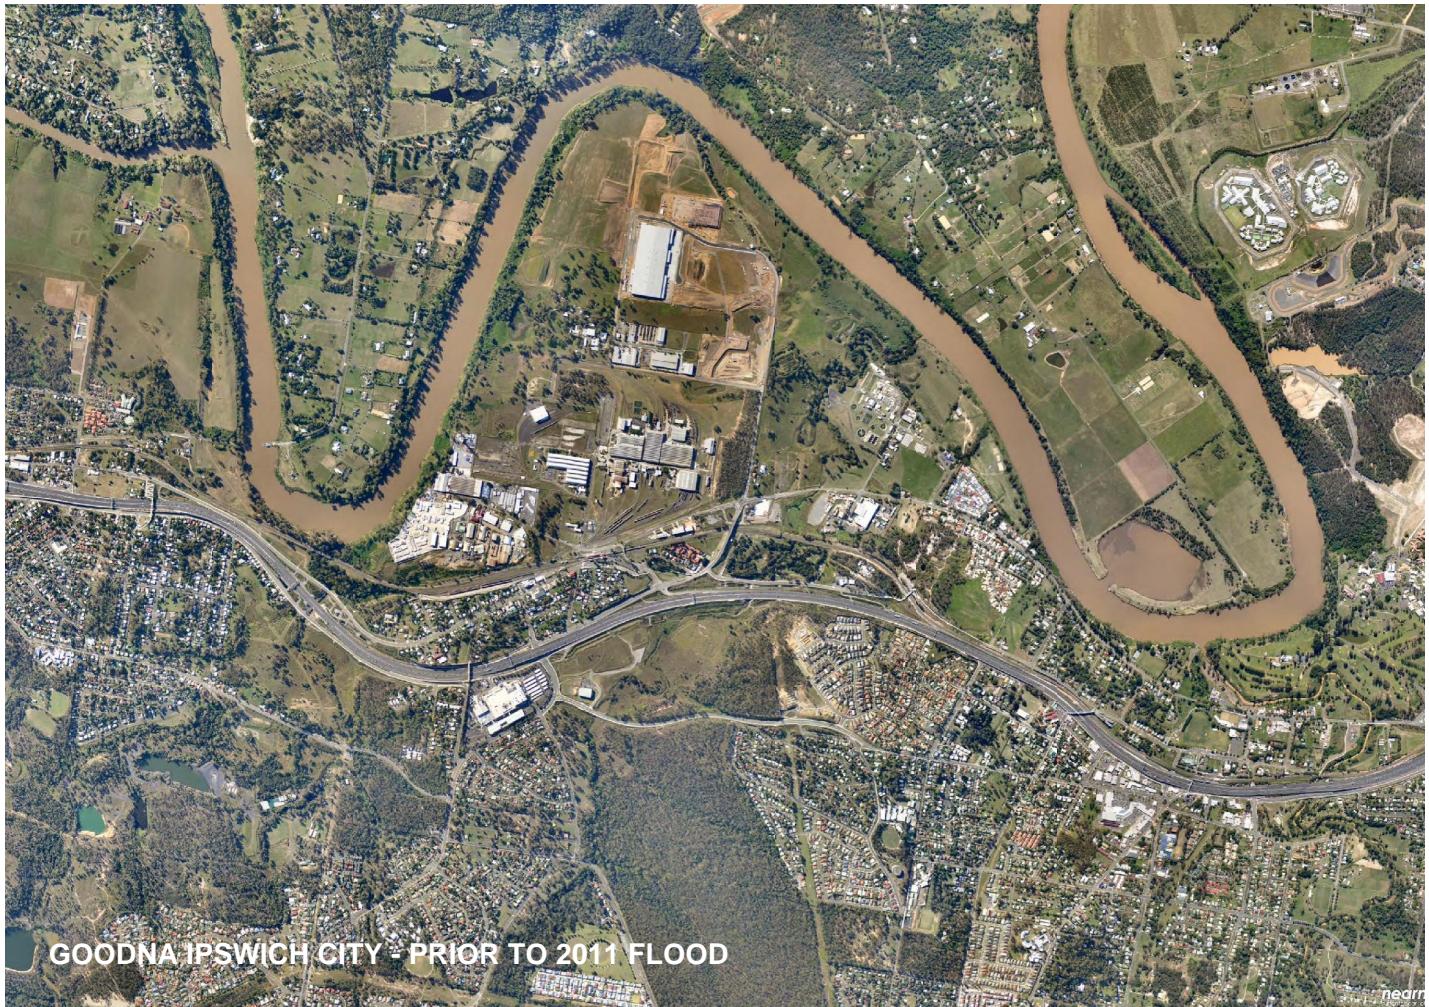
GOODNA IPSWICH CITY - PRIOR TO 2011 FLOOD

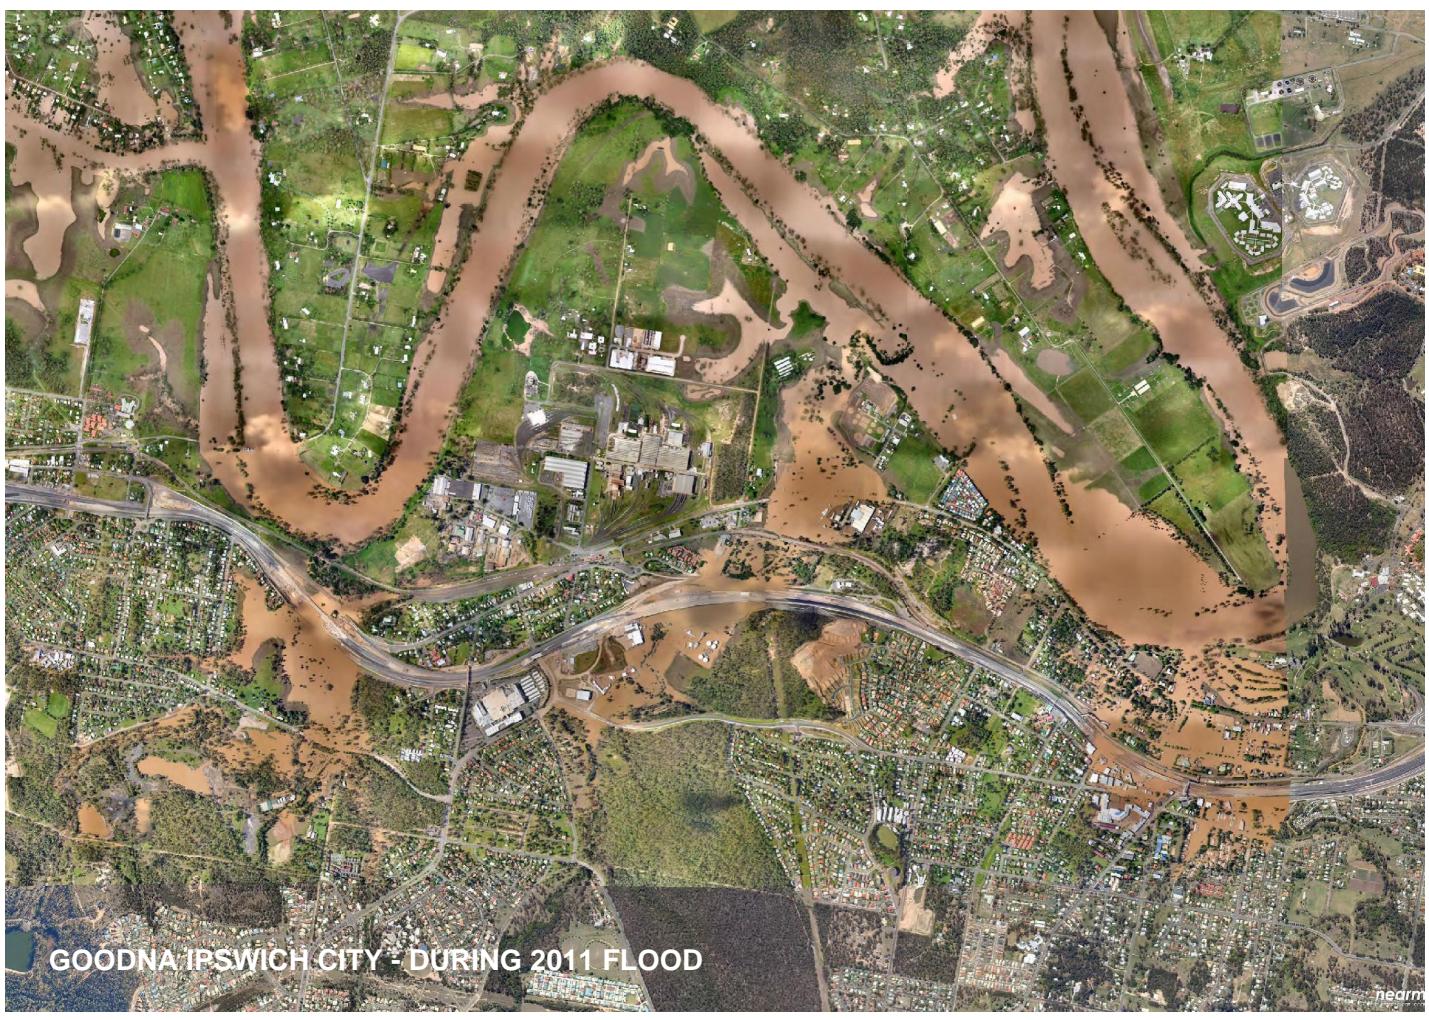
GOODNA IPSWICH CITY - DURING 2011 FLOOD
