**Advice
Drainage Plan Farm 70
Salamá, Puntarenas, Costa Rica**

Alterra-Report Farm 70 Costa Rica.doc

Alterra, Wageningen, 2007

This report presents a “second” opinion of the drainage plan for the teak plantation Farm 70, Salamá, Puntarenans in Costa Rica. The report discusses options to reduce the risk of high watertables in this teak plantation (71.56 ha).

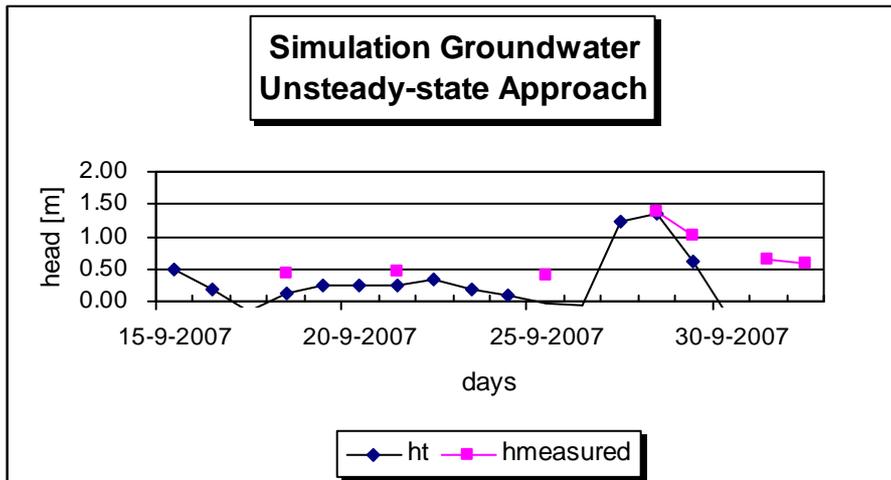
Table 5. Simulation of the drop of the watertable after the extreme rainfall event on September, 27, 2007

spreadsheet model based on the Zeeuw-Hellinga approach (Ritzema *et al.*, 1998) was used. The results are presented in Table 5.

Input:				
•	hydraulic conductivity	(K)	1.80	[m/d]
•	thickness of peat layer	(D)	4.00	[m]
•	drainable pore space	(μ)	0.15	[-]
•	drain spacing	(L)	25	[m]
•	time step	(dT)	1	[d]
•	design head difference	(h_0)	0.50	[m]
Measured and simulated head (difference water level midway between drains and in the drain) and corresponding discharge				
Day	Rain	h_t	q_t	h_{measured}
	[mm]	[m]	[mm/d]	[m]
15-09-07	8.2	0.50	49.0	
16-09-07	0	0.17	49.0	
17-09-07	2	-0.14	16.3	
18-09-07	55.2	0.12	-12.6	0.42
19-09-07	8.2	0.26	11.2	
20-09-07	9.4	0.25	24.6	
21-09-07	24.8	0.25	23.4	0.45
22-09-07	39.2	0.35	23.6	
23-09-07	0	0.20	34.0	
24-09-07	17.2	0.08	18.5	
25-09-07	0	-0.04	7.8	0.40
26-09-07	4.8	-0.06	-3.6	
27-09-07	189.2	1.23	-5.4	
28-09-07	12.4	1.34	130.3	1.40
29-09-07	20.6	0.61	144.8	1.02
30-09-07	7.8	-0.30	60.9	
01-10-07	45.4	-0.40	-26.6	0.65
02-10-07	0.0	-0.23	-35.3	0.60

The simulations indicate that with the selected drain spacing the watertable indeed drops back to 0.90 m after 36 hours. Thus it can be concluded that the selected drain spacing are appropriate.

5. The extreme rainfall events on September, 27, 2007, was used to verify the selected drain spacing under extreme conditions. Based on the presented data on the watertable drawdown it can be concluded that the selected drain spacing are appropriate.
